Geotechnical Investigation of
Cut Slopes at the Belina Mine Complex
and Haul Road
Carbon County, Utah

Valley Camp of Utah,
Helper, Utah

Morrison-Knudsen Co., Inc.
Boise, Idaho

October, 1983

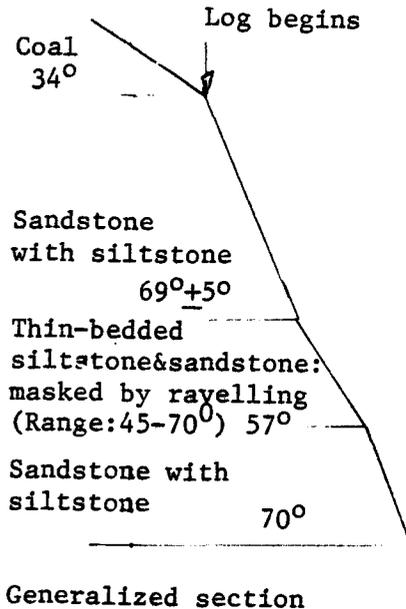
Figure 7

Elevation	Depth	Group Symbol	Description of Materials	Sample No.	Blows	Remarks
9042*	0		Sandstone: hard; fractured in part.			Composite log of cut slope behind the changehouse, at the center of the building. Depths shown in log are <u>estimated</u> only, from the base of the coal stratum.
9040.5	1.5		Siltstone			
9039.5	2.5		Sandstone: hard; joints strike N80W with dip 70-90°N.			
9038	4		Siltstone			
9037.5	4.5		Sandstone: hard, as before.			
9036	6		Shale and siltstone: hard.			
9034.5	7.5		Sandstone: as before, but secondary joint system strikes N20E and dips 80°E.			
9033	9		Alternating zones of sandstone and siltstone.			
9030	12		Coal			
9029.5	12.5		Sandstone: hard, as before.			
9028.5	13.5		Siltstone: thin-bedded (½ to 2"); soft rock. Source of erosion, ravelling, and undercut.			Generalized section
9025	17		Sandstone and siltstone: 1-6" thick bedding; joints strike N10E, dipping 85°E.			
9022	20

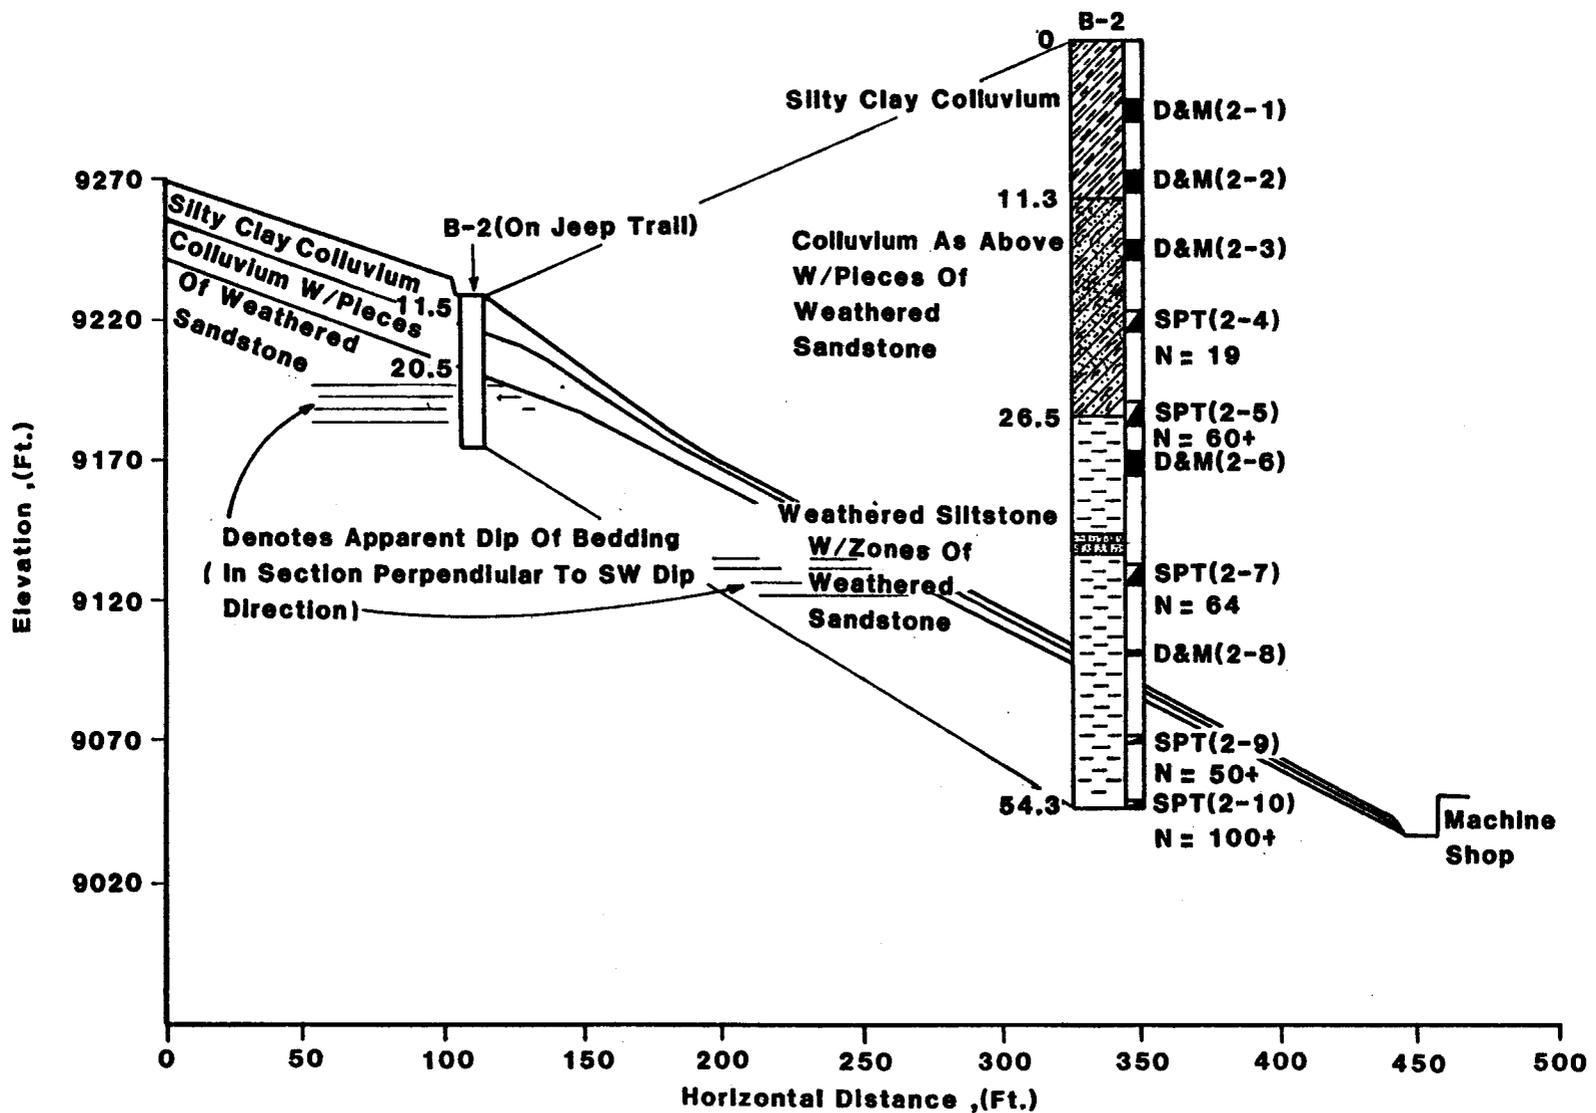
VALLEY CAMP OF UTAH, INC.
 BELINA MINE, CARBON COUNTY
 UPPER PORTAL BACKSLOPE SECTION B - B'
 (ACTIVE SLIDE AREA)
FIGURE 16

In general, the backslope above the upper portals appears to be in a nearly natural condition. The slide area seems to be more the result of natural weathering processes on a daylighting fault zone than a condition caused by mining activities.

6.1 GENERAL CONCLUSIONS: Slope stability analyses have indicated that the cut slopes in the area of mine facilities are, in general, stable. The steeper portion of the backslope above the upper portals, represented by section B-B', is the only backslope that does not meet the required 1.3 minimum factor of safety established by the State of Utah for cut slopes steeper than 2 horizontal to 1 vertical. It should be reiterated that this so-called "unstable" condition may not be related to mining operations and may rather be associated with natural geologic discontinuities.

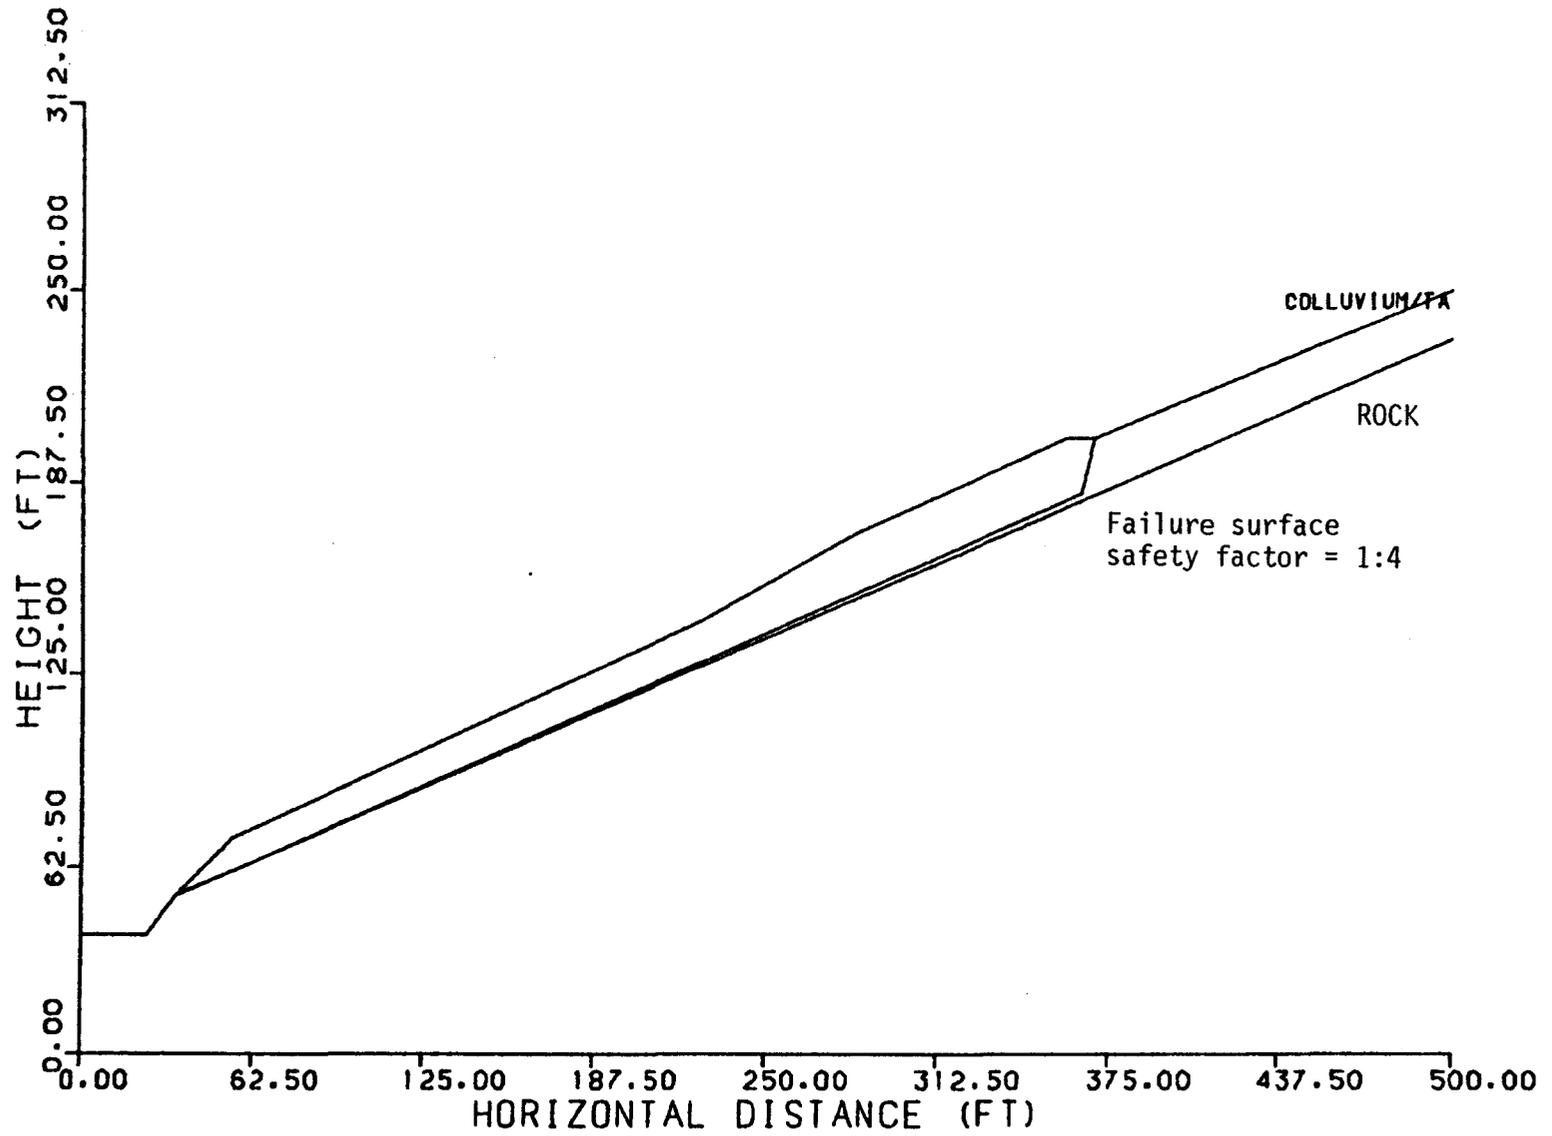
Figure 21

5.2 ANALYSIS OF BACKSLOPE ABOVE UPPER PORTALS: The computer-generated geologic models of the A-A' and B-B' sections are included in this report as Figures 21 and 22. The most critical failure paths passed through the colluvium and(or) talus interface with the underlying bedrock surface. For section A-A', the corresponding factor of safety against slope instability was 1.4. For section B-B' the factor of safety was 1.15 at the steepest portion of the slope, just below boring no. 2. Failure surfaces extending into bedrock materials had very high factors of safety, in excess of 2.5.

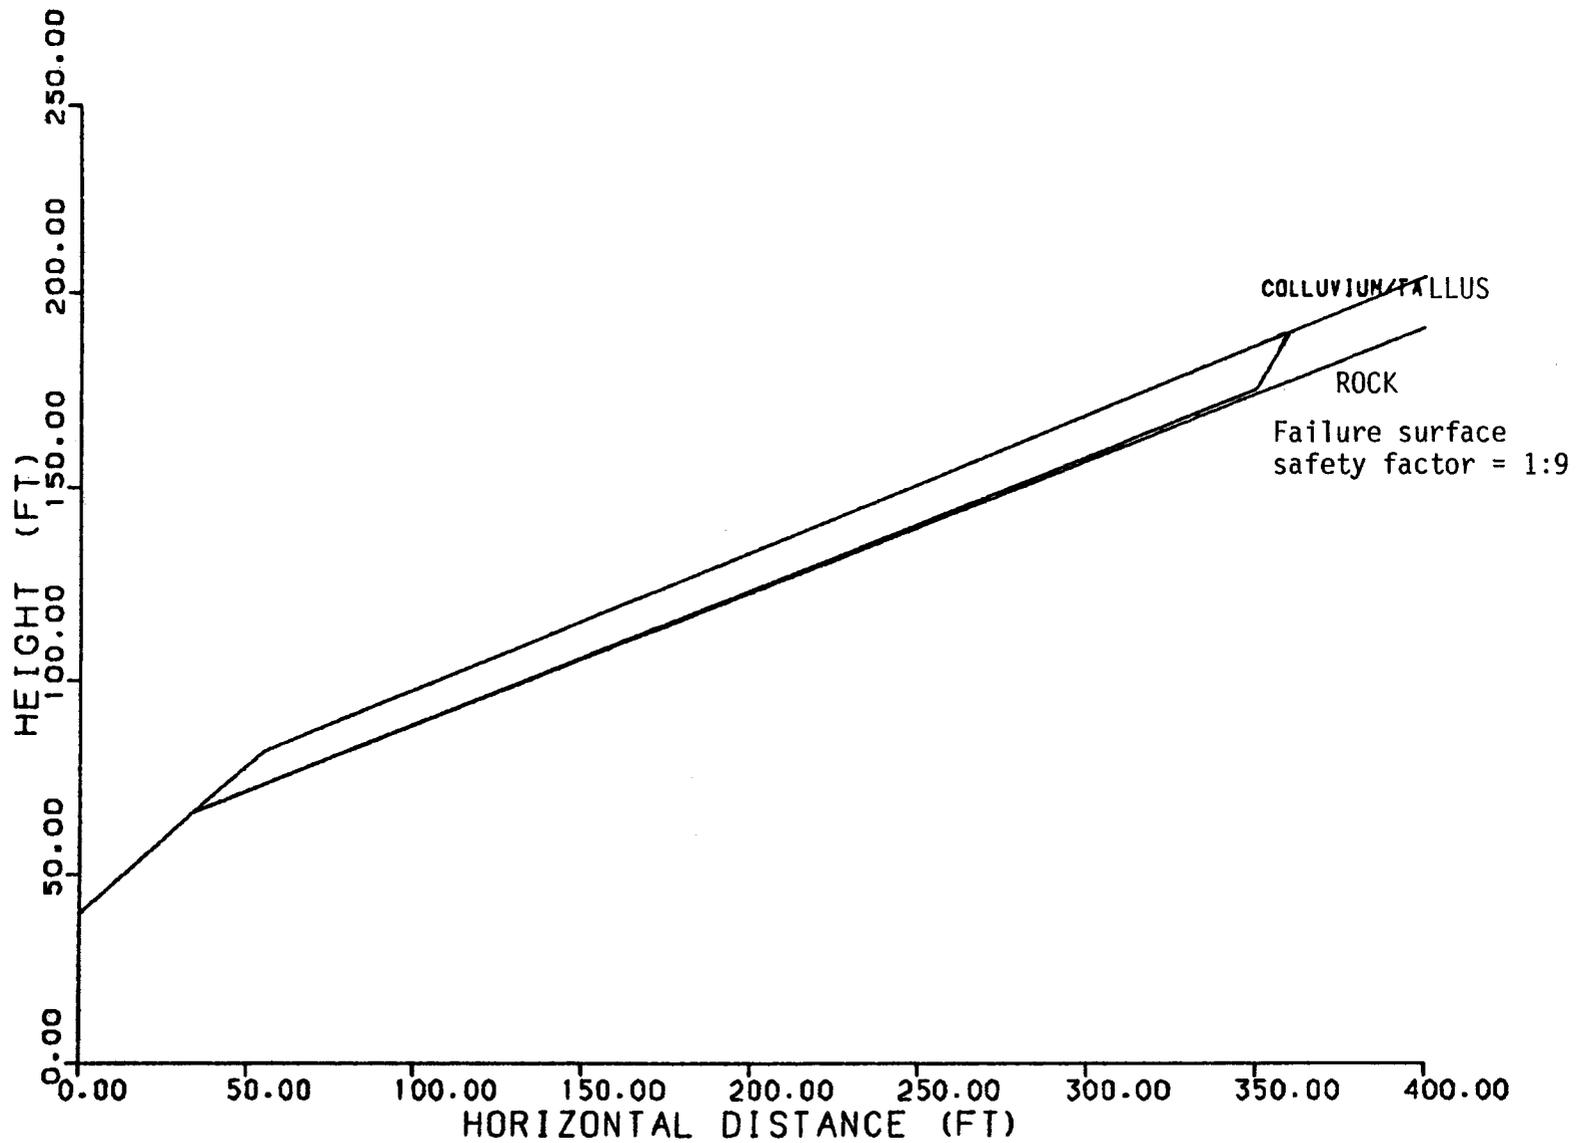
5.3 ANALYSIS OF BACKSLOPE ABOVE THE OFFICE/CHANGEHOUSE: Figure 23 presents the computer-generated geologic model of the C-C' section. As in the analysis for the adjacent backslope described above, the most critical failure path passed through the colluvium and(or) talus interface with the bedrock. The lowest factor of safety obtained was 1.9.

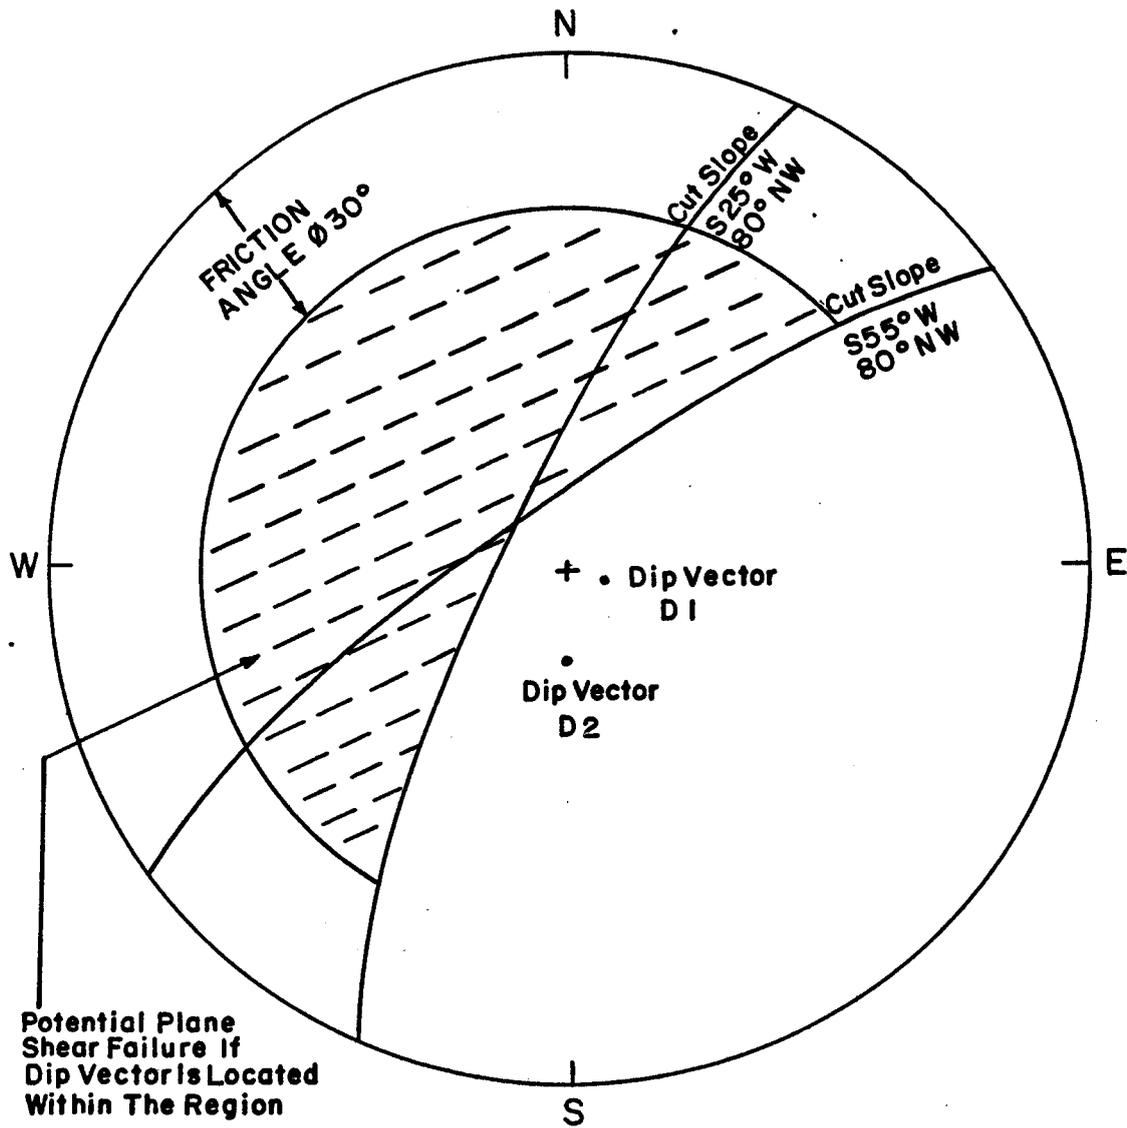
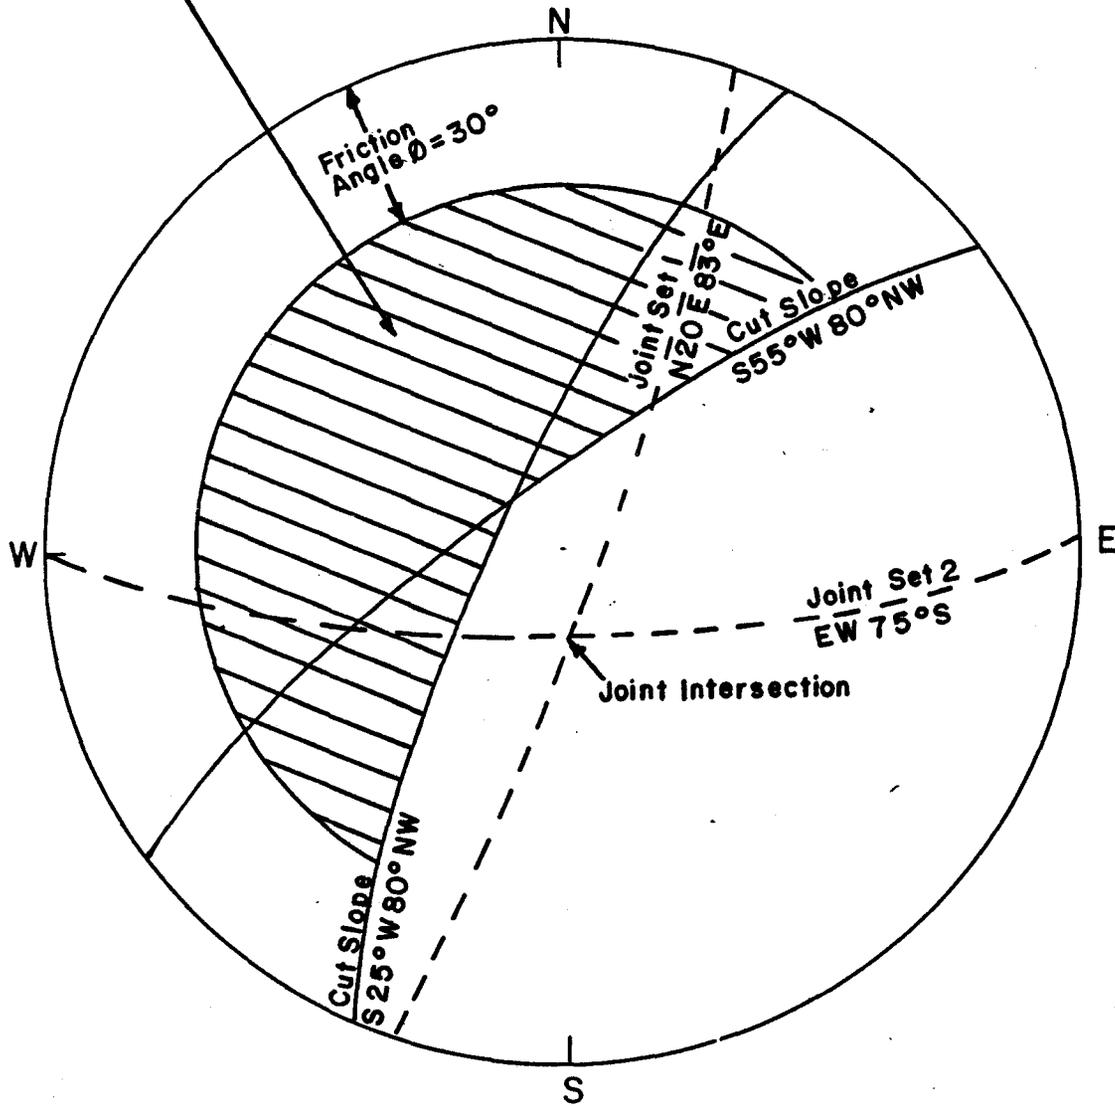
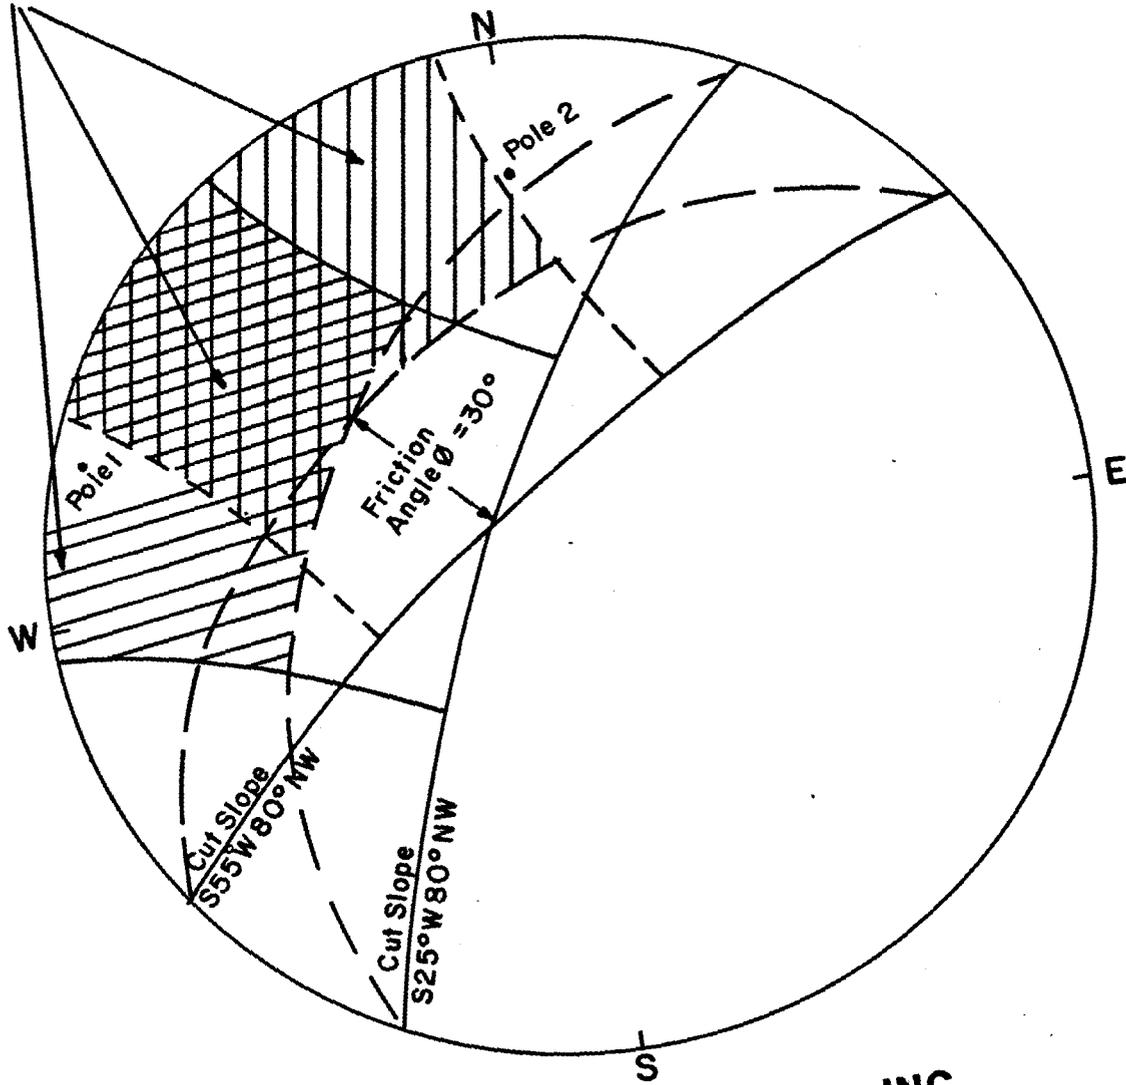
5.4 ANALYSIS OF THE CUT SLOPE NEAR THE COAL LOADOUT CHUTE: Stereographic projections are long recognized methods of presenting kinematic tests for various modes of slope instability. Using the cut slope log "B-7" and detail line data, stereographic projections were prepared for potential shear plane, wedge and toppling failures (Figures 24 through 26). The massive sandstone in this cut is extremely competent and joint orientations generally appear to be favorable. Only that portion of the cut slope striking S25°W shows a slight potential for failure in a toppling mode. However, the adjacent portion of the cut confines this potential toppling section, causing the entire slope to be safe.
