RE: Review: Demonstration of Design Event Exceedance (received September 6, 1991), Belina Mine Complex, Valley Camp Coal, Inc., ACT/007/001, Carbon County, Utah

INSPECTION REPORT

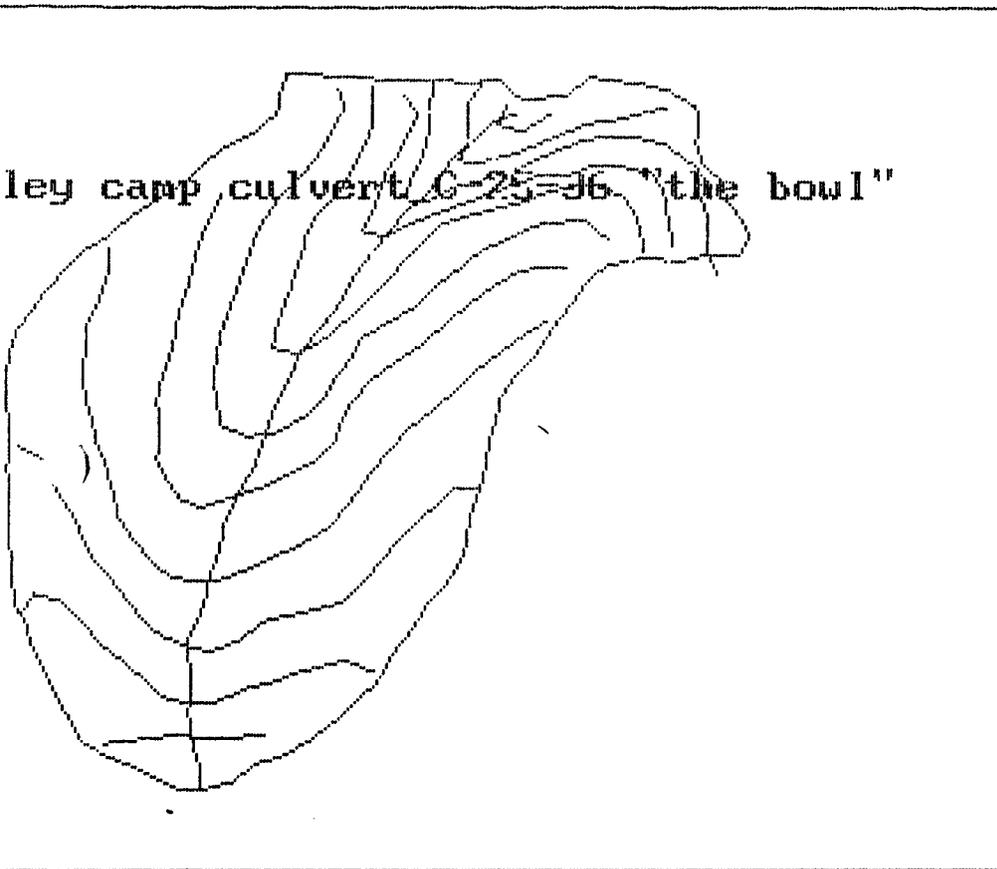
AREA: 156.26 acres

HYDRAULIC LENGTH: 4044.61 ft.

$T_c = 0.4940$, slope = 16.24%

$T_{PC, 10-6} = 1.55''$

$Q_{10-6} = 7.31 \text{ cfs}$ \therefore applicable value
