Re: N2000-46-1-2

Lodestar has received your letter of April 25, 2000 containing the rationale for not vacating the "failure to repair subsidence" NOV issued April 11, 2000. Had I realized that Inspector Hess had initiated a full review of the facts surrounding the NOV I would have presented the following information sooner so that he would have had time to review the progression of events surrounding the slump. Though belated, Lodestar would like to take this opportunity to provide additional information regarding the facts related to this issue. This letter will first establish the sequence of events when the subsidence began, next comment on the technical memo by Inspector Hess and then comment on the findings letter of April 25<sup>th</sup>.

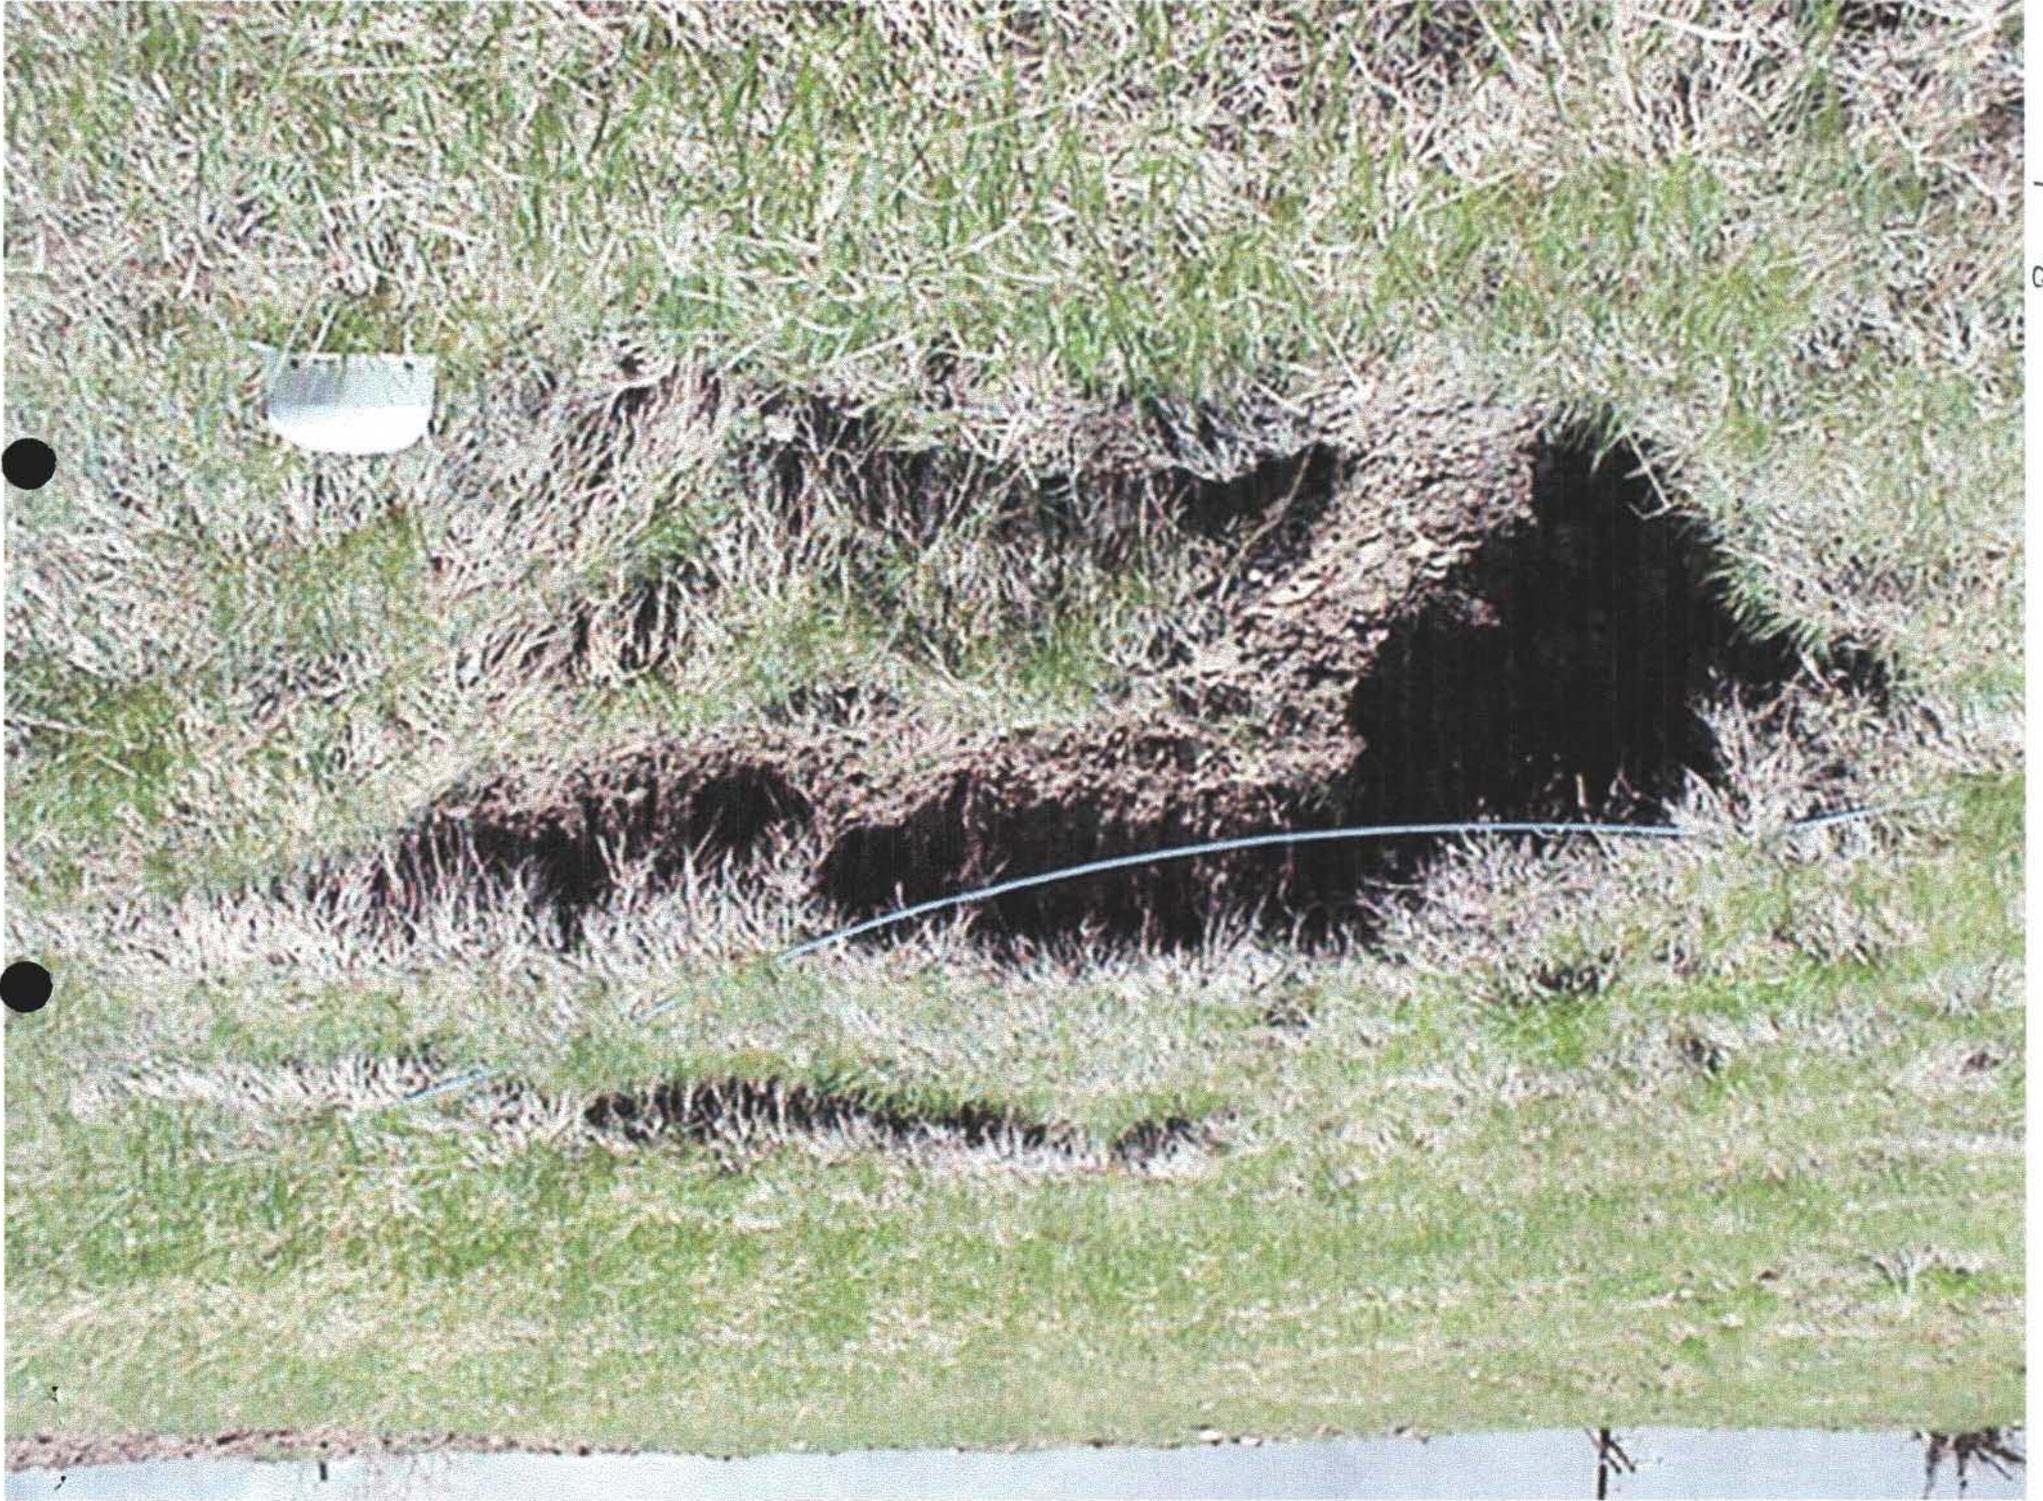
PHOTO 1

The ground surface above the mud flow was inspected for signs of piping. The only feature that was found was an old depression that was about 10' x 5' x 3' deep, see Photo 1. The depression appeared to be fairly old since there was vegetation growing in it. The depression also was not in the correct location. It appeared to be from a similar event that had occurred years previously and was about 100 feet outby the mud flow. Given the uncertainty of the location, the entire slope between the two mines was dangered off with danger tape at the top and bottom of the slope.
