Subject: White Oak Mine Subsidence Feature Inspection

Inspection Report For Coal Operations

Inspection Number JM-101000

Mine White Oak Purpose Special

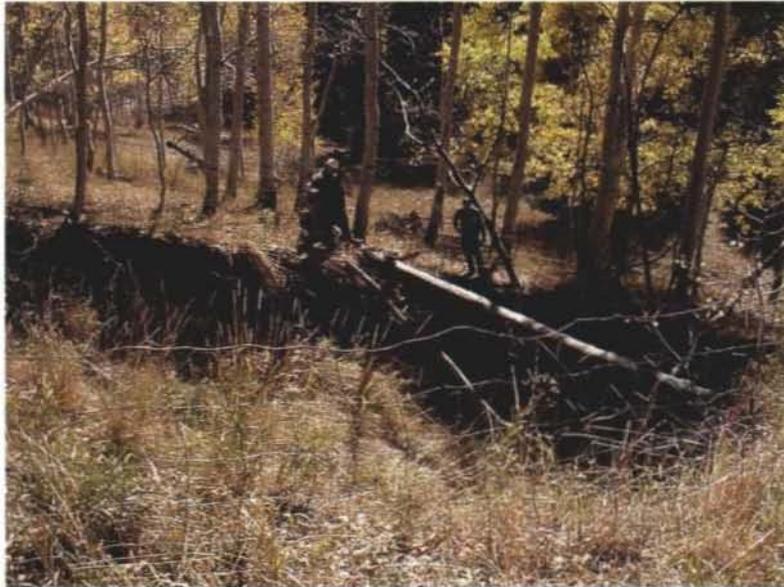
**#1 Boarding House Canyon Subsidence Sinkhole Item #23
Looking East (Note the Fence)**

In summary, after visiting the site the BLM recommends that nothing additional be done to reclaim the sites. The sites do not present any apparent hazards and no signs of additional disturbance is evident. The sites appear to be reclaiming naturally and that any attempts to assist in the reclamation will result in additional unnecessary disturbance. In addition, the BLM recommends that the fence around the Boardinghouse site be maintained. Monitoring of the sites should continue until such time that data is presented, and concurrence has been reached between DOGM, USFS and the BLM, that demonstrates subsidence is substantially complete.

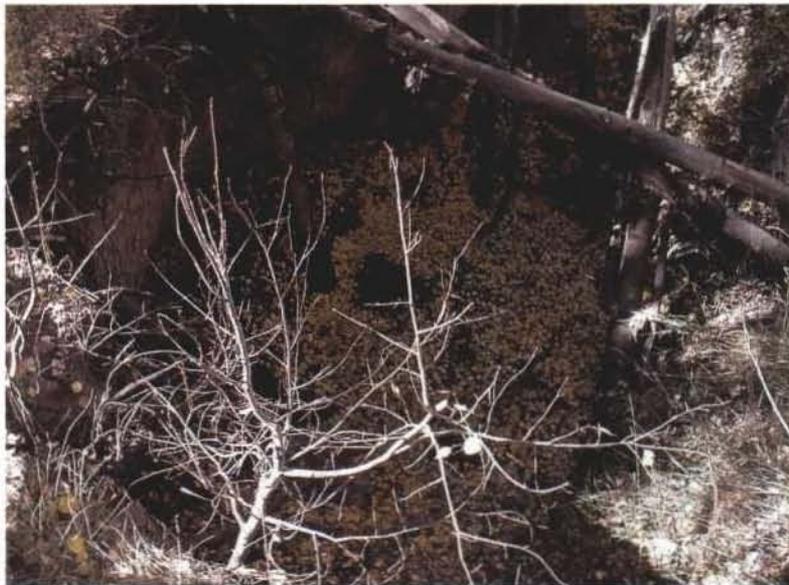
#2 Boarding House Canyon Subsidence Sinkhole Item #23 (Standing Water)

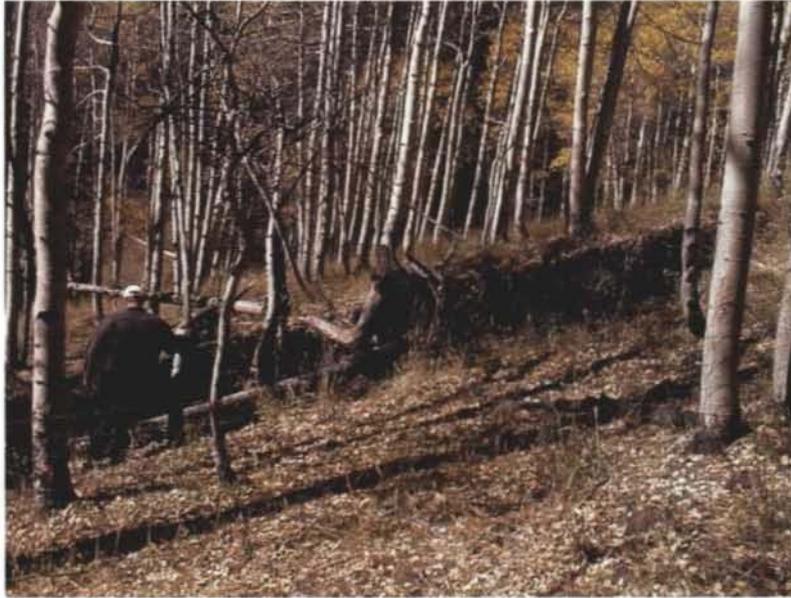
#3 Boarding House Canyon Subsidence Sinkhole Item #23
Looking West

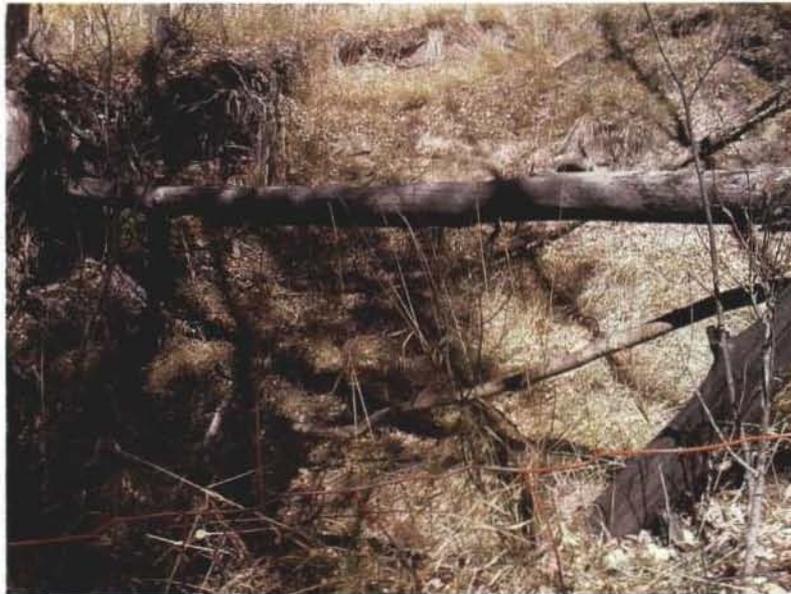
#4 Boarding House Canyon Item #23 showing slope into sinkhole.
Looking North

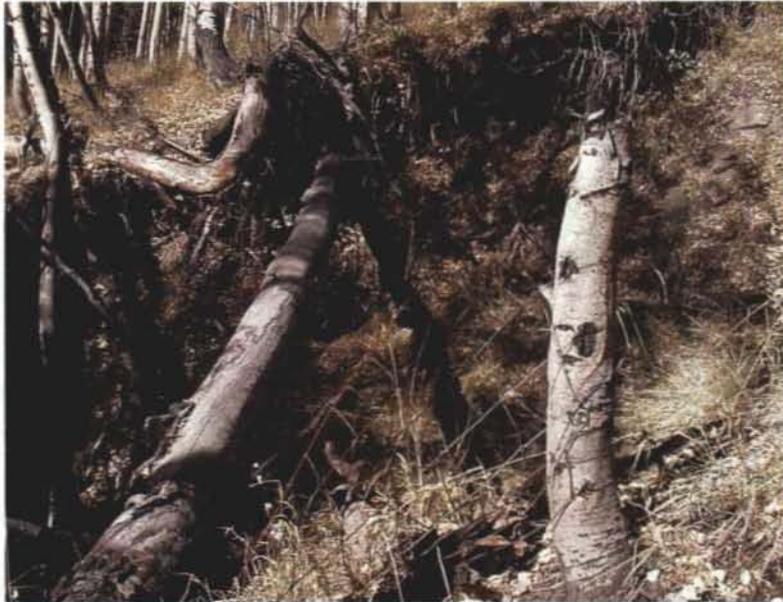
#5 Boarding House Canyon Item #23 showing slope into sinkhole.
Looking South-West

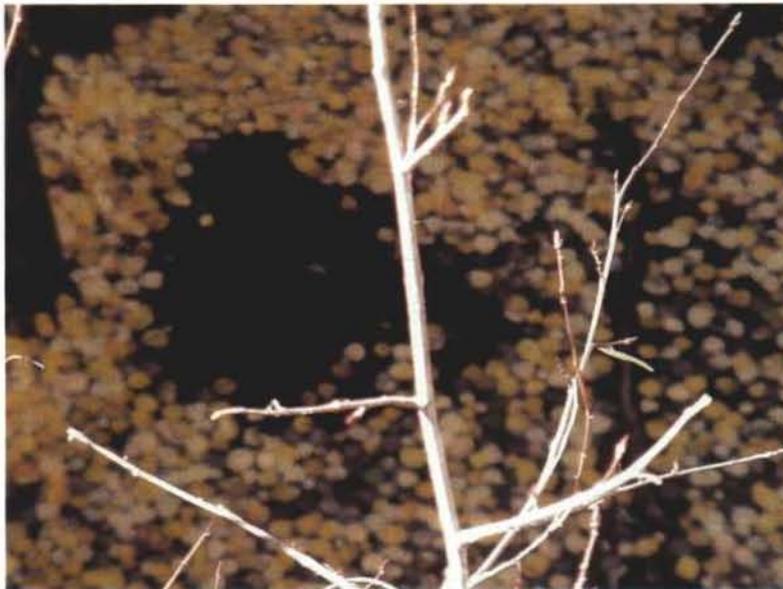
#6 Boarding House Canyon Item #23 showing close-up of standing water in Sinkhole.
Indicates lack of direct link with the mine.

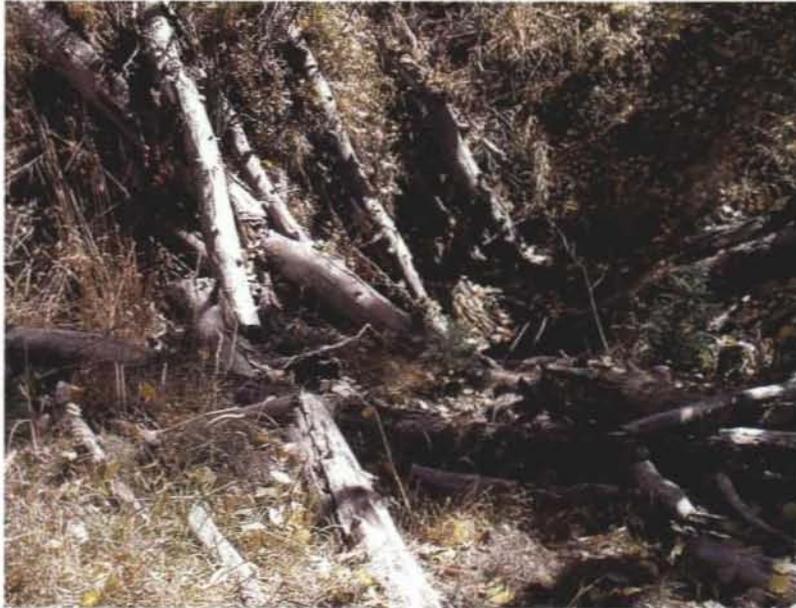
#7 Near 2nd South Section believed to be Item #2. No standing water.

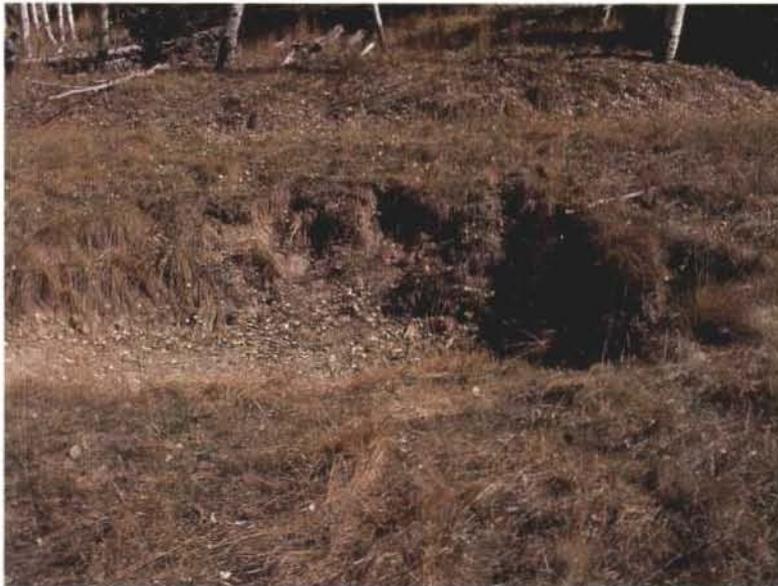
#8 Near 2nd South Section believed to be Item #1. Evidence of wildlife using area for wallow-area.

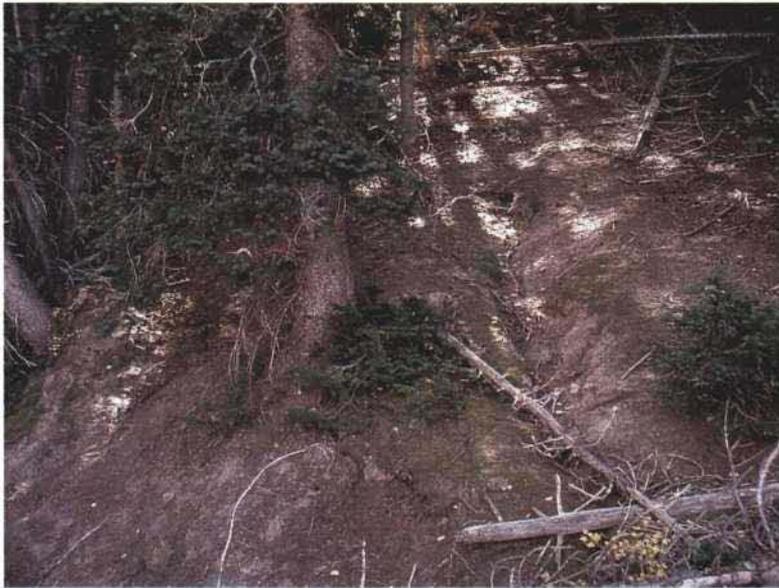
#9 Near 2nd South Section believed to be Item #42 (Crack)
Appears to be naturally occurring and not mining related.

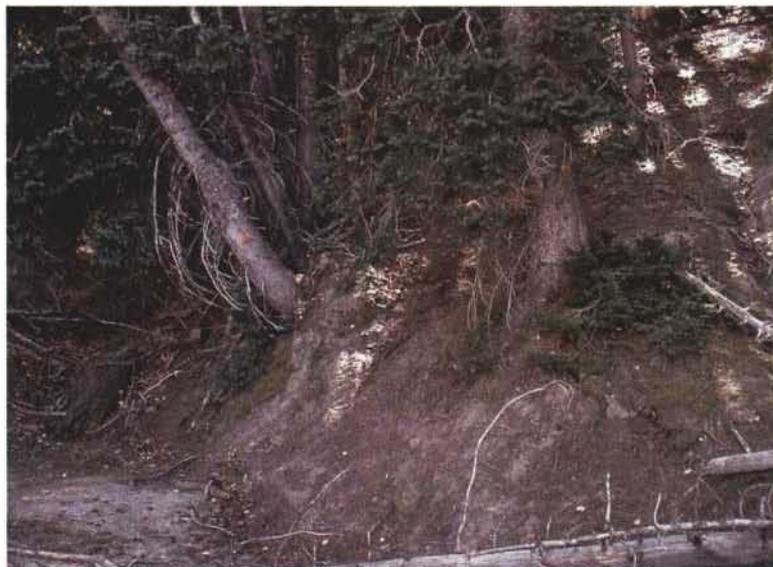
#10 Near 2nd South Section believed to be Item #42 (Crack)
Appears to be naturally occurring and not mining related.
