INSPECTION REPORT

Mine Name: White Oak #1 and #2 County: Carbon Permit Number: ACT/007/001
Permittee and/or Operator's Name: Lodestar Energy, Inc. and subsidiaries
Business Address: HC 35 Box 370, Helper, Utah 84526
Type of Mining Activity: Underground XXX Surface _____ Prep. Plant _____ Other _____
Company Official(s): John Walters, mining engineer
State Official(s): Peter Hess Federal Official(s): Jay Marshall, George Tetrault, USDOJ/BLM
Weather Conditions: Sunny, cool, 40's Fahrenheit/mild breeze
Existing Acreage: Permitted 3746 Disturbed 140.2 Regraded _____ Seeded _____
Status: Exploration _____ Active XXX Inactive _____ Temporary Cessation _____ Bond Forfeiture _____
Reclamation (Phase I _____ Phase II _____ Final Bond Release _____ Liability _____ Year _____)

PERMIT NUMBER: ACT/007/001

DATE OF INSPECTION: 10/06/2000

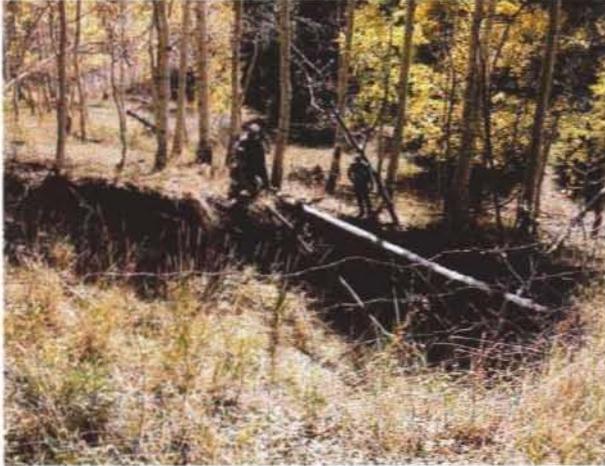
Impact #23 is of major concern due to the fact that it is located on Manti-Lasal National Forest surface in Boarding House Canyon. Occurring at surface elevation 9,341, the slump is approximately 30 feet wide and 48 feet long, with a depth of approximately 15 feet. Water was observed in the slump, indicating that no conduit exists between the surface and the Mine workings. Based on a review of a map titled "White Oak #1 Mine Overburden and Cover," approximately 350 feet of cover exists in this area. Impact #23 occurred when a previous permittee (mid 1980's) attempted to delineate a fault in the area, by developing three entries. When the extreme right hand entry was opened, the fragile overlying material chimneyed to the surface, creating the impact. There was no secondary extraction practiced in the area (based on the map), although secondary extraction via the splitting of pillars was practiced in the section immediately to the east (area in which subsidence impacts #22 and #53 occurred).

This area is surrounded by a three foot wire fence, and it appears that wildlife would have no difficulty getting out of the slump. There were no hoof prints evident, nor were there any carcasses.

#1 Boarding House Canyon Subsidence Sinkhole Item #23 Looking East
(Note the Fence)

It is this inspector's opinion that all three of the impacts are too far from any machinery access to mitigate, based on the guidance of "economically and technologically feasible" criterion, (R645-301-525.510). More environmental damage would be created than would be effectively mitigated by repairing the impacted areas.

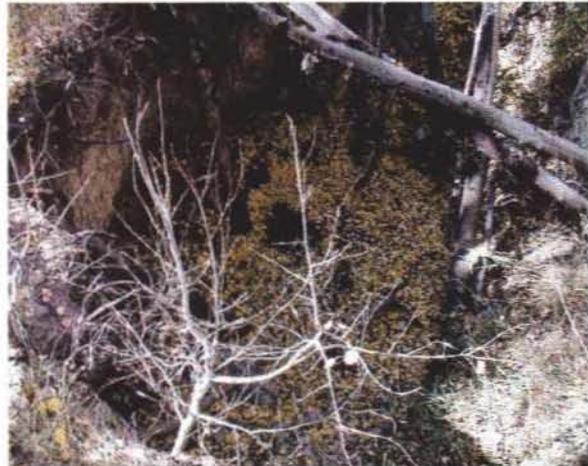
#2 Boarding House Canyon Subsidence Sinkhole Item #23
(Standing Water)

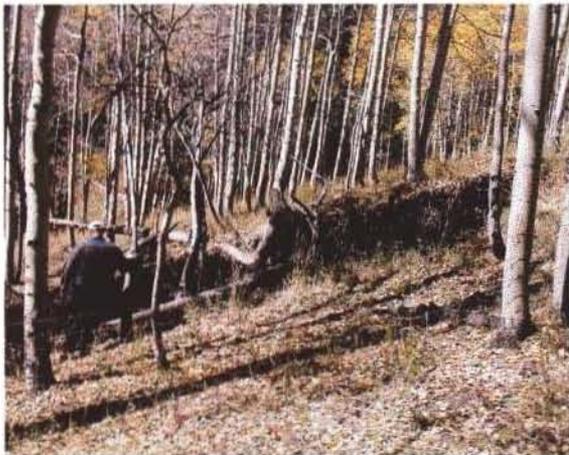
#3 Boarding House Canyon Subsidence Sinkhole Item #23
Looking West

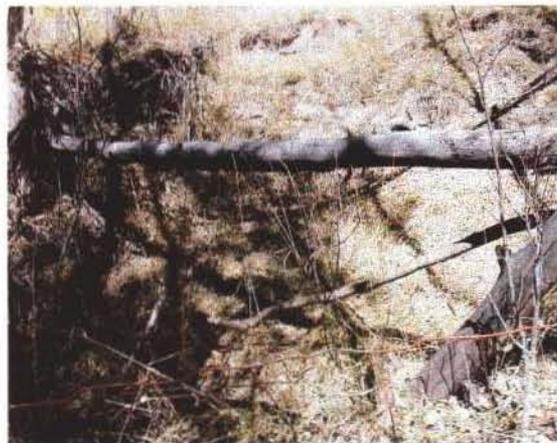
#4 Boarding House Canyon Item #23 showing slope into sinkhole.
Looking North

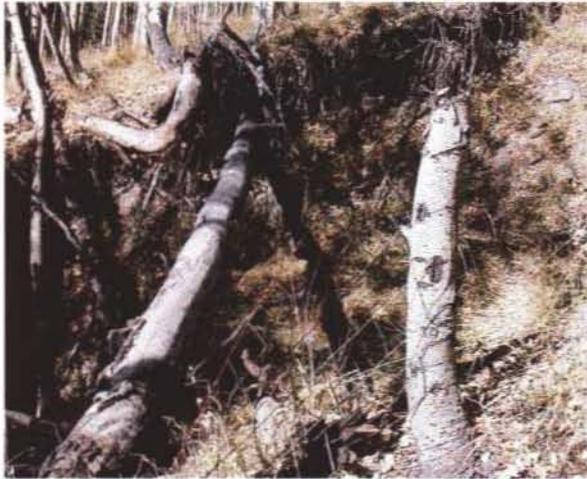
#5 Boarding House Canyon
Item #23 showing slope into sinkhole.
Looking South-West

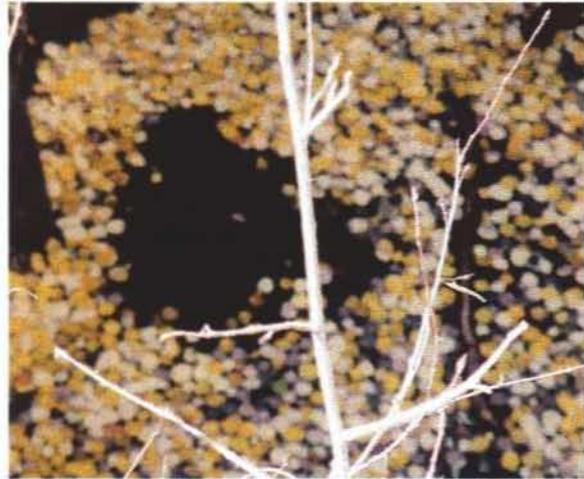
#6 Boarding House Canyon Item #23
showing close-up of standing water in Sinkhole.
Indicates lack of direct link with the mine.

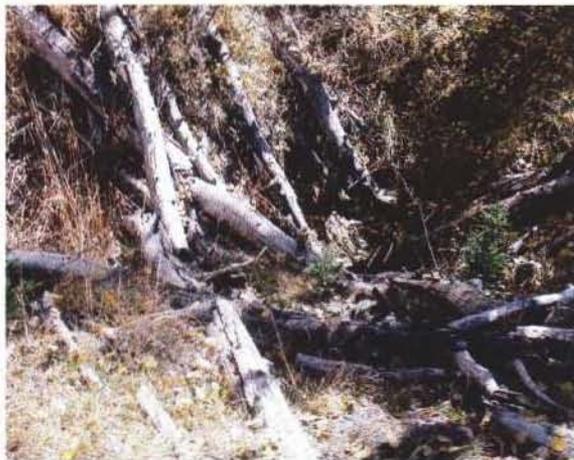
Impact area #2 also occurs in an area where the overburden depth varies between 300 and 400 feet. Two other areas were observed and it was assumed that these can be identified as areas #1 and #19. They are inline as shown on the previously mentioned map, which depicts them in an area where secondary extraction was practiced in shallow cover. Impact #2 is 32 feet in diameter and approximately 12 feet deep. There is no water in the hole. Vegetation, which has slumped in, continues to grow. Area #1 appears to be being used as a wildlife wallowing area.

#7 Near 2nd South Section believed to
be Item #2. No standing water.

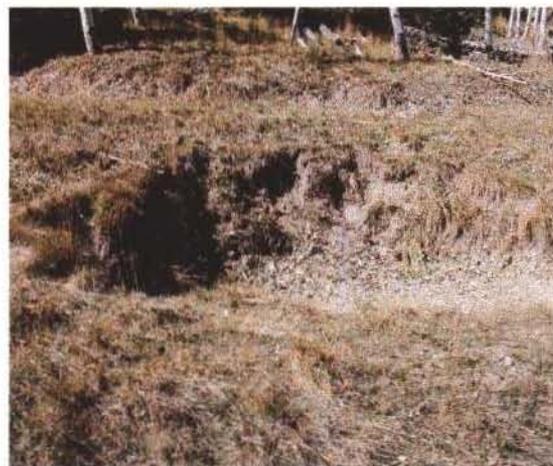
#8 Near 2nd South Section believed to be Item #1.
Evidence of wildlife using area for wallow-area.

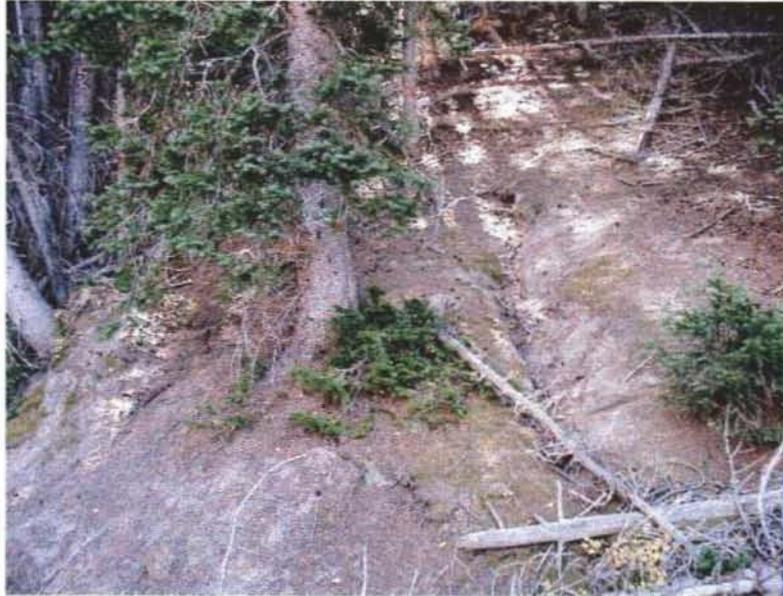
#9 Near 2nd South Section believed to be Item #42 (Crack)
Appears to be naturally occurring and not mining related.

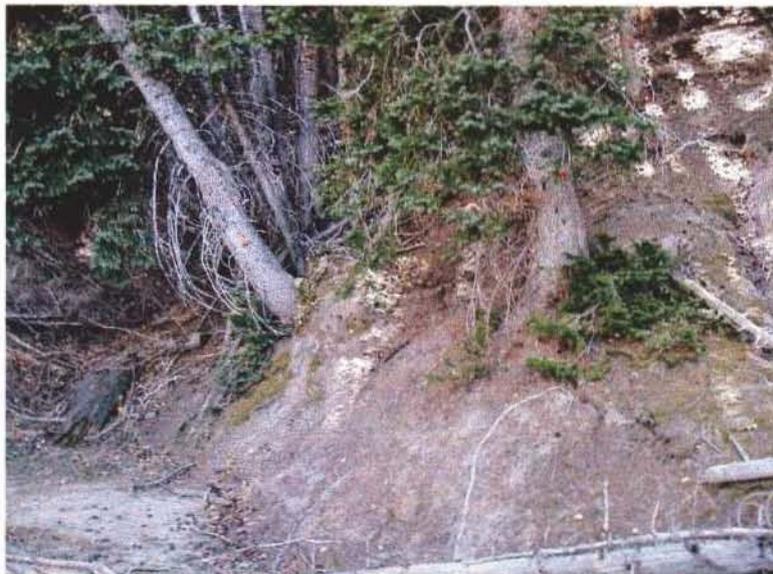
#10 Near 2nd South Section believed to be Item #42 (Crack)
Appears to be naturally occurring and not mining related.
