## Inspection Report

Permit Number:	C0070001
Inspection Type:	COMPLETE
Inspection Date:	Tuesday, June 19, 2012
Start Date/Time:	6/19/2012 11:00:00 AM
End Date/Time:	6/19/2012 3:30:00 PM
Last Inspection:	Wednesday, May 16, 2012

Site: **WHITE OAK MINE**

June 19, 2012 White Oak Inspection Report #3141 Attachment

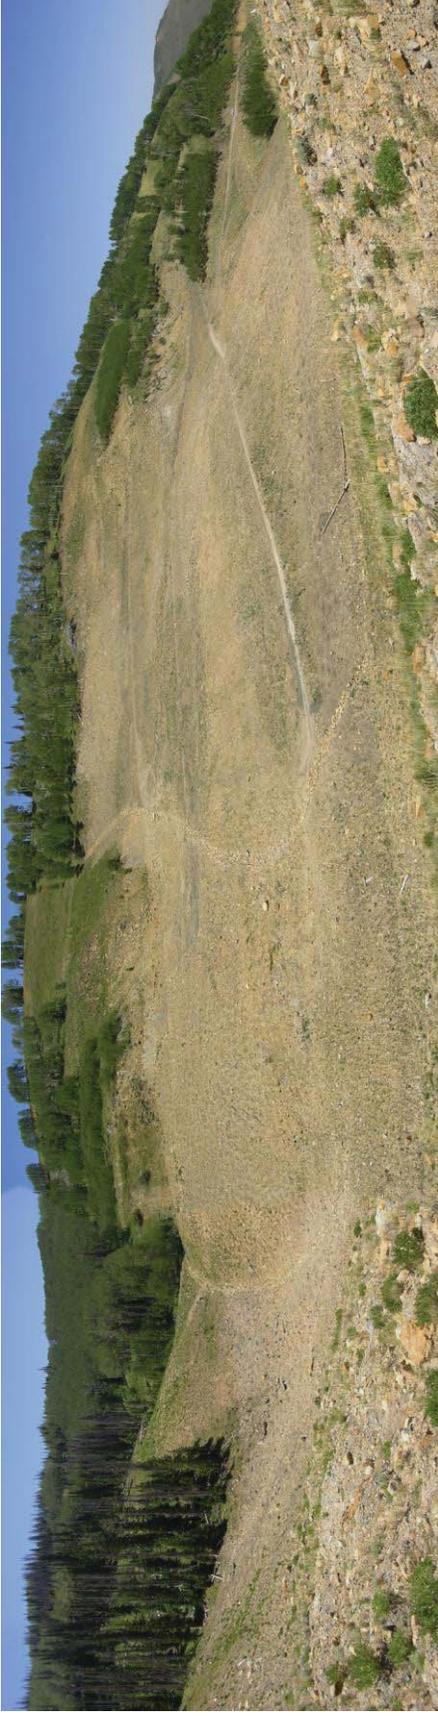
Panorama of upper Whiskey Creek and the untreated slope and treated east facing slopes.

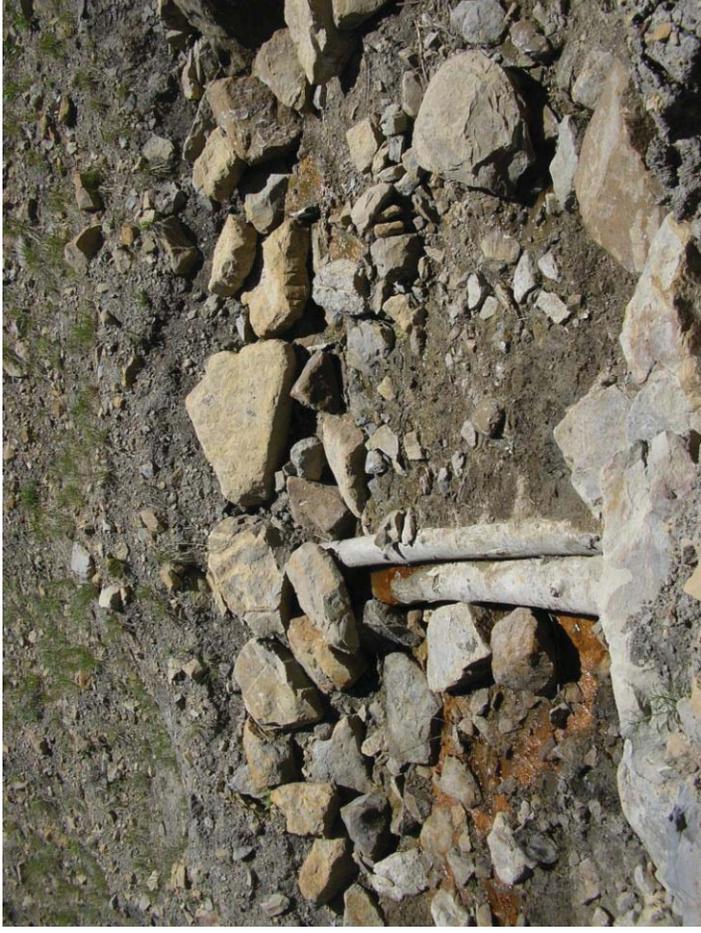
Drop structure #7

Oxidation of iron seep water within the stream channel at drop structure #7. This dissipates within 50 ft. See photos. There is no noticeable flow from Whiskey Creek to Eccles Creek.

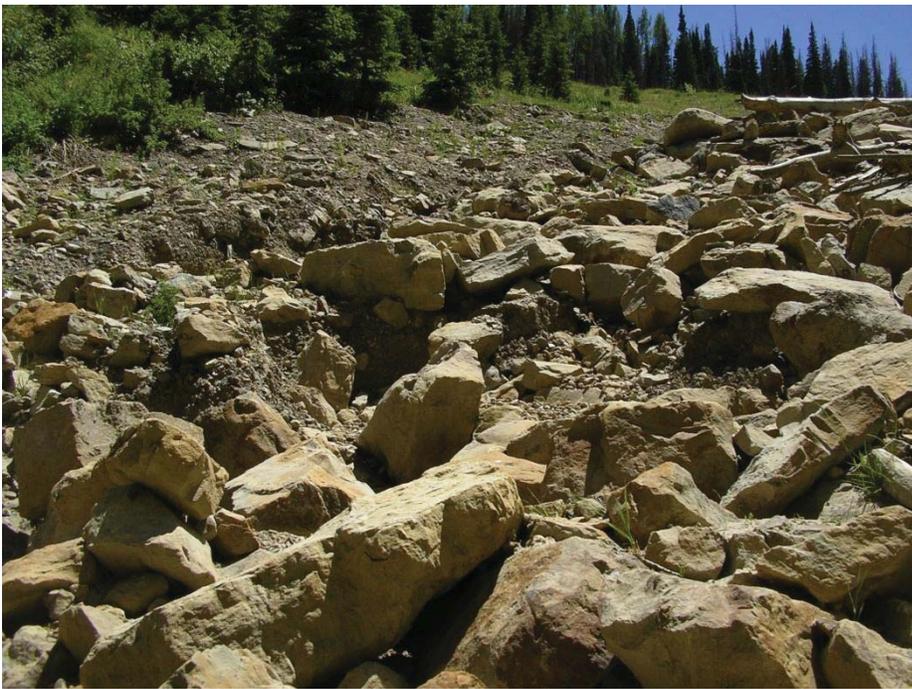
Ladder structure below drop structure #2

Walked reclaimed site. Revegetation and plantings are doing well on the slopes and in the channel. Grasses are in seed. Triticale has emerged from the 2011 seeding. The ladder structure below drop structure #2 needs to be watched. The rocks do not appear stable. The low flow water goes beneath the ladder and re-emerges at the disturbed area boundary.

The ladder between the first and second drop structures (counting from the bottom up) is becoming unstable. Now there is a 30 ft. of rock rubble between two lower pools and drop structures. Water is flowing beneath the ladder structures and exits at the undisturbed boundary. There are small surface cracks appearing in the fill above the small sink hole and perhaps some piping around the boulder. There is no cracking in the fill of the large sink hole, however the fill is no longer mounded high.
