Division of Oil, Gas and Mining

Inspection Report

Permit Number:	C0070001
Inspection Type:	COMPLETE OVERSITE
Inspection Date:	Wednesday, June 12, 2013
Start Date/Time:	6/12/2013 11:00:00 AM
End Date/Time:	6/12/2013 3:00:00 PM
Last Inspection:	Friday, May 31, 2013

Site: **WHITE OAK MINE**

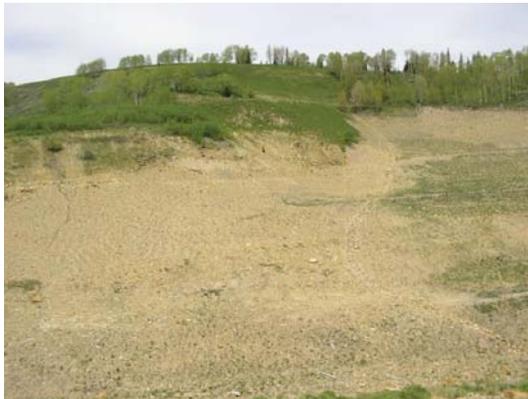
2013. The above image shows the SW facing slope which was reclaimed in 2005. The 2010 reclamation was limited to the right of the side channel.

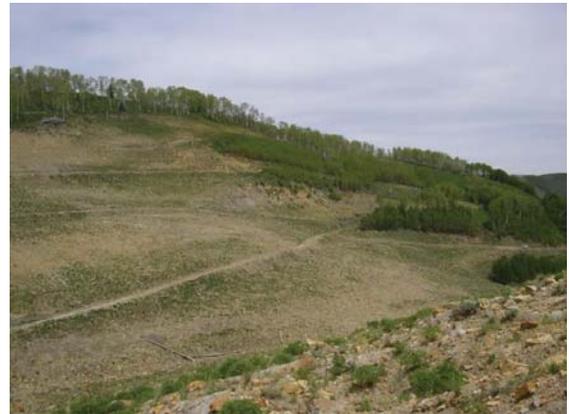
2013. Showing terraces C, B, A and Reach 2 of the Whiskey Creek stream channel that were stabilized in 2010.

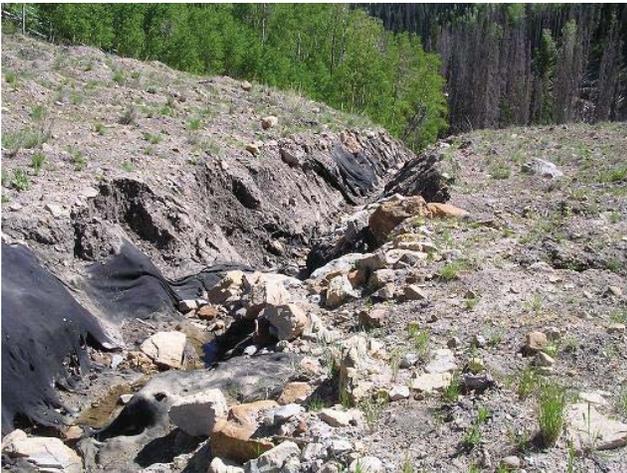
Reach 3 Images

Reach 3 downstream view prior to stabilization work in 2010. The channel was deeply incised and carrying sediment to Eccles Creek.

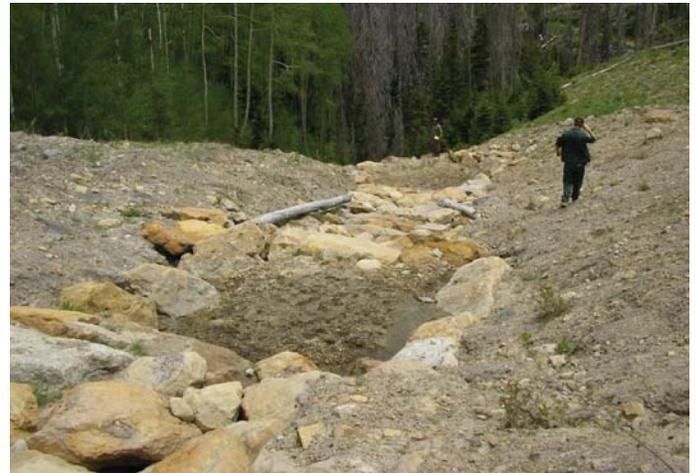
Two seeps were emanating from the slope above the Whiskey creek channel in Reach 2. One seep was emanating from beneath a drop structure in Reach 3. The Reach 3 seep was iron rich. A sample of this seep was taken in August 2012. The lab analysis is attached to this inspection report.

Reach 3 in 2013. Removal of geotextile fabric, widening of channel, creating a small meander and construction of rock drop structures was completed in 2011. Note riparian plantings on bank.

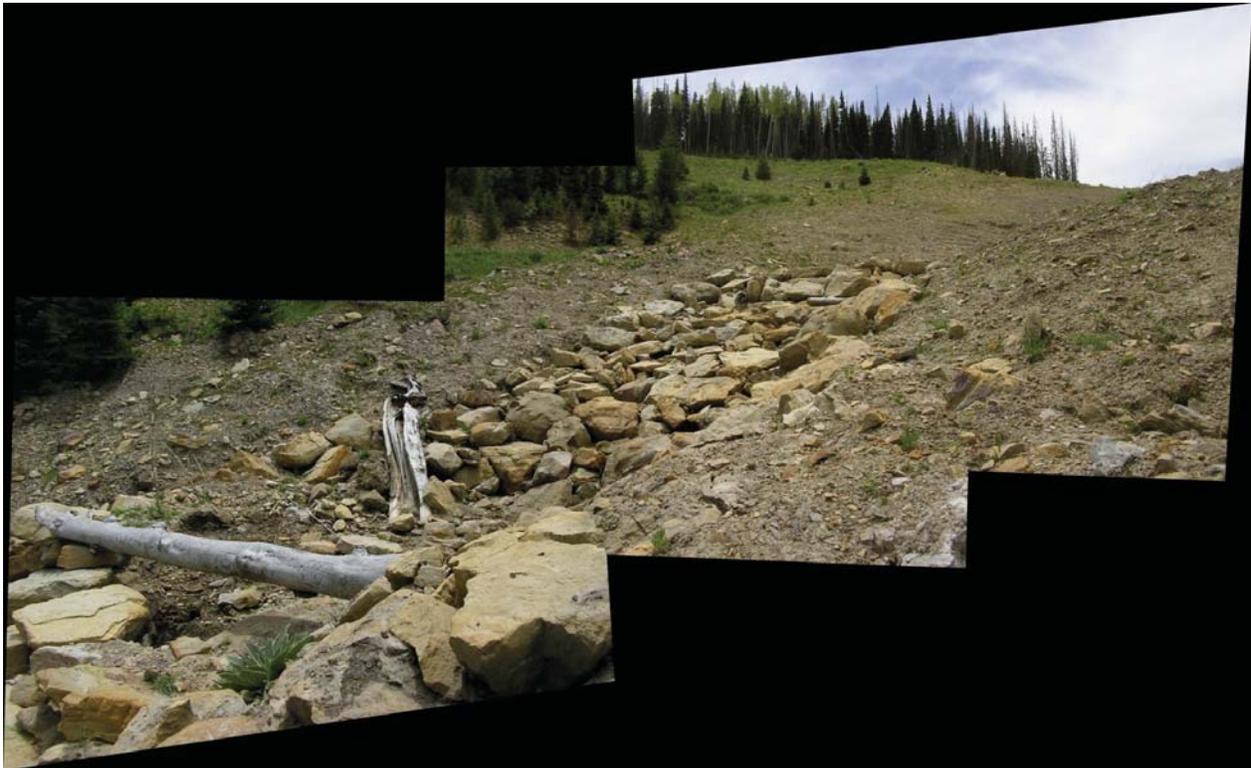
Reach 4 drop structure 2 on the bottom. Drop structure 3 at the top of rock ladder.

Disturbed area boundary in Reach 4.

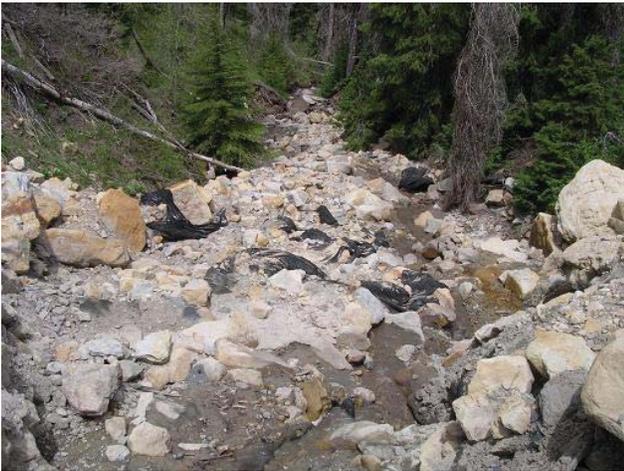
2010 before stabilization work.

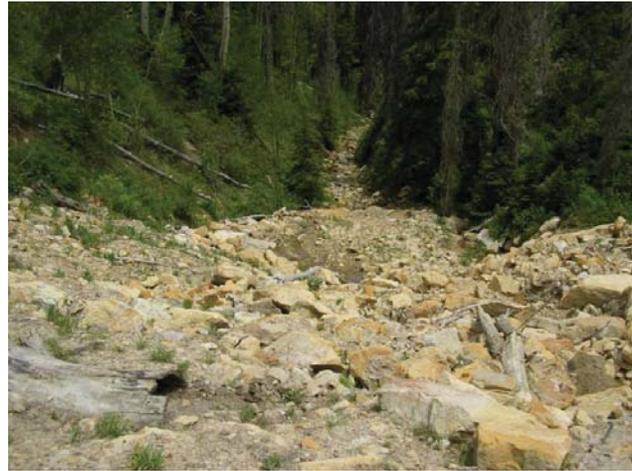
2013. Drop structure/pool #1 was constructed at the disturbed area boundary.

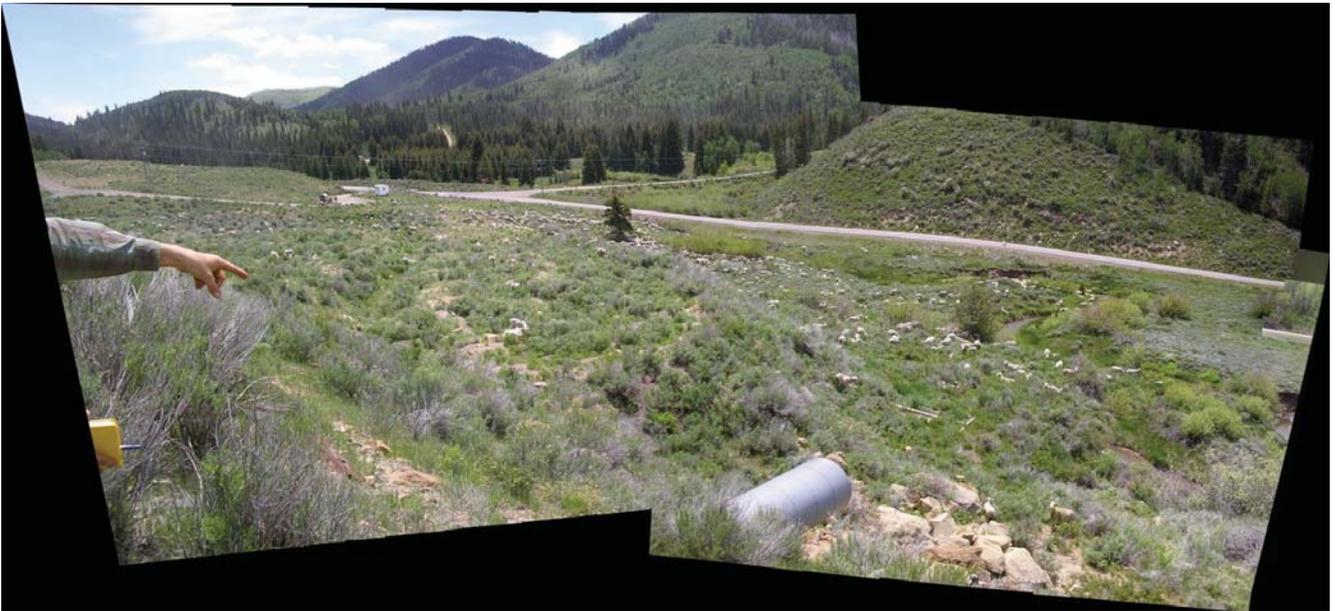
A herd of hundreds of sheep was grazing the loadout. The sheep were herded to the site today and the herder has set up camp at the loadout.

2013 Sheep grazing at the reclaimed loadout.
