## DOGM, Daily Construction Progress Report

White Oak Road Reclamation Project      C/0070001      PO 560 52000000001

Date: August 6, 7, 8      M T W Th F S

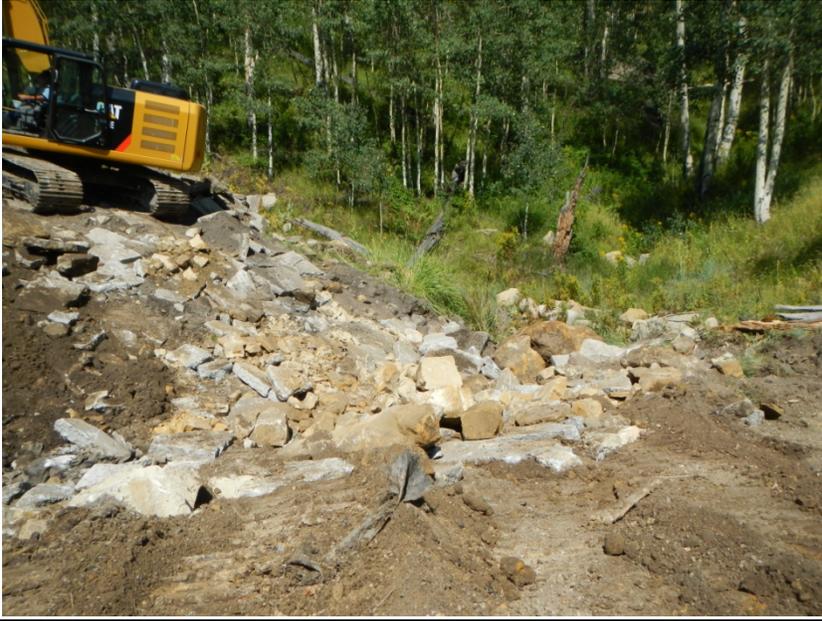
C1 removed. Installation of drainage swale in it's place.

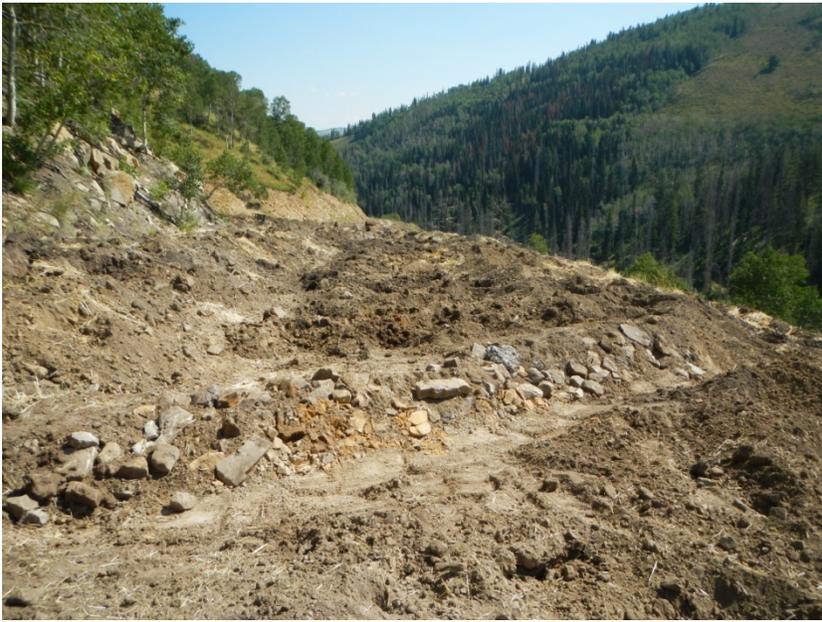
Asphalt buried in cult. Water bar installed along road

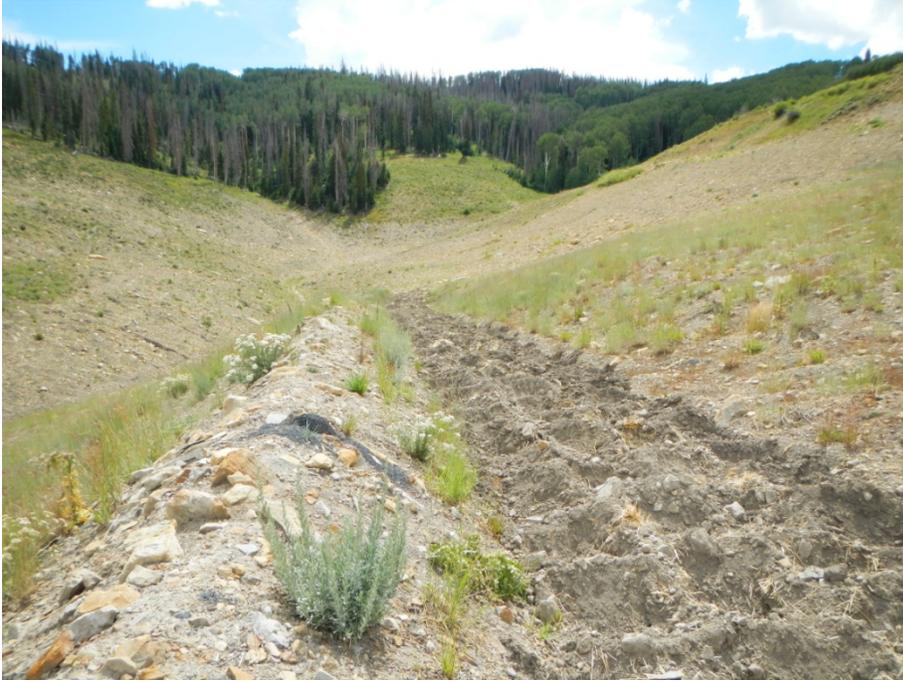
Terrace A pocked.

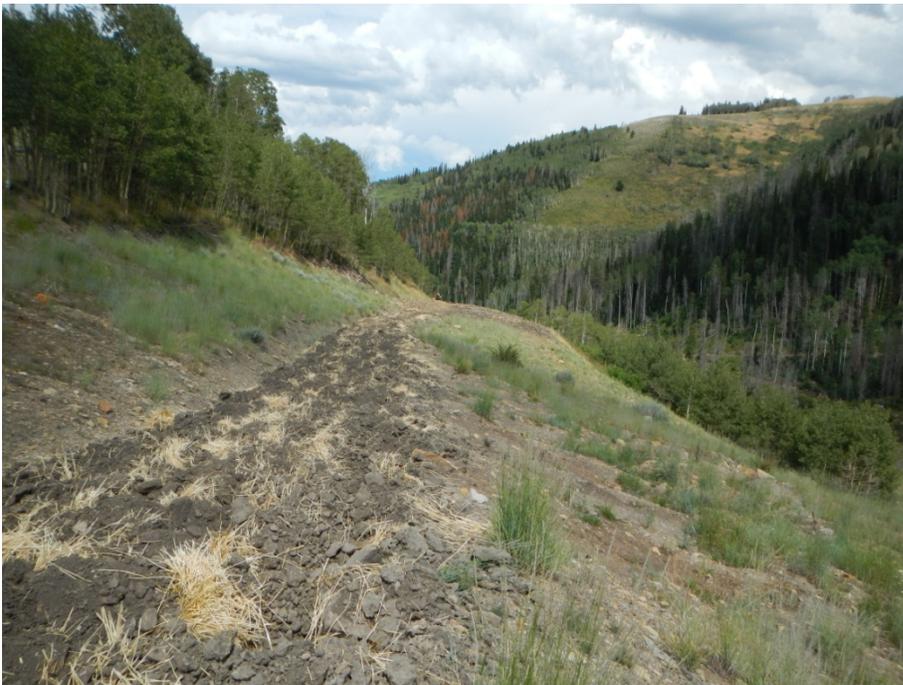
Road R1 pocked.

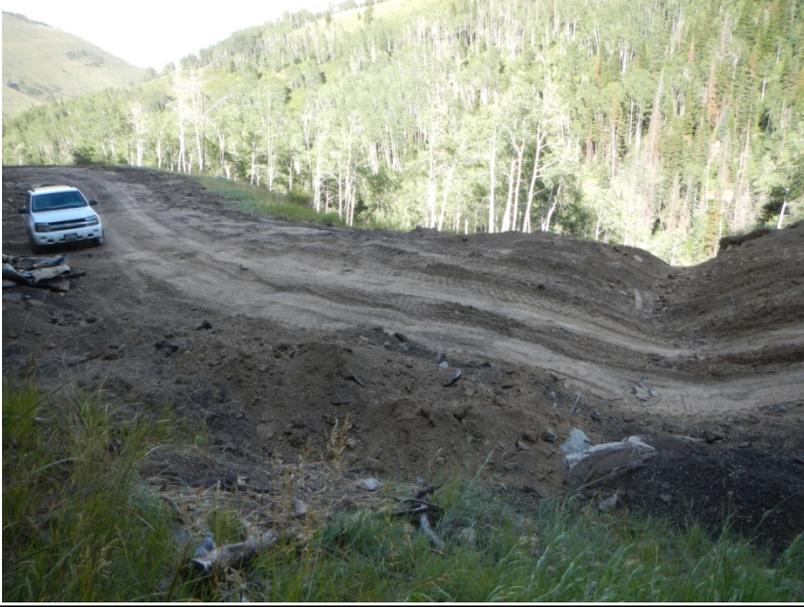
C3 removed.

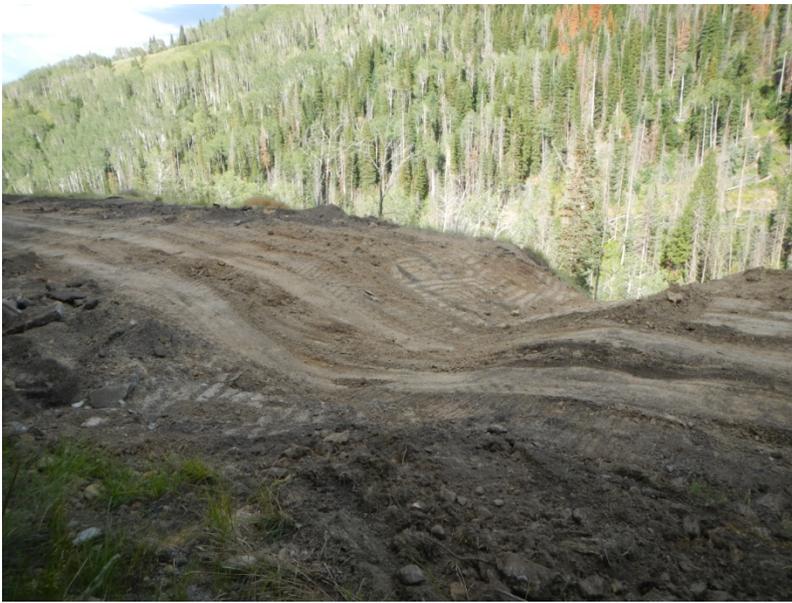
C2 removed.
