Inspection Report

| Permit Number: | C0070001 |
| Inspection Date: | Tuesday, September 20, 2016 |

Site: **WHITE OAK MINE**

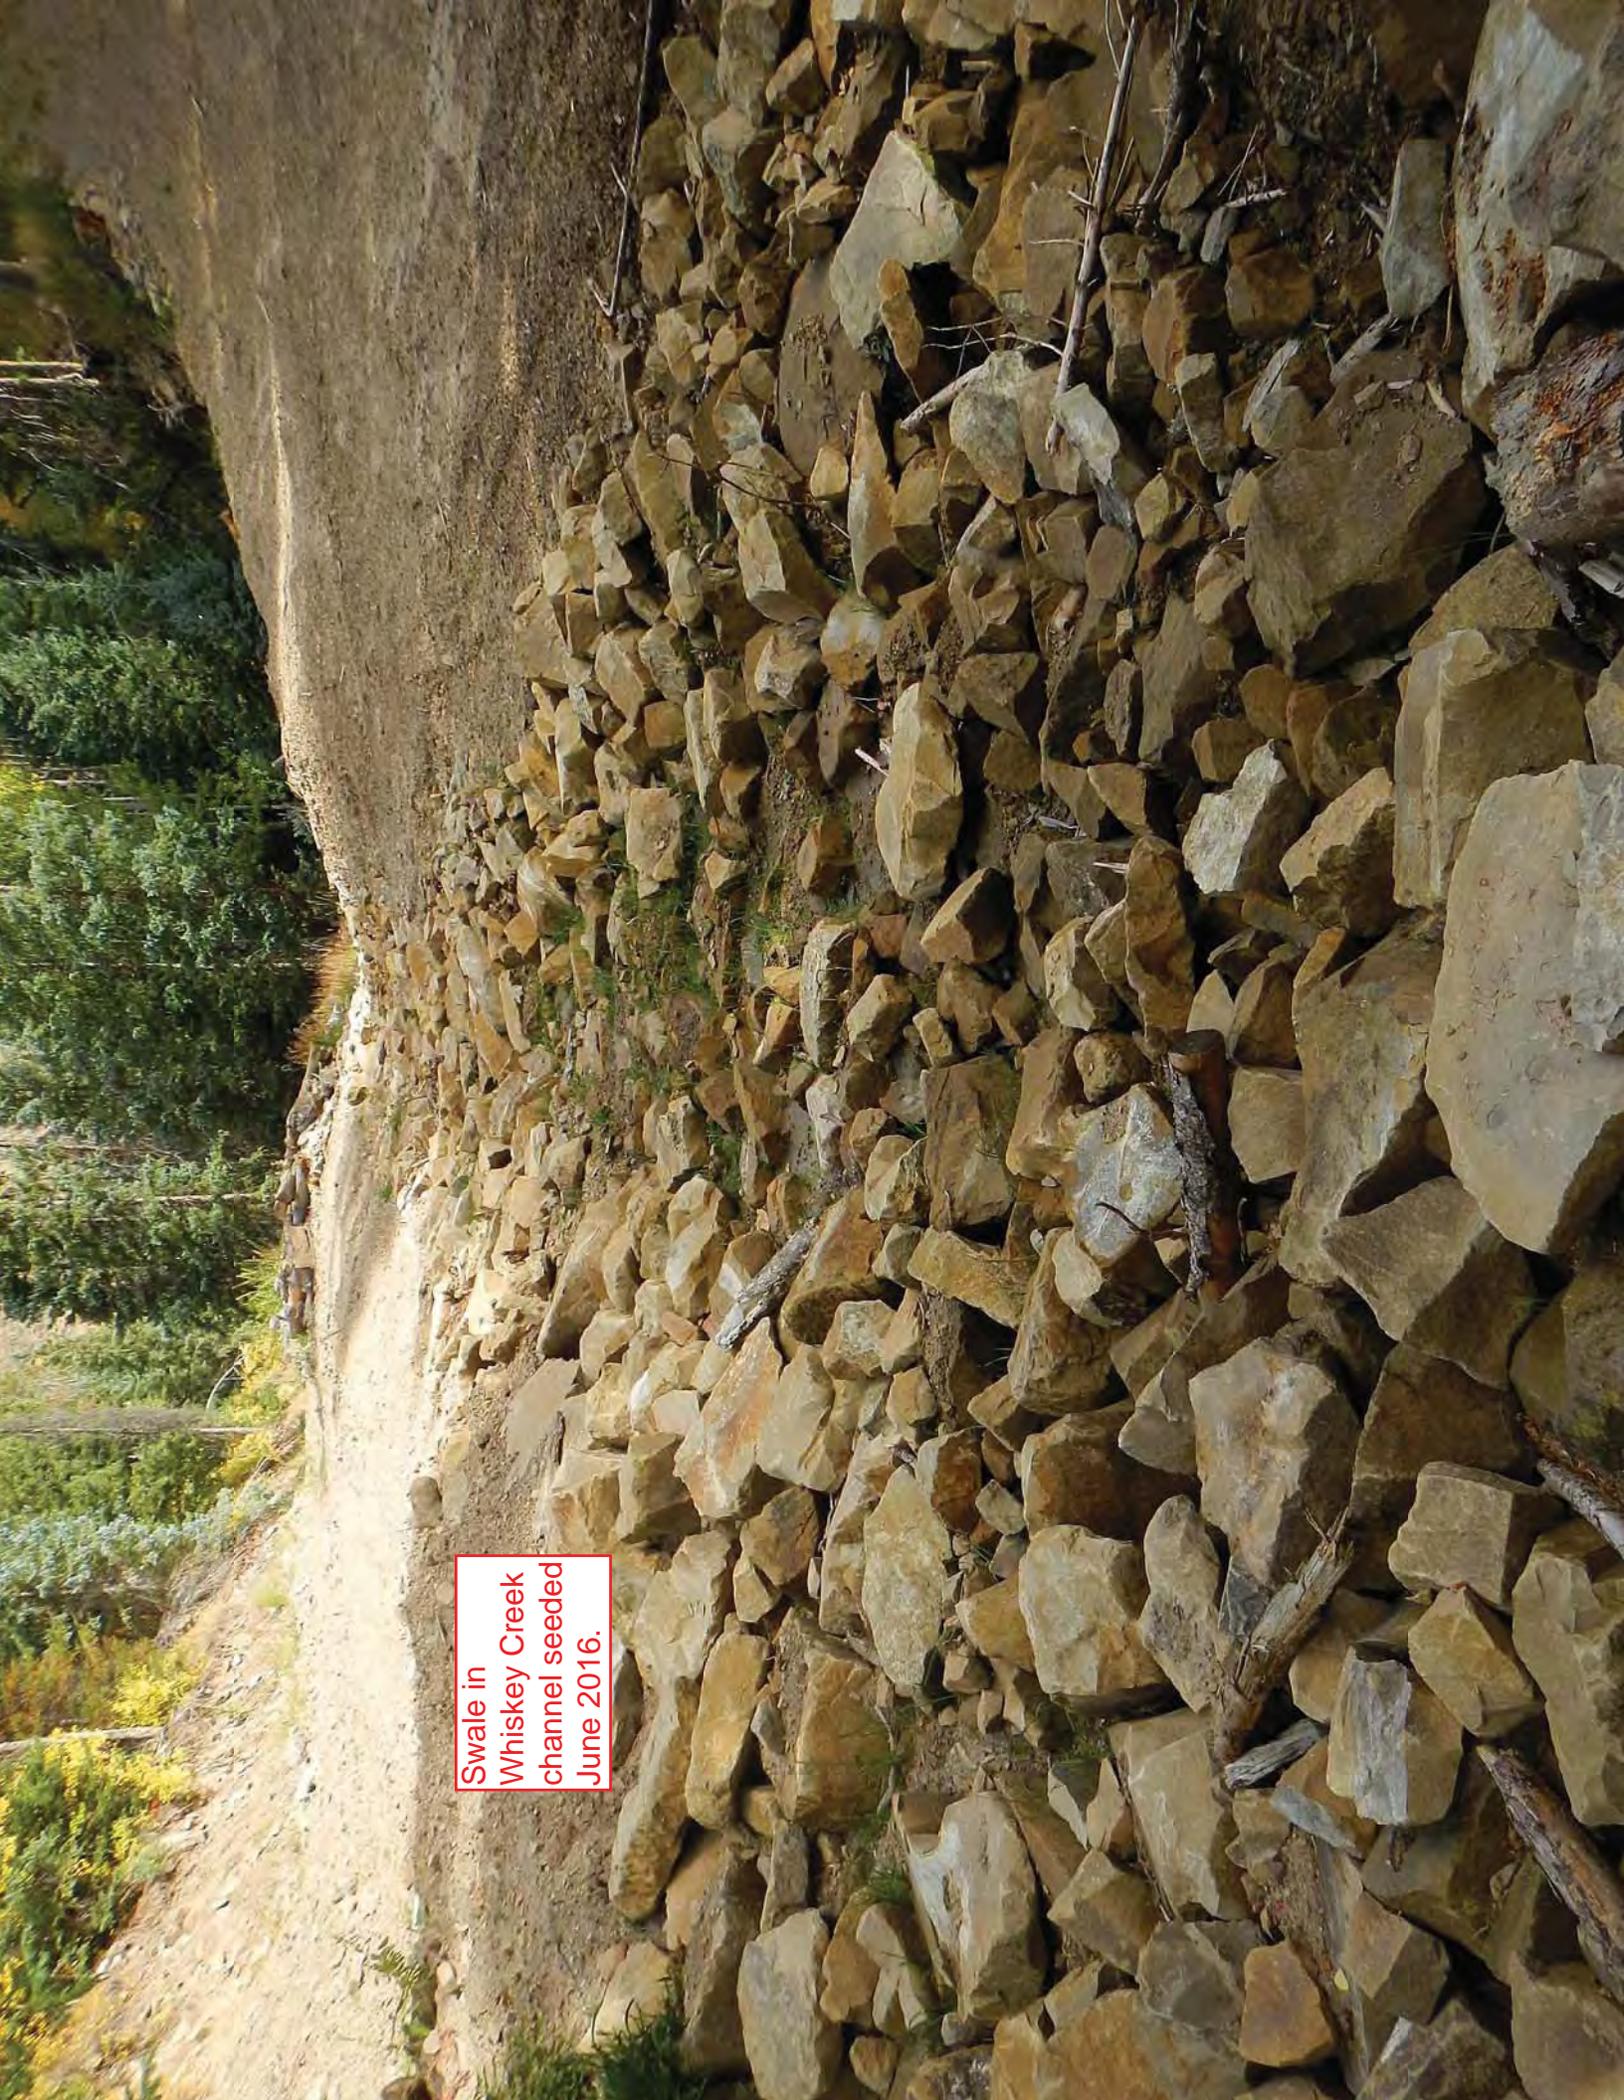
Swale in
Whiskey Creek
channel seeded
June 2016.

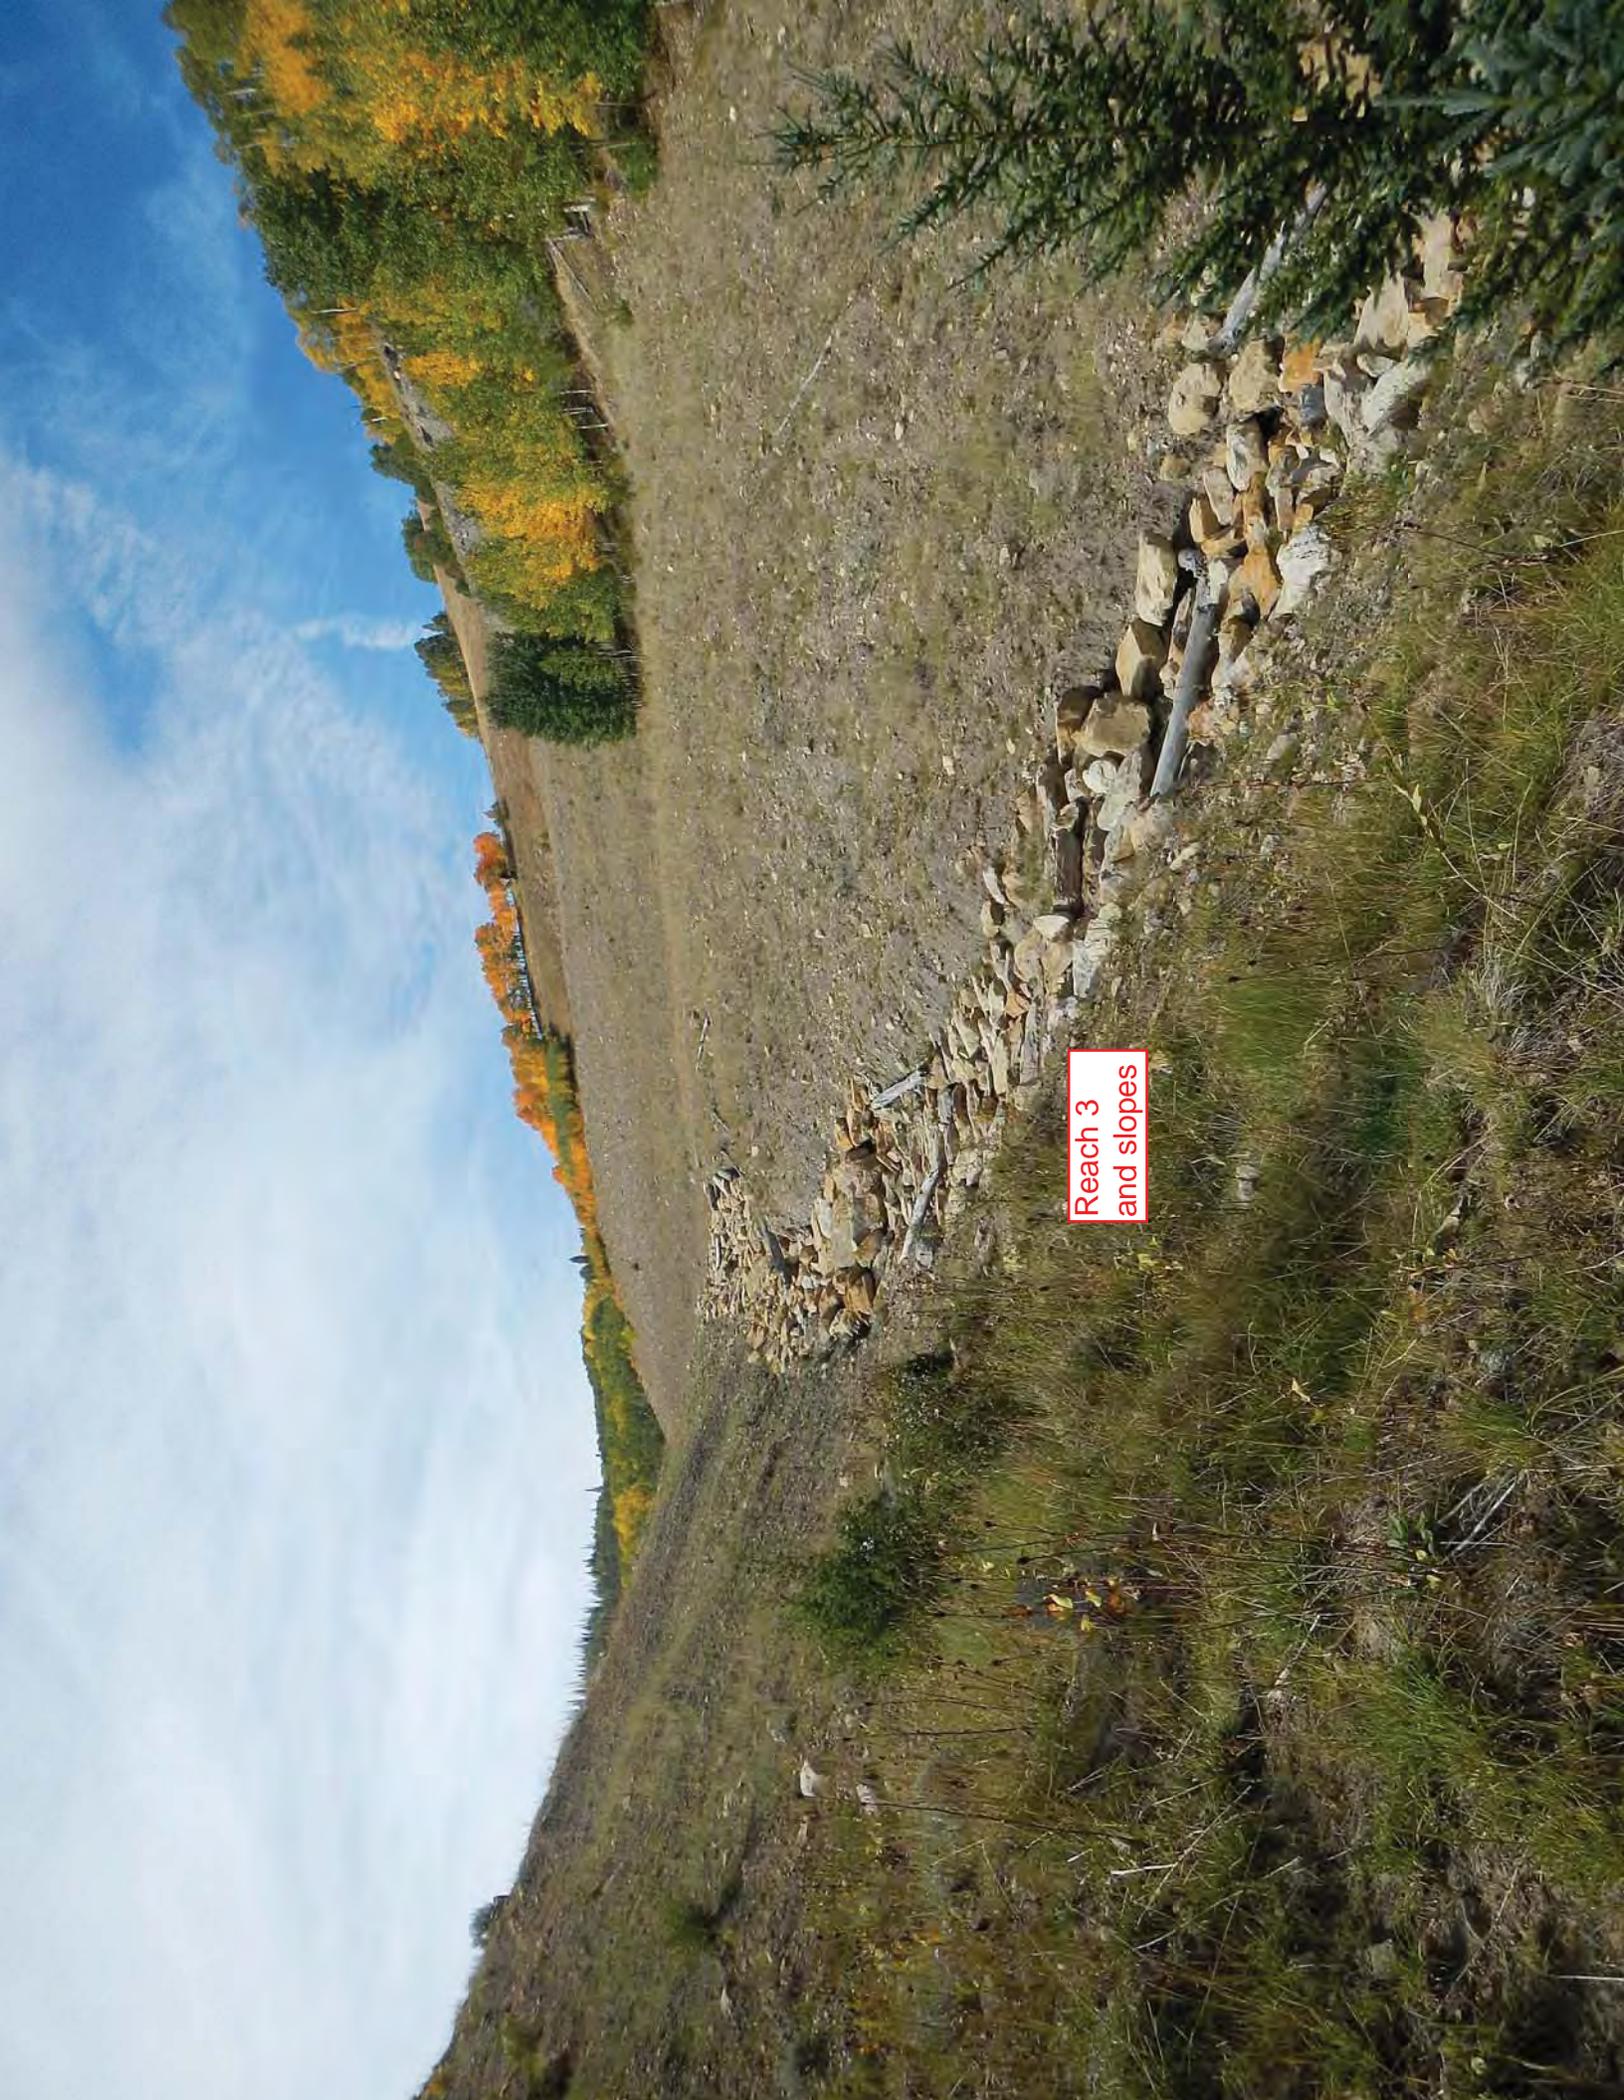
Flush of vegetation visible in the new swale in the Whiskey Creek crossing and in swales along the access road to the mine. Vegetation on either side of stream Reach 3 and 4 is filling in and there are few thistle plants. Thistle was noted in previously treated locations along Terrace A and B, but in reduced numbers. Sage transplants are thriving and blooming. Some clematis vines established. Alpine current did not establish. HUGE numbers of thistle along unreclaimed access road north of Terrace C. Half a dozen willows established along banks of Eccles Creek, and one or two rushes.

Reach 3
and slopes

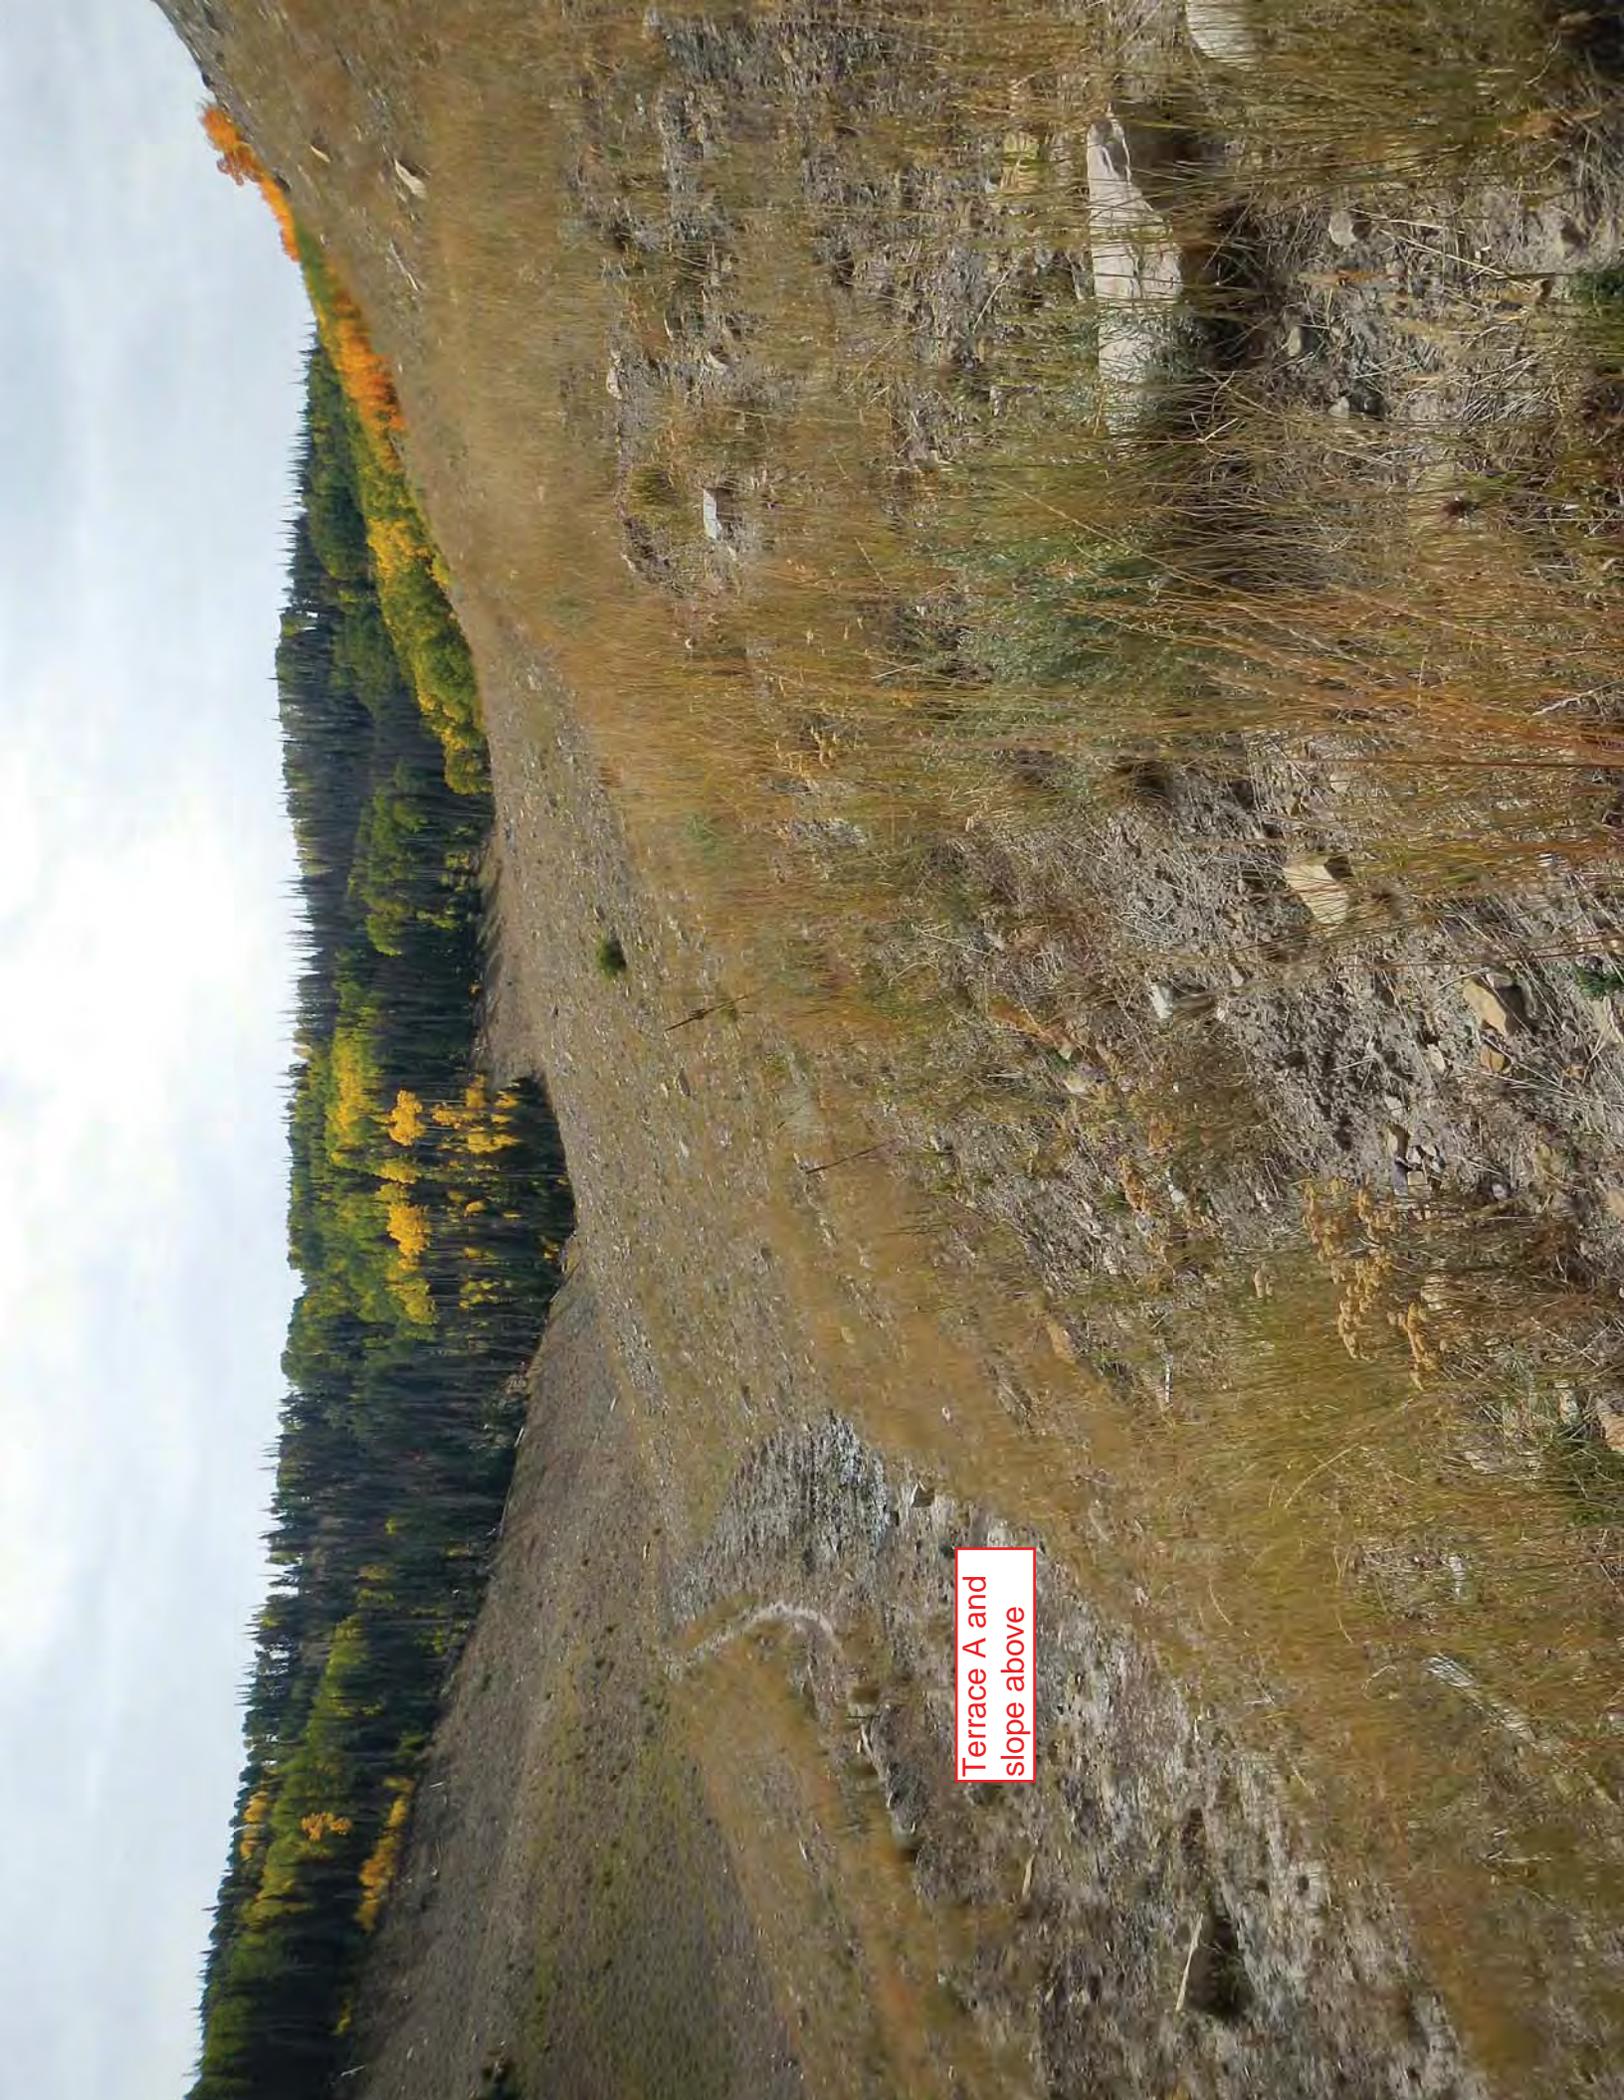
Terrace A and slope above

General location of control rebar

sink hole rebar

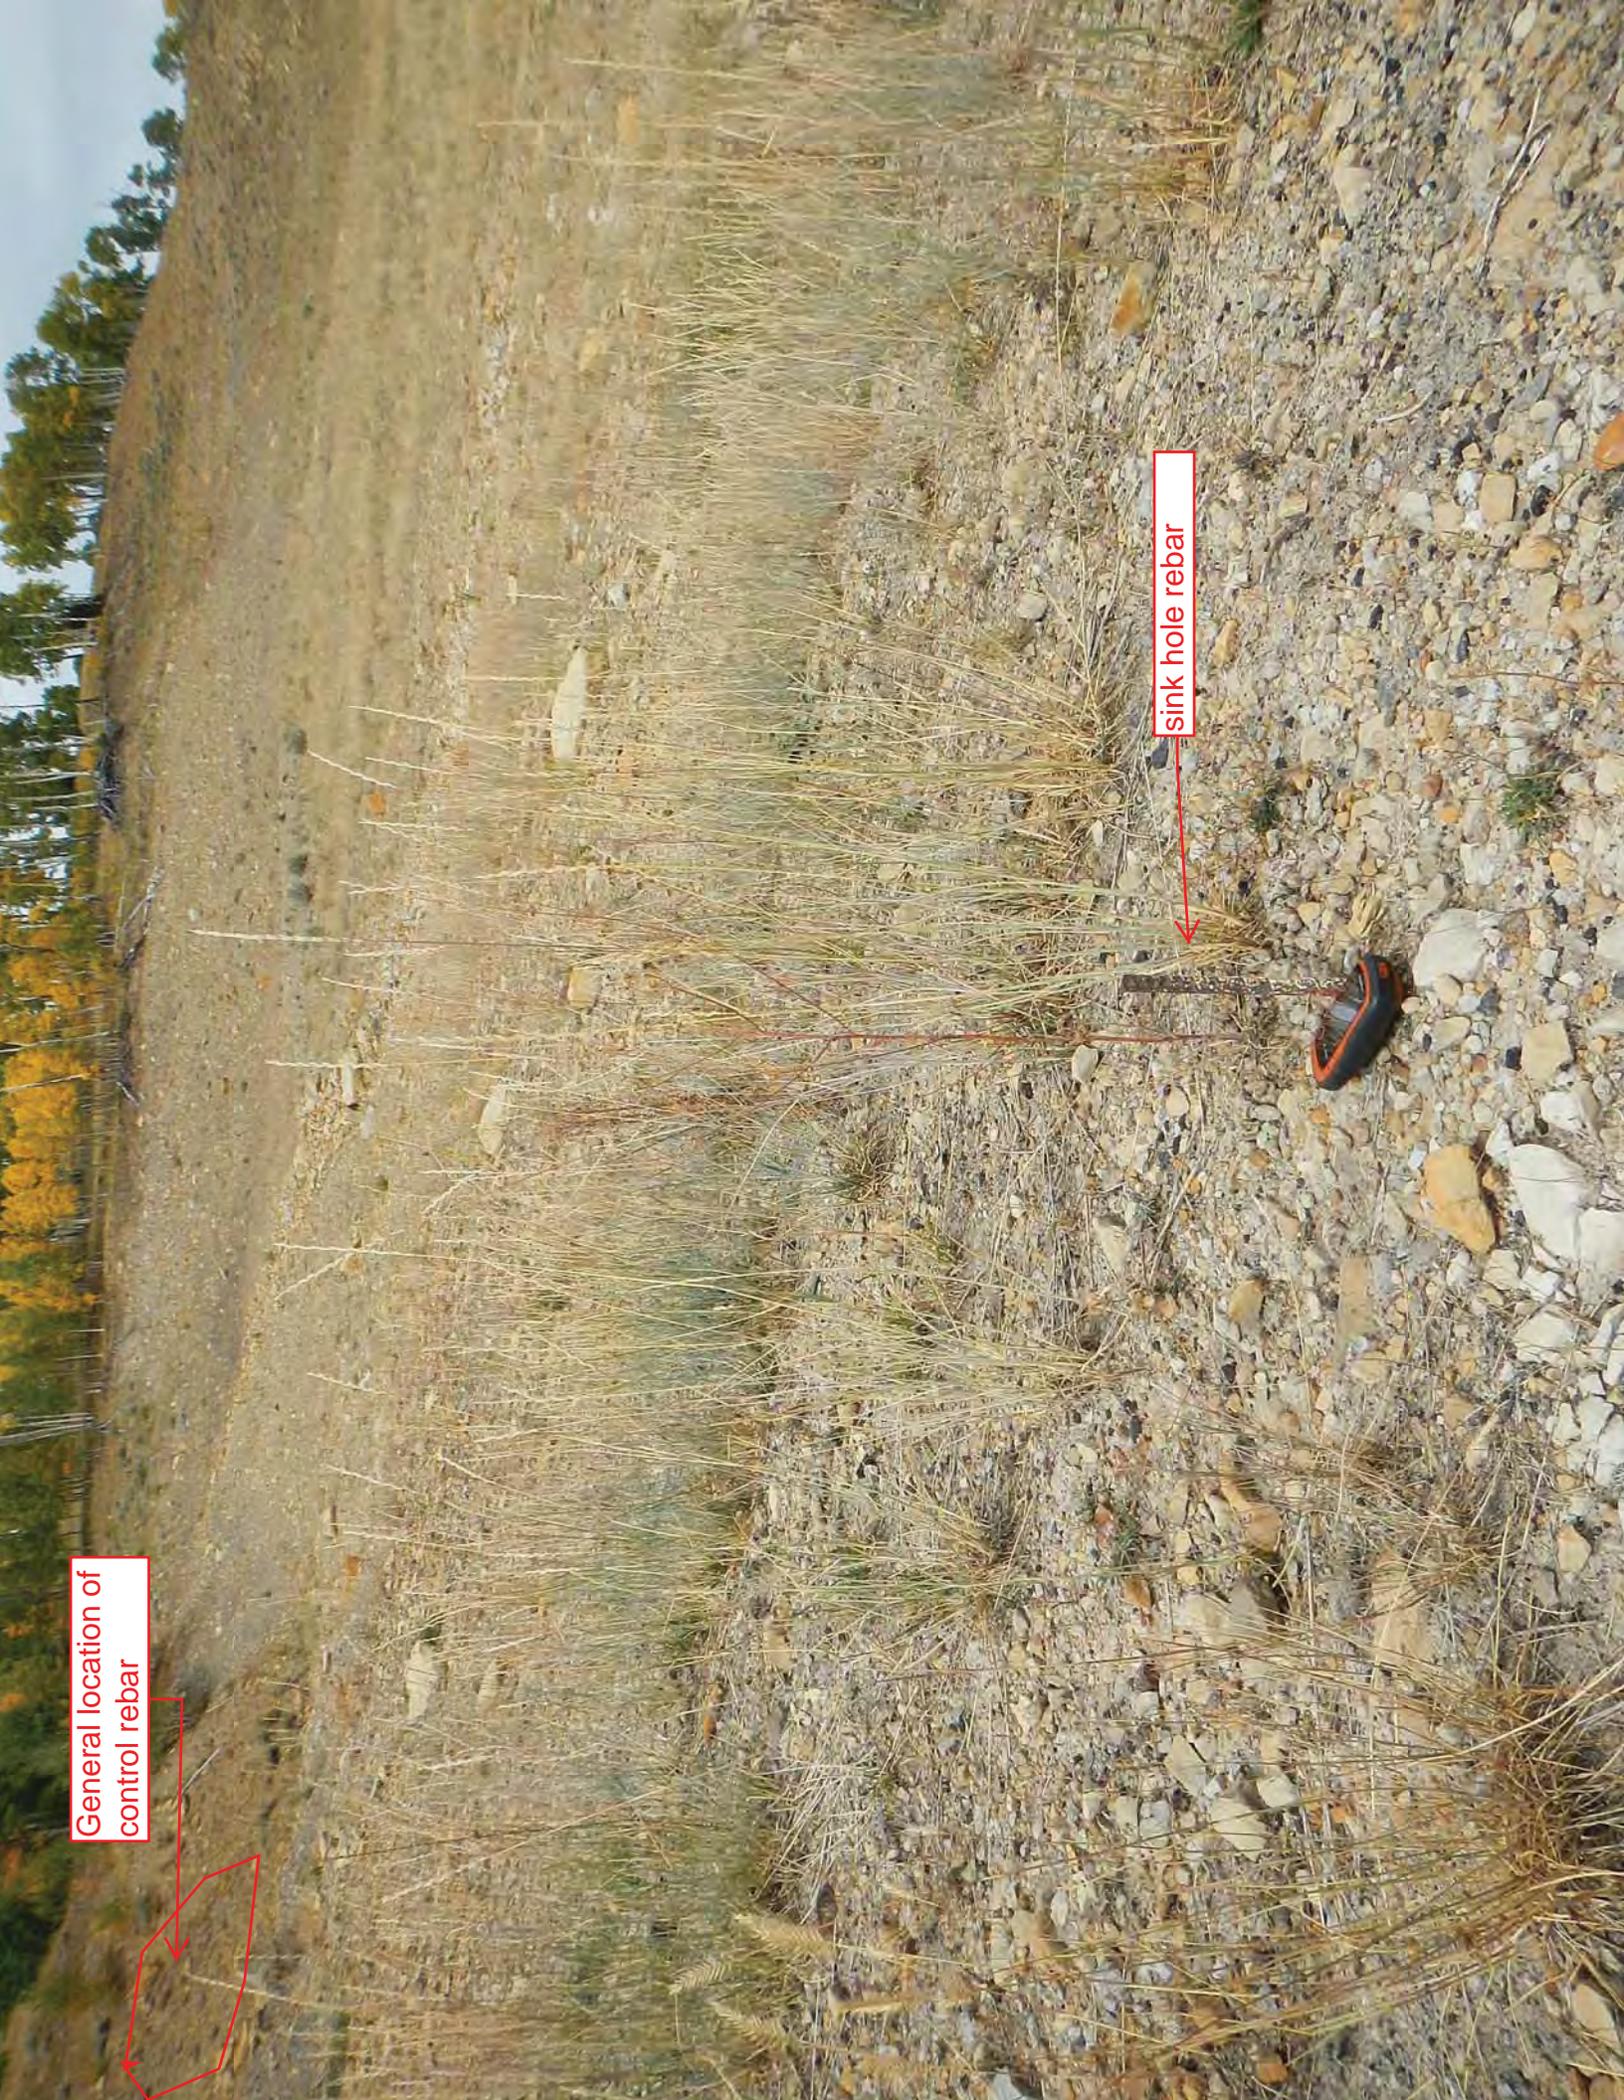
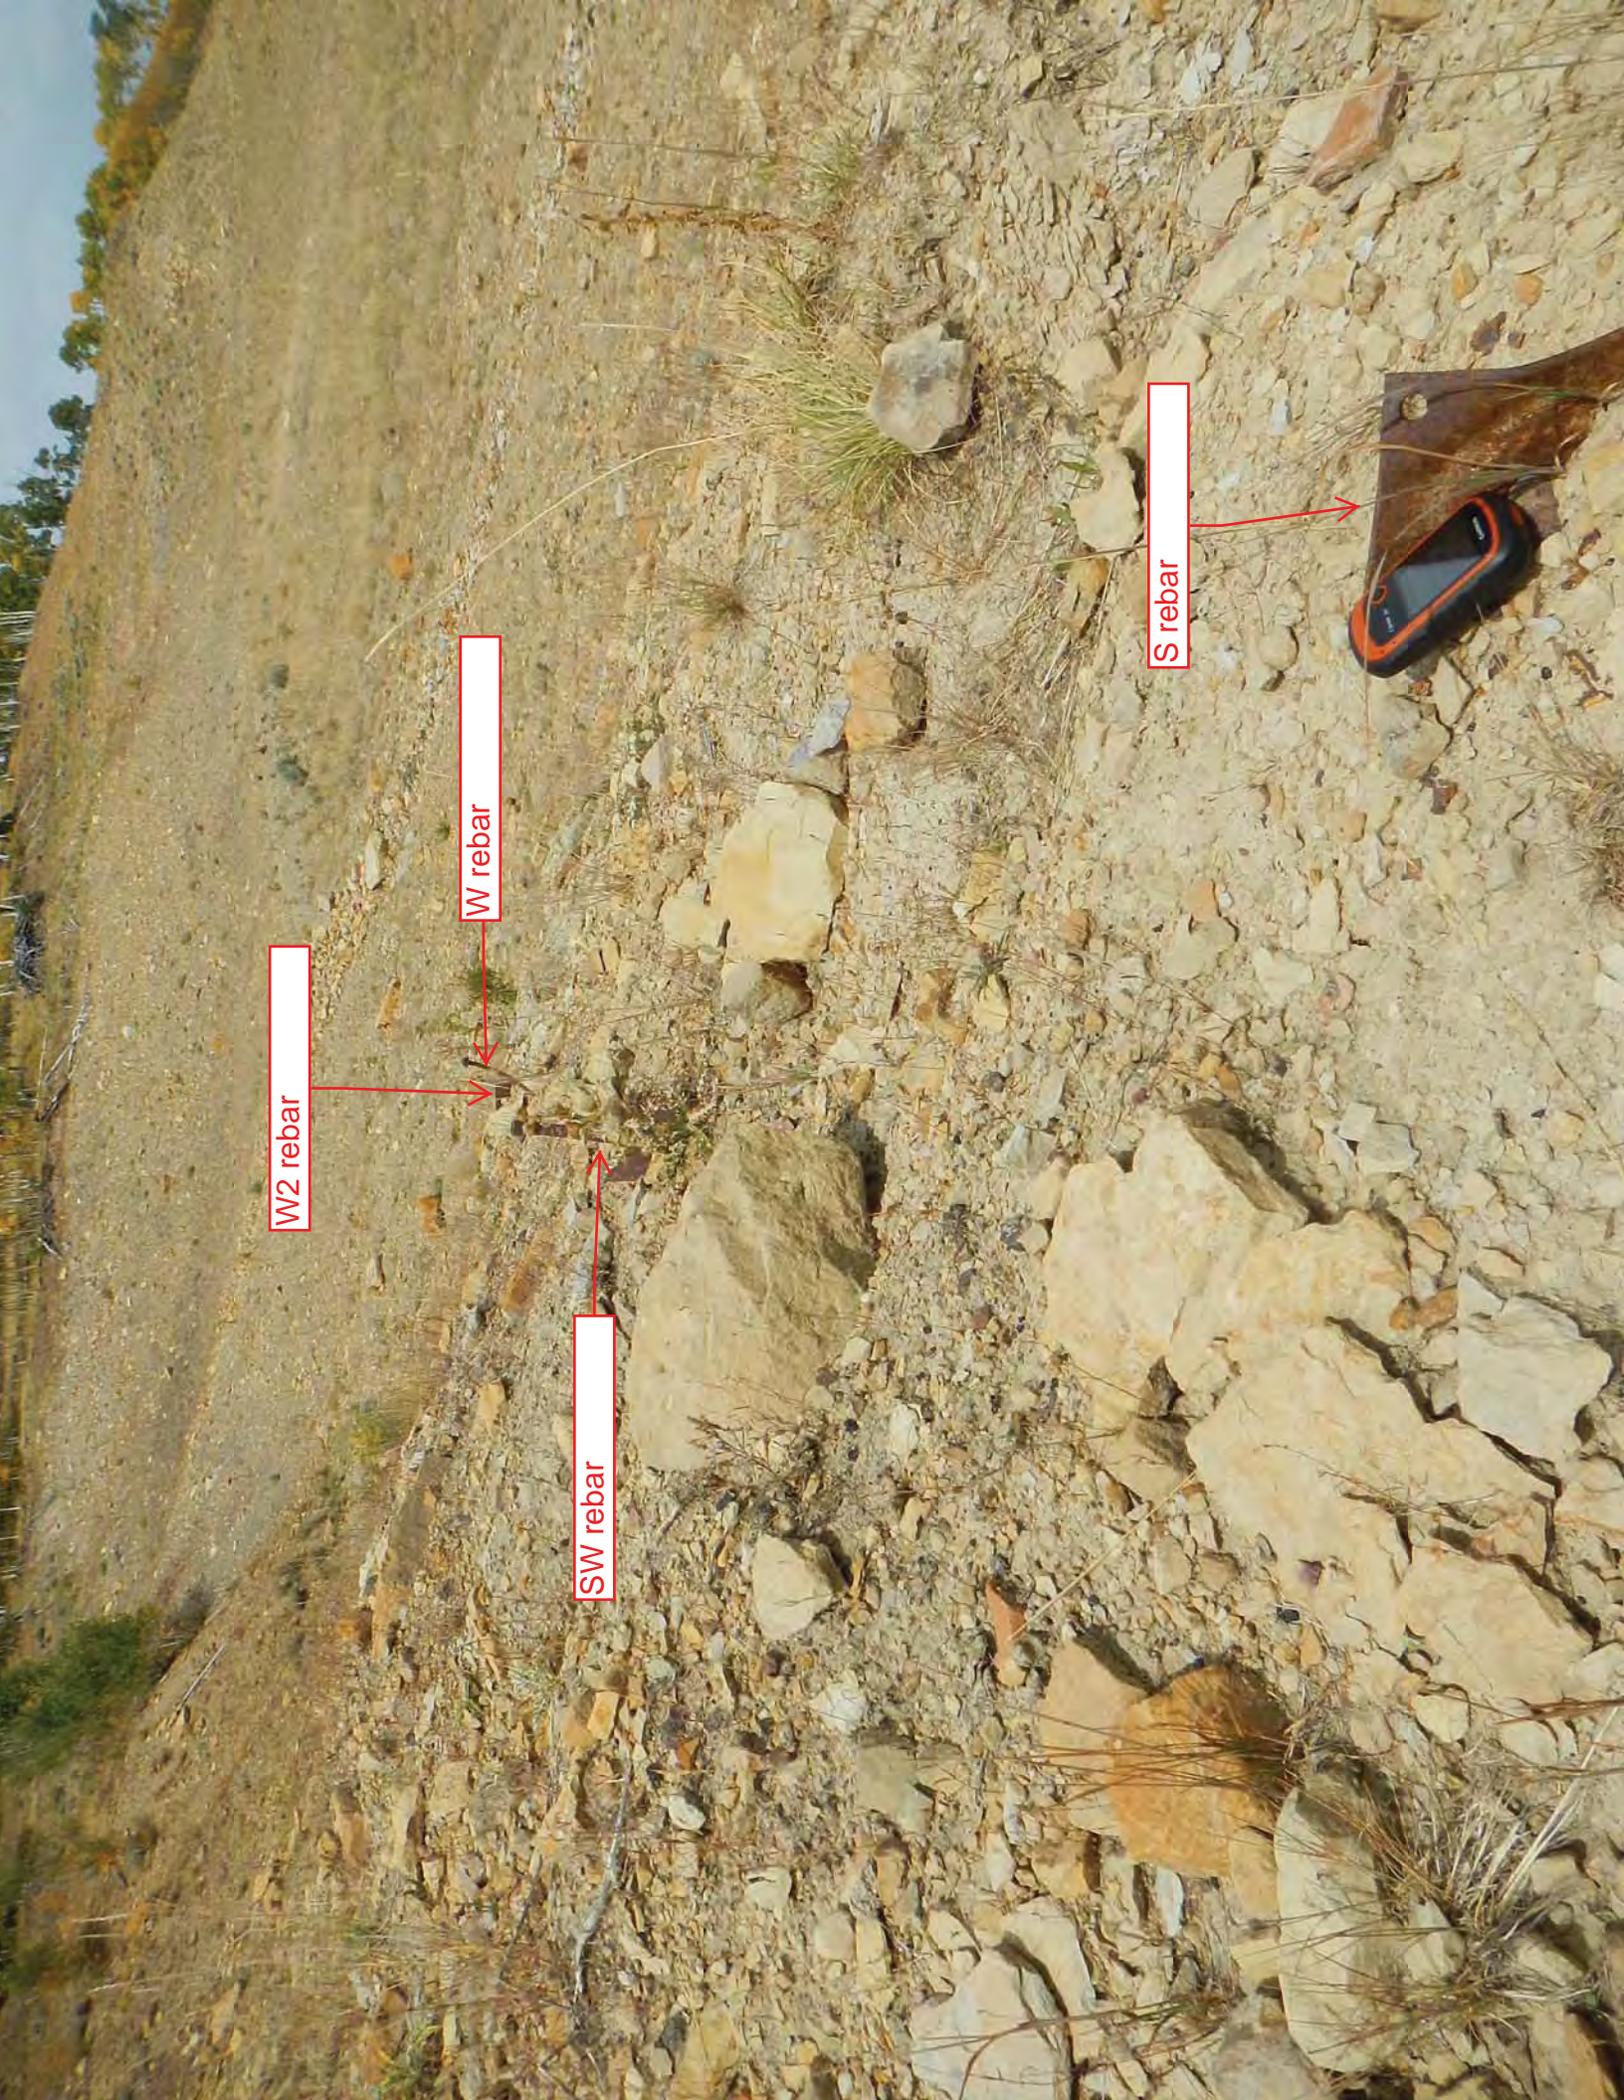
Sink holes stable. GPS readings of rebar taken on and around large sink hole. Compare to elevation at initial placement. GPS waypoints are attached to this inspection report.

W2 rebar

W rebar

SW rebar

S rebar

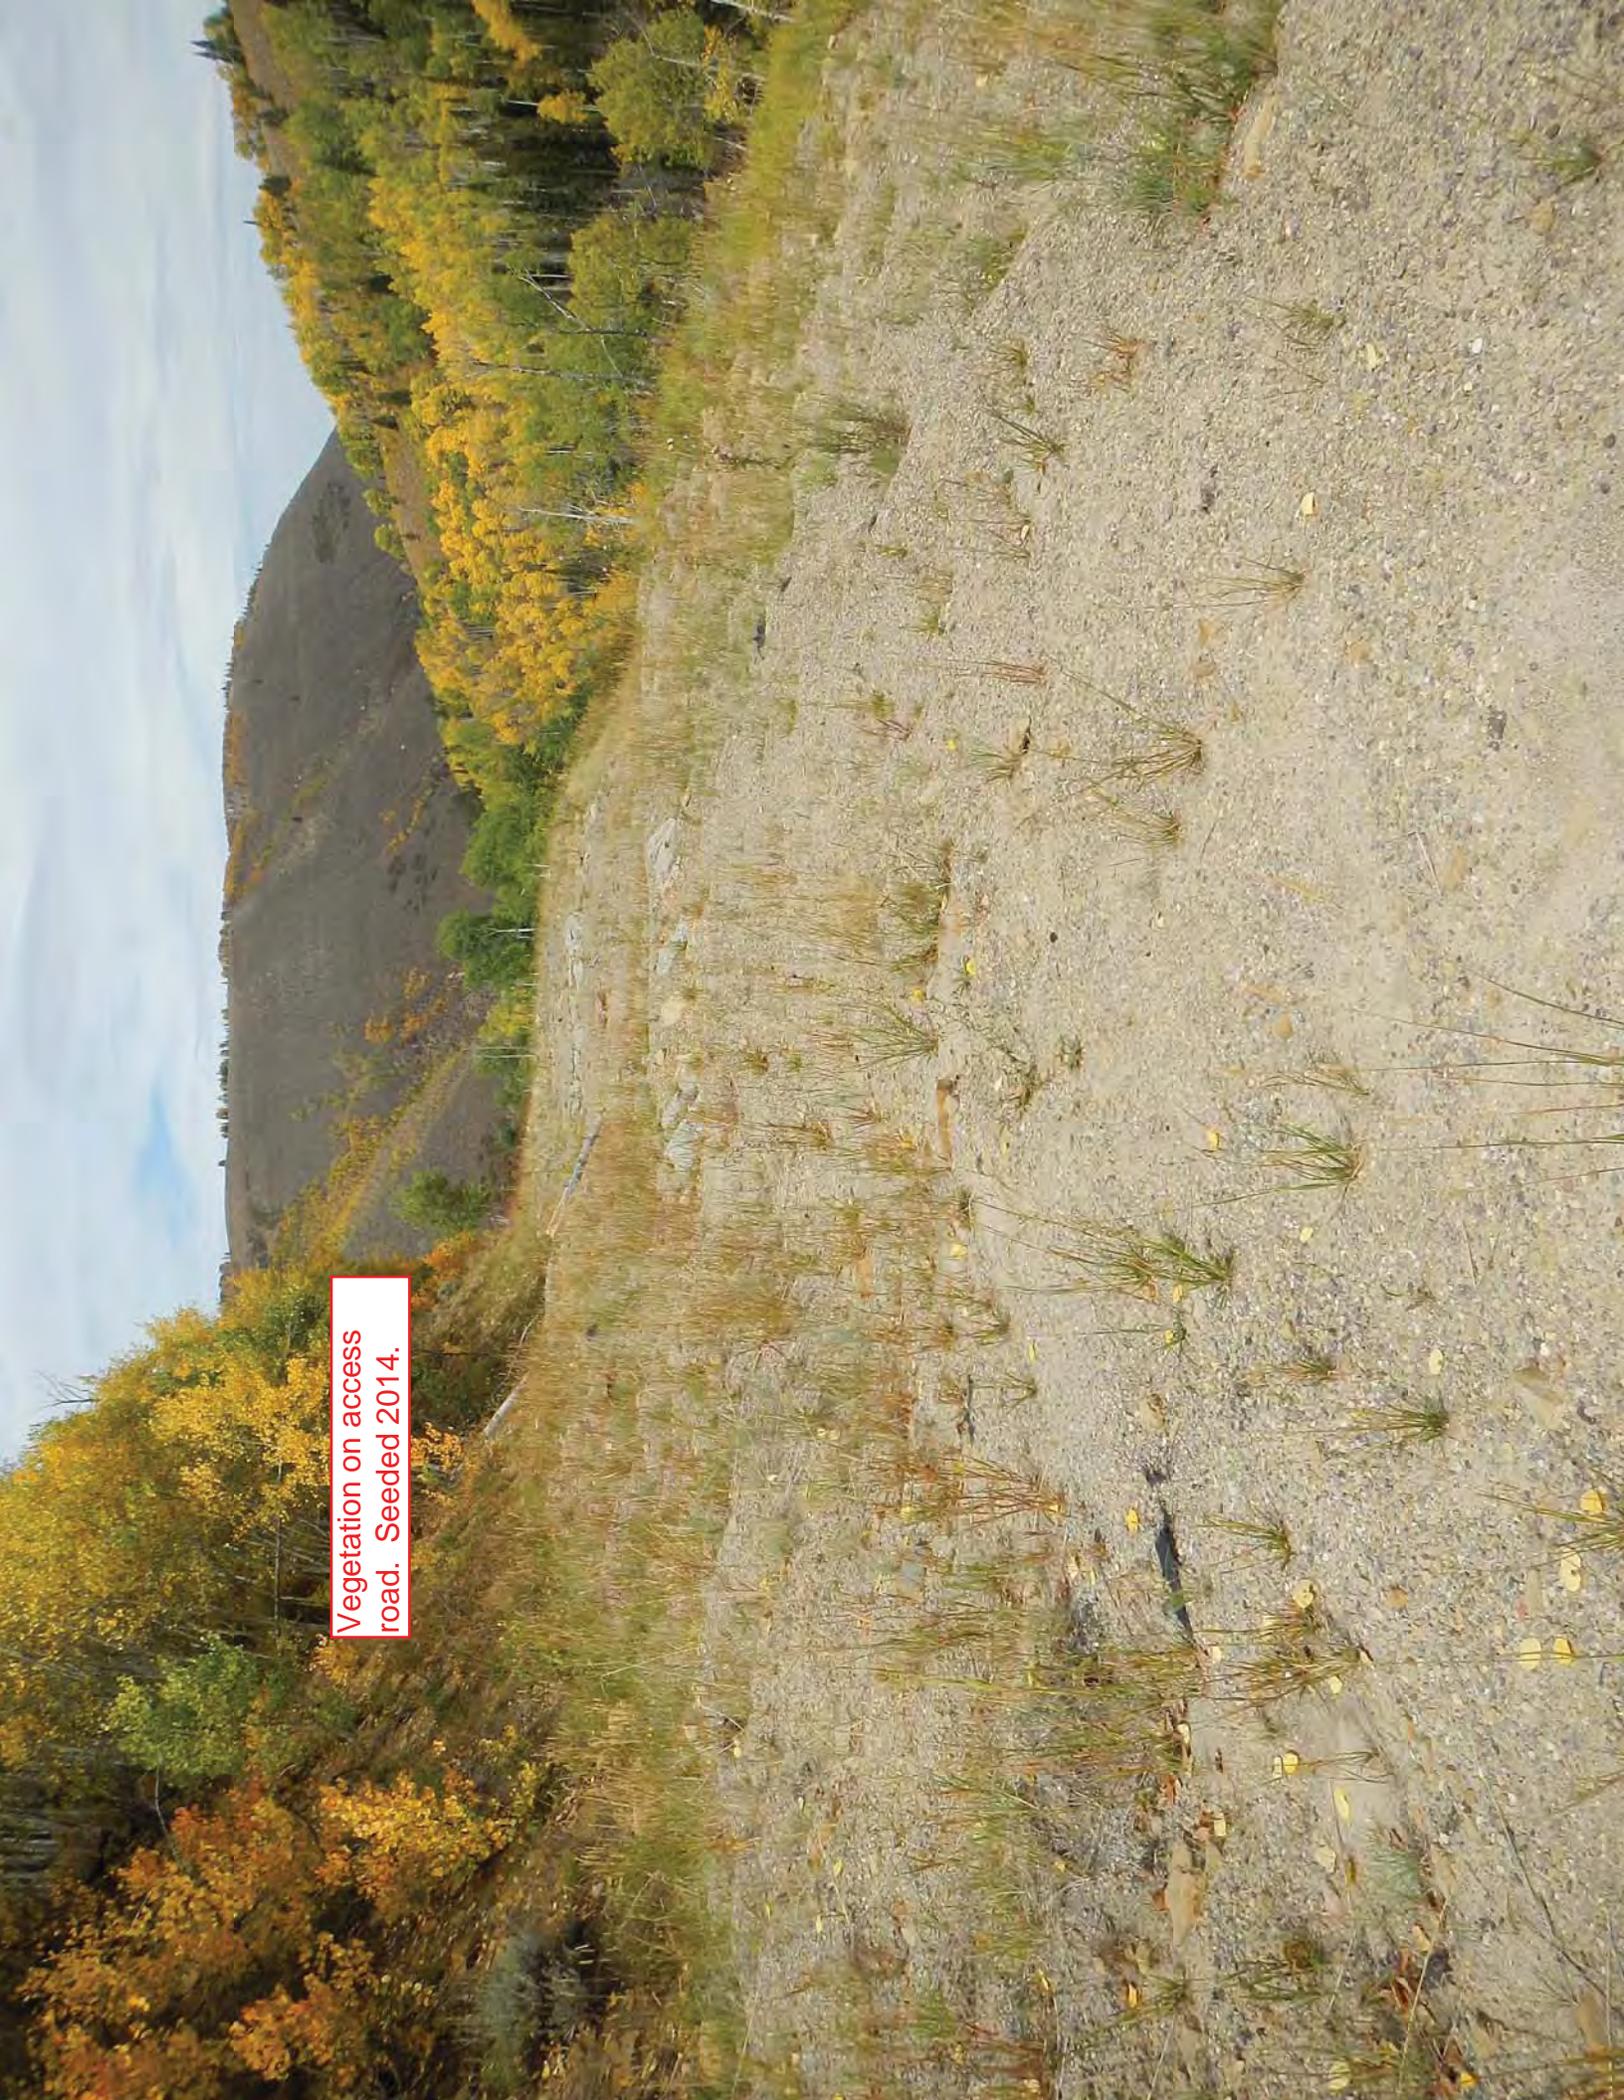
Vegetation on access road. Seeded 2014.

Looking upslope
across swale on
access road.
Seeded 2014
