Inspection Report

| Permit Number: | C0070001 |
| Inspection Date: | Tuesday, September 20, 2016 |

Site: **WHITE OAK MINE**

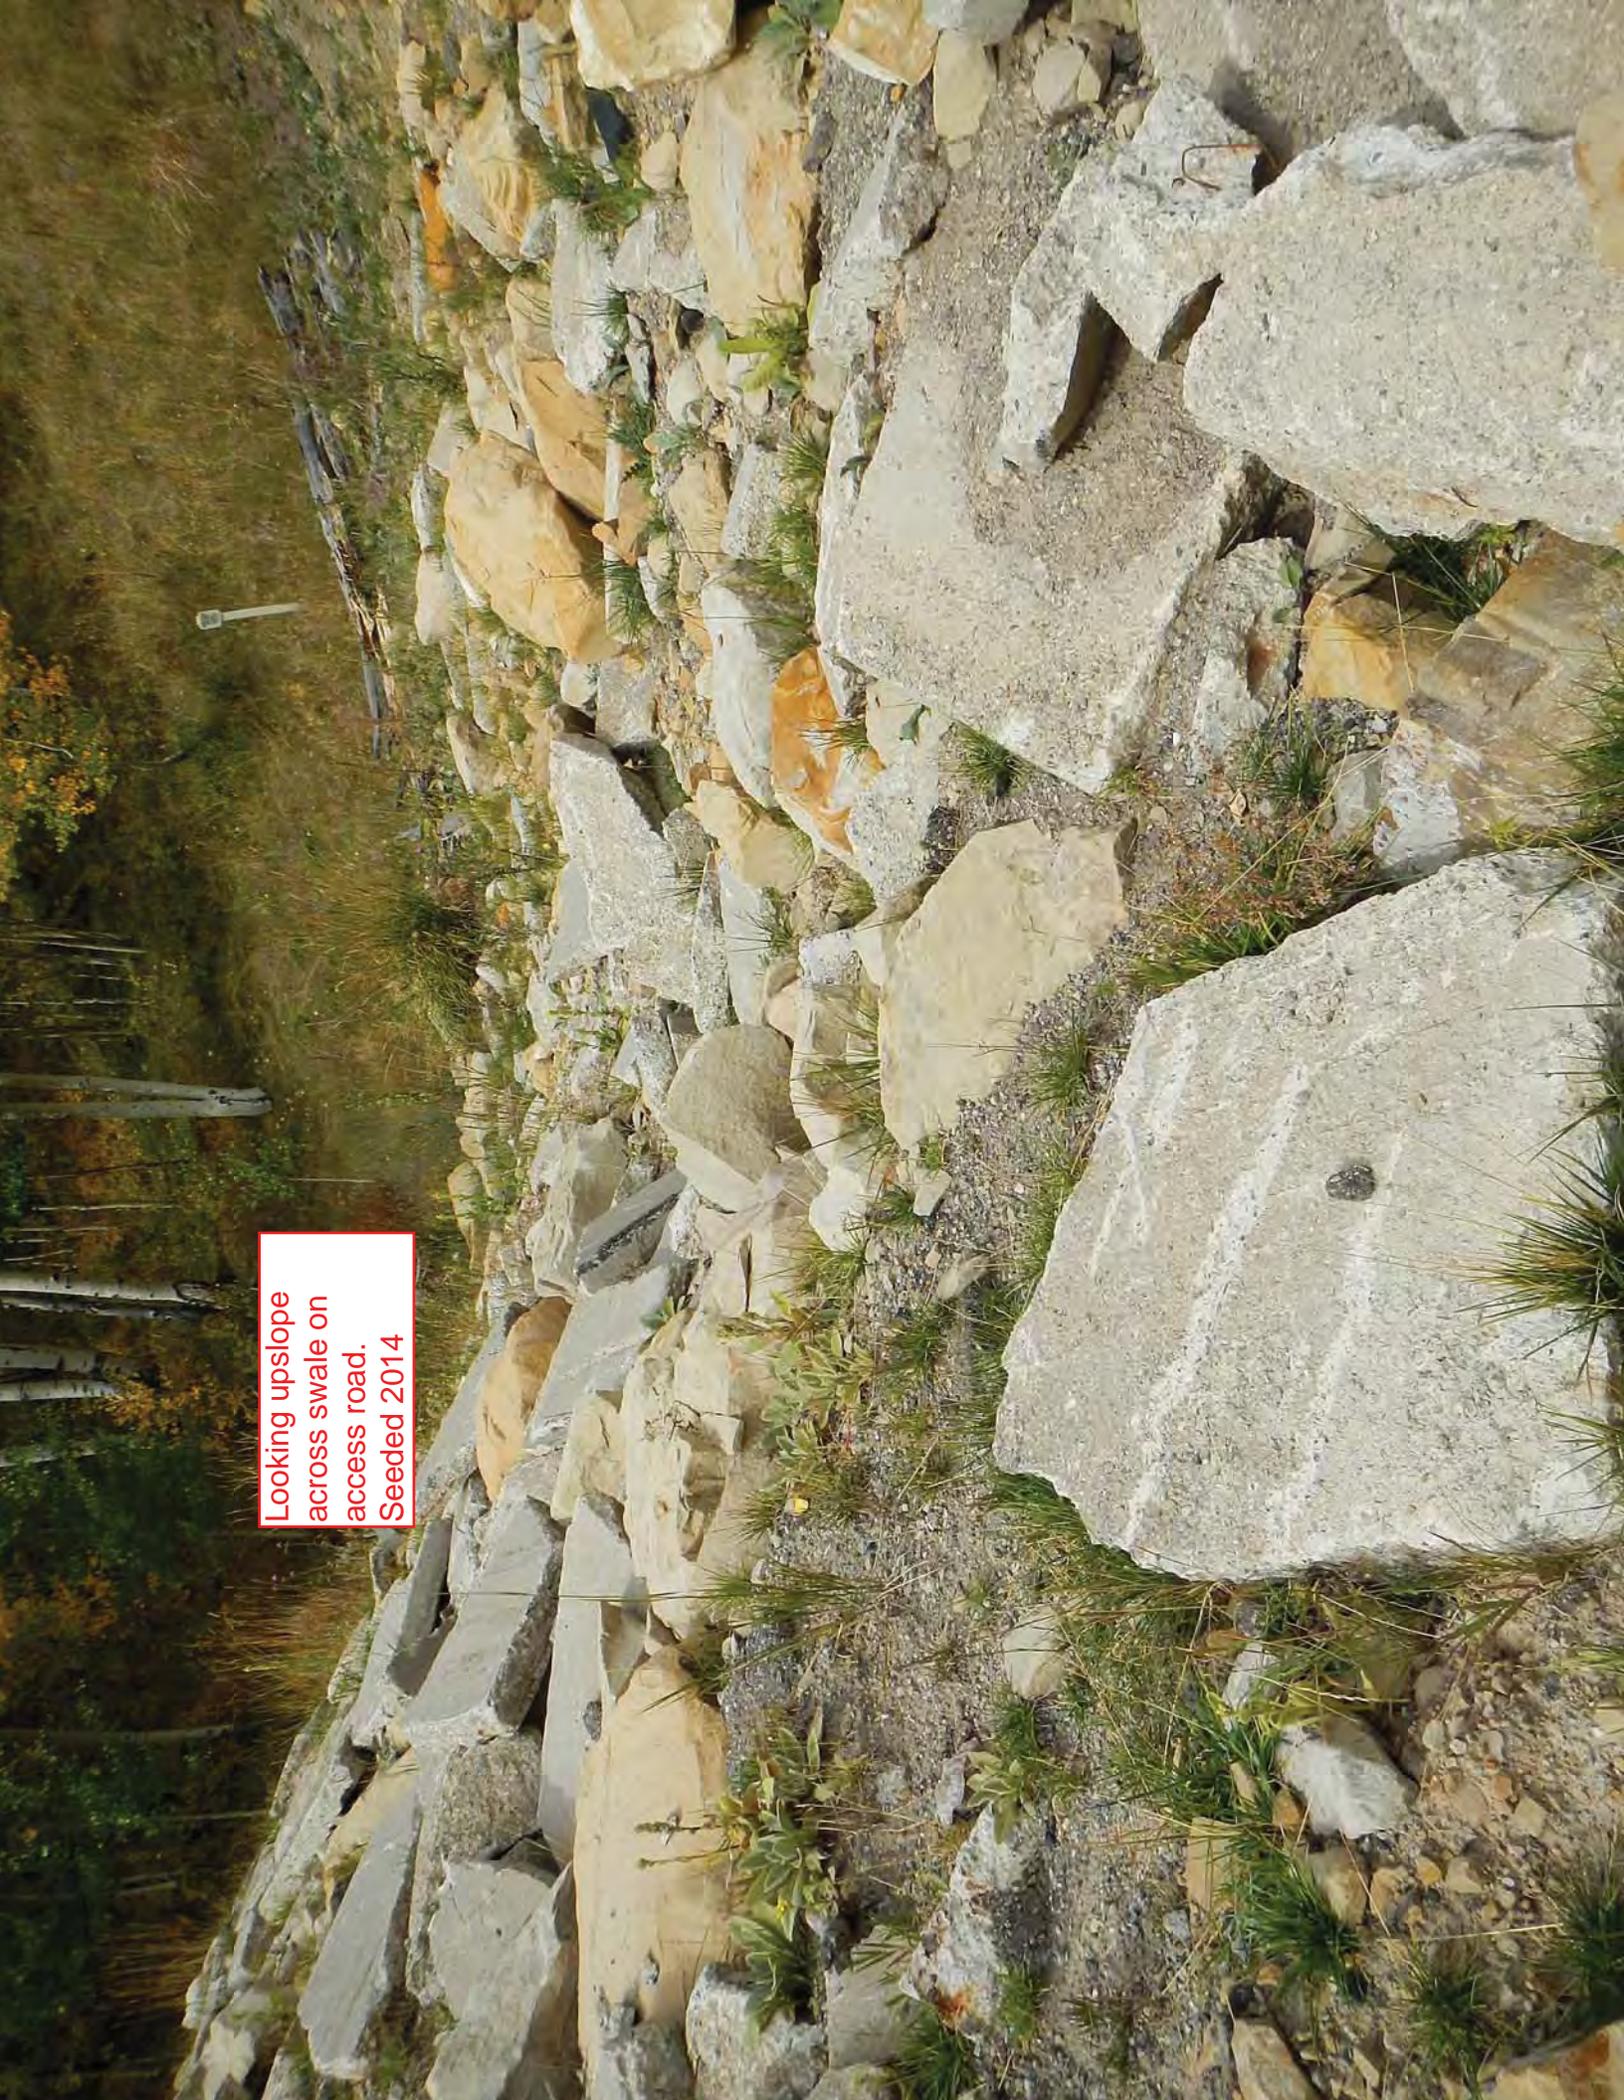
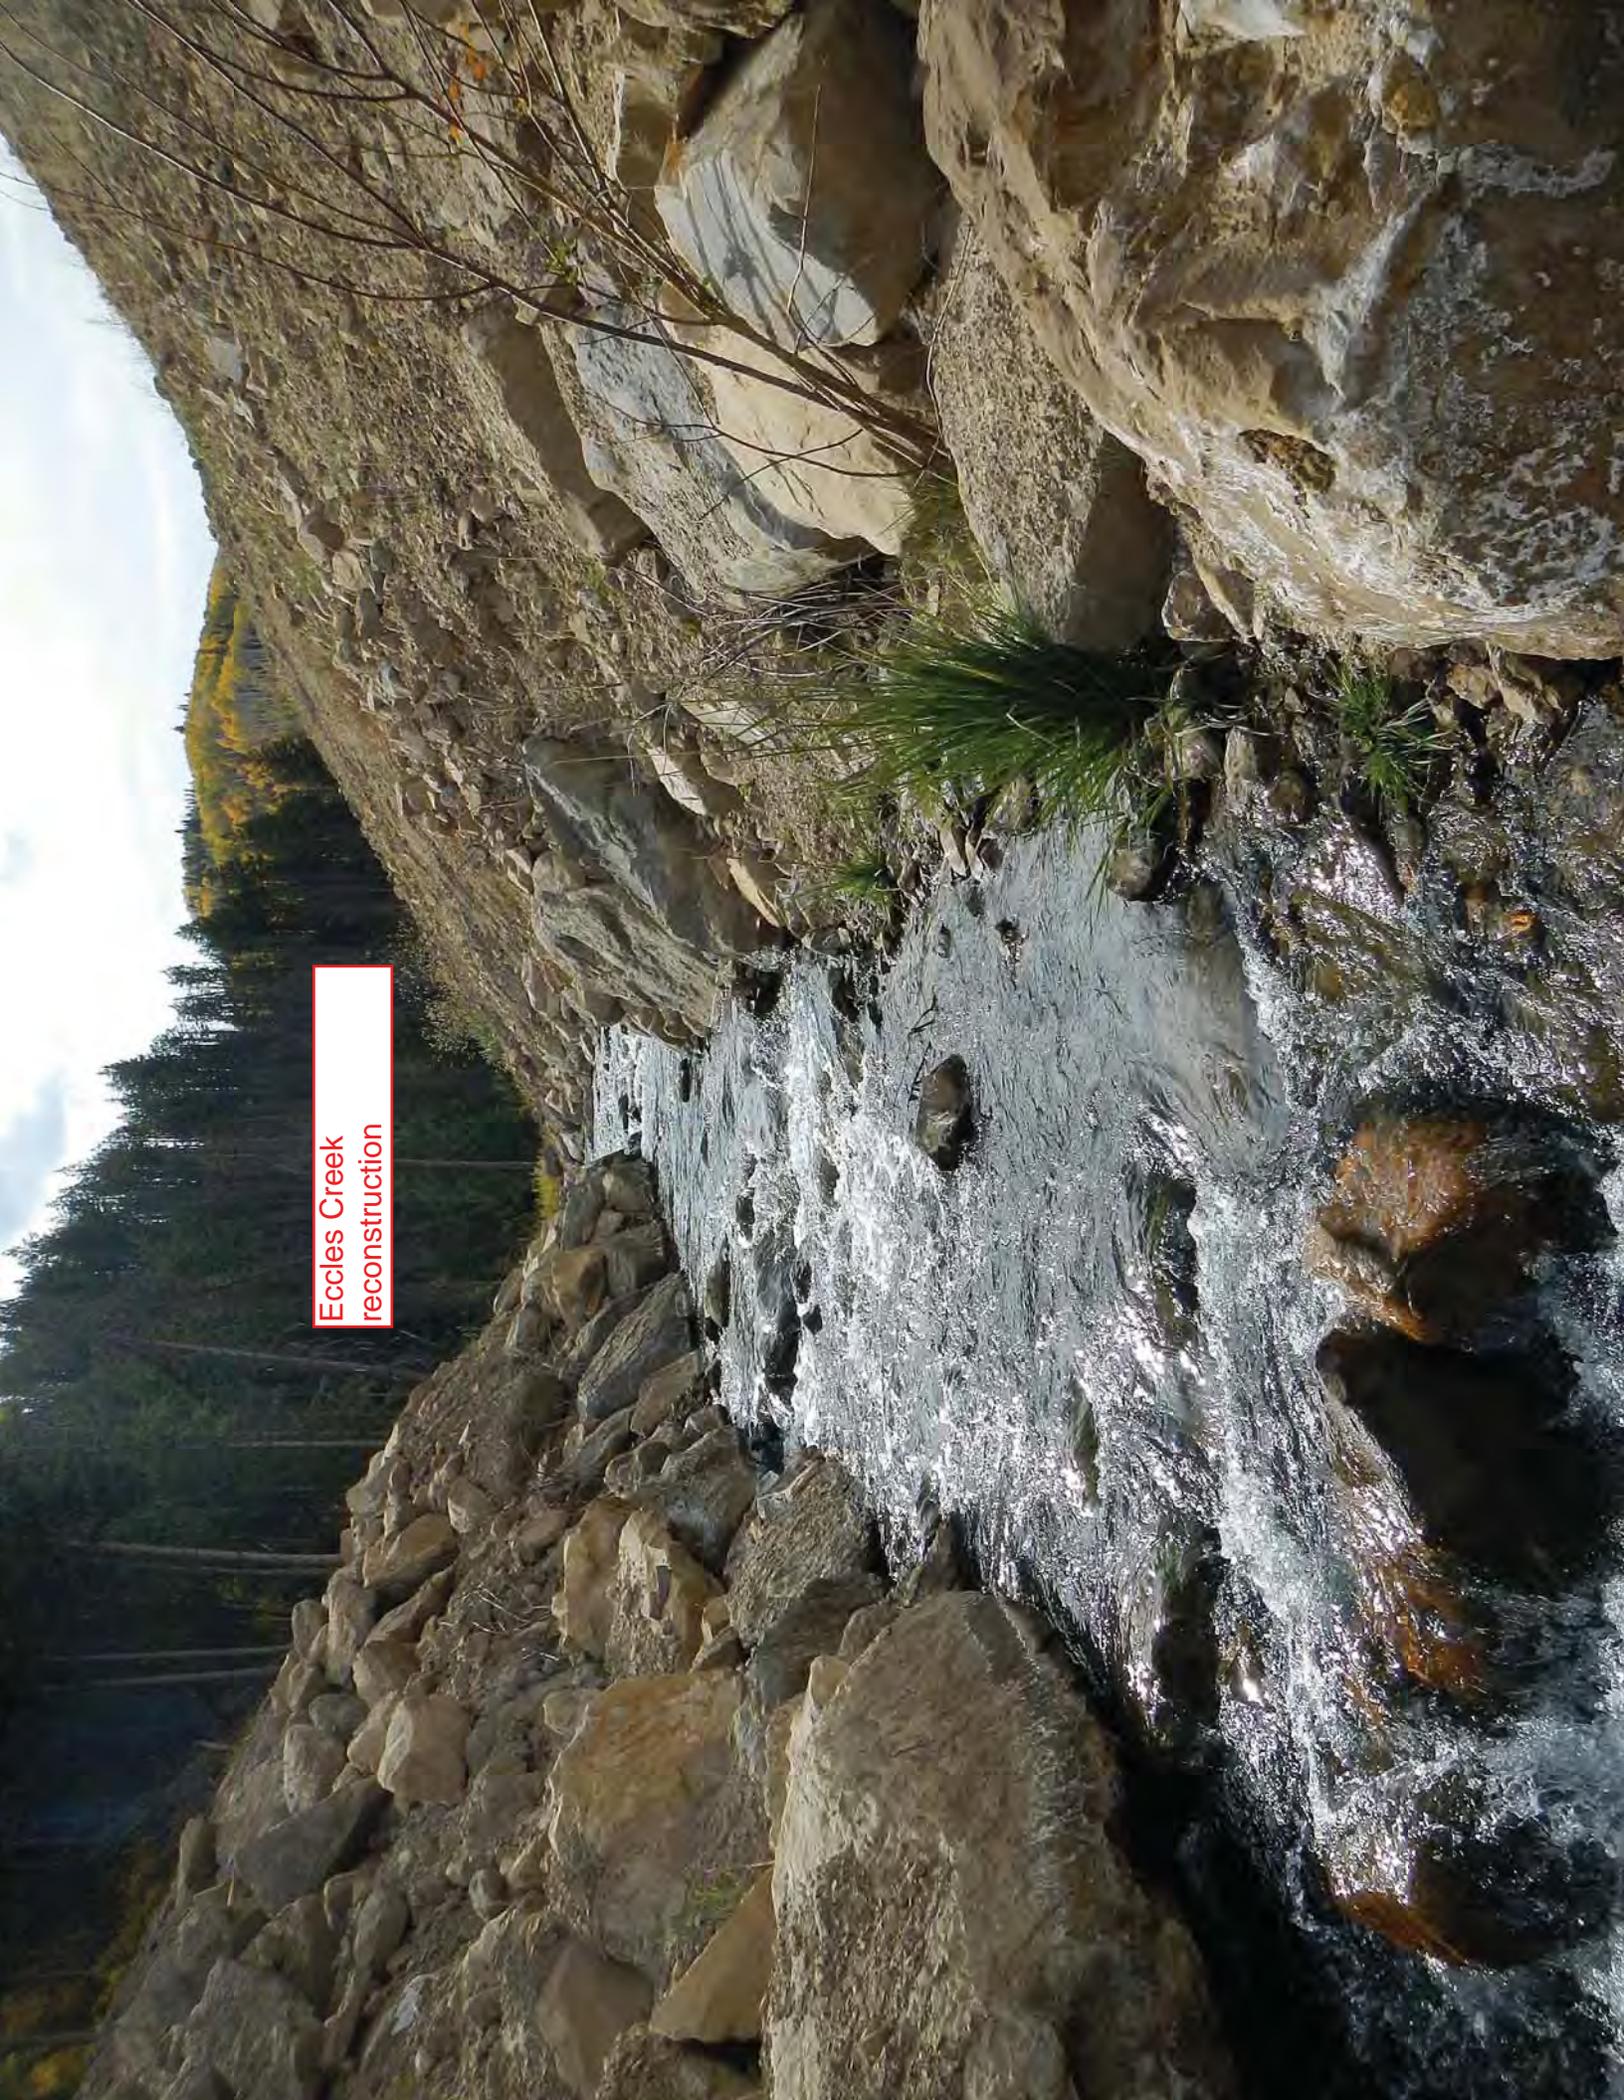
Eccles Creek
reconstruction

The OGM water quality database data for Skyline's monitoring location on Eccles Creek at VC6 (above the Eccles Creek culvert removal) indicates that flow in Eccles Creek was approximately 2,500 gpm during construction in October-November 2015. Flows through the reconstructed channel in the first and second quarter 2016 were 2,424 and 1,687 gpm, measured at VC6. Justin Hart, Aquatics Manager Division of Wildlife Resources, stated that the removal of the culvert in Eccles Creek has opened up a mile of stream for fish passage.
