# Inspection Report

Permit Number:	<b>C0070001</b>
Inspection Type:	COMPLETE
Inspection Date:	Thursday, November 03, 2016
Start Date/Time:	11/3/2016 3:00:00 PM
End Date/Time:	11/7/2016 3:00:00 PM
Last Inspection:	Tuesday, September 20, 2016

Permittee: **LODESTAR ENERGY INC**  
 Operator:  
 Site: **WHITE OAK MINE**  
 Address: ,  
 County: **CARBON**  
 Permit Type: **PERMANENT COAL PROGRAM**  
 Permit Status: **FORFEITURE**

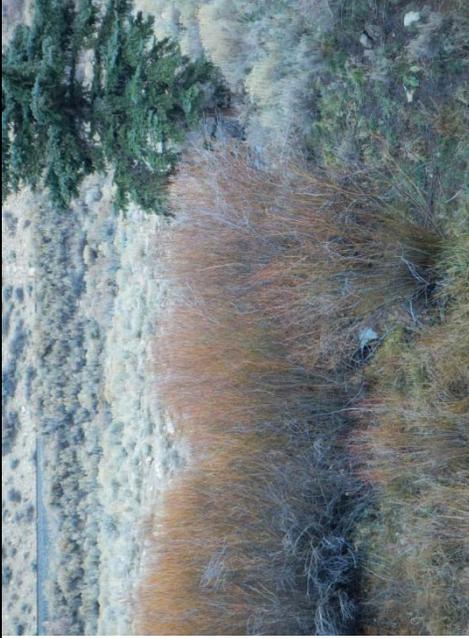
At the loadout: The outlet of culvert C-14-42 was clearly visible on the bank above Mud Creek, photo 1. East of the RR water is ponded a foot to two feet deep at culvert C-1-32, photo 2. Culvert C-4-42 East of the RR tracks is exposed at the surface and torn open. This damage was first noted on May 12, 2009. This culvert is the responsibility of the RR, but has not been maintained. The opening in the 42 inch culvert is approximately 16 inches square and presents a hazard to wildlife (especially when snow covered), photo 3. I piled RR ties and rocks over the opening to temporarily fix the problem, photo 4. I will contact the RR to report the issue. Culvert C-7-24 passes beneath the access road North along the RR tracks. C-7-24 is crushed at its inlet in ditch D7, photo 5. Some erosion of the road is occurring as a result.

**PHOTO 1** Loadout: The outlet of C-14-42 is visible on the bank above Mud Creek.

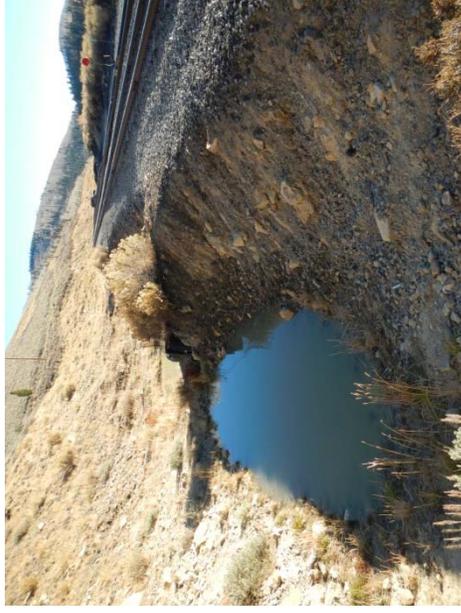
**PHOTO 2** Looking South at water ponded in ditch at C-1-32.

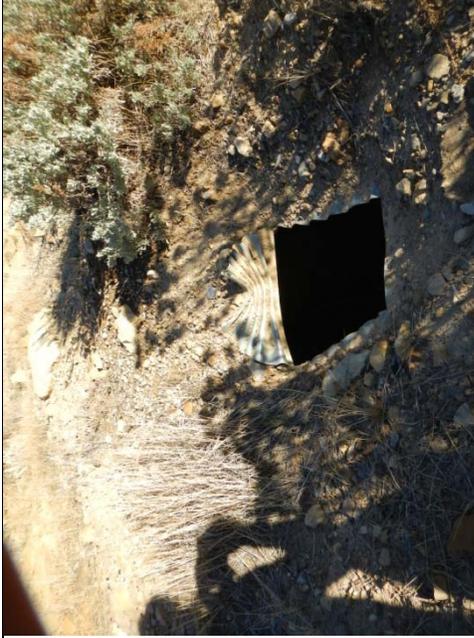
**PHOTO 3** Culvert C-4-42 is ripped.

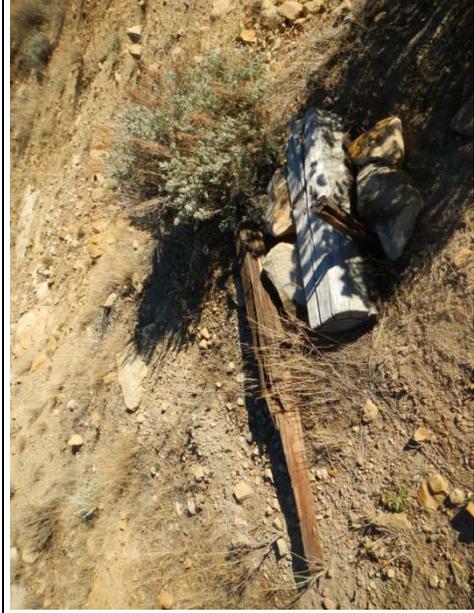
**PHOTO 4** Culvert C-4-42 temporary fix.

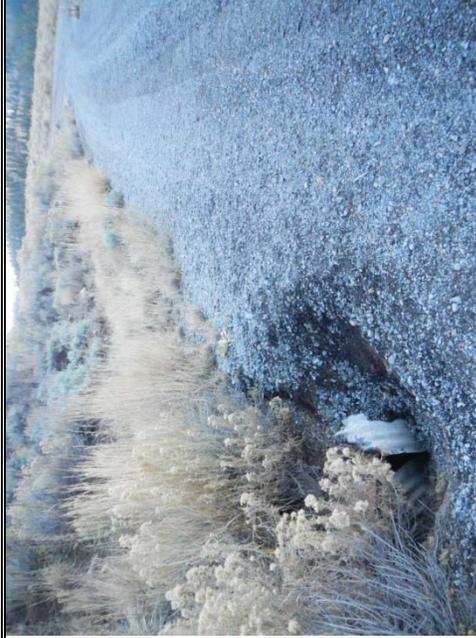
**PHOTO 5** Culvert C-7-24 damage on RR access road North.

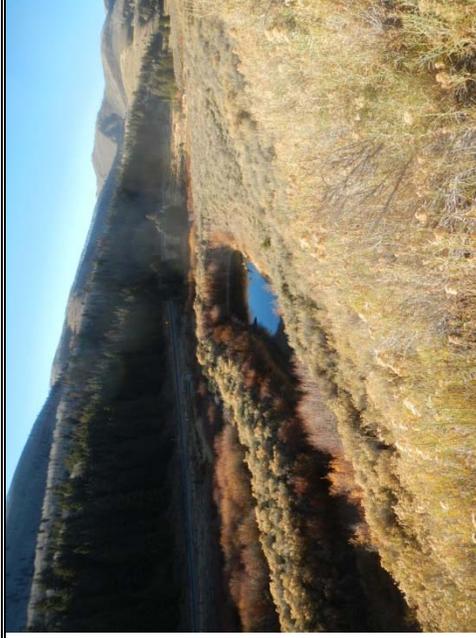
At the Loadout: Pond 001A is holding water, photo 6.

**PHOTO 6** Pond 001A

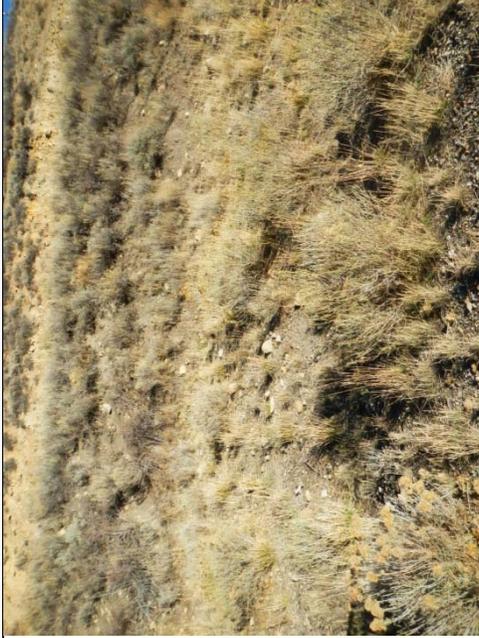
**PHOTO 7**

At the loadout, four years ago (11/6/2012), thistle was noted being dominant above the reclaimed culvert 2-14-42. Now there is no thistle in this location. The area is vegetated with grasses and shrubs, photo 7.

Vegetation on repaired section of C-14-42.

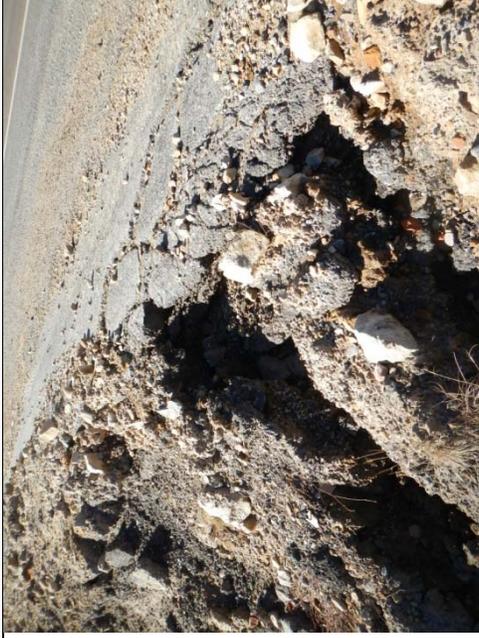
**PHOTO 8**

Road drainage from Hwy 264 is creating erosion gullys down the reclaimed slope, photos 8 and 10. Sediment has settled at the river bank in some locations, creating ideal planting sites. Other sediment is beginning to fill in the deep hole just below that reclaimed site.. Keenan Storrar, Division hydrologist, and I met with Jim Chandler and Brian Nielson of the Utah Department of Transportation to discuss placement of road drainage control along Hwy 264 to prevent further damage. A plan of action was agreed upon. UDOT will install a culvert to collect road wash and direct it outside the reclamation area. This work will be coordinated with Brian Nielson. The Division will write a WRI grant to acquire money for installation of further sediment controls along the reclaimed slopes. The work will be done next spring/early summer.

Erosion of reclaimed slopes above Eccles Creek from road wash.

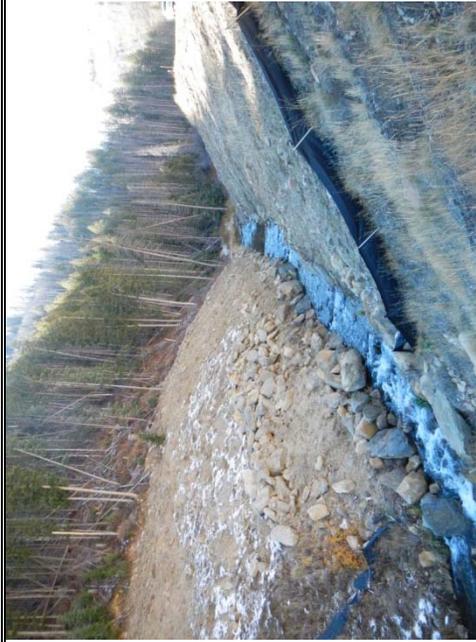
Vegetation is getting a start on the slopes above the reclaimed Eccles Creek. Photo 9. Two seeded forb species are frequently encountered: sanfoin and small burnet, photos 11 & 12. Wheat grass is also frequently encountered, nursed by Triticale which is now dry and dead. To further encourage vegetation and erosion control of the slopes, I spread the remaining Whiskey Creek project seed (one five gallon bucket full on each side of the creek). Seed mix is attached.

**PHOTO 9** Looking upstream at reclaimed Eccles Creek.

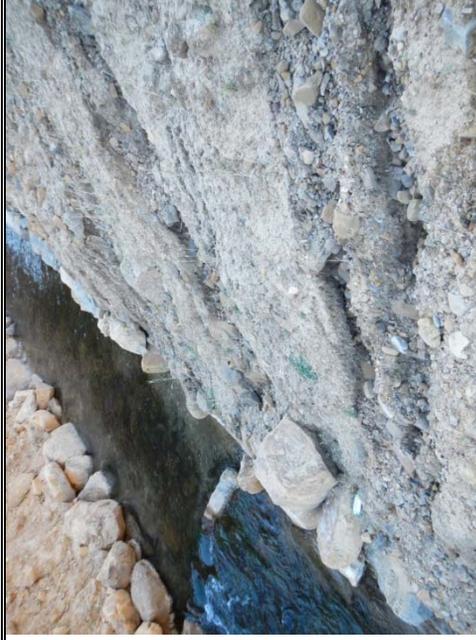
**PHOTO 10** Erosion rills go all the way down to the stream.

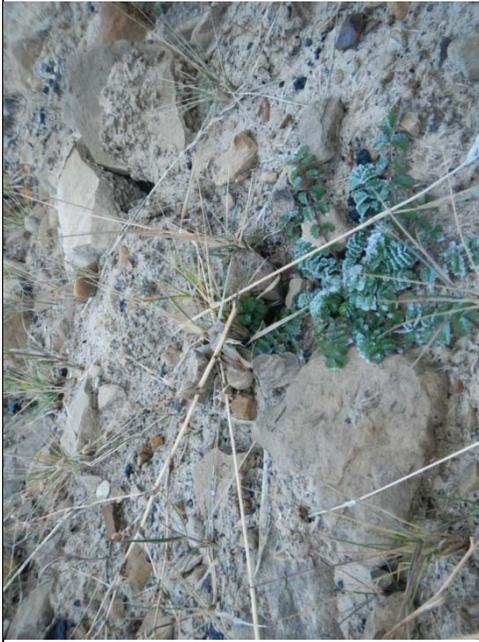
**PHOTO 11**

Seeded species: small burnett and grasses on reclaimed slope at the end of the first growing season.

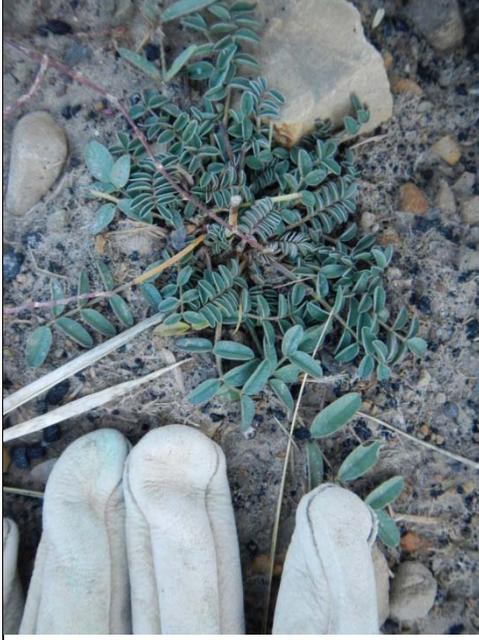
**PHOTO 12**

Seeded species: sanfoin on reclaimed slope at the end of the first growing season.
