Inspection Report

Permit Number:	C0070001
Inspection Type:	COMPLETE
Inspection Date:	Tuesday, July 9, 2019
Start Date/Time:	7/9/2019 10:30:00 AM
End Date/Time:	7/9/2019 6:00:00 PM
Last Inspection:	Tuesday, June 5, 2018

Permitee: **LODESTAR ENERGY INC**
 Operator:
 Site: **WHITE OAK MINE**
 Address: ,
 County: **CARBON**
 Permit Type: **PERMANENT COAL PROGRAM**
 Permit Status: **RECLAIMED**

PHOTO ATTACHMENT – White Oak Mine July 9, 2019

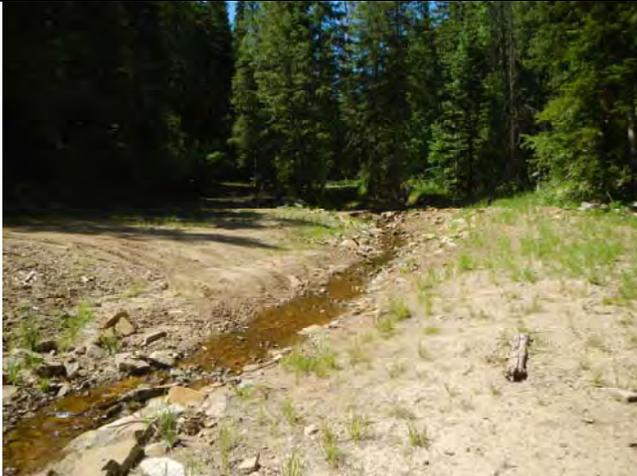
Only the right fork of Whiskey Creek is flowing. Historically, in the 3rd quarter, the average flow in Whiskey Creek was 4.48 gpm at VC4 (MRP Chap 7, p. 700-26, VC4 flow data). Seeps emanating from the toe of the East facing slope in Reach 2 are contributing further water. (Seeps were analyzed, see Incoming document 11142012). Much further downstream, flow was observed in The Bowl side canyon (on the West) and in Sheep Canyon (on the East), both contributing to Whiskey Creek. Whiskey Creek is flowing all the way to its confluence with Eccles Creek and the water is clear.

Flow in Whiskey Creek across constructed swale at bottom of canyon

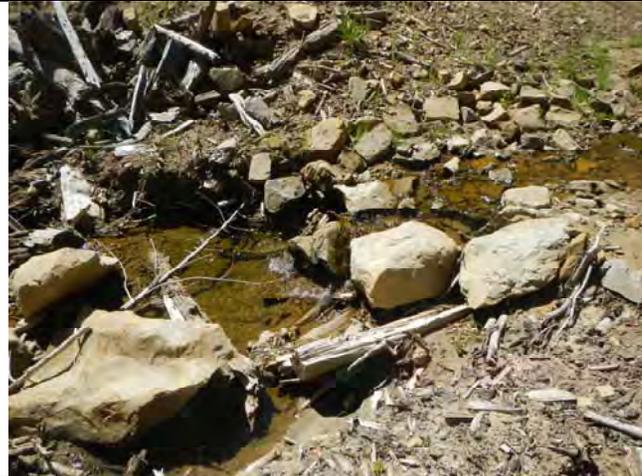
Flow exiting Whiskey Creek swale

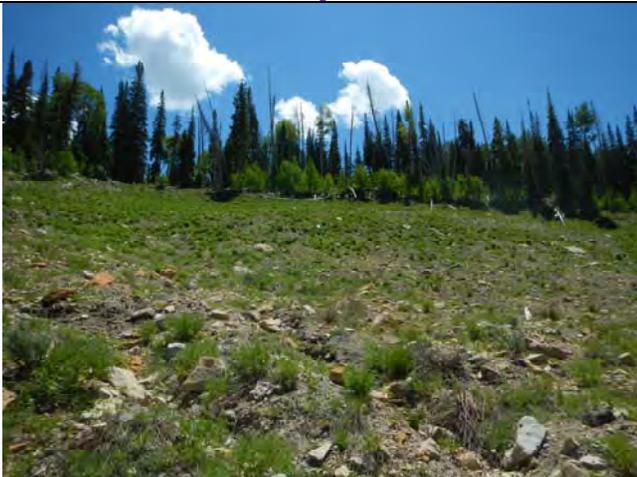
The 2010 regrading and installation of terraces on the East facing slopes has stabilized those slopes. All wood straw and mulch applied in 2010 and 2011 has decomposed. The West facing slope, which was not reworked, has many erosion gullies. Most of these gullies are 9 - 12 inches deep and have exposed underlying rock fragments. This sediment has been carried down to the Whiskey Creek channel where it has silted in the drop structures. Photographs of each drop structure are attached.

Mine site West facing slope

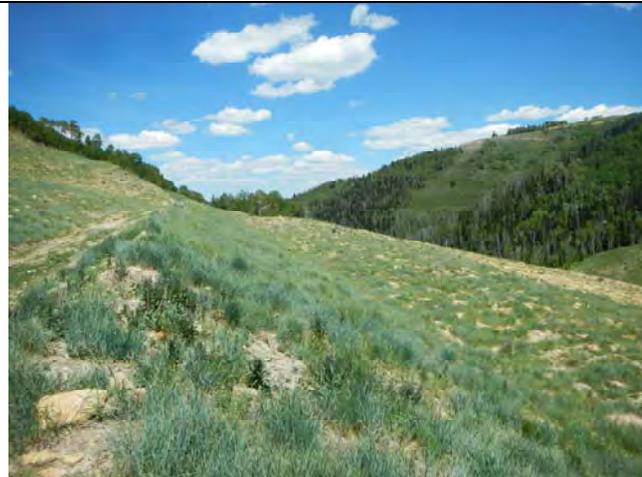
Mine site East facing slope

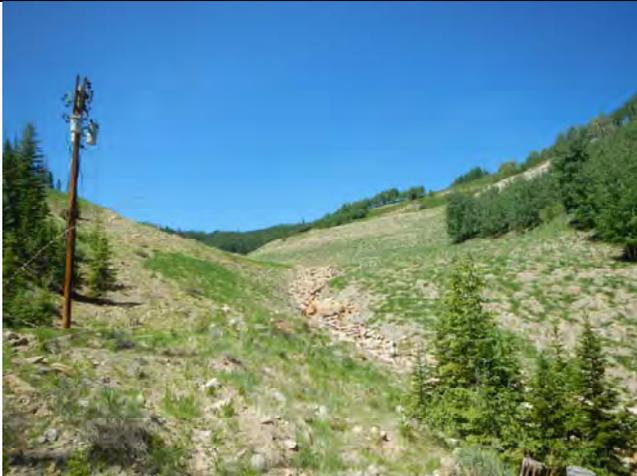
Utility pole with transformer remains standing at the cement well pad on the NW disturbed area boundary. The transformer should be removed.

Utility pole with transformer and slopes of reclaimed Reach 3 and Reach 4

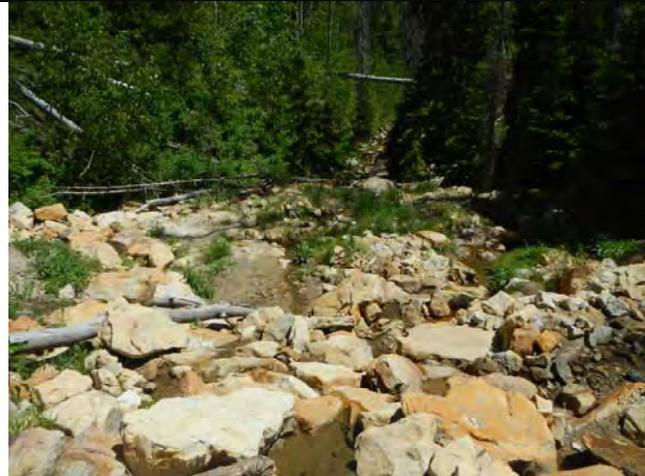
Looking downstream at drop structure 1 and undisturbed area

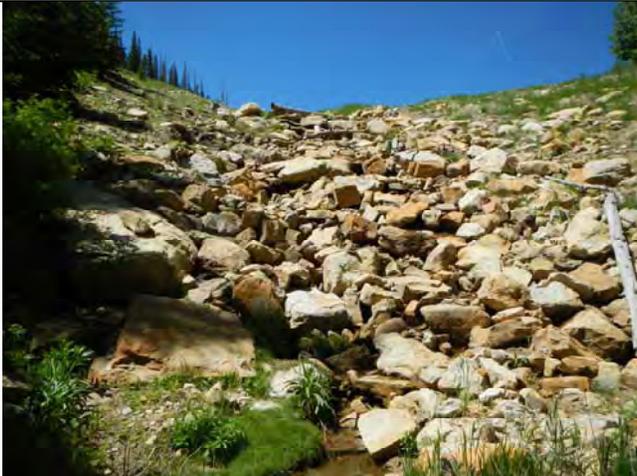
Looking upstream from drop structure 1 at Reach 4 (43% slope)

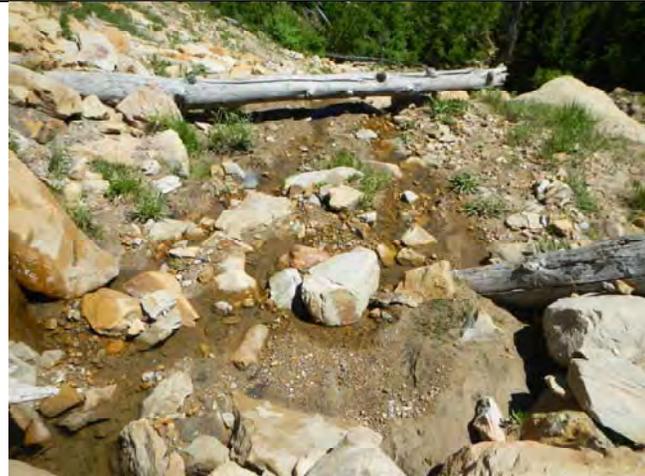
Looking downstream on drop structure 2

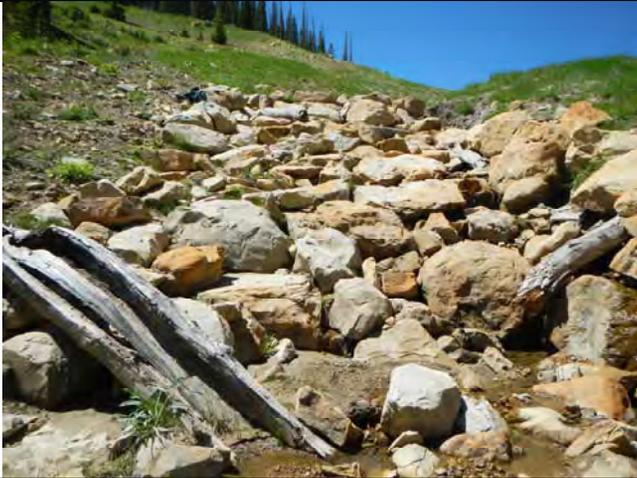
Looking upstream from drop structure 2 at Reach 4

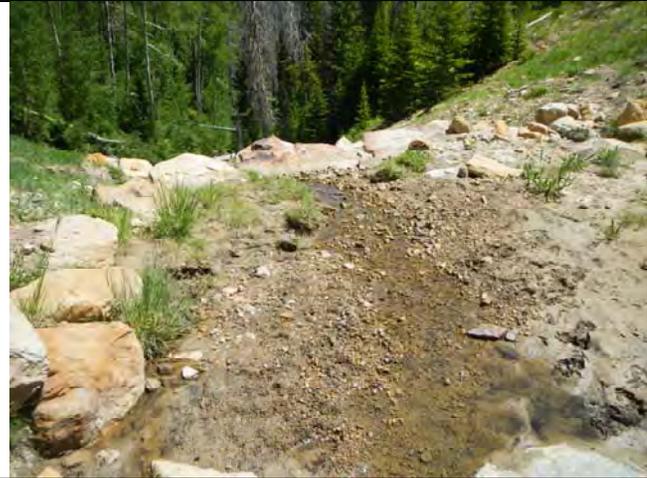
Looking downstream on drop structure 3

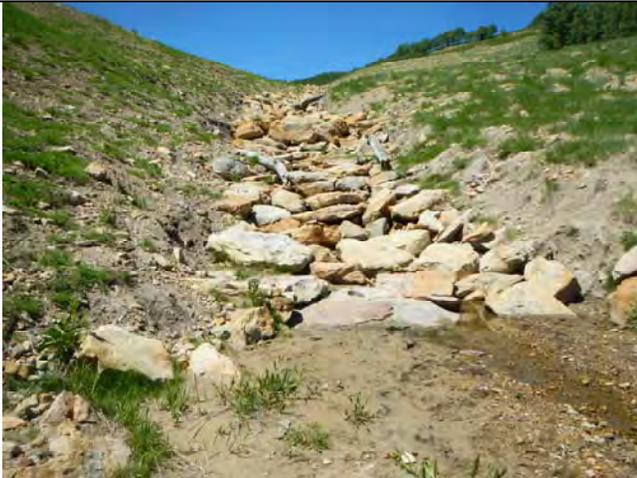
Looking upstream from drop structure 3 at Reach 3 (29% slope)

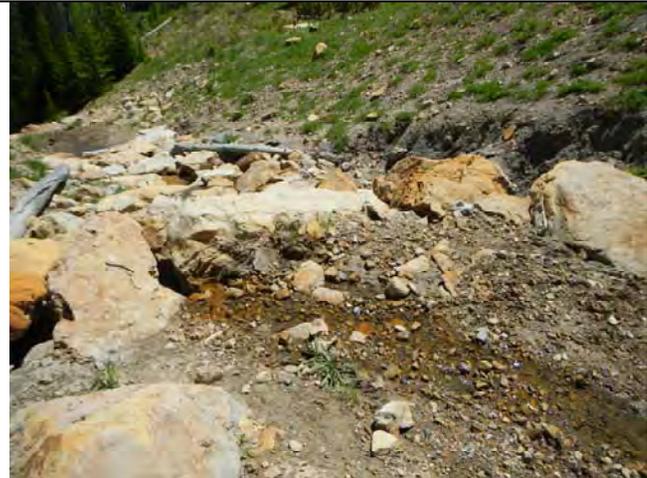
Looking downstream at drop structure 4

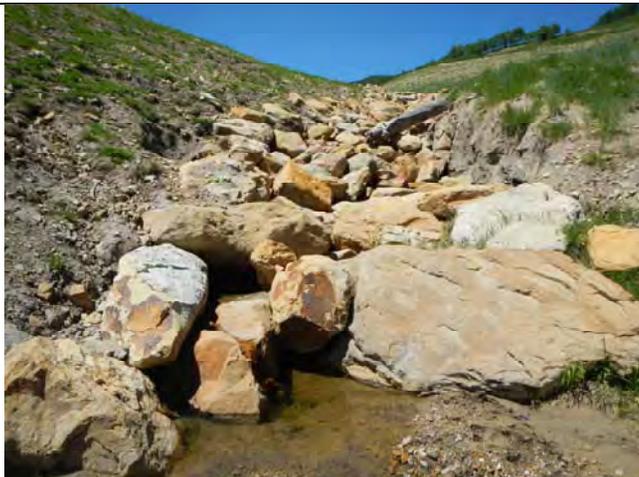
Looking upstream from drop structure 4 at Reach 3

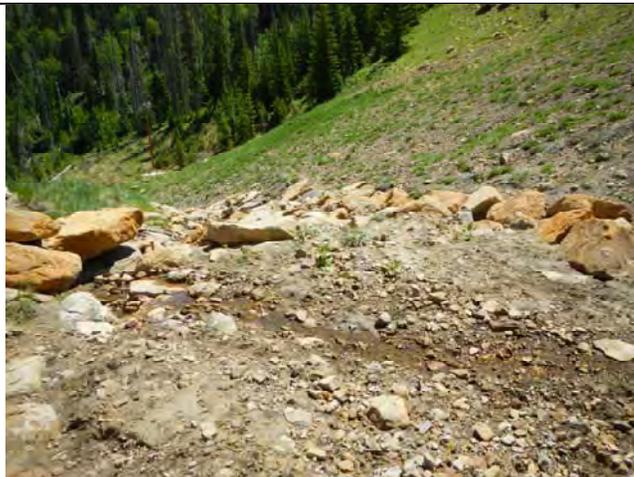
Looking downstream on drop structure 5

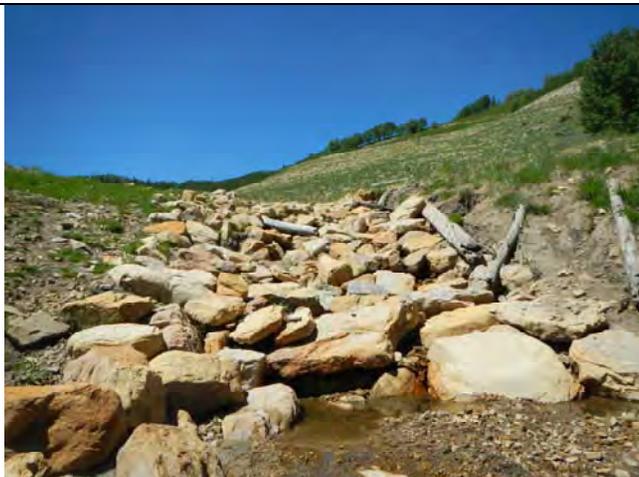
Looking upstream from drop structure 5 at Reach 2 (13% slope)

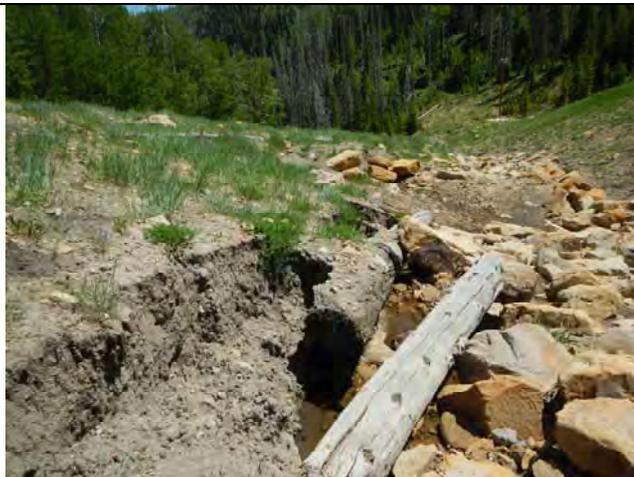
At the mine site, the reclaimed side channel on the East Facing slope is stable and dry. The reclaimed Whiskey Creek channel is stable in all reaches, with some undercutting of the channel banks in Reach 3. This erosion has not changed noticeably since August 2017.

Undercutting just above drop structure 5

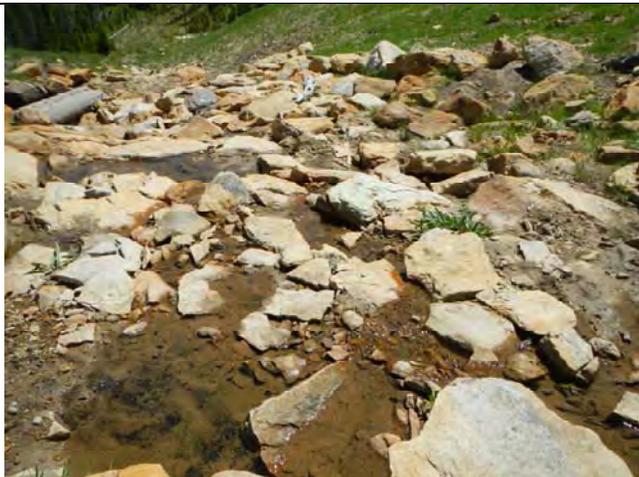
A seep high in iron stains a portion of the reclaimed Whiskey Creek in Reach 2. By Reach 3, the presence of iron is no longer visible. A seep high in iron flows through the bypass culvert at the loadout and into Mud Creek. The oxidized iron leaves a rust stain on the culvert and stream bank.

Looking at drop structure 6 and seep

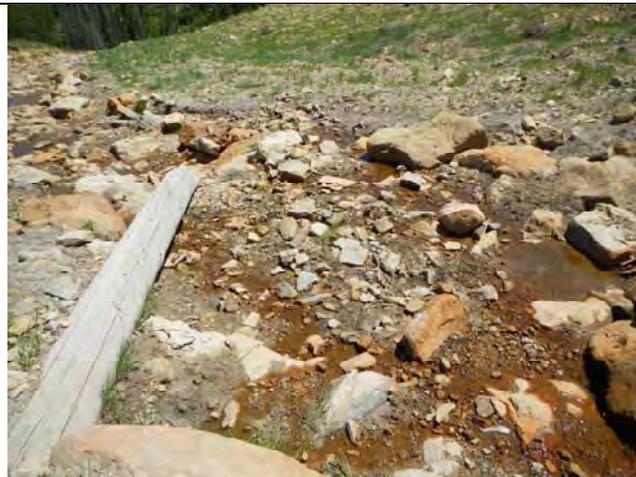
Looking downstream on drop structure 7

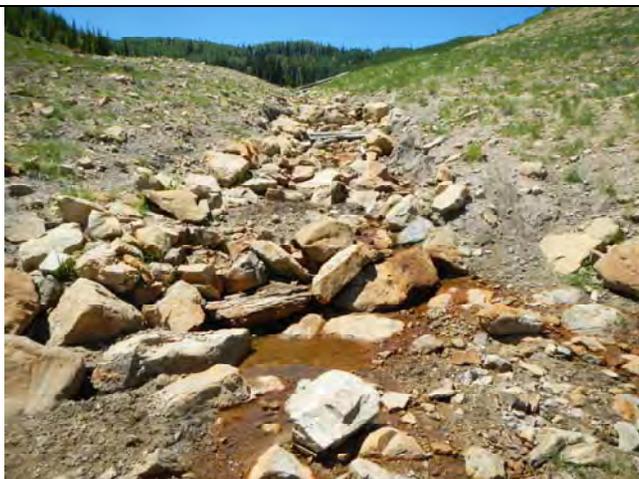
Looking upstream from drop structure 7 at Reach 2 (7% slope)

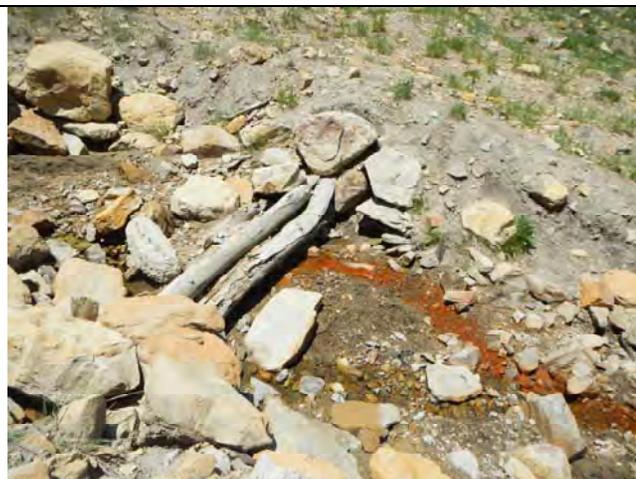
Drop structure 8 and seep

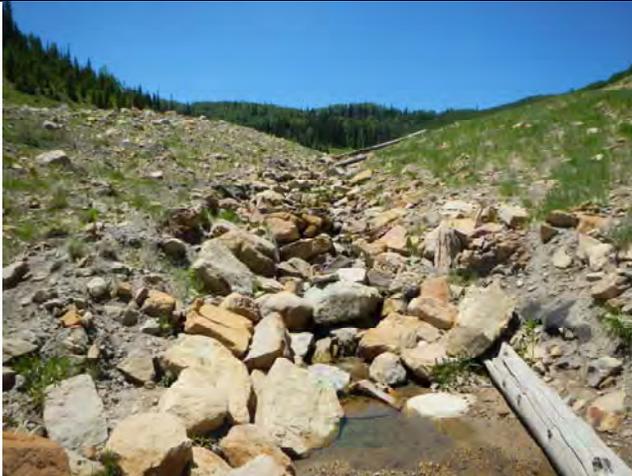
Looking upstream at Reach 2 (7% slope) from drop structure 8. This section of Reach 2 was reclaimed in 2005 and was not reaffected in 2011.

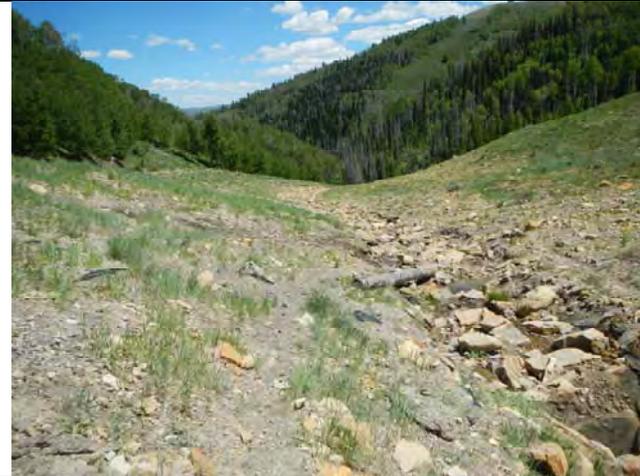
Looking downstream at Reach 2 reclaimed in 2011.

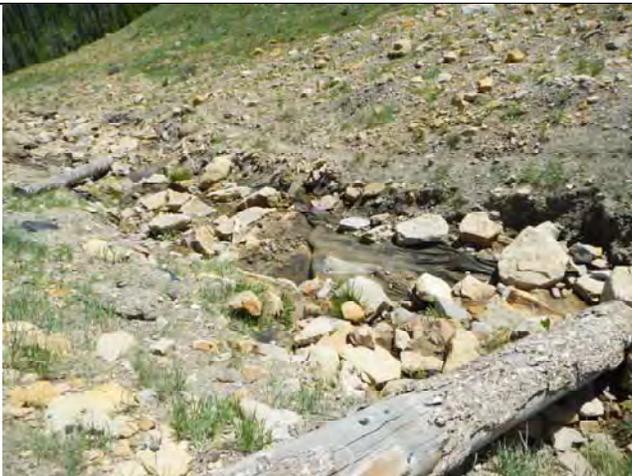
Exposed geotextile in Reach 2 reclaimed in 2005.

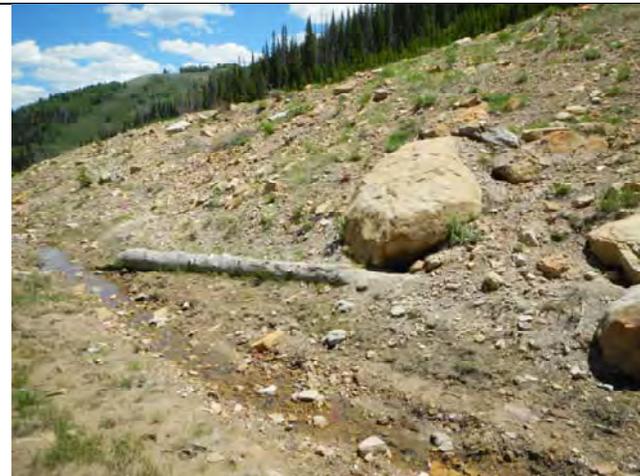
Reach 1 and boulder above former sinkhole.

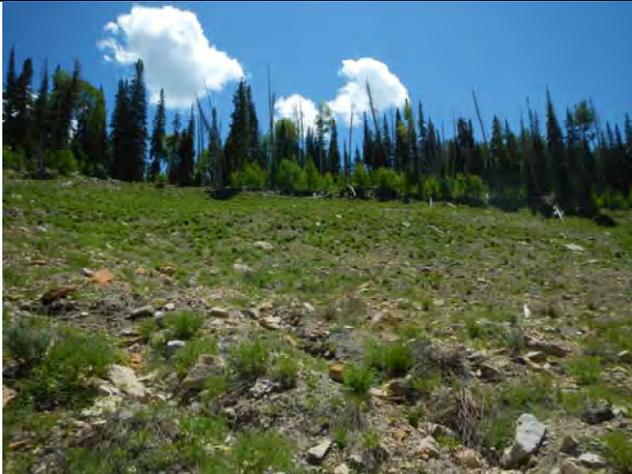
Vegetation on West facing slope reclaimed 2005.

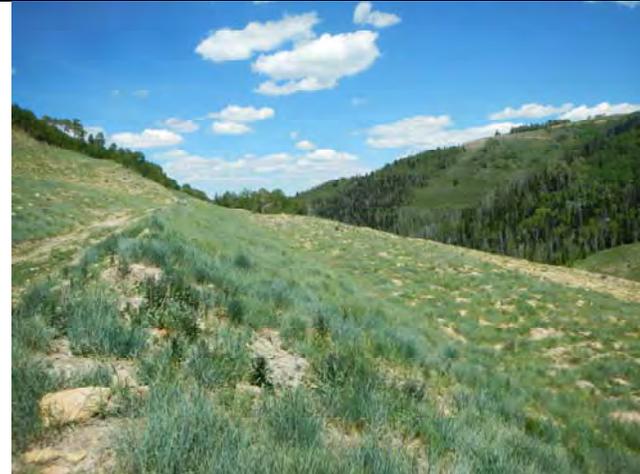
Vegetation on East facing slope reclaimed 2001.

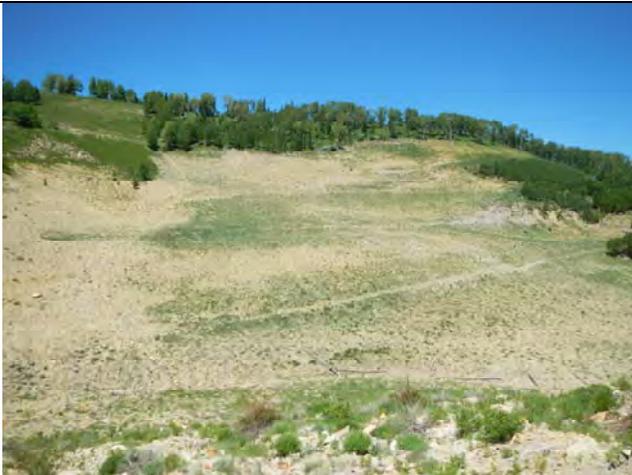
Terraces C, B, and A (lowest) on East facing slope

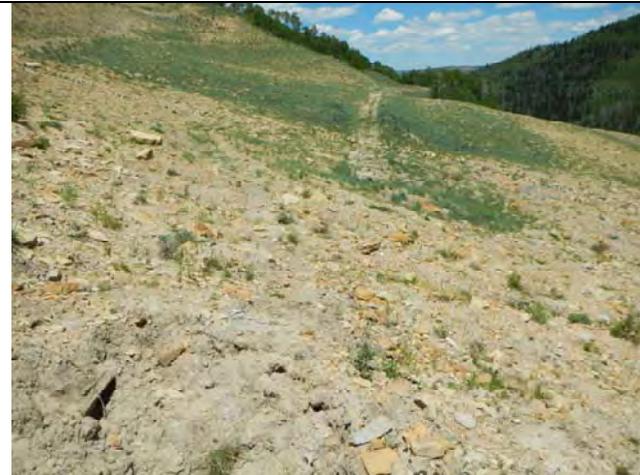
The reclaimed upper and lower sink holes appear stable. The stability of the upper sinkhole could be confirmed through a survey of the current elevation compared to the elevation provided by Innovative Excavation in 2011 in their final (as-built) report. Two roof bolt markers were installed at that time and are still in place.

A new sink hole may be developing near the reclaimed upper portal sink hole. This depression is approximately 7 feet across and has a sunken appearance, with edges abruptly dropping down a foot or so.

Edge of new depression and reclaimed upper sinkhole.

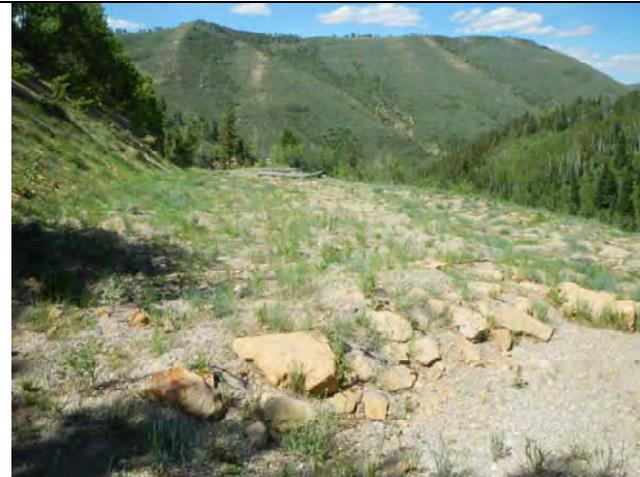
Reclaimed asphalt access road.

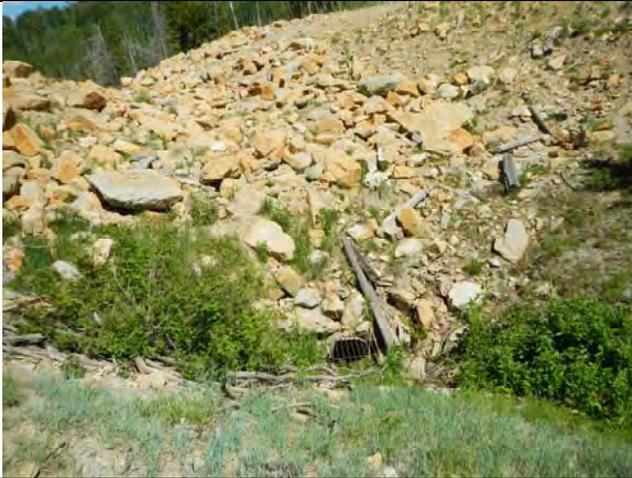
Reclaimed roads are stable and show no sign of erosion. Water bars were placed every 100 ft (every 50 ft for the steeper grade at the turn above The Bowl). All water bars are functioning on the access road. Swales replaced culverts in the small drainages. Swales are stable and vegetated with no sign of erosion. Water flows through the culvert at The Bowl, beneath a swale of riprap with a d50 of 2 ft. The trash rack on this culvert was unobstructed.

Swale above The Bowl trash rack and culvert.

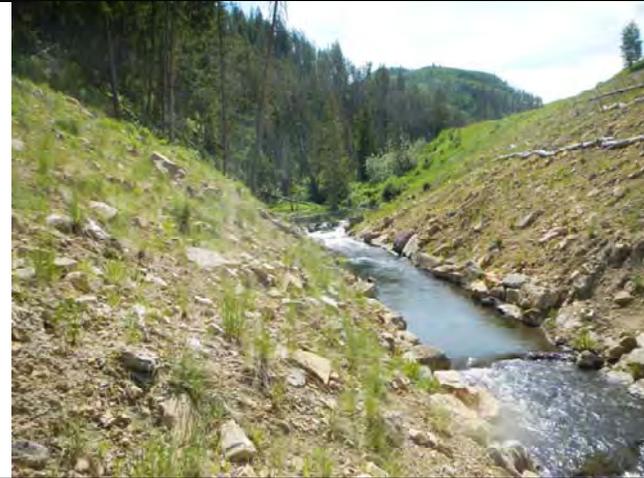
The Eccles Creek restoration is stable. The beaver still maintain a dam at the upper end of the reconstruction. The beaver dam has ponded water approximately 50 feet upstream of the reclamation. On June 19, 2019, Eccles Creek was flowing at approximately 2,300 gpm (~ 5.0 cfs) based on monitoring data from the Skyline Mine.

Eccles Creek reclamation

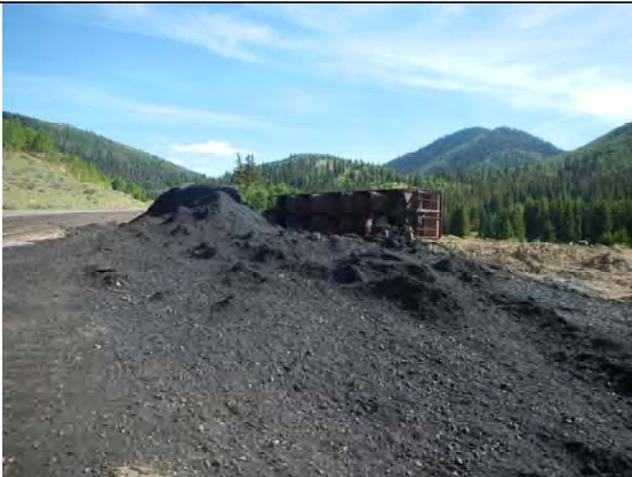
A railroad car overturned on the White Oak loadout reclamation site. During the clean up, the flat surface of the reclaimed area was affected by vehicles and there is little vegetation growing. The overturned RR car and a pile of coal remain on the reclaimed area.

Piles railroad ties, gravel, wood and metal debris have been stacked along the access road at the loadout. An overturned railroad car remains along with a pile of coal on the reclaimed area adjacent to the loadout tracks.

Loadout RR car spill

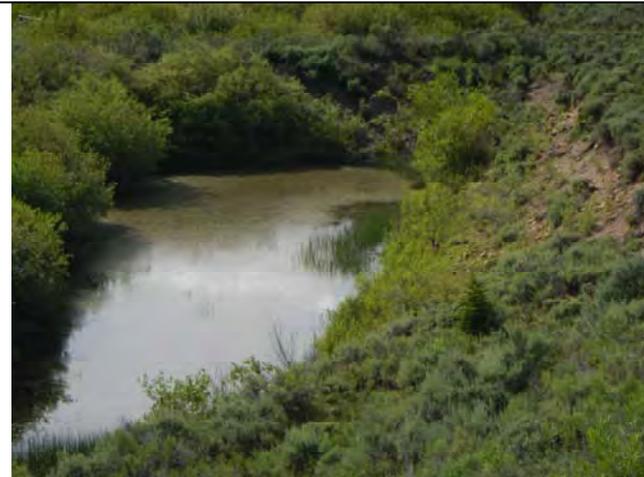
The Loadout sediment pond 001A is holding water. A deer was at the pond.

Loadout sediment pond 001A
