PRICE RIVER COAL COMPANY

File: ACT/007/004
7413

December 11, 1985

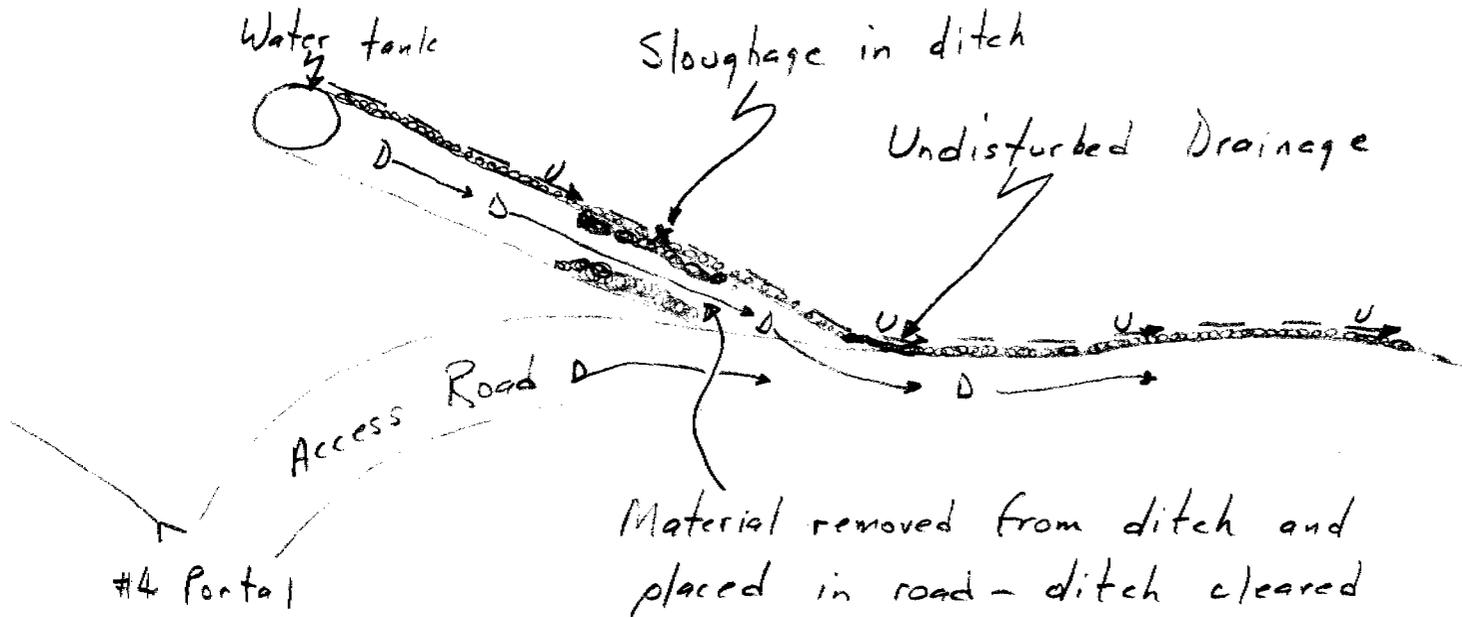
During a recent inspection, a rock sloughage was found in the undisturbed diversion ditch below the water tank at No. 4 portal. The sloughage was cleaned out immediately, as well as could be done, with a front end loader. A back hoe was moved to the area from Castle Gate in the afternoon, and an attempt was made to further rectify the situation. Due to the amount of snow present, slope and softness of the ground under the machine, this attempt was not particularly successful. It was decided to allow the material to freeze overnight and try again the next morning - this was done, but due to the snow cover and the slope of the ground, the muck removed from the ditch was left on the road, and a ditch cleared through it for the disturbed drainage.

Material removed from ditch and placed in road - ditch cleared thru muck for disturbed drainage to pass

Permanent repairs to the road and further repairs to the ditch will be undertaken in the Spring when the ground has stabilized and will not pose a great danger to the machine operator.
