State of Utah
DEPARTMENT OF NATURAL RESOURCES
DIVISION OF OIL, GAS AND MINING

March 15, 1995

RE: Draft Review, Reclamation As-Built, Castle Gate Mine, Amax Coal Company,
ACT/007/004-94E, Working File, Carbon County, Utah

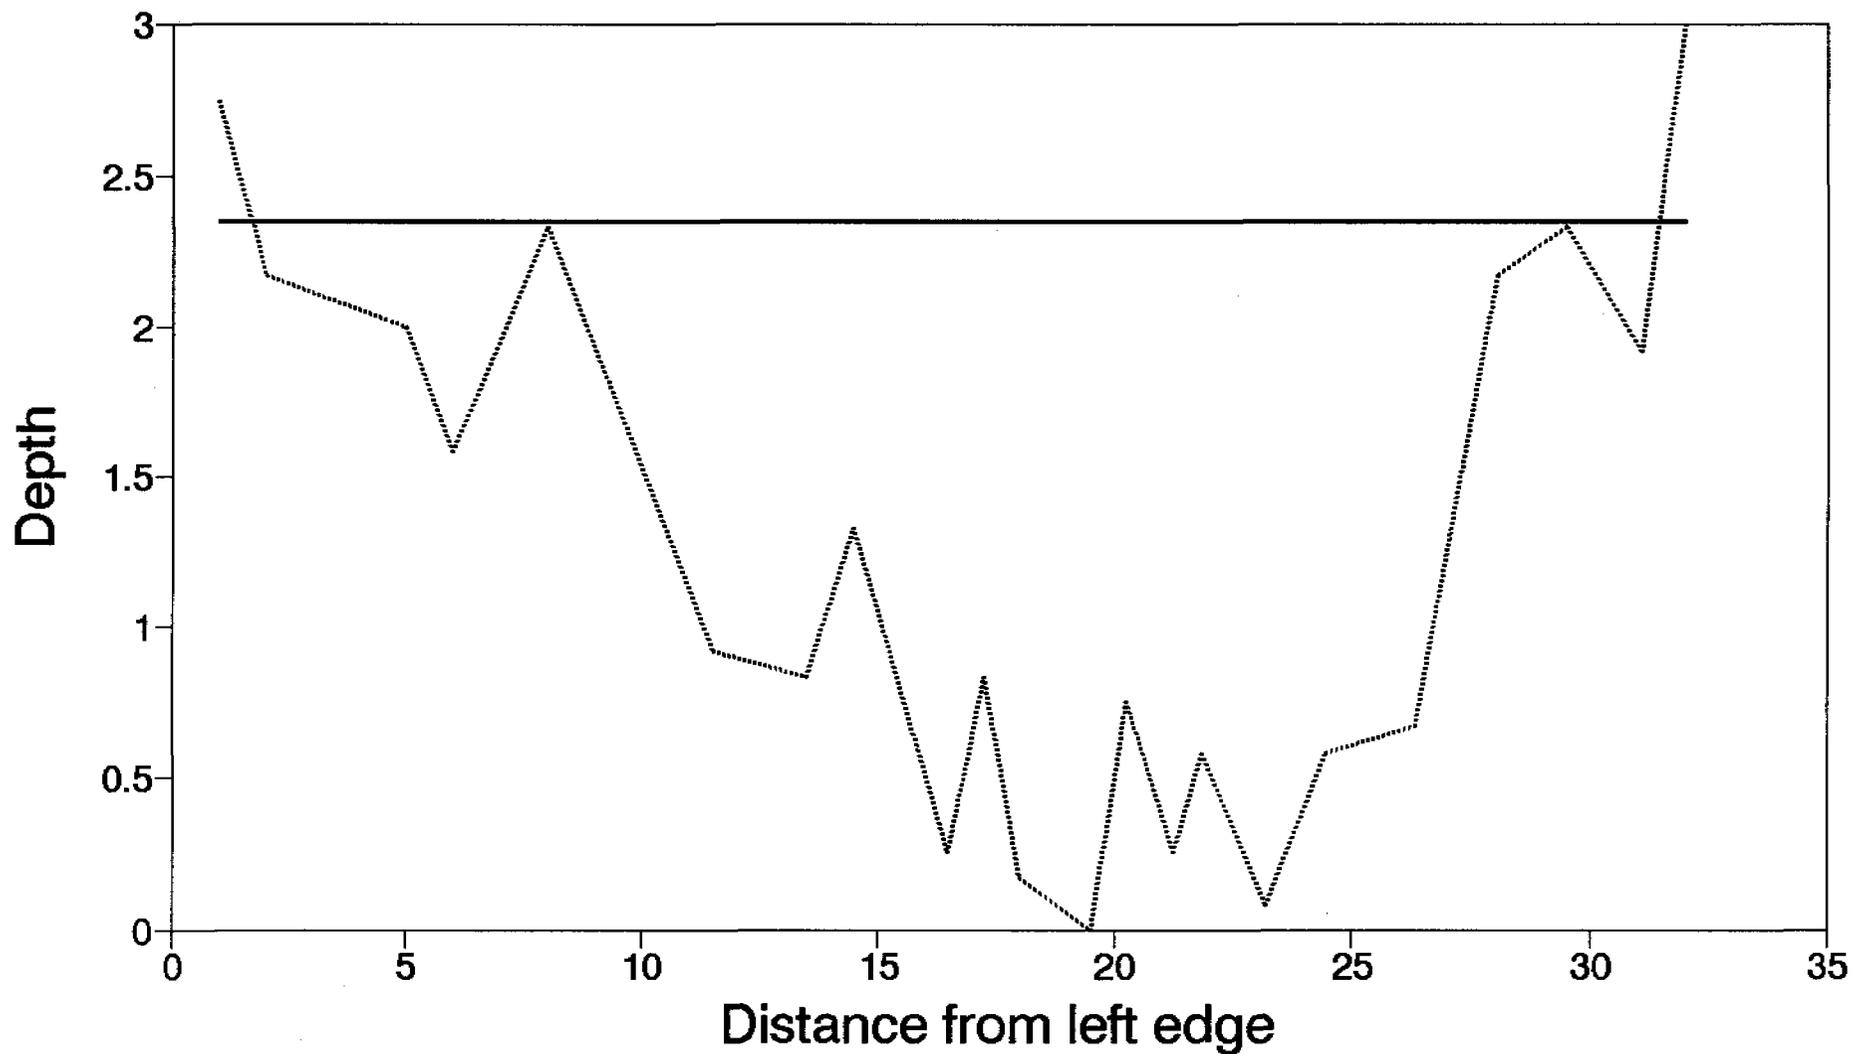
Sowbelley Reclamation, Sbrd-1A ~ 0+15

The freeboard on SBRD-1A, 1B, 1C, 1D, 9, and 10 all have less than 1.0-feet of freeboard. 1B, 1C, 1D, and 9 are less than 0.5-feet. Three of which are less than an 0.1-feet. These channels will be remeasured to see if they are as marginal as originally thought. Field measurements show that some areas are not adequate to convey the volume for the design storms.

1. All diversions must included, at minimum, 6-inches of freeboard above the size requirements which pass the design (100-year, 24-hour) storm event. Areas that do not have adequate flow depth to contain the 100-year, 24-hour storm runoff will need to be modified or reconstructed to the original design size.

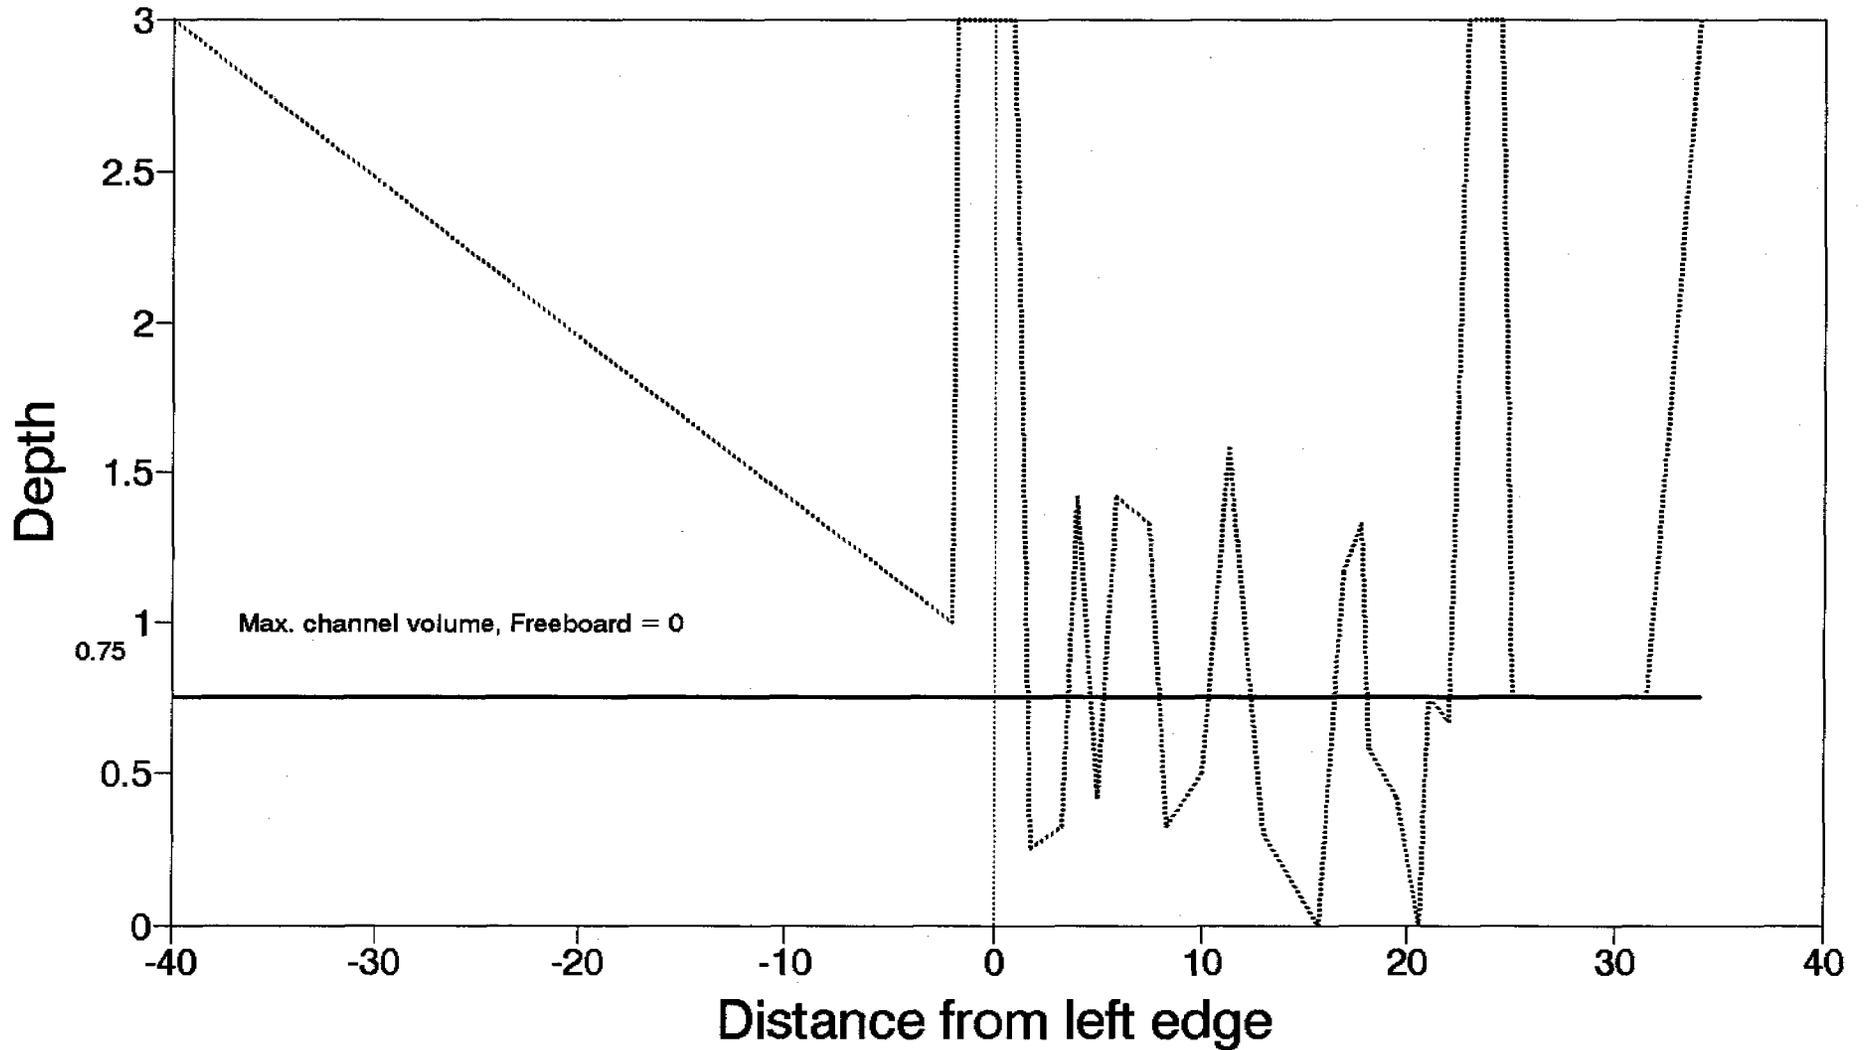
Sowbelley Reclamation, Sbrd-1C ~ 5+00

Field measurements made by the Division show that some areas are not adequate to convey the volume for the design storms. It appears that riprap was place on areas that were to shallow to begin. Then after the riprap was place the effective flow area was diminished even more. See the attached figures (Cross Sections and Rating Curves for SBRD-1C.) Areas where flow depth is not adequate will require reconstruction.
