INSPECTION REPORT

Mine Name: Castle Gate County: Carbon Permit Number: ACT/007/004
Permittee and/or Operator's Name: Amax Coal Co.
Business Address: P. O. Drawer PMC, Price, Utah 84501
Type of Mining Activity: Underground Surface Prep. Plant Other
State Officials(s): Paul Baker and Steve Johnson
Company Official(s): Johnny Pappas and Ben Grimes
Federal Official(s): None
Weather Conditions: Mostly sunny, 40's, about 8" of snow at Goose Island, less at lower elevations
Existing Acreage: Permitted- 7646.5 Disturbed- 197.5 Regraded- 33.2 Seeded- 33.2 Bonded- 162
Increased/Decreased: Permitted- 0 Disturbed- 0 Regraded- 0 Seeded- 0 Bonded- 0
Status: Exploration/Active/Inactive/Temporary Cessation/Bond Forfeiture
Reclamation (Phase I/ Phase II/ Final Bond Release/ 10 for Goose Island Liability Year)

Attachment to Inspection Report for Castle Gate Mine, ACT/007/004, January 3, 1997

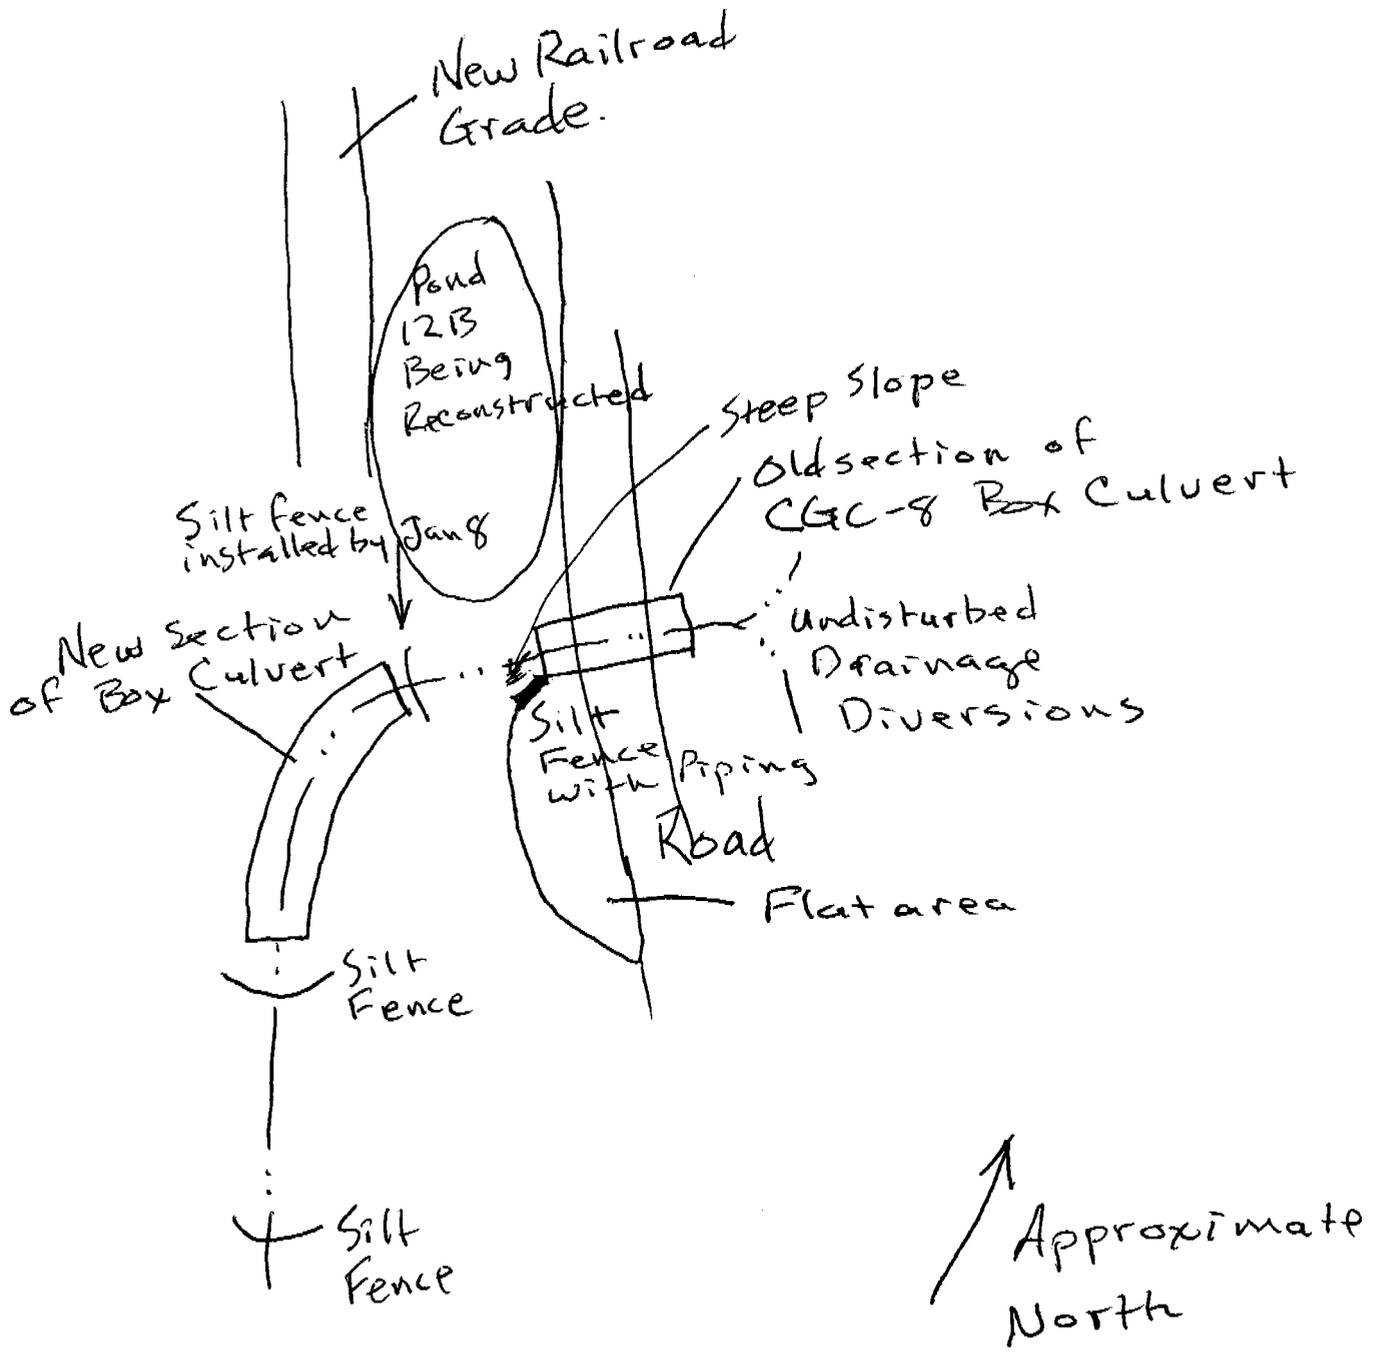
To the southeast of the outlet of the old portion of CGC-8, there was a flat area right next to the road, the drainage from which could not be routed to a sediment pond. Some drainage from the road and other nearby areas also goes to this flat area. The operator and/or utility companies were working to install or move some utility lines in this area. Drainage from the flat area was being directed toward the outlet of the old portion of CGC-8, and there was a silt fence right before the drop down to the culvert. (See

attached drawing.) After passing the silt fence, the water was going down a steep embankment to the outlet of the old portion of CGC-8 which is a diversion that carries water from undisturbed areas. From this point, any water that continued to flow down the diversion would pass through two silt fences (three on January 8) as discussed under "Sediment Ponds and Impoundments" above and as shown in the drawing.

At the time of the inspection, the silt fence where water discharged into the undisturbed drainage diversion was not functional. Water was piping under the silt fence, and the water had a sheen, apparently from petroleum products. Because of the heavy equipment working in the area, it was not surprising to see the sheen.

Having the water pipe under the silt fence wasn't considered too much of a problem because there were two other backup silt fences. However, there was nothing to stop the oil and grease from getting in the undisturbed drainage diversion. We did not see water leaving the disturbed area; it seemed to be ponding in the diversion or perhaps soaking into the ground. Even so, unless something was done to collect the oil and grease getting into this diversion, it would probably eventually end up in the Price River. Mr. Johnson and I considered it a violation to not be treating water from a disturbed area before it entered a drainage meant to carry water from undisturbed areas and to not have an effective treatment for oil and grease before it could potentially leave the permit area. Violation N97-41-1-3, part three of three, was issued for failing to minimize disturbance to the hydrologic balance within the permit and adjacent areas.
