DEPARTMENT OF NATURAL RESOURCES
DIVISION OF OIL, GAS AND MINING

RE: Phase I Bond Release Application, Castle Gate Holding Company, Castle Gate Mine, ACT/007/004-BR00B

TECHNICAL MEMO

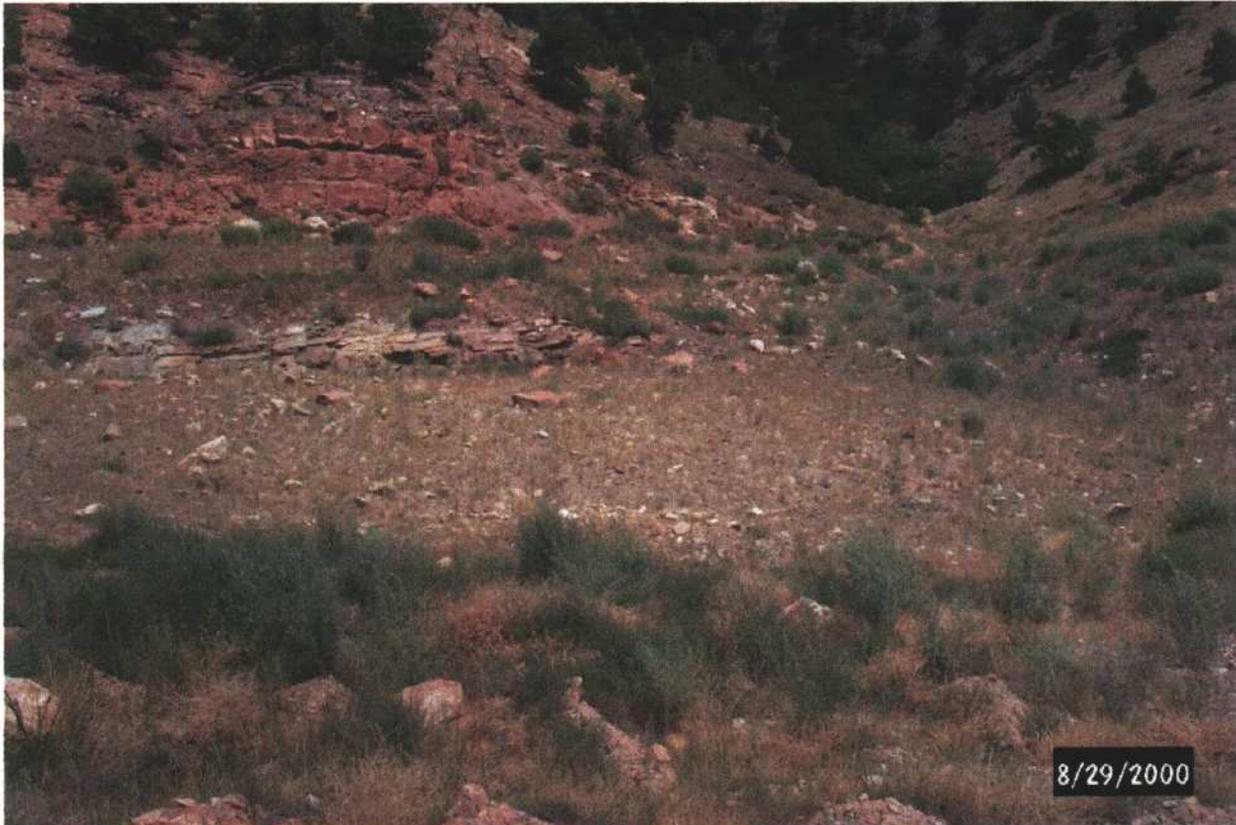
Reclaimed vegetation in the reclaimed scale house area appears to be adversely affected, both in cover and size, in comparison with surrounding reclaimed vegetation (see attached photo). As a result, the Division sampled soils in this small, affected area on August 29, 2000. Field observations were made and the soil sample was tested for pH, EC, Ca, Mg, and SAR:

- The soil is hard and very difficult to penetrate and break up with a spade. When finally disturbed with the spade, the soil has no structure and sifts like loose flour. There is plenty of larger rock with a greater abundance of gravel within the soil matrix.
- Random samples were taken from a dozen locations within this area and a composite soil sample was mixed into a gallon sized sample.
- Results of soil testing after air drying, sieving through an 18 mesh sieve, and preparing a saturation soil paste and extract:

physical properties show that the soil has no structure and sets up to a very hard consistency. This area was used for both equipment staging during reclamation work and where soil was screened to recover rip-rap. Most likely, this soil is what was left over after screening soil to collect rip-rap rock. During screening, the soil's structure and coherency would have been completely destroyed.

Figure 1. Castle Gate Mine, Hardscrabble Canyon, Old Scale House area were equipment staging area was located during reclamation. Vegetation appears to be impacted from adverse soil conditions that include lack of structure and crusting.

To help relieve the physical problems and rebuild soil structure, the Division recommends that organic matter (e.g., composted bio-solids) be added to the soil and worked into the upper 6 to 8 inches.
