Re: Phase I Bond Release, Castle Gate Holding Company, Castle Gate Mine, C/007/004-BR00B, Outgoing File

#### **DECISION DOCUMENT**

Phase I Bond Release

**Castle Gate Mine**

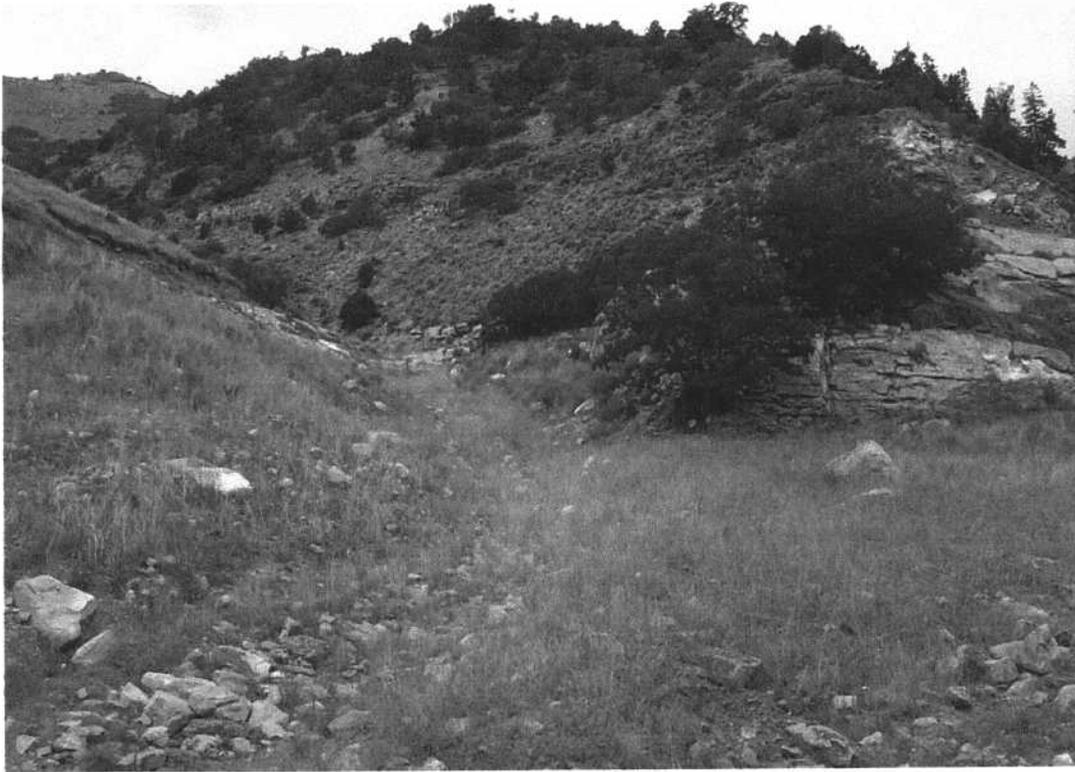
South of the old preparation facilities, and 700 feet south of the No. 4 bathhouse, was a warehouse. This warehouse was remodeled to include office space within the existing structure. Above and to the west of the warehouse, is a gully containing the "Dog Flat" storage area. This area was revegetated in 1987 but was regraded in 1996 to reestablish the natural drainage (Appendix A, Site Photos, Fig 1).

Figure 1. The Dog Flat storage area was filled with coal processing waste prior to reclamation.

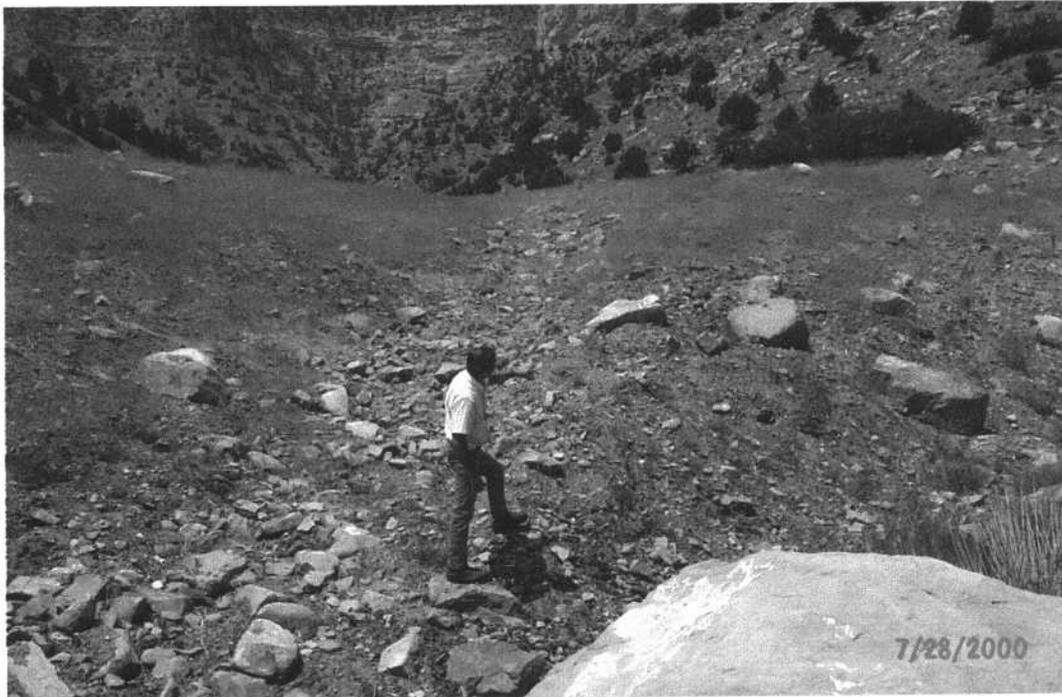
In Hardscrabble Canyon, the Goose Island refuse area was graded and seeded in 1984. Transplants were planted in 1985, and Phase I bond release was given later in 1985. Limited regrading was done in this area in 1999 (Appendix A, Site Photos, Fig 2).

Portions of the previously reclaimed Goose Island refuse area were re-disturbed in the fall of 1999 to increase soil cover depth and to improve a drainage channel. Surface roughening techniques included deep gouging the newly place soils.

Figure 2. Recent re-working of channel in Goose Island.

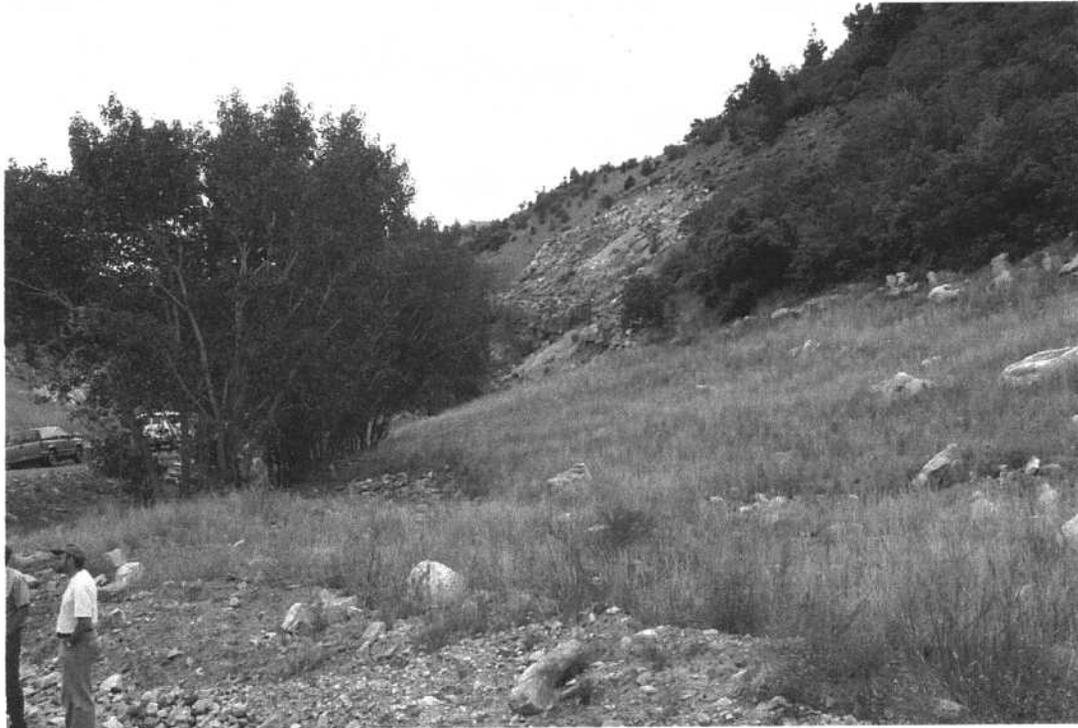
Figure 3. Cottonwood trees retained by careful grading.

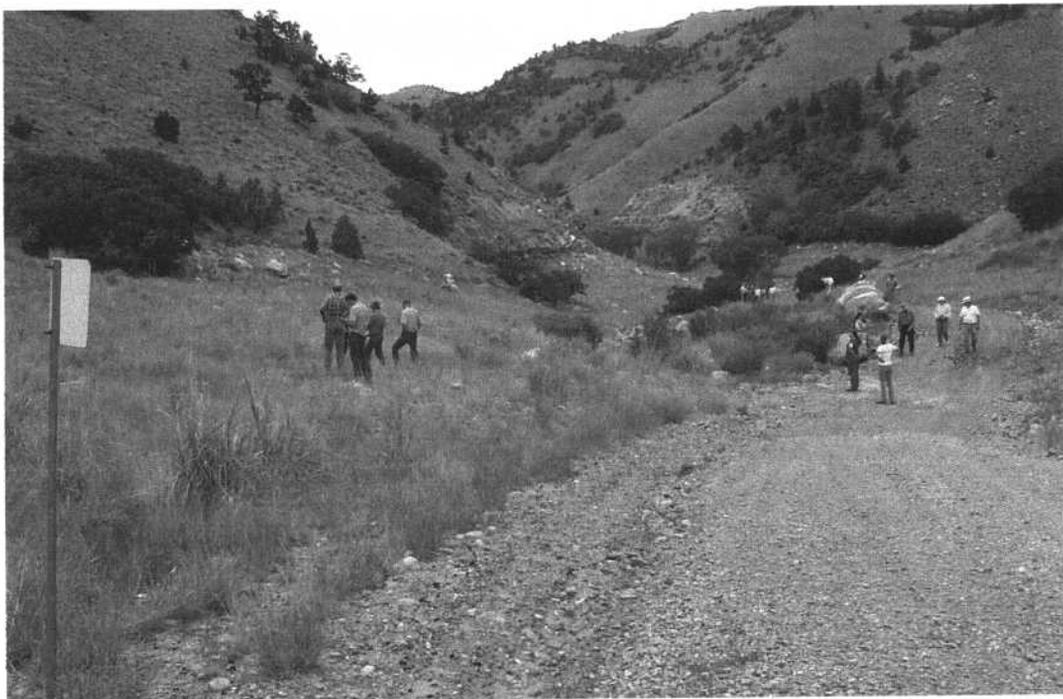
Beginning at the gate, 0.2 miles of the road is in the Carbon County road system. From this point up, the road is on land owned by the permittee (Appendix A, Site Photos, Fig 4). The road is used by a local rancher, Boyd Marsing, to trail his livestock to the top of the plateau where he leases grazing rights from Lee Diamanti and the Bureau of Land Management.

The main canyon road will be retained as part of the postmining land use plan. The road is classified as a primary road and meets the design standards. Division representatives found the road to be in good repair when they visited the site on July 28, 2000, and during the bond release inspection on September 20, 2000.

Figure 4. Road retained for postmining land use through main canyon.

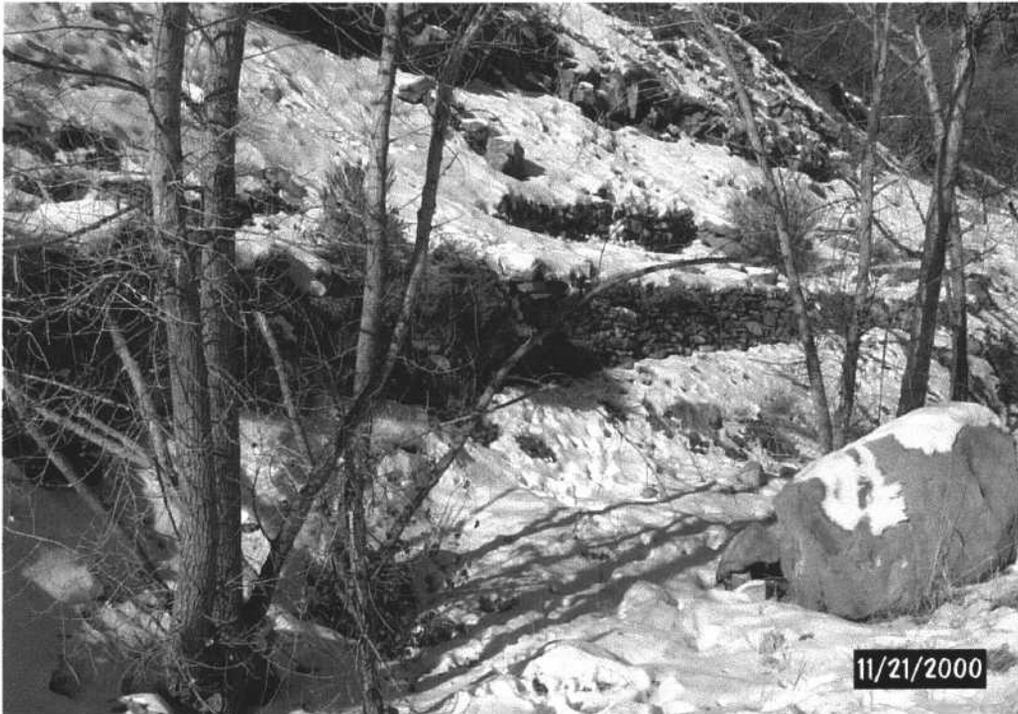
A 75 foot section of rock wall was retained in the area of the upper bath house (Appendix A, Site Photos, Fig 5 & 6). The rock wall is similar to other rock walls found in Carbon County that were constructed around the turn of the 20<sup>th</sup> century. The rock wall is considered an enhancement to the postmining land use. The people of Carbon County are very proud of their mining heritage and do not want all traces of coal mining remove from these sites. The wall will help remind those who pass through Hardscrabble Canyon of that heritage.

Figure 5. 75 feet of stone wall was retained in reclamation.

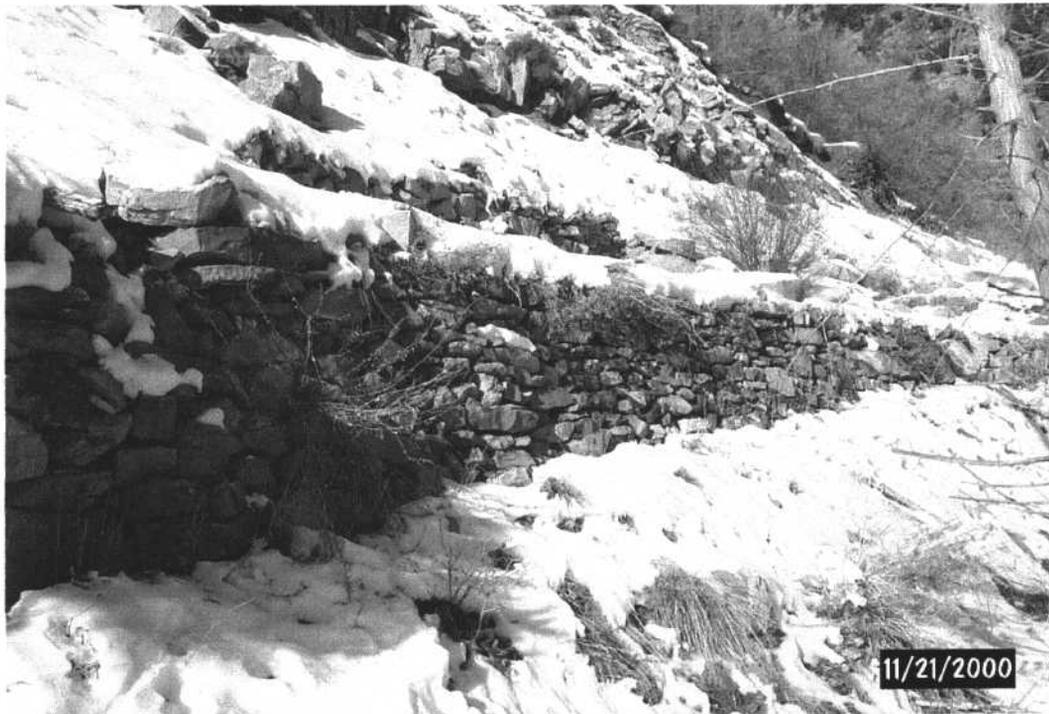
Figure 6. The stone wall is typical of work done in the early 1900's.

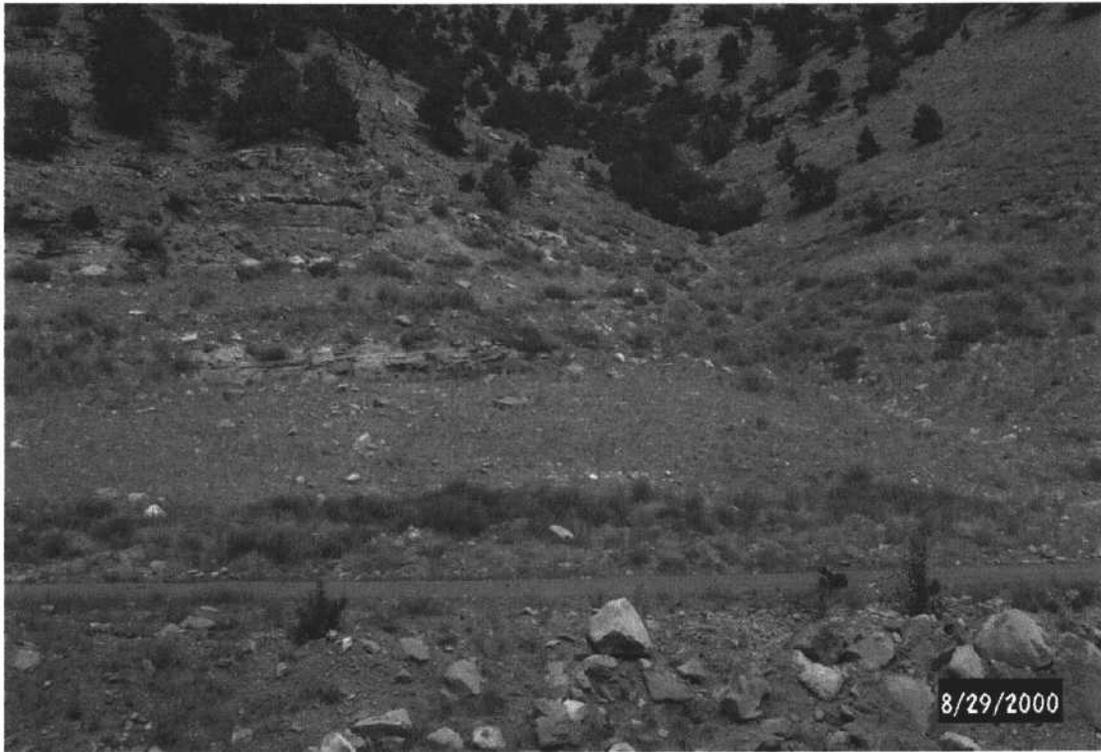
There is an area near the old scalehouse where the vegetation does not look as dense or healthy as it does in other areas. As discussed in the "Topsoil and Subsoil" section of his review, the Division believes this may be caused by a soil structure problem that may resolve itself.

Figure 7. Area with reduced vegetation near former location of scalehouse.

In the area where the scalehouse once stood is an area with less vegetation than surrounding areas. Soil tests did not show problems with salt or sodium contents, but it is possible there are some problems with physical characteristics, particularly the structure. The area is not large enough and the vegetation is not reduced enough that it should cause problems for overall revegetation success. If the problem is truly related to the soil structure, it will probably remediate itself over time.

There are a few areas where there could be revegetation or erosion control problems, but these are relatively small and are expected to stabilize naturally. The Division inspectors should be aware of these areas, check them periodically, and notify other Division staff of any problems found.

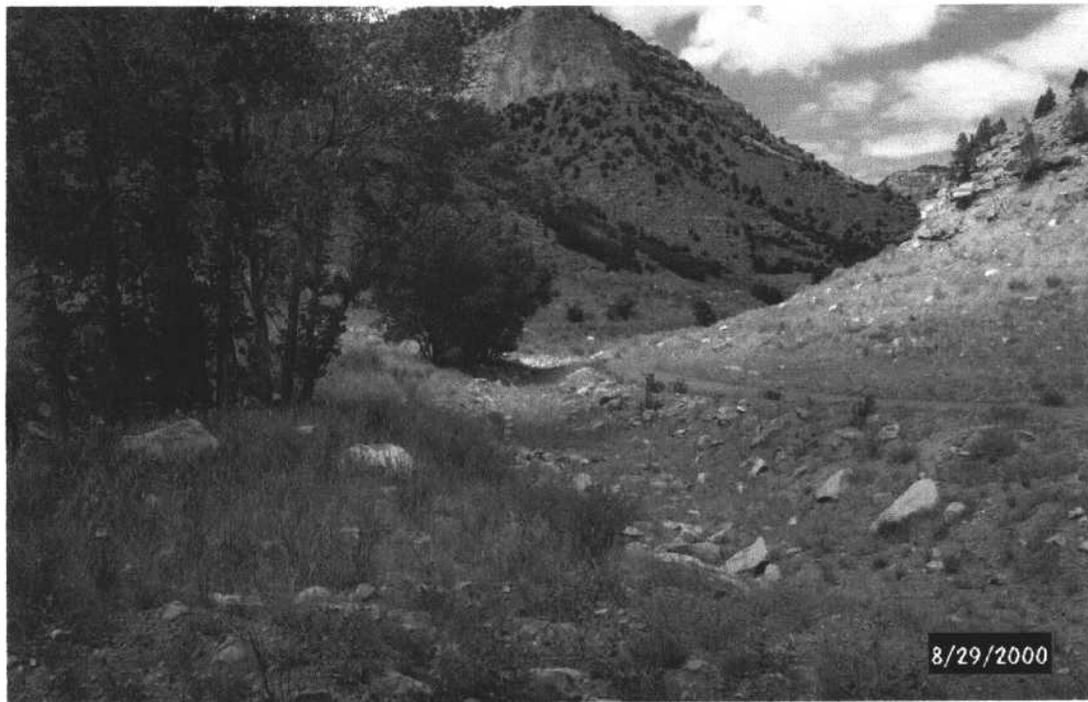
A thorough inspection of the Hardscrabble site on November 21, 2000, indicated very little flow has occurred in the main channel and its tributaries since reclamation (Appendix A, Site Photos, Fig 8). Significant deep-gouging exists on all reclaimed areas which retains moisture and reduces surface erosion. All operational culverts, temporary berms and diversions and silt fences have been removed. The design standards set for the reconstruction of Hardscrabble Creek have been met. One straw-bale dike still remains immediately downstream of site B-11 at the southern end of the property. The dike is still fully-functional, and showed very little retention of sediment since its installment in 1996.

Figure 8. Intermittent drainage through main canyon has had only minor flows.
