RE: SKYLINE MINES - WATER MANAGEMENT REPORT

SKYLINE MINES

Water Handling Schematic
 12-5-92 Kww

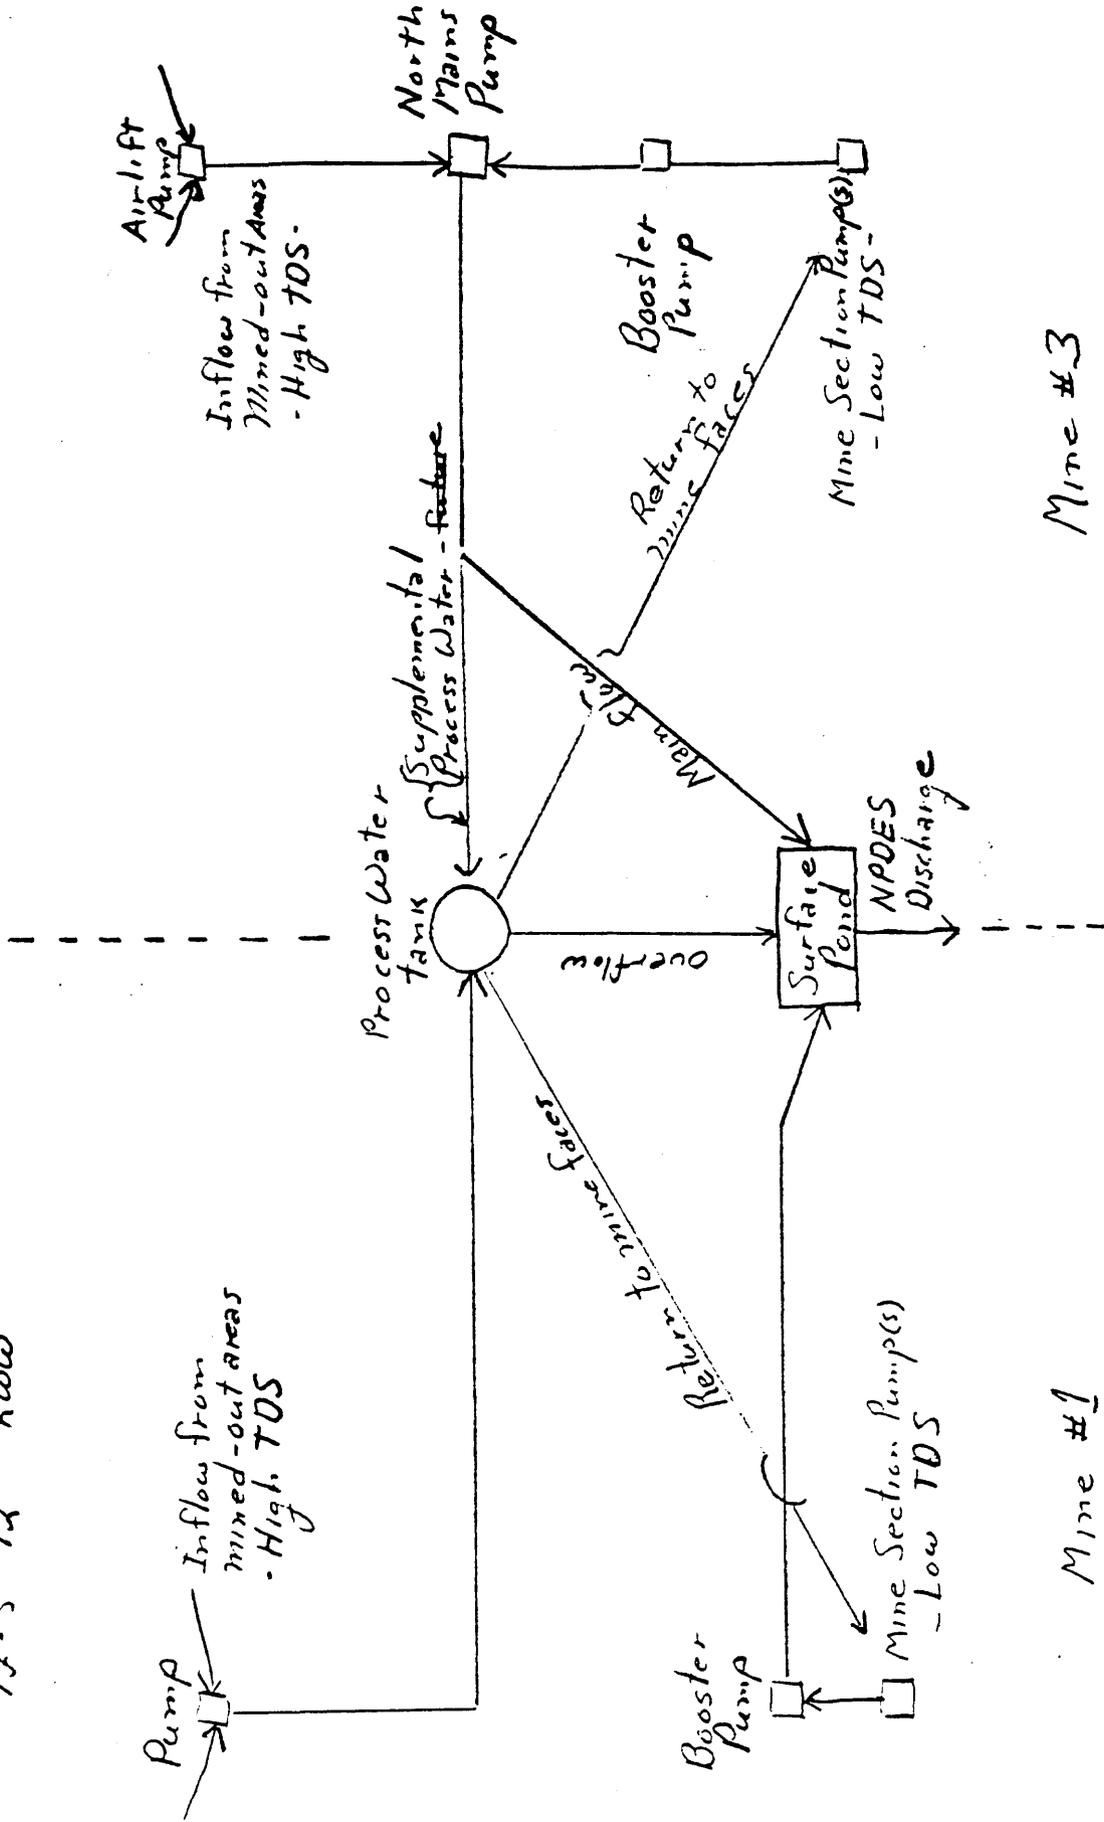
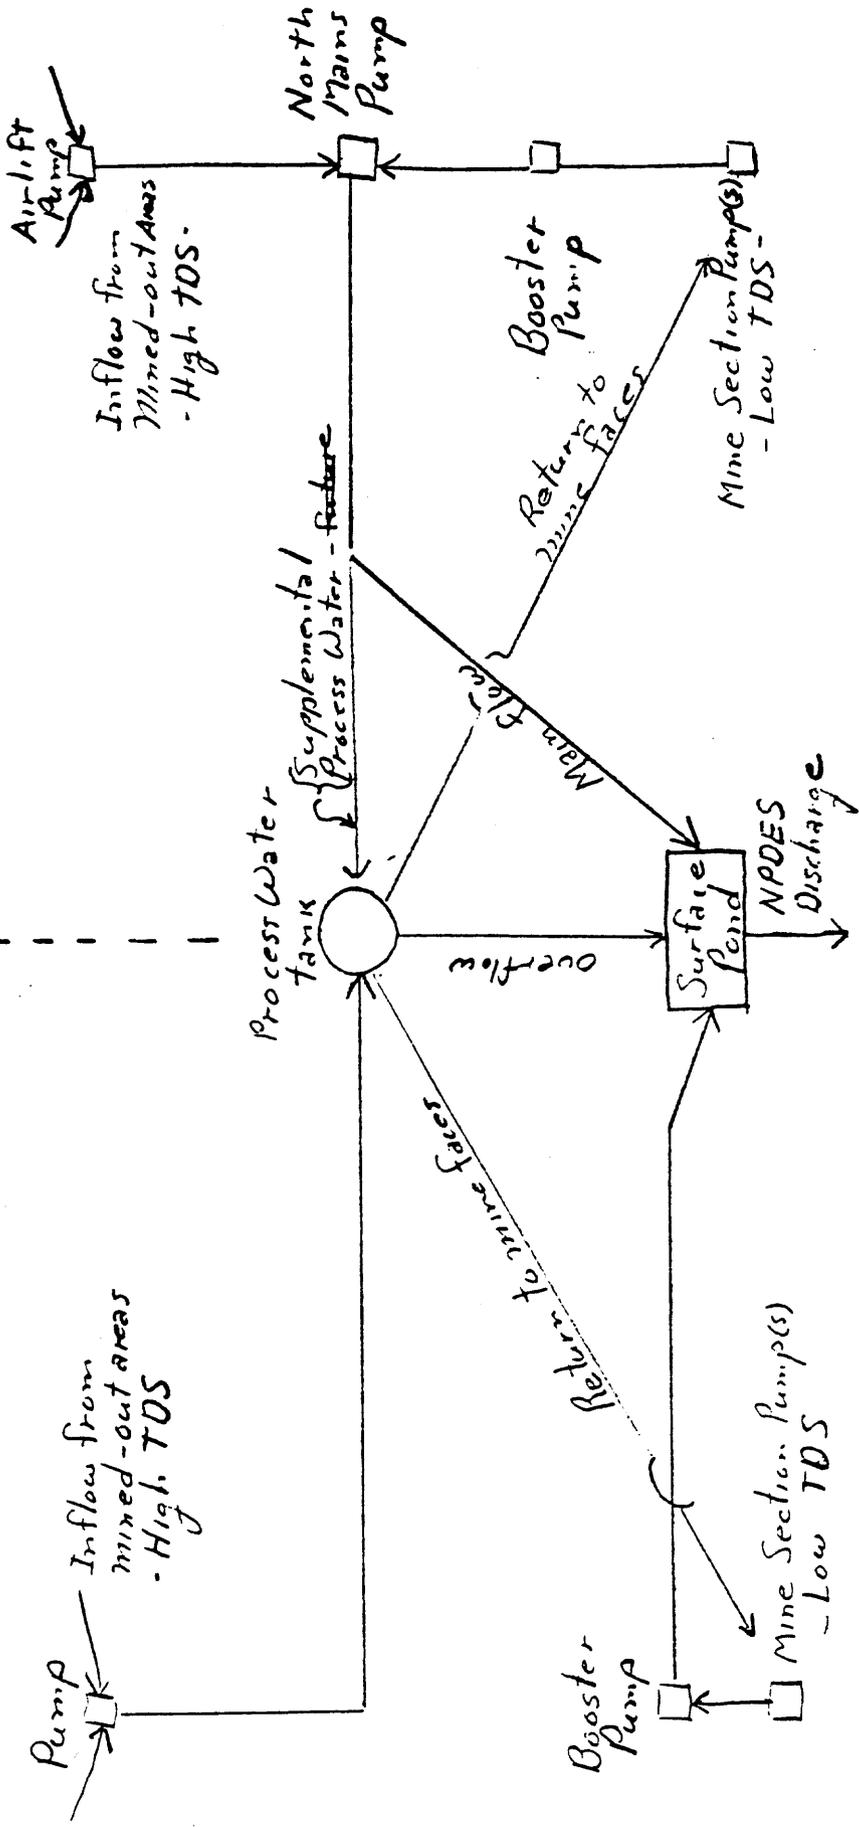
- An attempt was made to control the water level in a high TDS contribution area known as the North Mains Sump (see attached schematic diagram). Stabilizing the water level helps reduce the amount of re-entrained rockdust.
