Nov. 23, 1999

# TROUGH SPRINGS RIDGE SUBSIDENCE CRACKS: OCCURRENCE AND MITIGATION

Canyon Fuel Company, LLC  
Skyline Mines  
M. Bunnell  
11/99

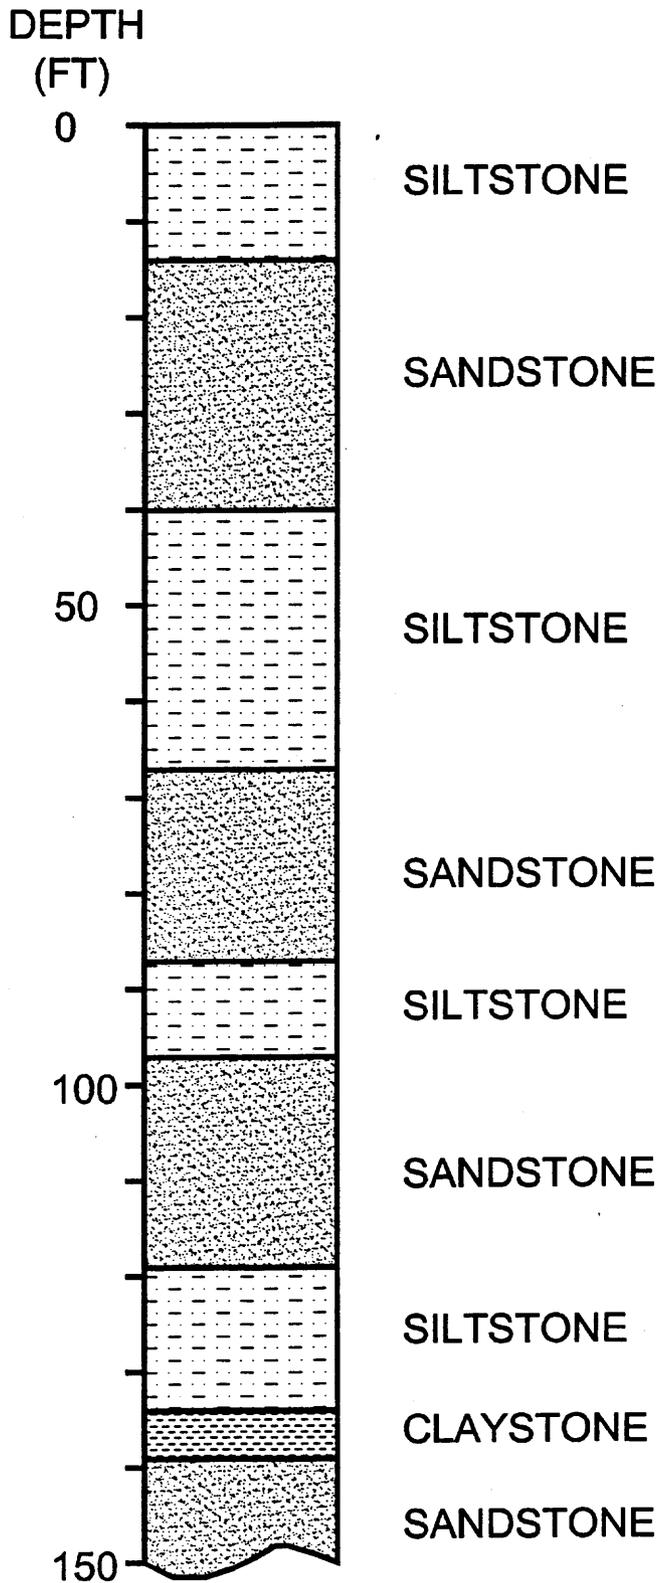
**FIGURE 1**  
**NEAR-SURFACE STRAT COLUMN**  
**TROUGH SPRINGS RIDGE**  
**SUBSIDENCE CRACK ZONE**

Figure 1 shows the general stratigraphic column of the near-surface based on two exploration boreholes located within 1500 ft. of the subsidence crack zone to the northeast and northwest (Map 1). Both holes were collared at about the same elevation as crack development within the crack zone, showing a zone of interbedded sandstone and siltstone, with at three prominent sandstone beds near the surface ranging in thickness

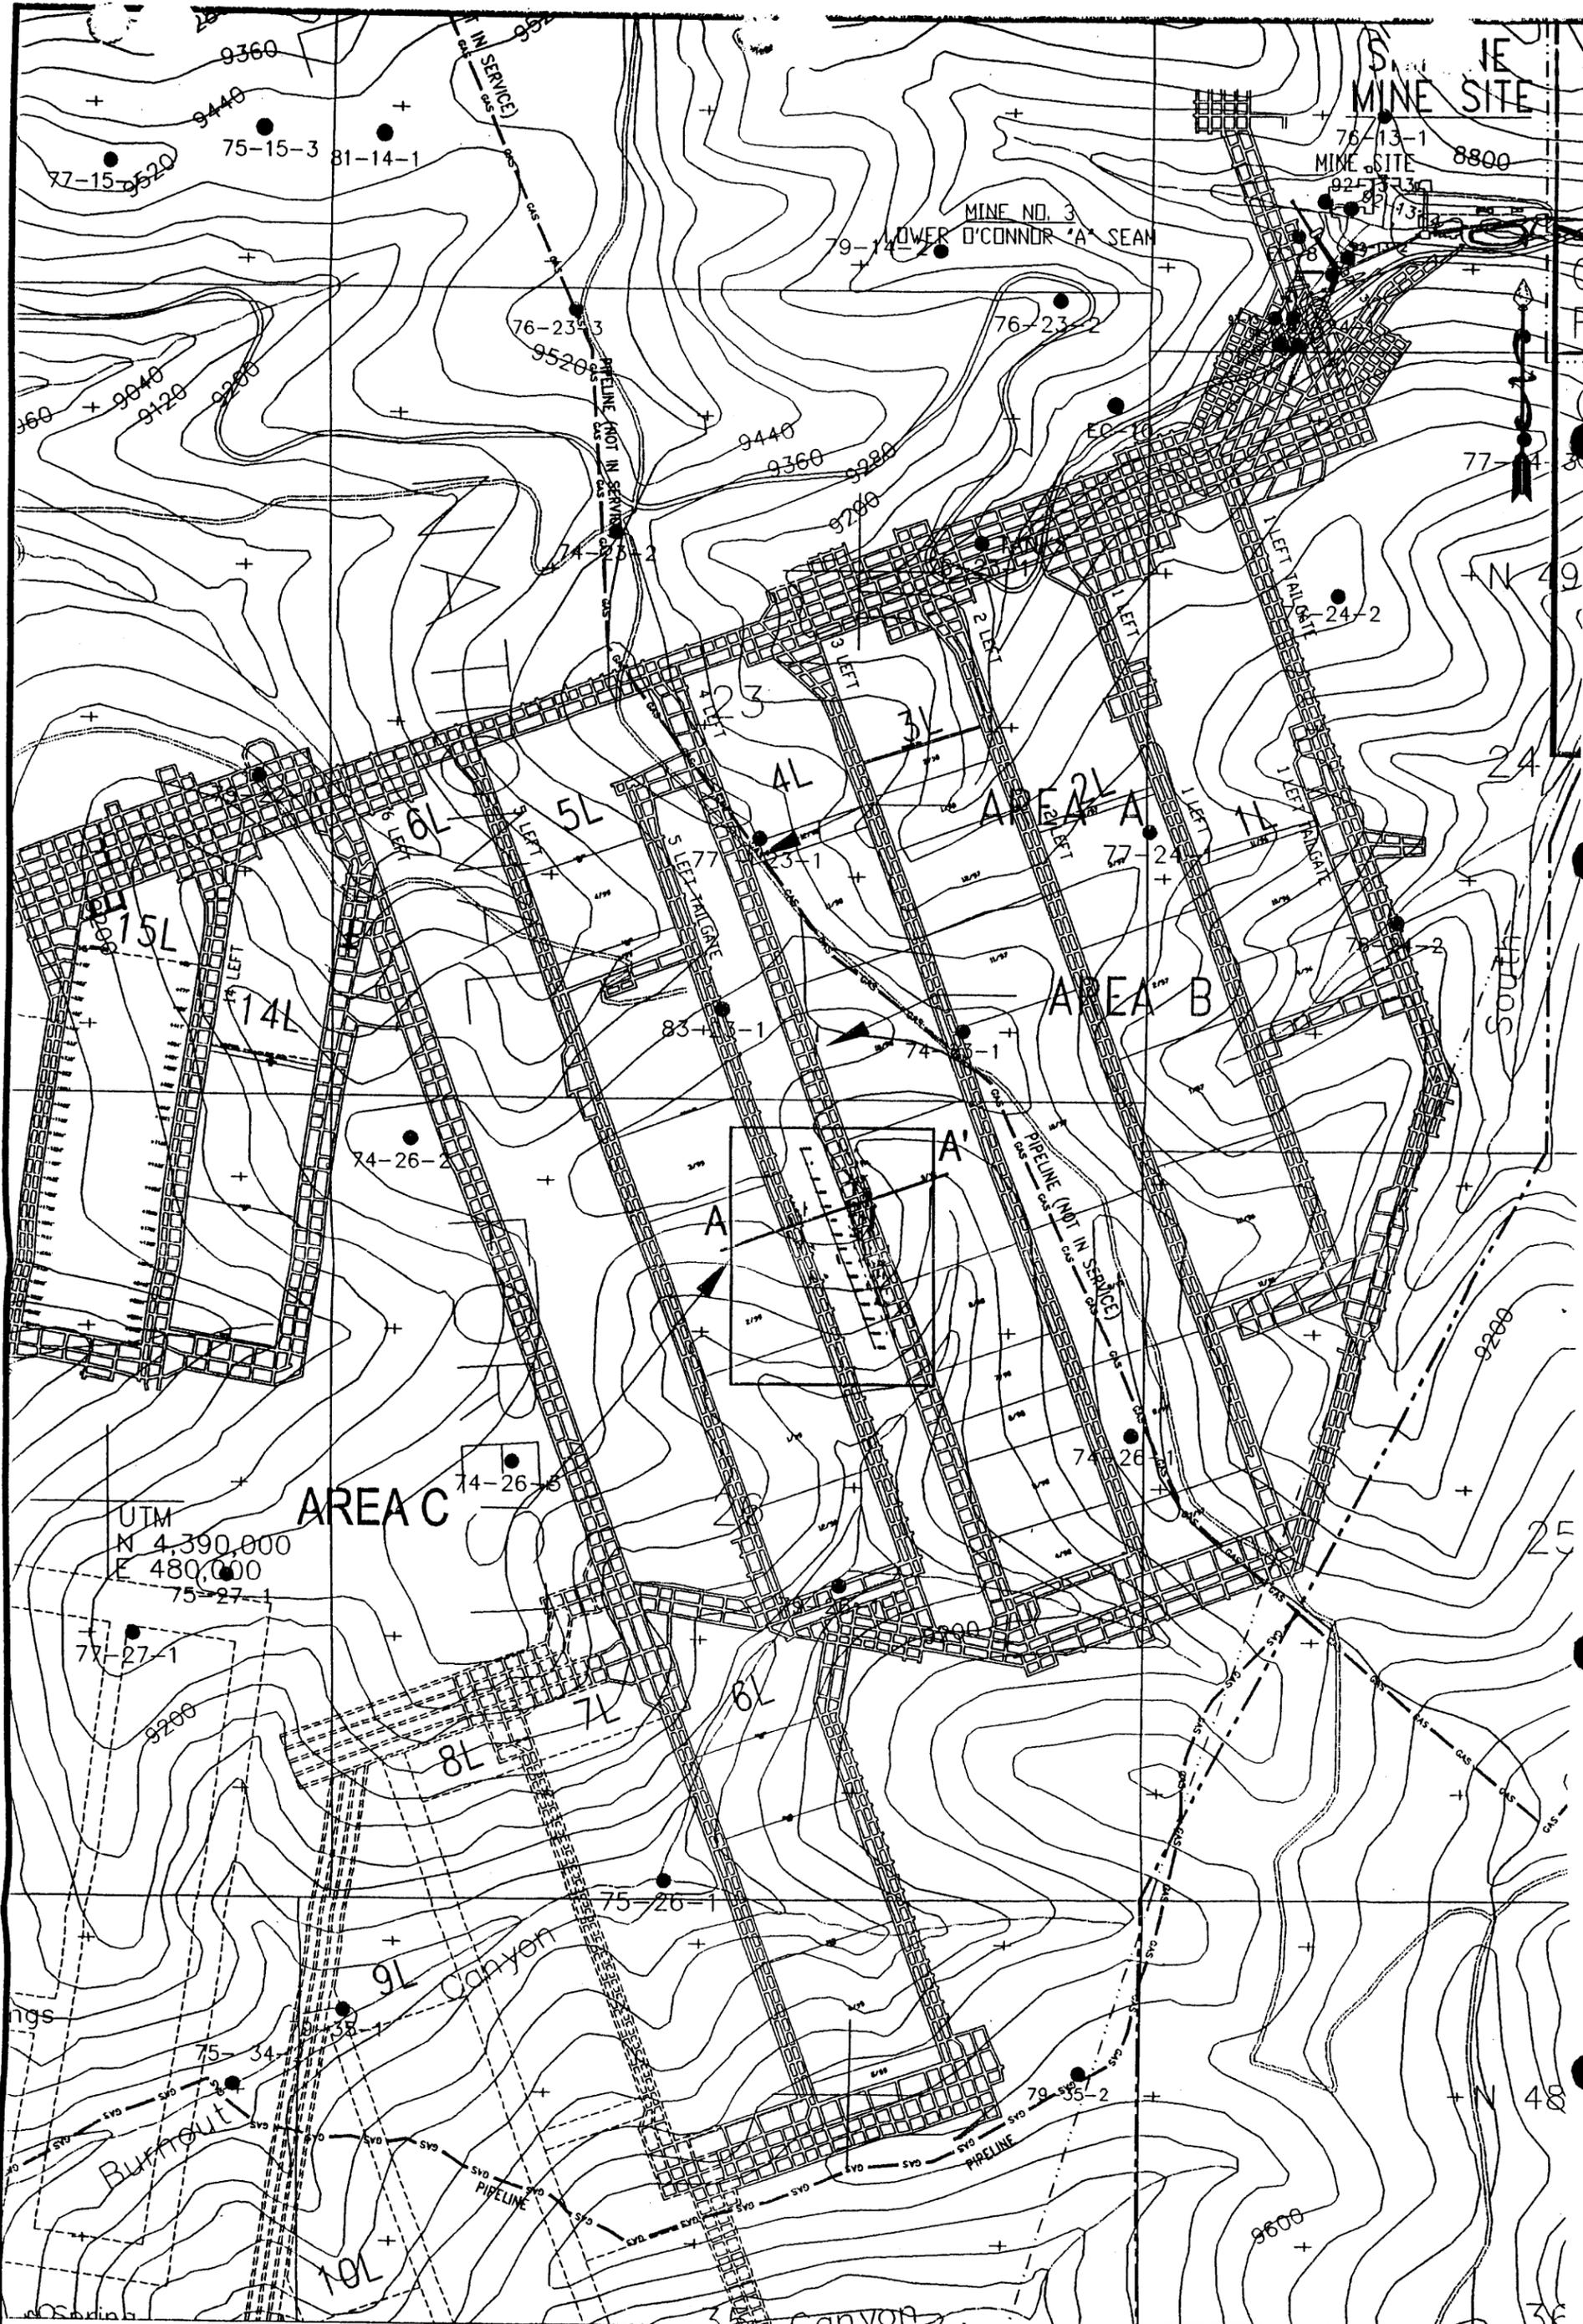
MAP 1

In mid-August, 1999, a number of subsidence cracks (labeled "Area B" on Map 1) were observed immediately west of Trough Springs Ridge, located in the SW ¼, SE ¼, Sec. 23, T 13 S, R 6 E. No cracks were noticed in the area during earlier observations in June, with the exception of several minor cracks in the dirt road to the north (labeled Area A). It appears the majority of these cracks developed during July and August. On Sept. 1, 1999, Will Wilson (USFS) and I were looking at cracks in area B to determine the best mitigation technique when a sheep herder informed us there were more extensive cracks along the small ridge to the south. Upon investigation we found a zone of cracks approximately 700 ft. wide and 1500 ft. long. This zone, shown on Maps 1 and 2 (labeled "Area C"), was much more extensive than any observed or mapped to date in the Skyline area.

Maps 1, 2, 3, and 4 show mine development with various critical parameters. Maps 1 and 2 show mine workings with surface topography. Map 3 shows mine workings with cumulative subsidence contours as of Oct. 1998. Map 4 shows mine workings with overburden thickness contours above the Lower O'Connor B seam.

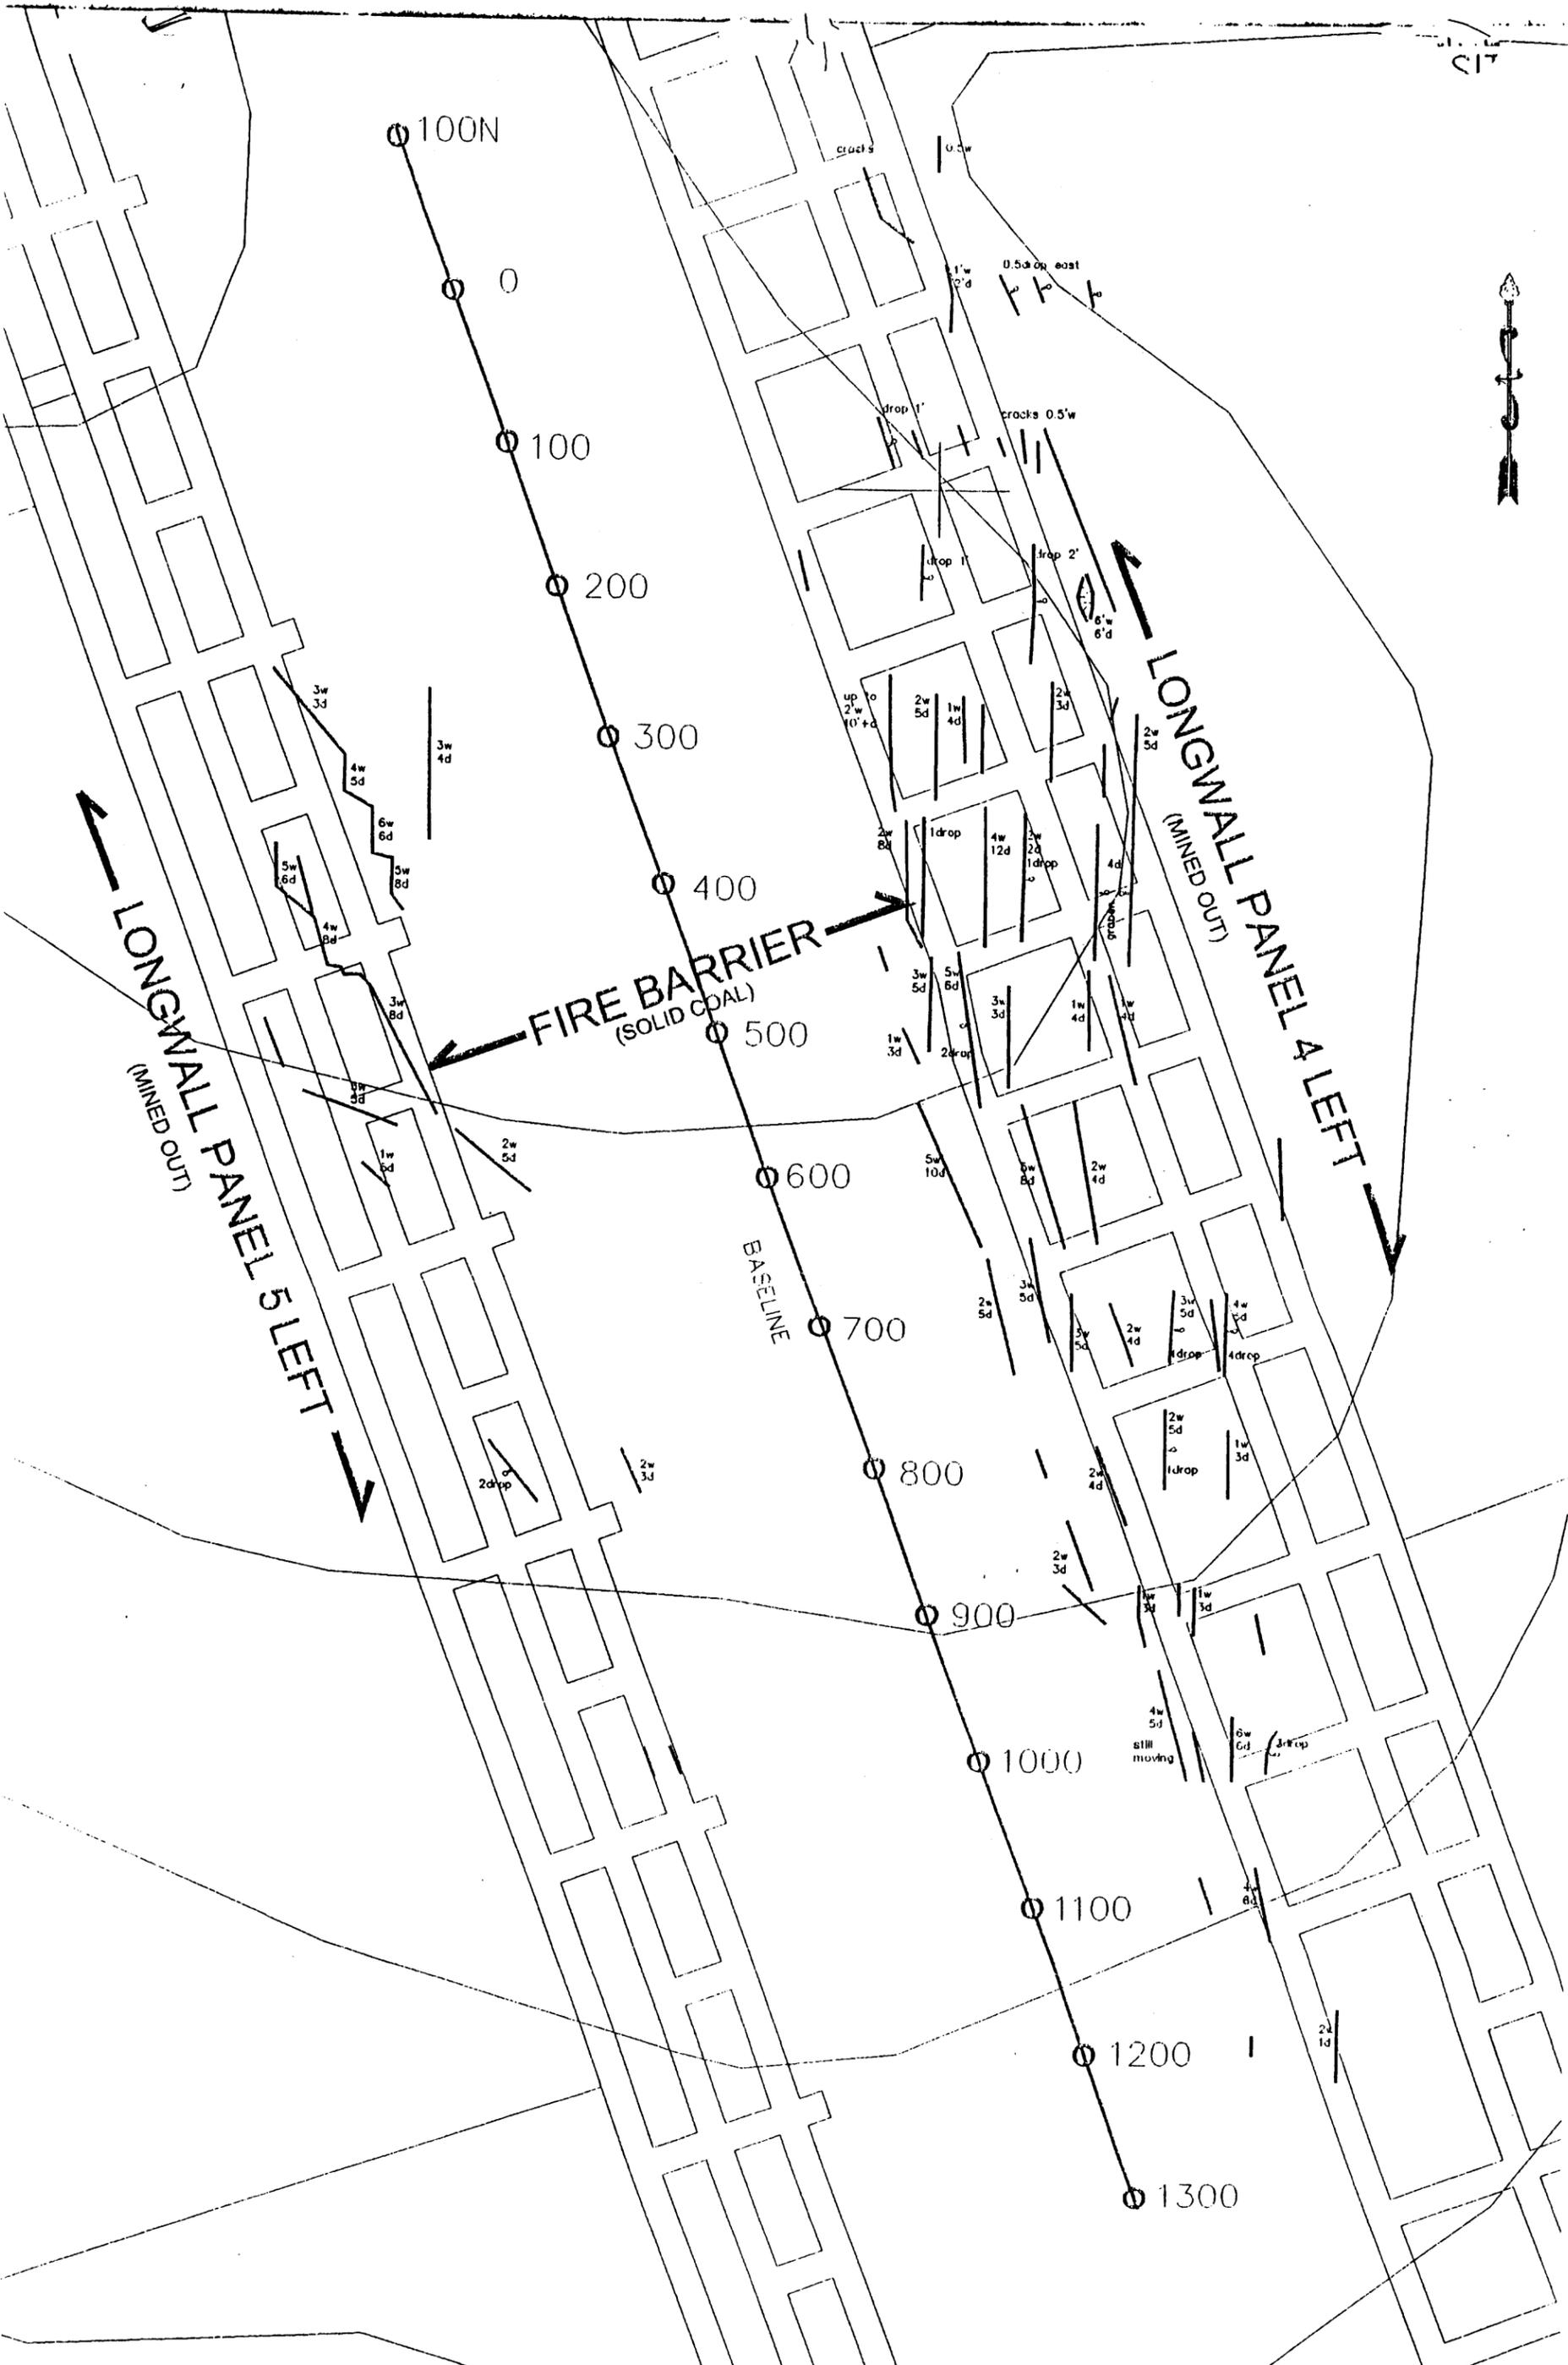
MAP 2

from 10 to 30 ft. The lower of these sandstone layers is exposed in the area of station 1200 to 1300 on the baseline (Map 2). Wherever cracks penetrated the soils at the surface, it was possible to observe fractured bedrock beneath. Cracks tended to propagate along preexisting joints and fractures in the rock. The principal joint orientation is about N 5 to 10 E with secondary joints running N 60 to 70 W. Cracks did not extend southward and downslope of the sandstone outcrop.

Subsidence cracks formed along the crest of a small northwest-southeast oriented side-ridge. Appendix 1 is a collection of photographs of various cracks and slump structures within the zone. Cracks ranged in width from inches to over 5 ft. with depth varying from inches to over 25 ft. Map 2 shows two distinct parallel zones of fracturing which extend in a north/south orientation. The majority of cracks vary in orientation from N 5 E to N 20 W with some cracks turning in a N 60 to 80 W orientation. Cracks development appears to be influenced by primary and secondary jointing in the bedrock as well as mining orientation beneath.

Map 2 shows detailed results of surface mapping. Crack development occurs primarily over the bleeder pillars indicating the location of the zone of maximum tension at the surface. No cracks were observed immediately above the center of the fire barrier.

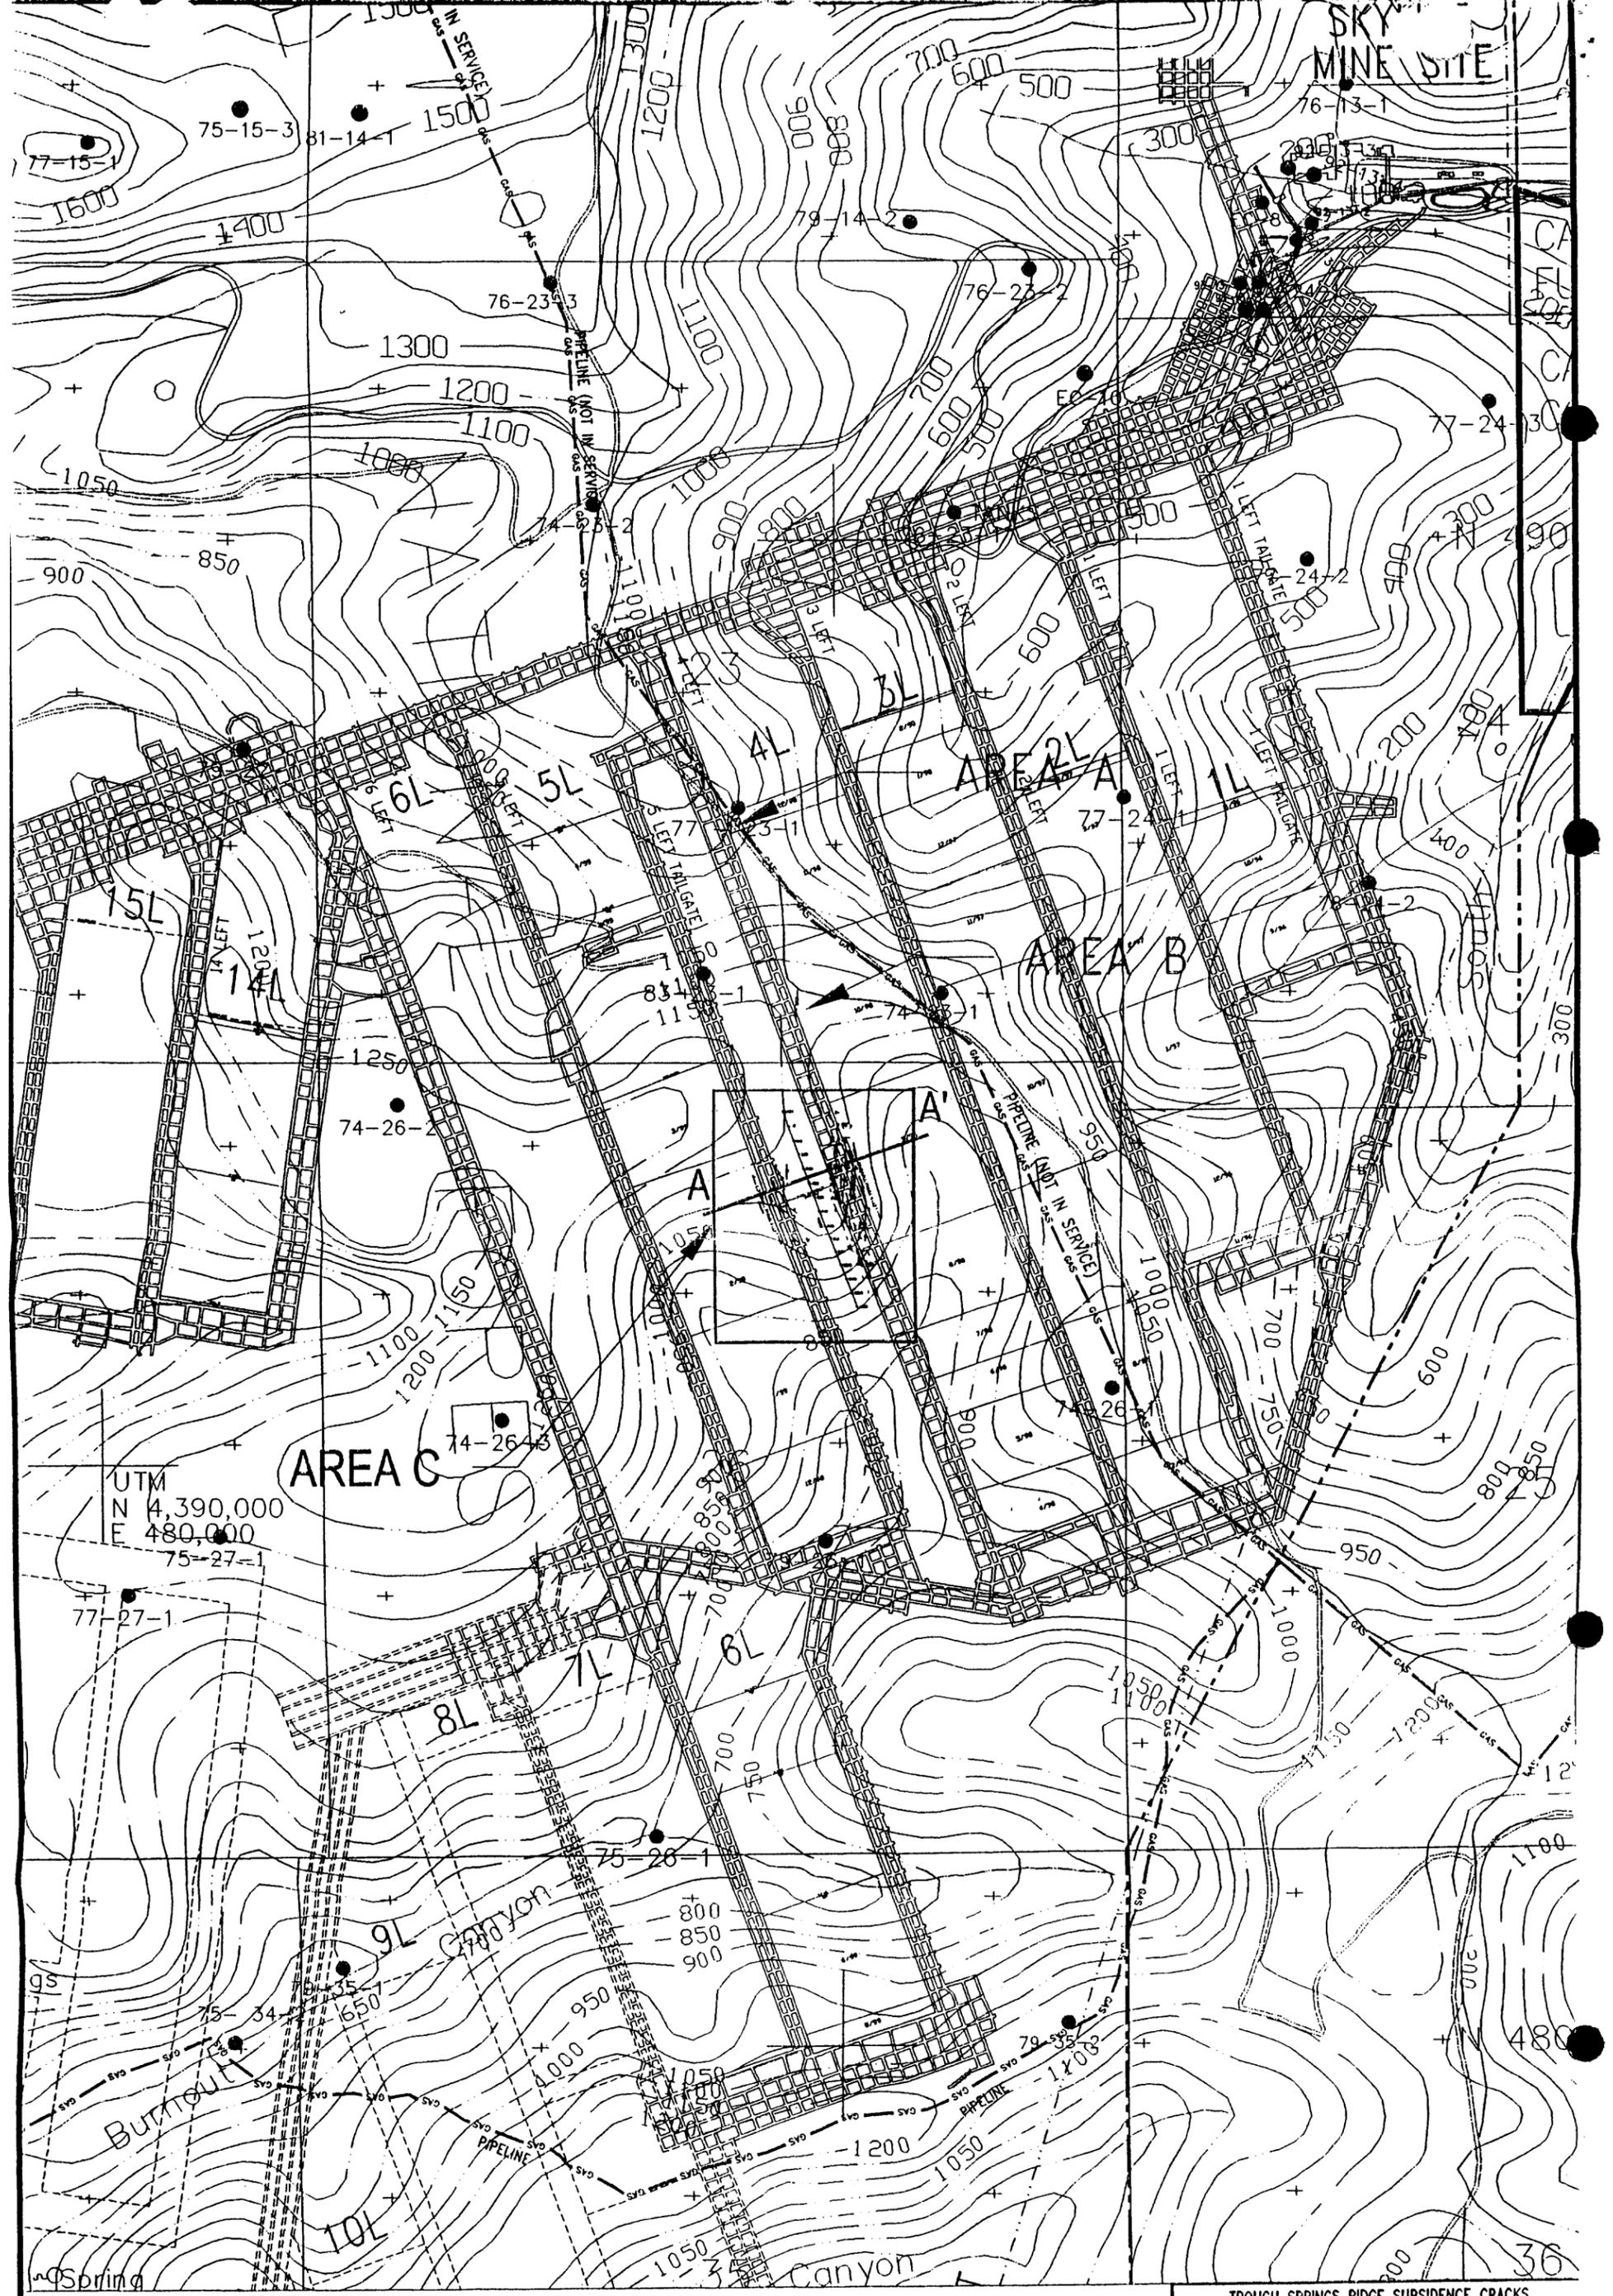
MAP 4

Map 4 shows overburden above the Lower O'Connor B seam in the area to range from 800 to 1100 ft. Normally, tension cracks are thought to develop at lesser amounts of overburden. In this case cracks diminish with lesser amounts of overburden, indicating that factors other than overburden are at work in this case. It should also be noted with the two seams, 18 to 20 ft. of coal has been extracted on either side of the fire barrier.

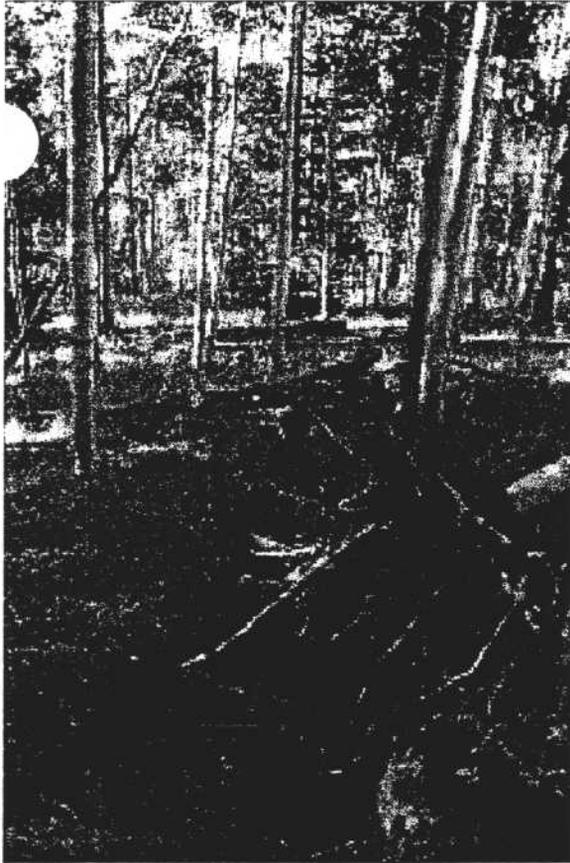
Crack with 1' vert. scarp. Approx 1' wide, 2' deep.  
Note aspen that has been uprooted.

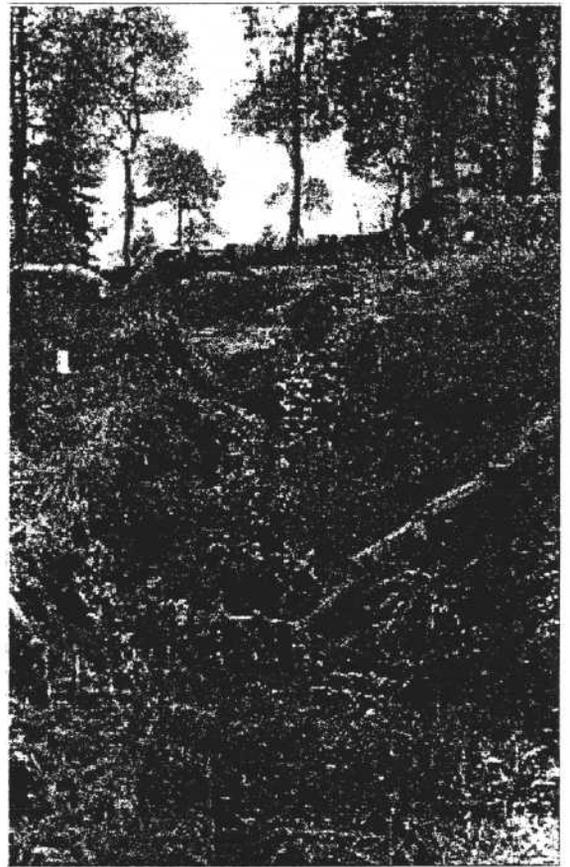
A "graben"-type crack. Boundary cracks  
are approximately 7' apart.

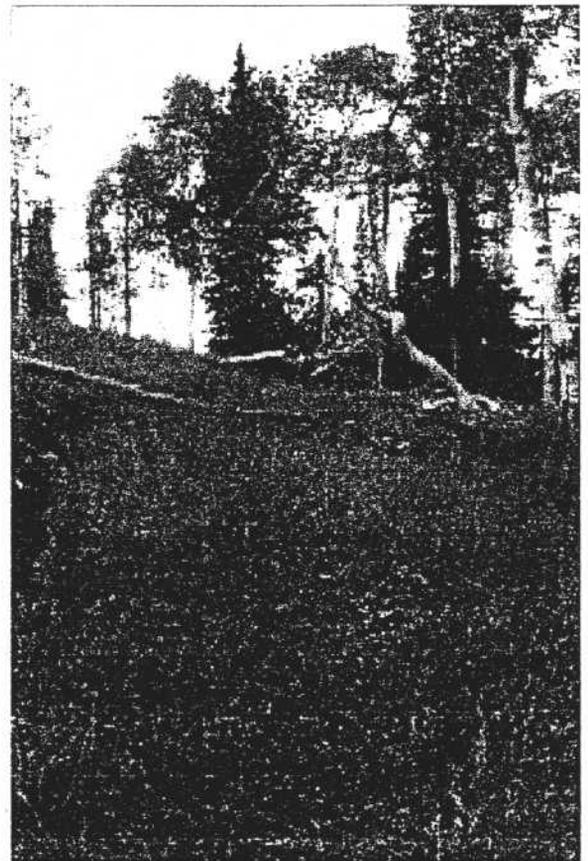
Larger "graben"-type feature with boundary  
scarps approximately 20' apart. Note aspens  
falling toward center.

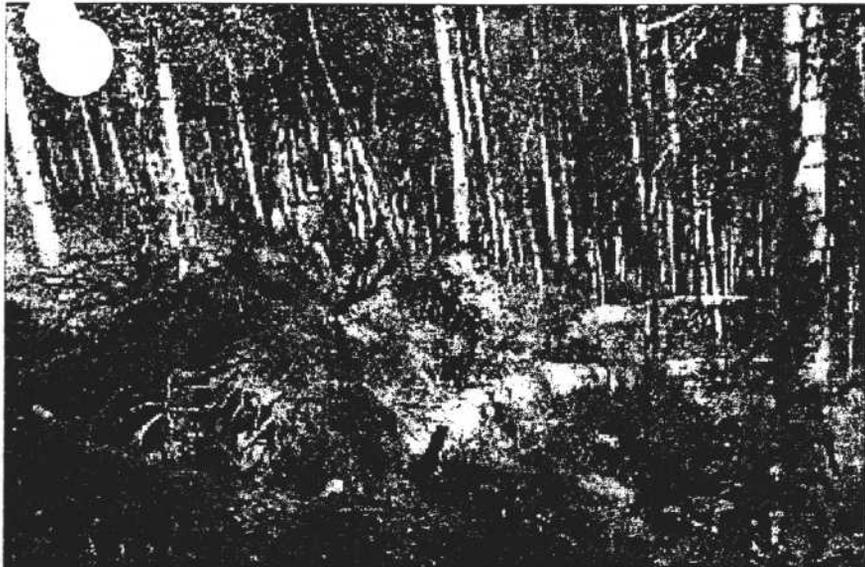
Scarp on hillside (approx. 2') with uprooted aspen.

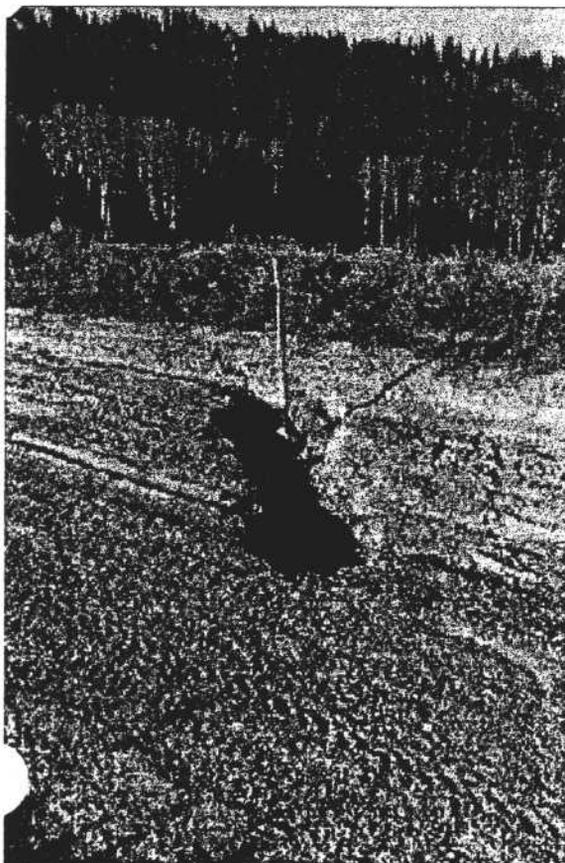
Crack in road approx. 2' wide, 1' deep. Area A.

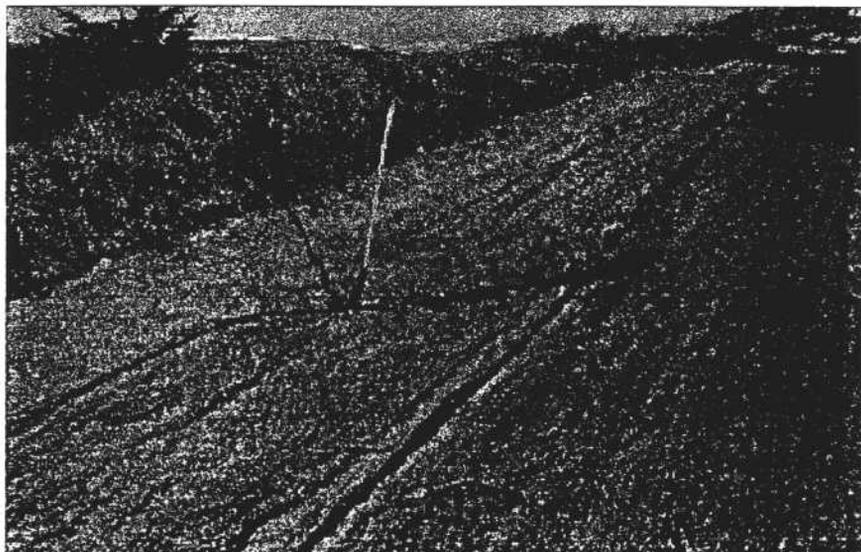
Crack in road. Area A.

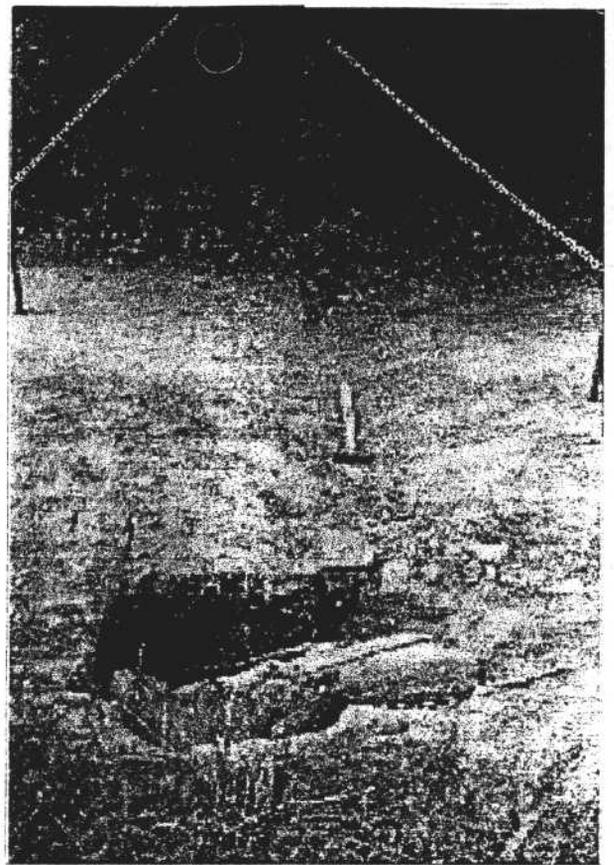
Crack in old road approx.  
2' wide, 6' deep. Area B.
