State of Utah
DEPARTMENT OF NATURAL RESOURCES
DIVISION OF OIL, GAS AND MINING

September 15, 2000

Re: Subsidence in Burnout and James Canyons, Canyon Fuel Company, Skyline Mine, ACT/007/005

Date & Time: September 7, 2000, 9:00 AM to 3:30 PM

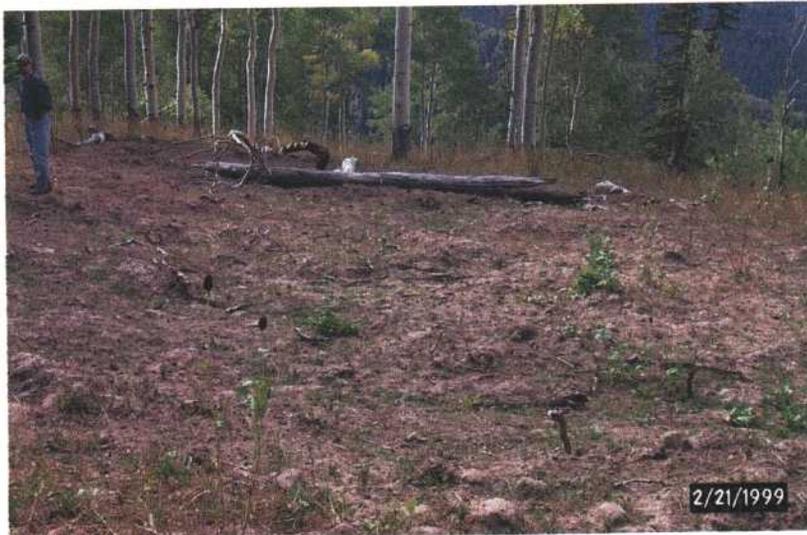
Revegetation has not been too successful in the repaired areas near the top of the ridge (see Figure 1 pg 6), but it has been moderately successful in the lower areas. We attribute this to two factors. First, the summer has been unusually dry, and although there were some late summer thunderstorms, the late spring and early summer, critical times for seedlings, were very

dry. Second, we saw a lot of sign of sheep grazing. We saw several places covered with tarweed, a weedy annual forb that is prone to invade overgrazed high elevation sites. Tarweed is also dominant on some of the repaired areas.

Figures 1 and 2 show subsidence repairs on the slopes above Burnout Canyon. Notice the long series of silt fences in the lower picture.

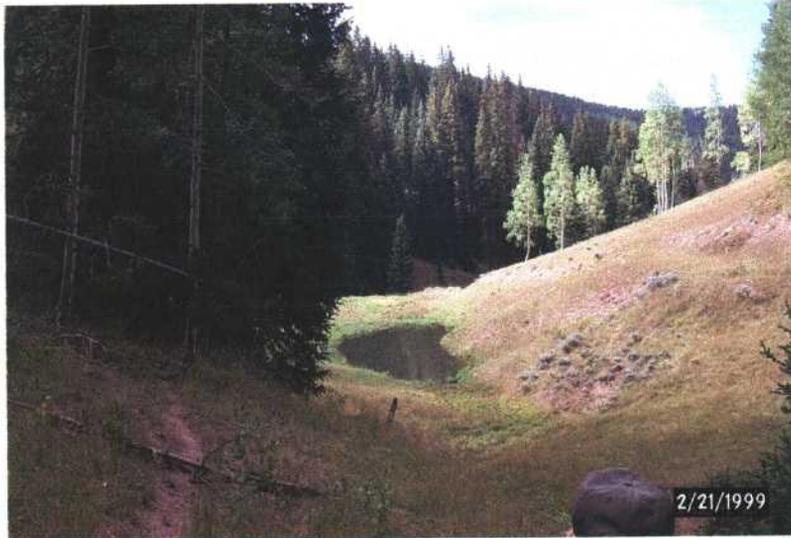
As we were walking down Burnout Canyon, we saw no water in the channel until just above the upper fork where the uppermost flumes have been installed. Just above this fork in the main channel, subsidence has altered the topography so that a small pool (about 15 by 30 feet) has formed (see Figure 3 pg 7). We consider this pool to be a habitat enhancement. Although water was previously available for terrestrial animals, We expect salamanders and other amphibians to eventually live in this pool.

Figure 3 is a small pond in Burnout Canyon that has formed as a result of subsidence. There are some springs right in this area, and there is often no water in the stream above this point.

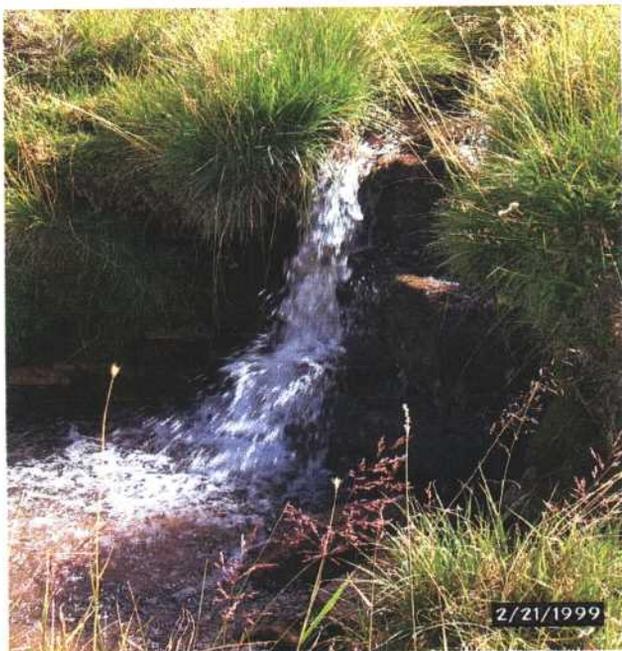
Near the lower end of Burnout Creek, there is about a four-foot-high waterfall that clearly inhibits fish movement up Burnout Creek (see Figure 4 pg 7). It's obvious some fish are able to get up the waterfall, but we felt the creek would be used a lot more if the waterfall wasn't there. Chris Hansen said Canyon Fuel would be willing to work to eliminate the waterfall if everyone decides that would be a good idea and if the necessary permits could be secured. The job might take as little as half of a day for a few people with hand tools.

Figure 4 is a waterfall in Burnout Creek about 100 yards up from the Electric Lake high water mark. We suspect fish may have trouble getting above this waterfall.

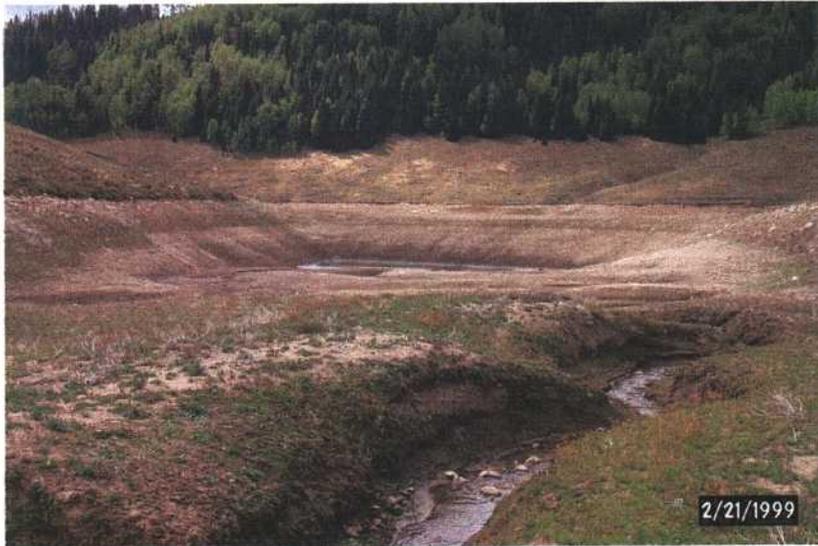
We took a boat across Electric Lake to James Canyon and hiked up this canyon to the Forest Service boundary where Canyon Fuel has a flume. At the bottom of James Canyon is a sort of dike that was apparently once a road used to haul material for the Electric Lake dam (see Figure 5 pg 8). When the water level in the reservoir is to the high water mark, the top of this dike is about five feet under water and fish would have free access up James Creek. We assume there is a culvert under the dike, and when the water level is lower than five feet below the high water mark, fish would have to go through the culvert to make it into James Creek. We did not see the culvert, and although we assume it is there, we do not know whether it allows free passage for

the fish or if it is filled with sediment. Even if it is there and is clear, the dike presents an obstacle because fish would have to find it to get back and forth from Electric Lake to James Creek.

A concern of having the large dike at the mouth of James Creek is that fish may be trapped in the creek. When the lake is high in the spring, fish can easily get up the creek for spawning. Shortly thereafter, the lake is drawn down and the hatched fish are impeded from swimming back to the lake. It was noted at the conclusion of our field trip that the concerns about the dike are totally separate from any of the issues relative to the permitting actions proposed by Skyline Mine.

Figure 5 shows James Creek and the dike/road at the bottom.

The Wildlife Resources people intend to check to see if they can find the permits and agreements from the original construction of the Electric Lake dam and see if there is any mention of this road/dike and whether it was supposed to have been removed or at least breached. They agreed they would not contact Utah Power and Light but would allow the people from Canyon Fuel to make those contacts, at least for now.

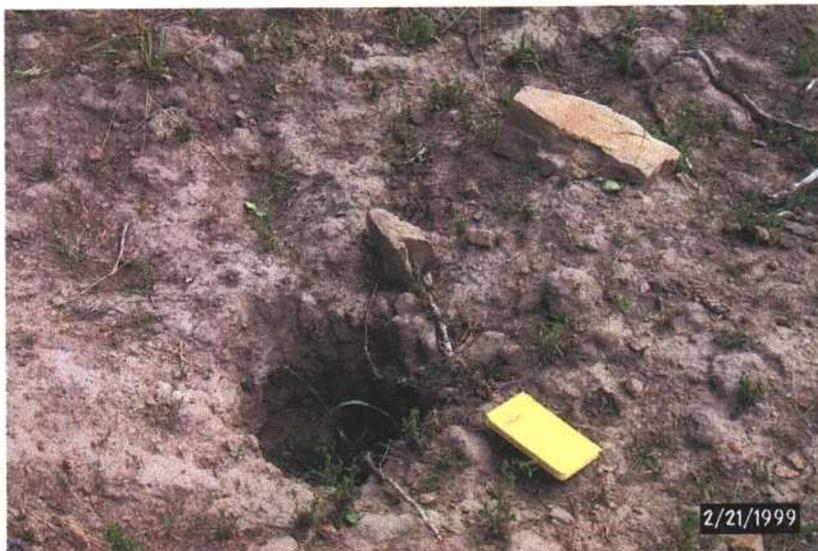
The subsidence cracks in the upper part of Burnout Canyon were repaired using material from adjacent areas. We found and photographed a few piping holes (see Figure 6 pg 8). Mark Bunnell said Canyon Fuel intends to wait until next year to see if there are more holes then come back and repair them with hand tools. We saw no danger to the public or to livestock or wildlife from the holes.

Figure 6 shows piping in the subsidence repair area.
