State of Utah

Division of Oil, Gas & Mining

Inspection Report

Permittee: **CANYON FUEL COMPANY LLC**
 Operator: **CANYON FUEL COMPANY LLC**
 Site: **SKYLINE MINE**
 Address: **HC 35 BOX 380, HELPER UT 84526**
 County: **CARBON**
 Permit Type: **PERMANENT COAL PROGRAM**
 Permit Status: **ACTIVE**

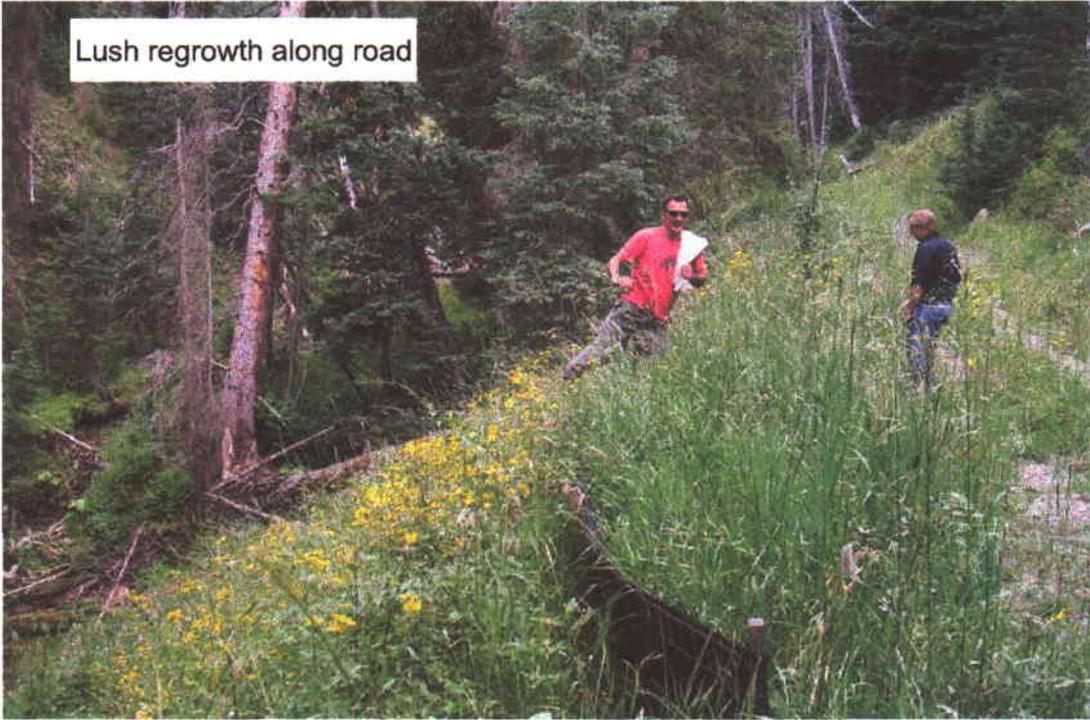
Last summer the permittee, DOGM, and the US Forest Service agreed upon a plan to recontour the Right Fork road. We inspected the South Fork reclamation which was re-graded in August 2005 to provide better reclamation of the right fork road, along which topsoil had been stored during operations of Mine #1 portals. The initial reclamation work had left a road cut that was unsatisfactory to the Division and the USFS. During this inspection, we noted that the vegetation along the road from the pump house to the Right Fork was providing good cover, although no additional seeding or grading was done after the traffic disturbance during the re-grading last year. Some thistle plants were noted along the road., but swales and silt fences were well vegetated. The creek below was running clear. Along the road to the Right Fork (the area where major regrading was done) varied in ground cover. The main reason was the soil type. Where topsoil (dark brown) was on the surface, vegetation did well. Vegetation was limited where subsoil was on the surface. (The subsoil had been stored in the "land bridge" across the stream. It was noticeably lighter in color and higher in clay content). Even so, there were some sprigs of grasses beginning to grow in the subsoil. This is the first growing season for the Right Fork. See photos.

Lush regrowth along road

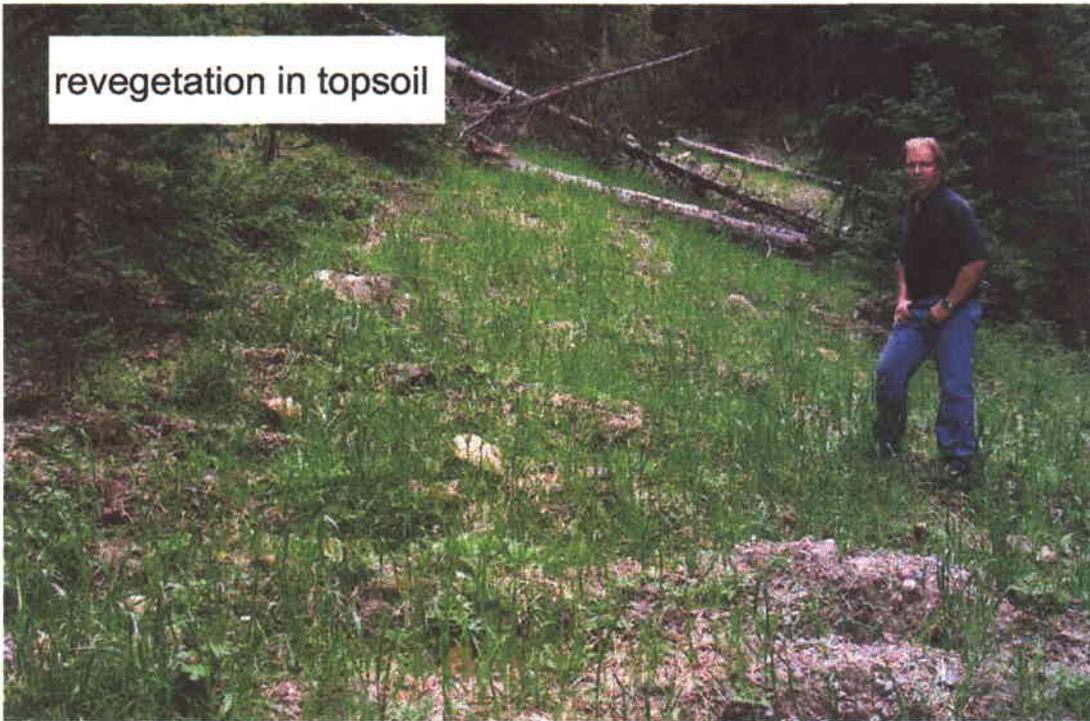
revegetation in topsoil

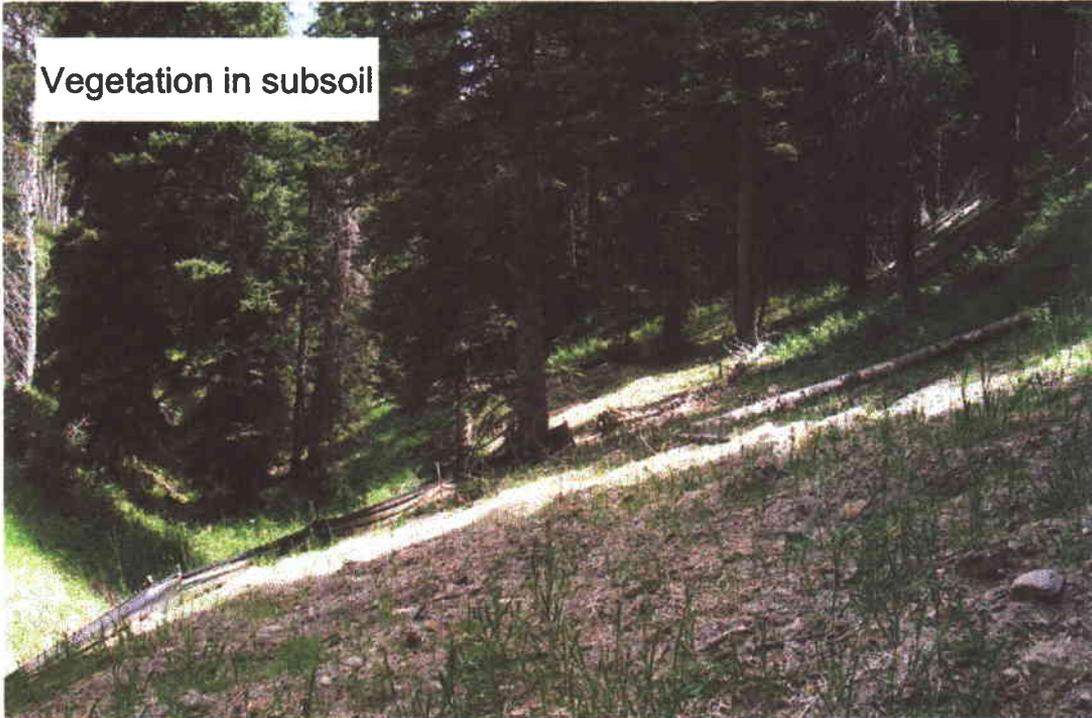
Vegetation in subsoil

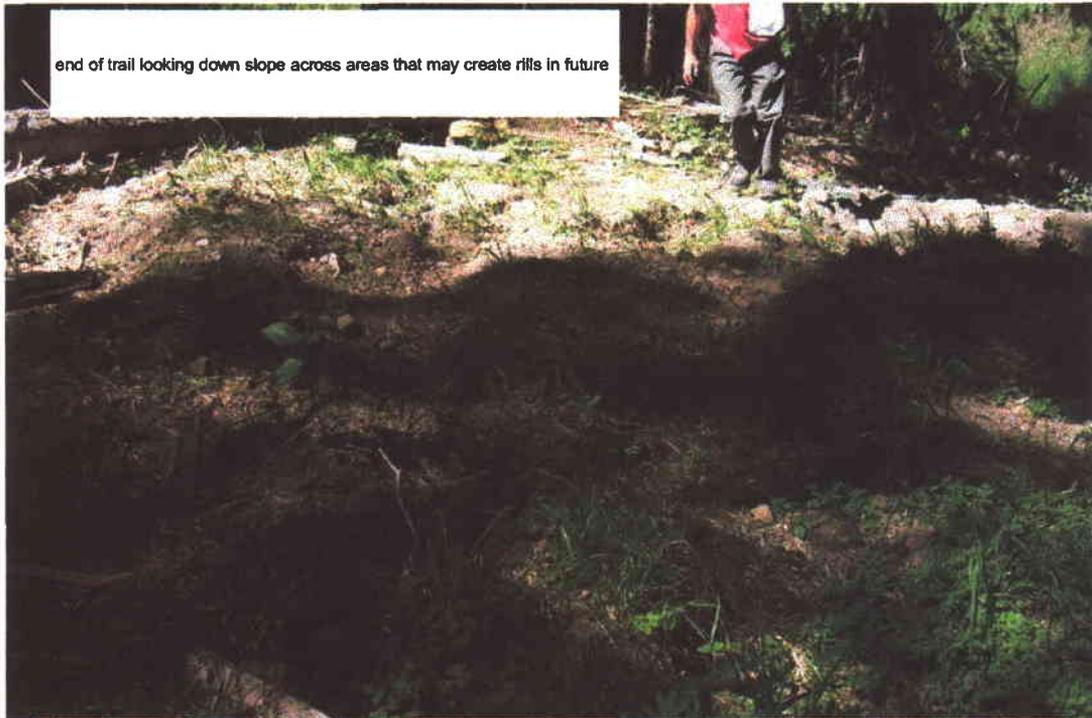
The main sediment control for the Right Fork was pocking the surface. However, silt fences were used at the base of the slope to keep sediment out of the ephemeral channel. In some areas, the silt fences contained sediment. The Division may note small pocks will not always contain the sediment on slopes and additional sediment control is needed. Slopes along this road were 4h:1v to 2h:1v.

end of trail looking down slope across areas that may create rills in future
