Canyon Fuel Company, LLC  
**Skyline Mines**

C/007/005

2006 Annual Report

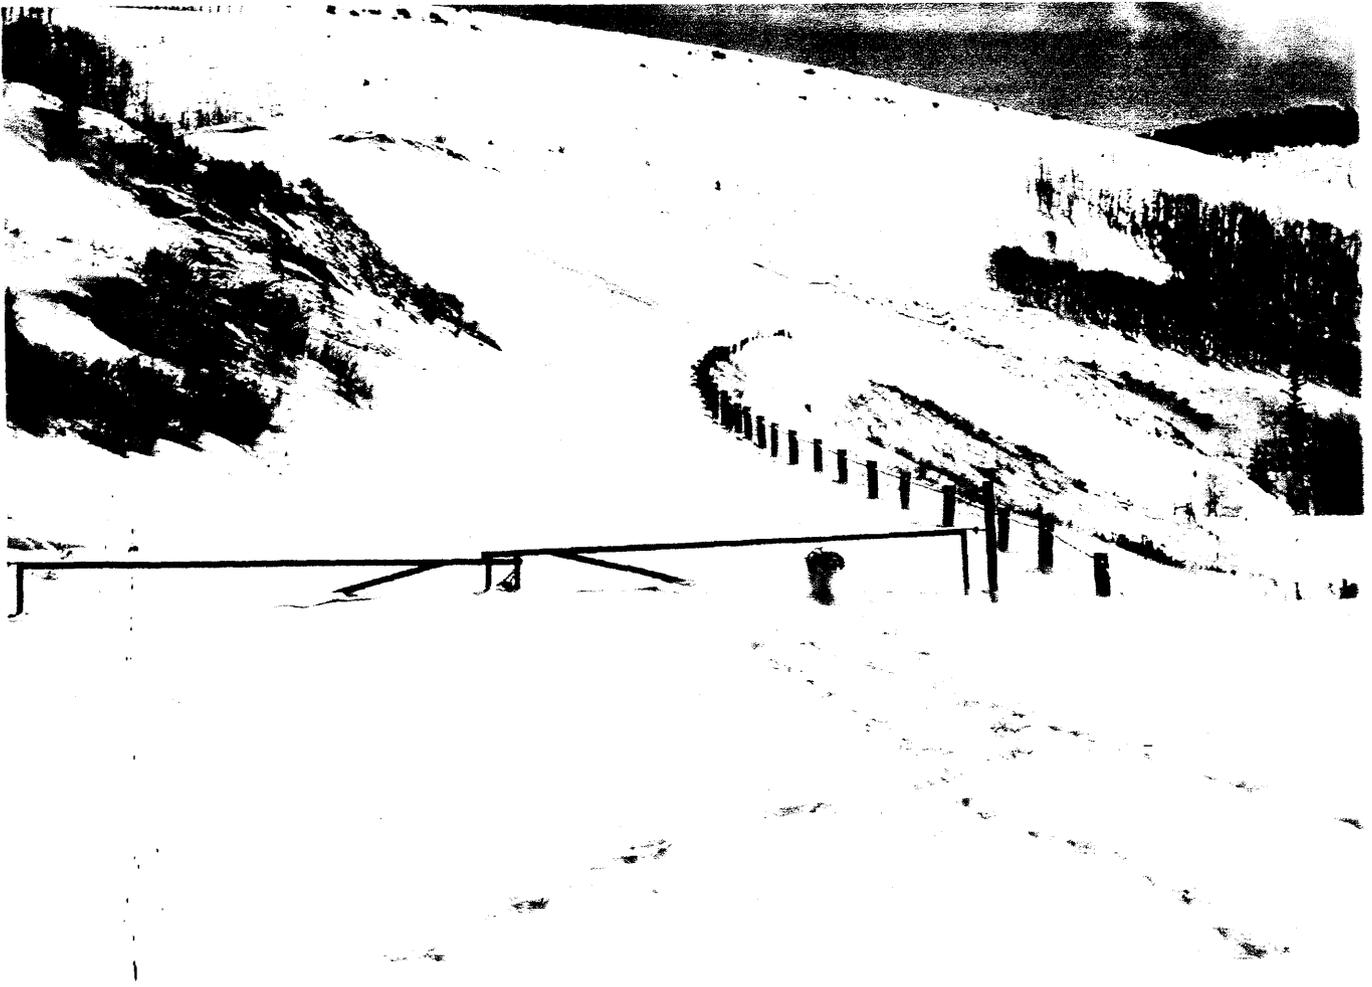
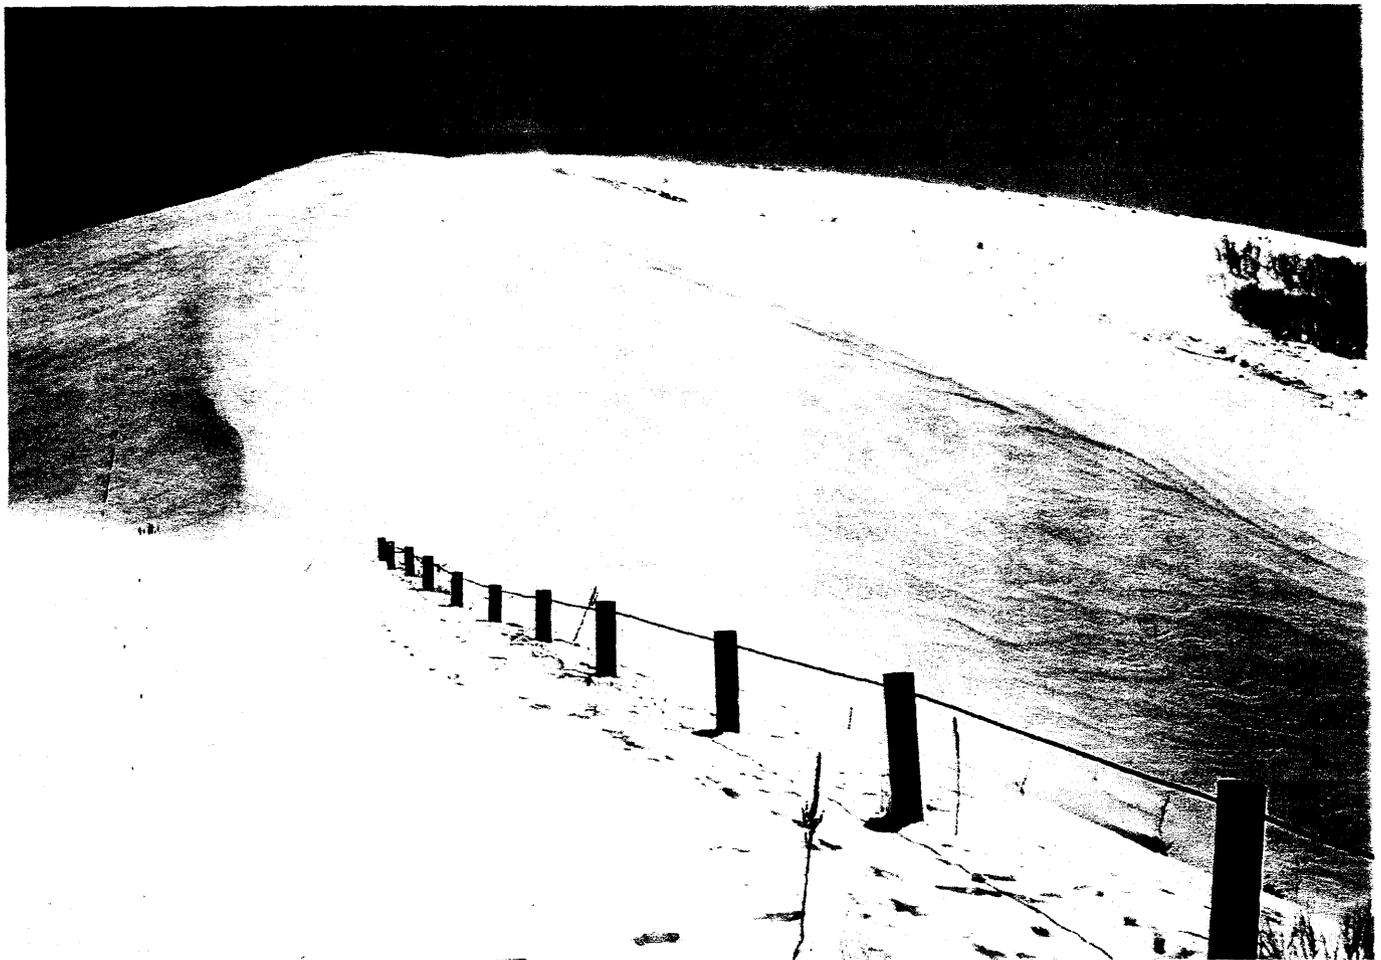
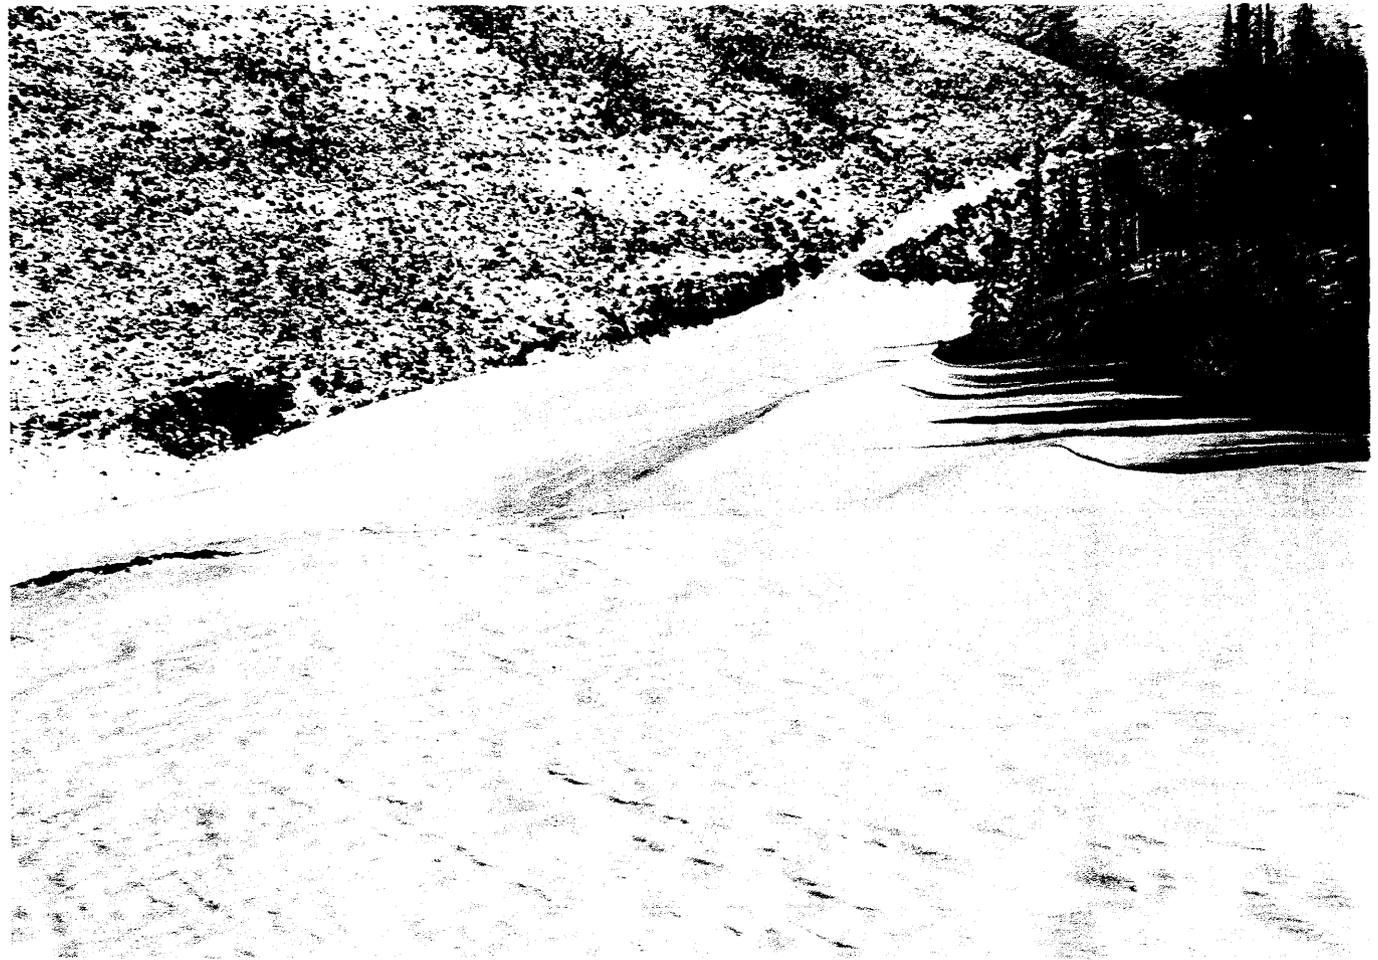
No instability or structural weakness was noted during the 1st quarter 2006 inspection. The site was snow covered (photos attached). The sedimentation pond was snow covered and did not contain any water or ice at the time of the inspection.

No hazardous conditions were observed at the time of the inspection.
