WATER QUALITY MEMORANDUM

Utah Coal Regulatory Program

January 22, 2008

RE: 2006 Second Quarter Water Monitoring, Canyon Fuel Company, LLC,
Skyline Mine, C/007/0005-WQ06-2, Task ID #2551

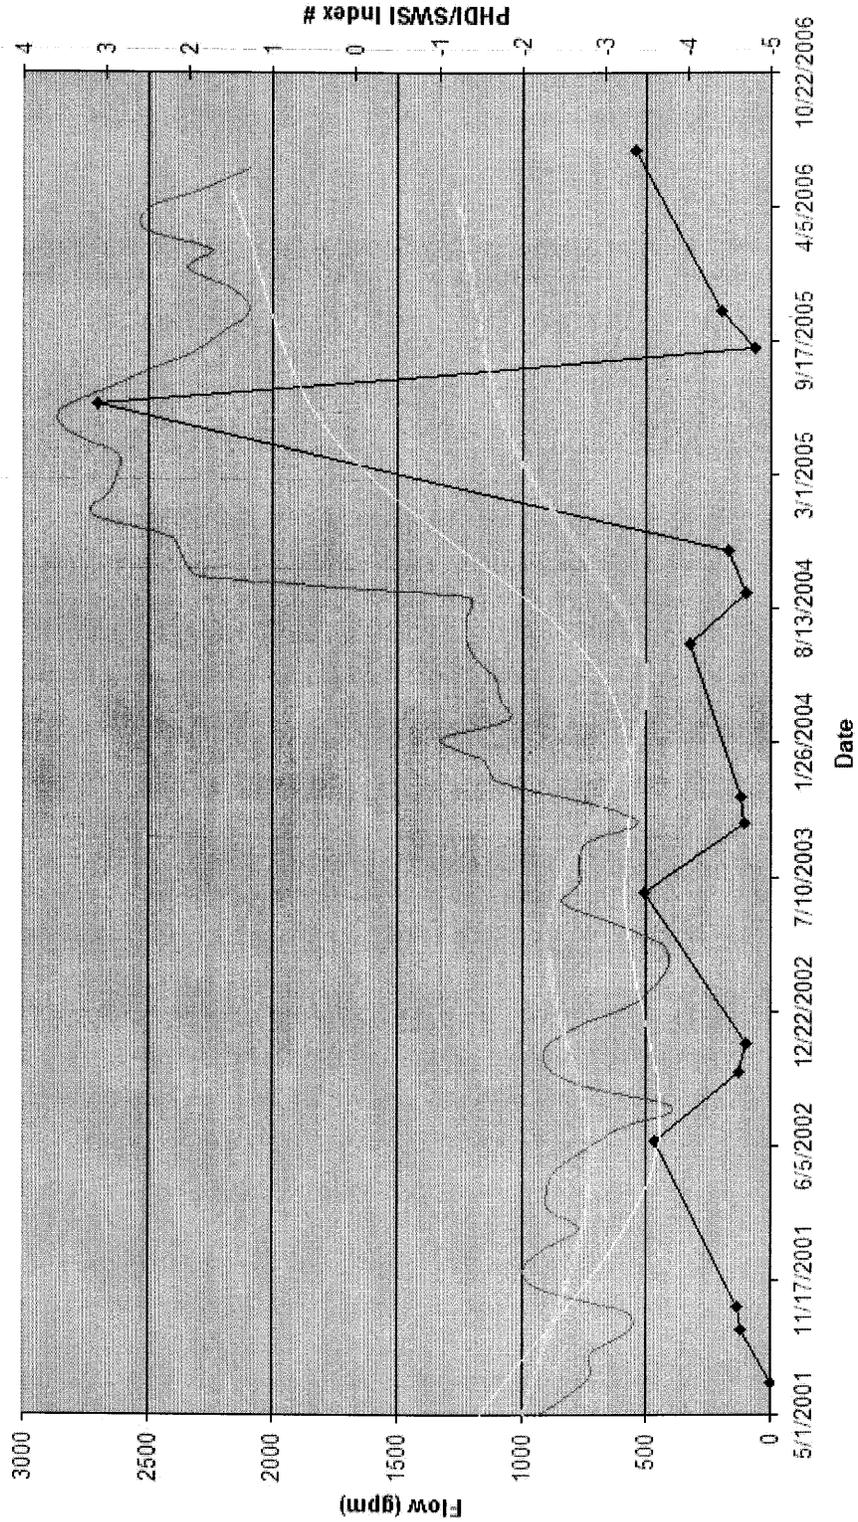
Flow vs. Palmer Hydrologic Drought Index and Surface Water Supply Index
 CS-16

Flows were higher than average at CS-16, CS-18, F-9, WQ3-43, and WQ4-12. Monitoring of these sites began in 2001 or 2002. Both the Palmer Hydrologic Drought Index (PHDI) and Surface Water Supply Index (SWSI) show 2001-2004 as "dry" years, and there is an upswing during this quarter. Flows at all sites track well with the indexes.

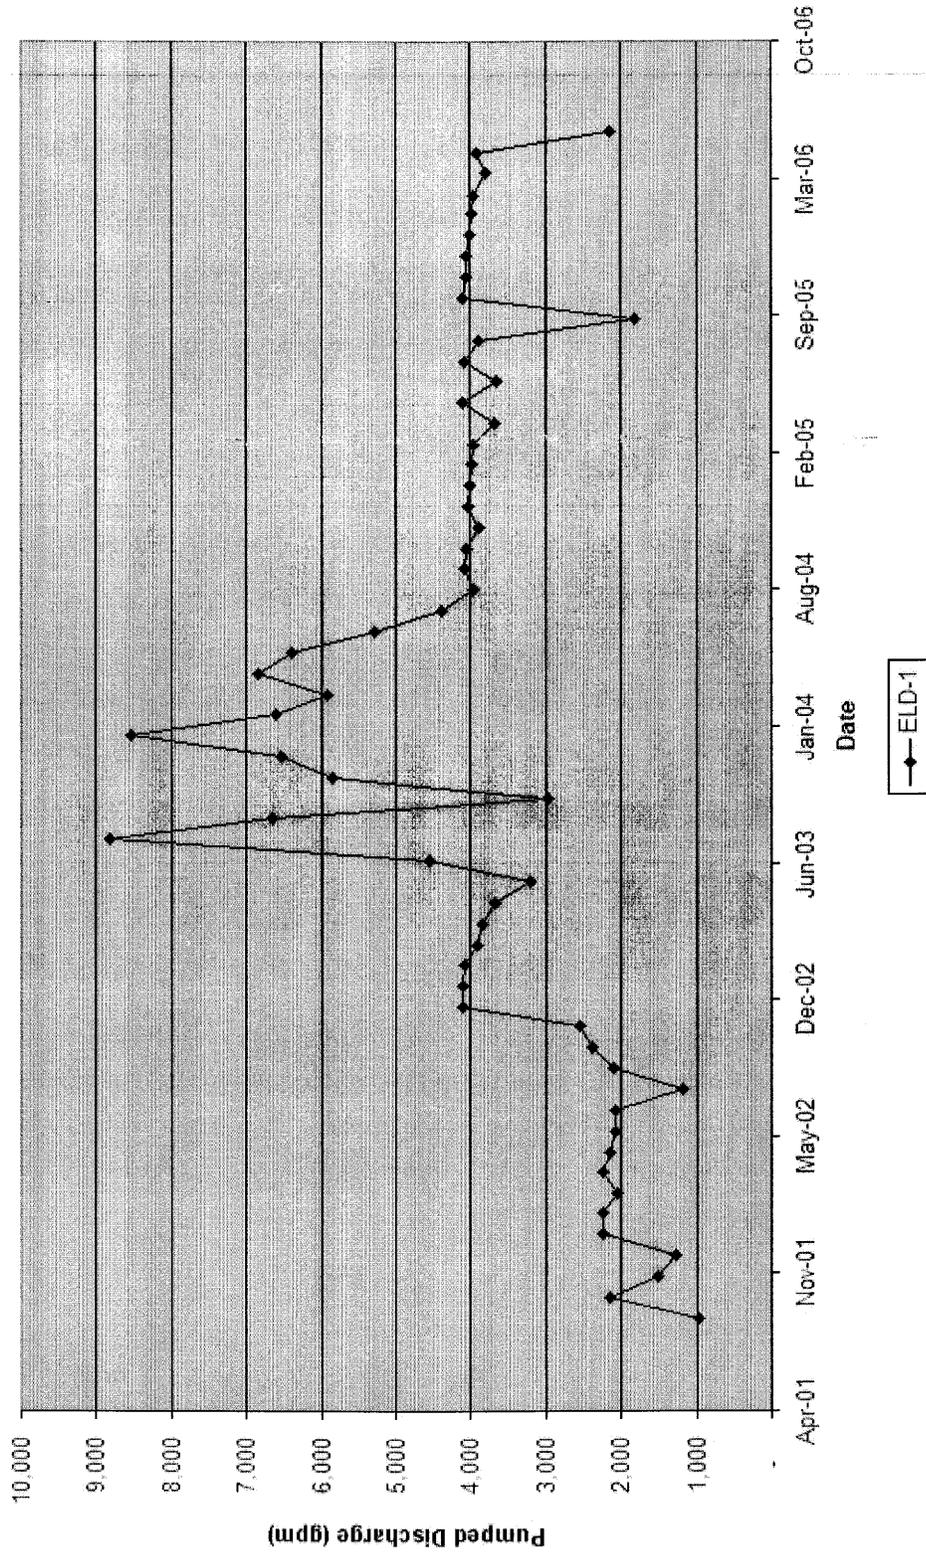
Monthly Average Discharge to Electric Lake
ELD-1 (combination of all JC wells)

Discharge from JC-1 has been steady at around 4000 gpm since August of 2004. In August 2005, the monthly average dipped to below 2000 gpm when PacifiCorp shut the pump off for 15 days. The June average is just above 2000 gpm because the power line to the pump was being rebuilt, leaving no power to the pump for over a week. A steady discharge around 4000 gpm is projected for the foreseeable future, except in cases such as these.

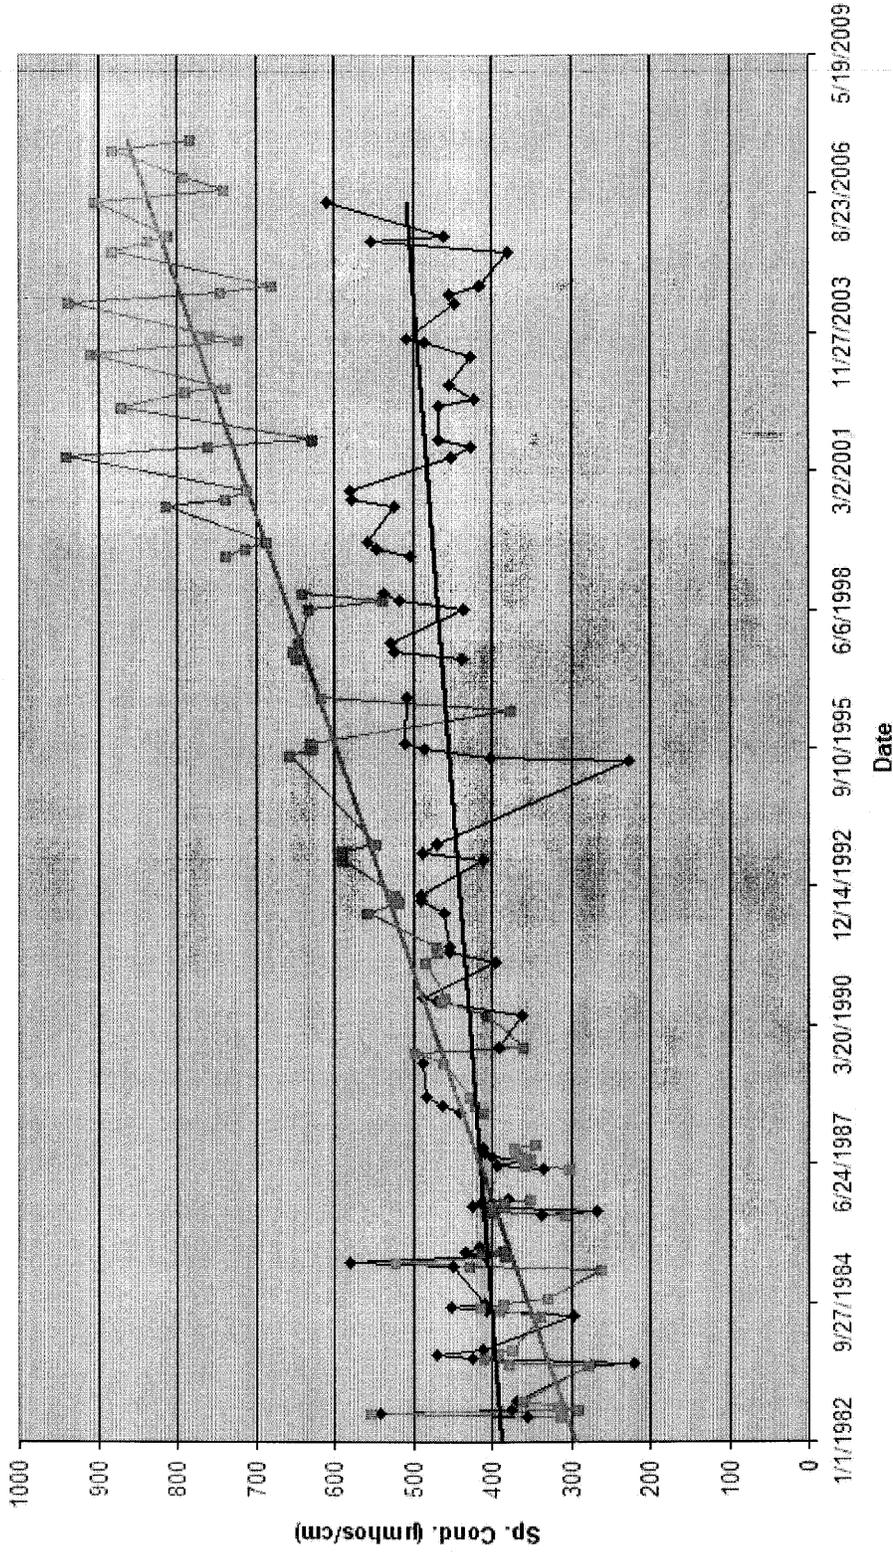
Specific Conductivity

There is a strong upward trend in the specific conductivity at S22-5 ($R^2 = 0.851$), and a weak upward trend in the specific conductivity at S35-8 ($R^2 = 0.2236$). There is no standard for specific conductivity, but it is closely related to total dissolved solids (TDS). The TDS at each of these sites is within the expected range.
