Inspection Report

InspectionID Report Number: 2109

Permittee: CANYON FUEL COMPANY LLC
 Operator: CANYON FUEL COMPANY LLC
 Site: SKYLINE MINE
 Address: HC 35 BOX 380, HELPER UT 84526
 County: CARBON
 Permit Type: PERMANENT COAL PROGRAM
 Permit Status: ACTIVE

**Inspection Report #2109 Attachment
(Mid-Term Task 3353)**

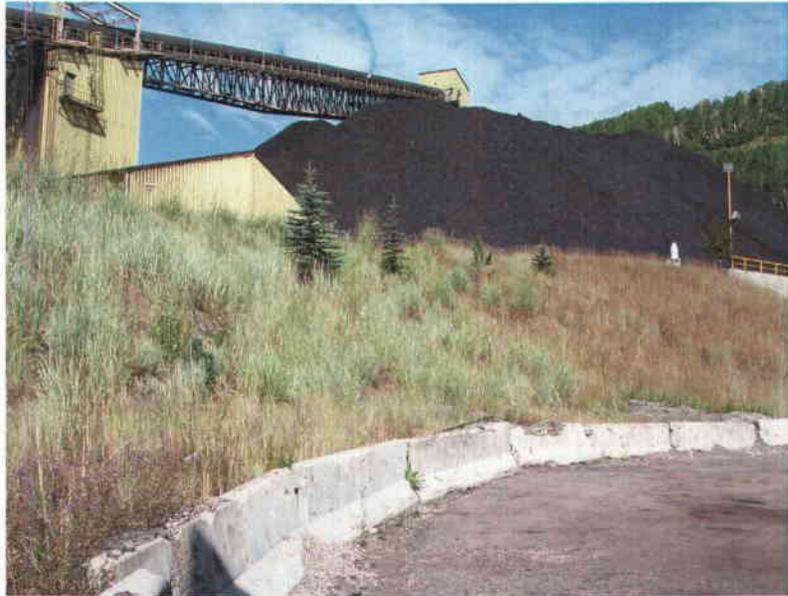
Interim vegetation on slope below mine site coal pile.

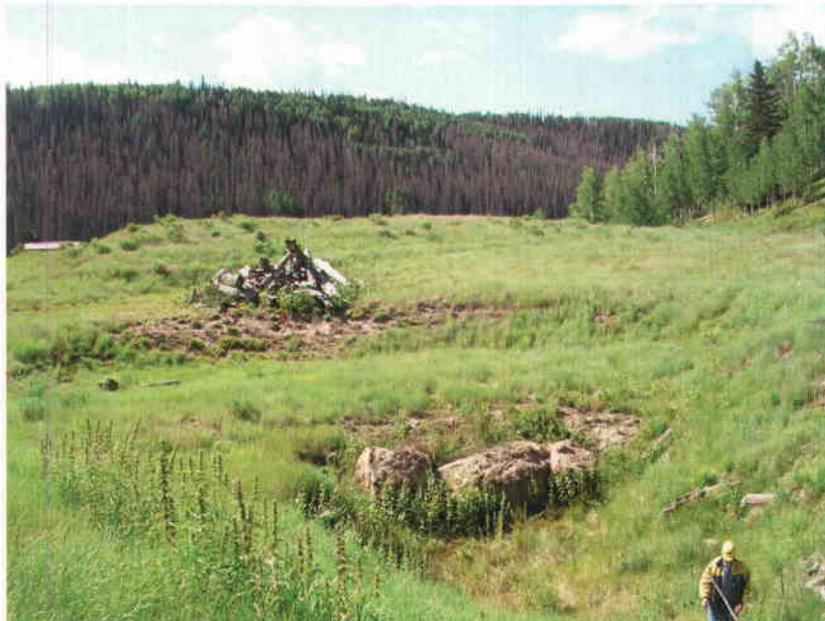
Minesite topsoil pile well vegetated with basin wildrye, aster, rabbitbrush, and coneflower, but a few thistle and hounds tongue should be removed before creating a problem. (Deer near pile, within 200 ft. of BC3 Fan). Railroad loadout topsoil stockpile vegetated and free of coal fines. Rail topsoil vegetation quite dry compared to minesite. Waste rock site topsoil and subsoil piles were recently established. Both topsoil and subsoil piles have been left at the angle of repose. Waste rock topsoil pile slopes need to be graded for long-term storage, roughened, and seeded this fall. Subsoil pile should also be treated, if it is to be redistributed as subsoil at the site (R645-301-232.500). A small stockpile of soil salvaged from recent conveyor maintenance should also be seeded and protected, if it will be stored for use as subsoil or topsoil.

Mine site topsoil stockpile.

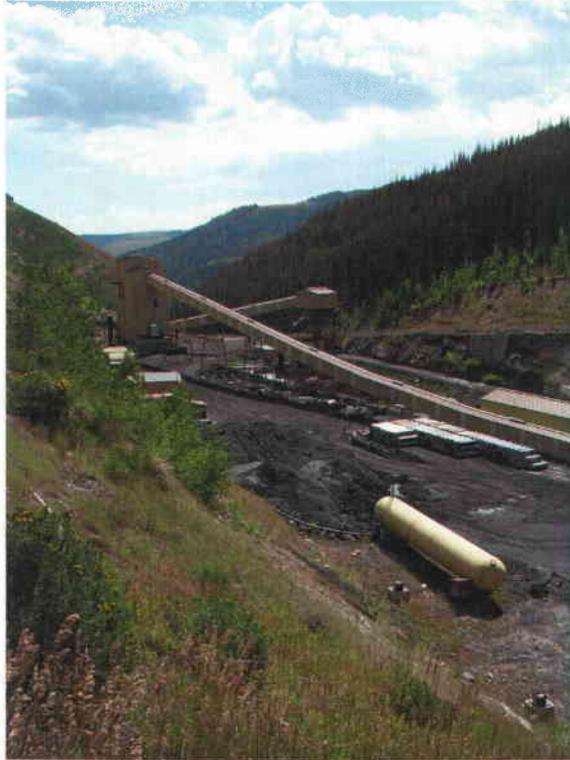
Mine site conveyor and sediment pond.

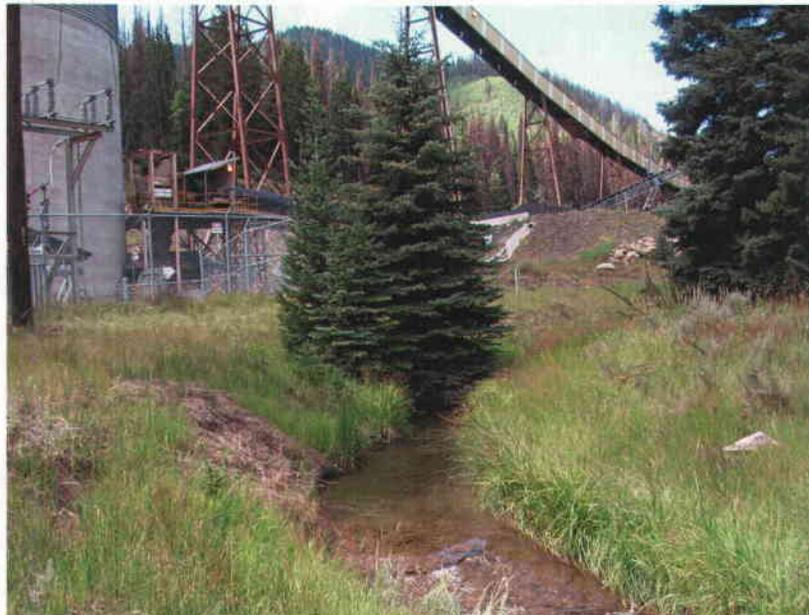
At the RR loadout there were no coal fines off the disturbed area and Eccles Creek adjacent to the loadout was running clear, see photo.

Eccles Creek flowing past railroad loadout and beneath conveyor.

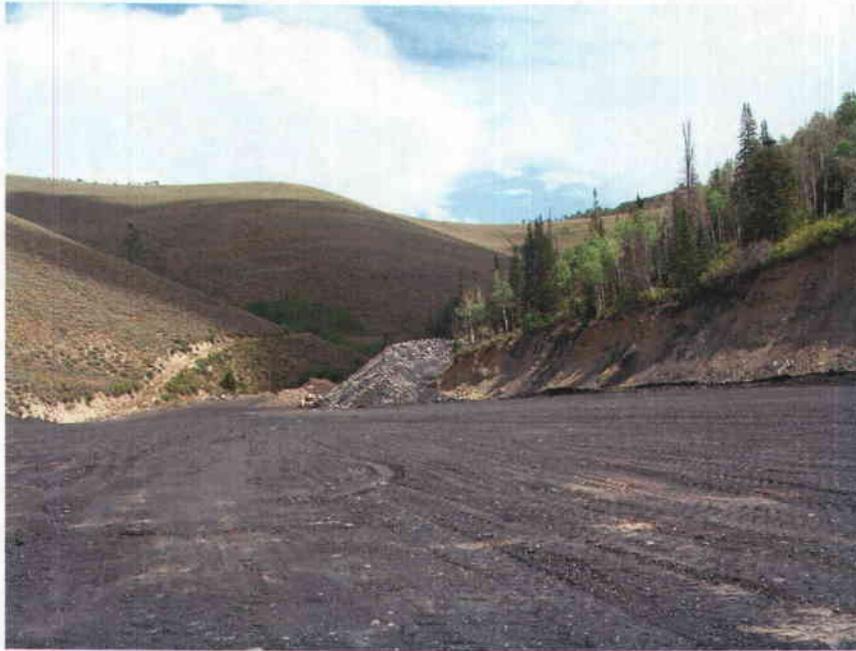
143,000 Tons of coal mine waste was remined from the site since June 2008. There has been no expansion upslope as described in the MRP. The upper terrace at the site has expanded into the NE draw to accommodate a waste rock pile (3% of the 143,000 Tons or approximately 4,000 Tons of waste rock) and topsoil and subsoil piles.

Waste rock site.

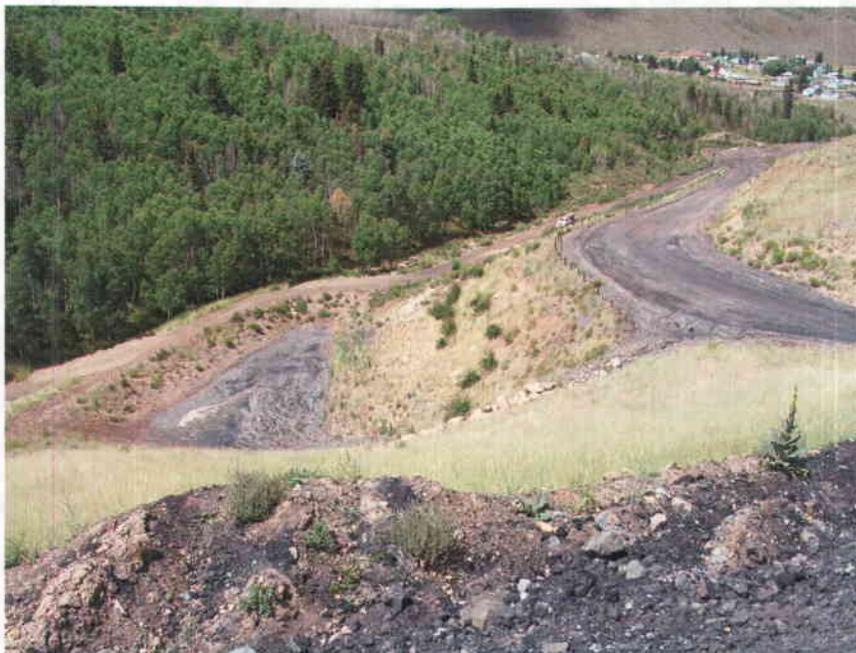
Waste rock site outslope and sediment pond.
