Technical Analysis and Findings
Utah Coal Regulatory Program

PID: C0070005
TaskID: 4684
Mine Name: SKYLINE MINE
Title: ABANDONMENT OF WATER MONITORING WELLS

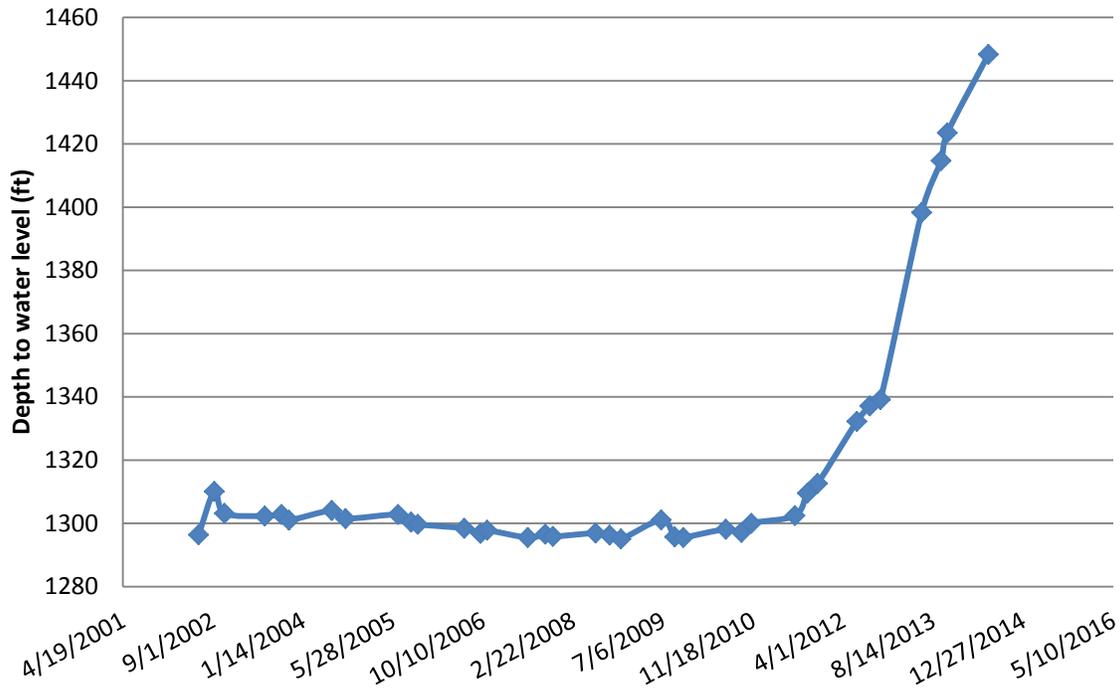
Well W91-26-1 has been monitored since June of 2002 and has reported a depth to water of about 1300 feet from 2002 until late 2012 when the water level has been dropping quickly. The latest water level, taken in June of 2014 indicated a depth to water level as 1448 feet. This is a drop of almost 150 feet in two years, when the water levels only fluctuated about 15 feet over the previous ten years.

R645-301-731.214 Water monitoring wells 91-26-1 and 91-35-1 are the only groundwater monitoring wells located within the North Lease. Well 91-26-1 provided ten years of consistent groundwater levels before the levels began dropping in 2012. The groundwater levels in this well appear to be still be dropping. Well 91-35-1 was the closest monitoring well to 91-26-1 prior to it becoming blocked. A new water monitoring well should be established to continue monitoring groundwater

The Permittee should establish additional monitoring well/wells to observe water level trends in the north lease area. New wells should be drilled as close to previously monitored wells as possible, and screened in the same geologic formation.

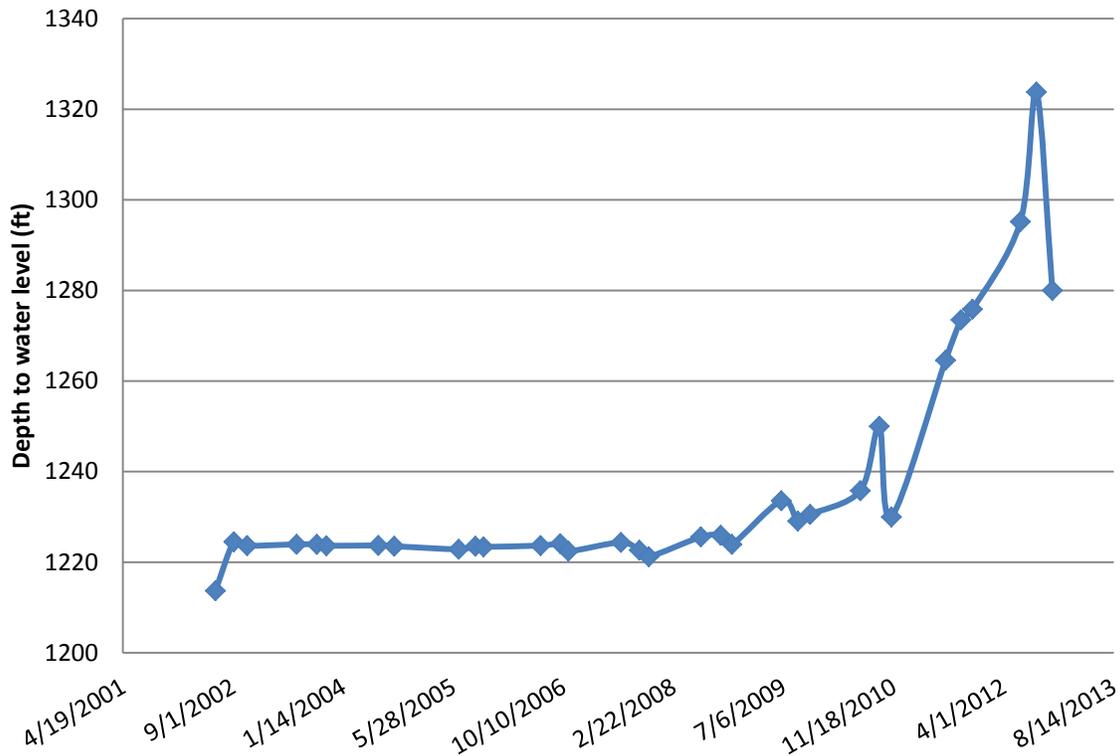
Well 91-35-1 was the closest monitoring well to W91-26-1 until it became blocked in 2012, but for about two years prior to becoming blocked, it was also seeing a water level drop.
