**U.S. DEPT. OF THE INTERIOR
OFFICE OF SURFACE MINING
Mine Site Evaluation
State Program**

MINE SITE INSPECTION NARRATIVE

MINE: Skyline Mine

DATE OF INSPECTION: April 26, 2017

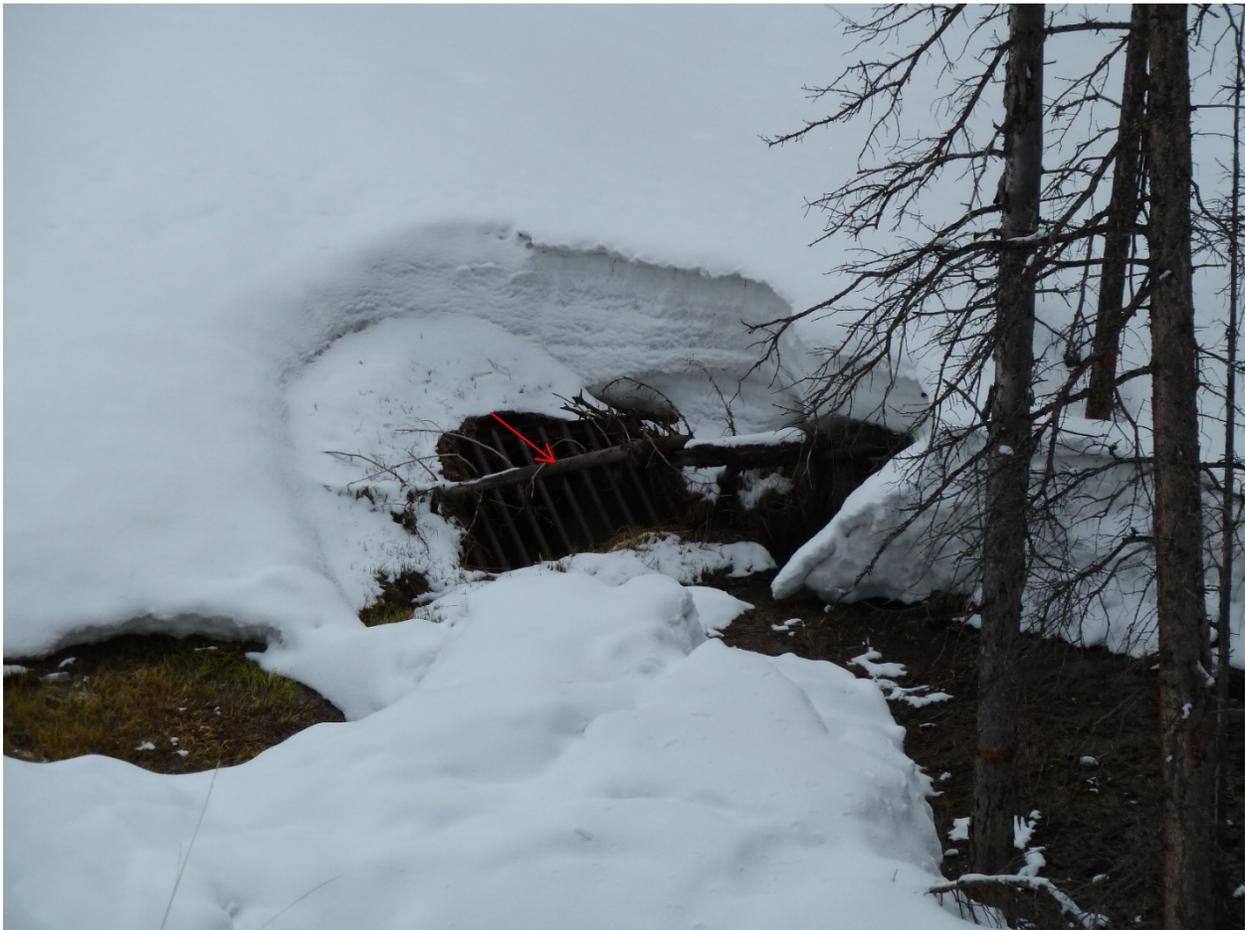
UC-2 inlet. Water flowing through, could only observe at a distance due to unsafe terrain (snow and steep slope). Trash rack appeared mostly clear other than a dead tree fall on the upper portion that was not currently impeding any water flow. Appears to be functioning as designed (Figure 1). OSMRE recommends (1) the entire inlet, including the trash rack, be maintained (e.g. cleaned, cleared, and repaired as needed) as soon as possible and (2) this maintenance project follow a safe work plan.

- UC-2 inlet has a dead tree fall in front of the trash rack, which should be removed and the entire inlet inspected for proper function.

Figure 1. Inlet to UC-2. Note the dead tree fall (red arrow).

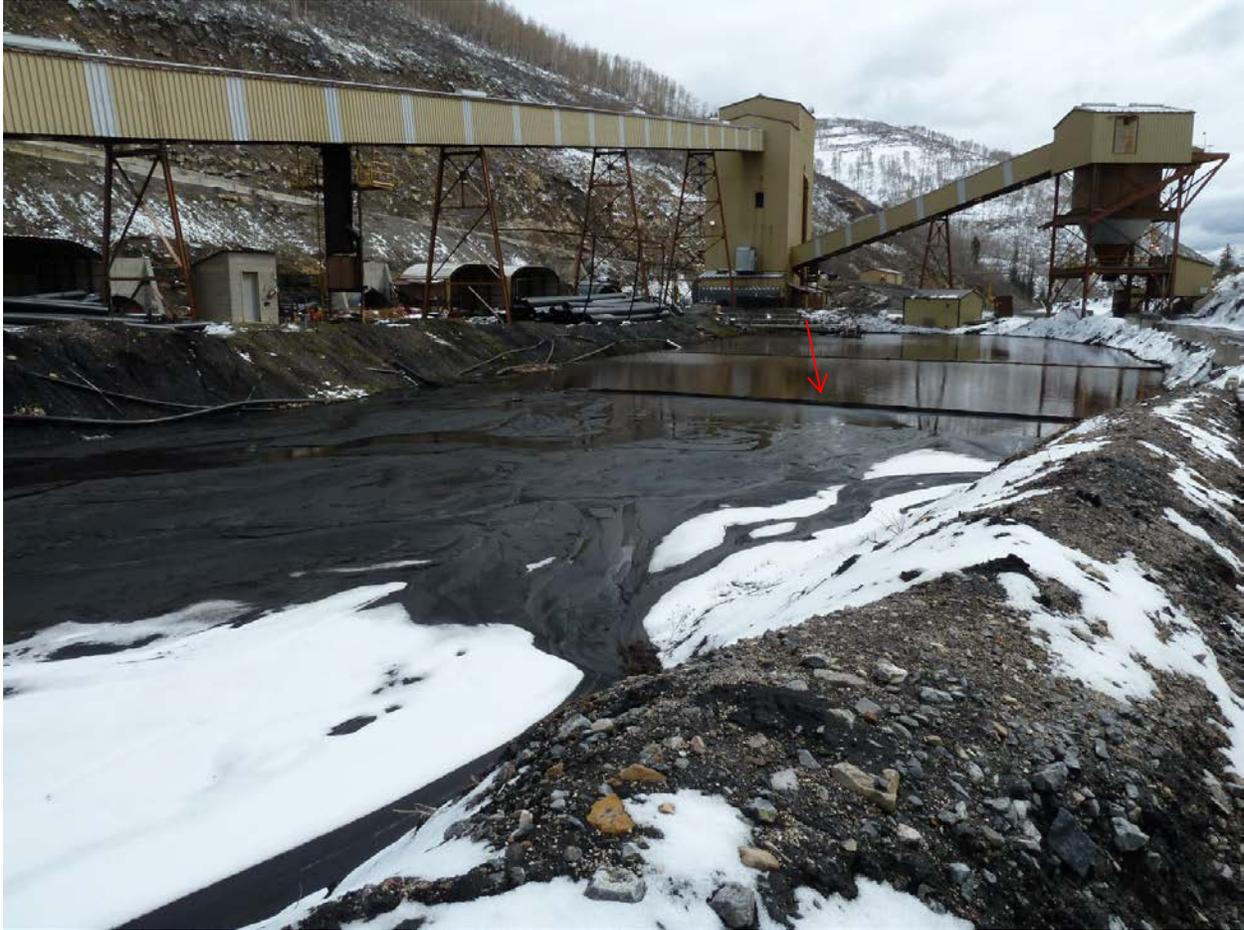
Sedimentation Pond. Filling with sediment, there are two curtains that slow water velocity and help drop sediment into the pond. The operator stated due to the above average precipitation during the winter that caused sediment to accumulate and wear out one of the curtains, it is in need of replacement (Figure 2). This curtain is on order, according to the operator

- Main Facilities Sedimentation Pond sediment curtain. The operator stated that one of the curtains is scheduled to be replaced (the replacement is on order) due to the above average precipitation during the winter causing sediment to accumulate and the curtain to become overly worn. DOGM should follow up on this curtain replacement.
- Loadout Facilities DC-2. Inlet should be cleared and the surrounding hill should be supported. The group spoke about this culvert inlet, and the operator stated there are plans to dig the hill back a bit and install gabion structures to prevent sediment clogging this inlet in the future.

Figure 2. Main Facilities Sedimentation Pond. Note the first curtain (red arrow) due for replacement with its high sediment load on the main inlet side.

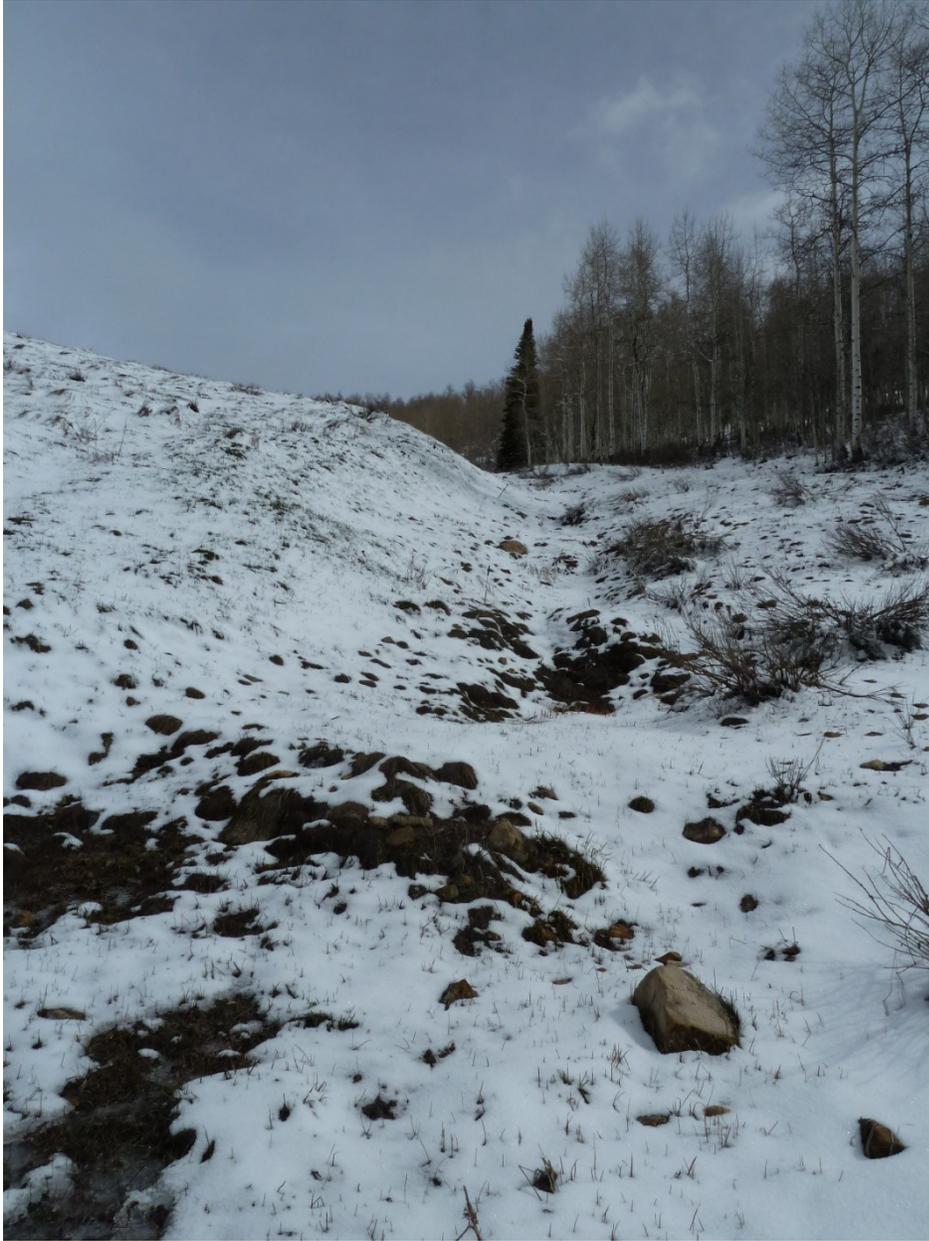
Topsoil drainage ditch. As observed from the bottom of the pile (did not walk the ditch due to safety concerns), appeared to be functioning as designed with no damage. Snow and ice present on the banks and ditch bed (Figure 3).

Figure 3 - Topsoil Ditch, functioning as designed with snow and ice covering this structure.

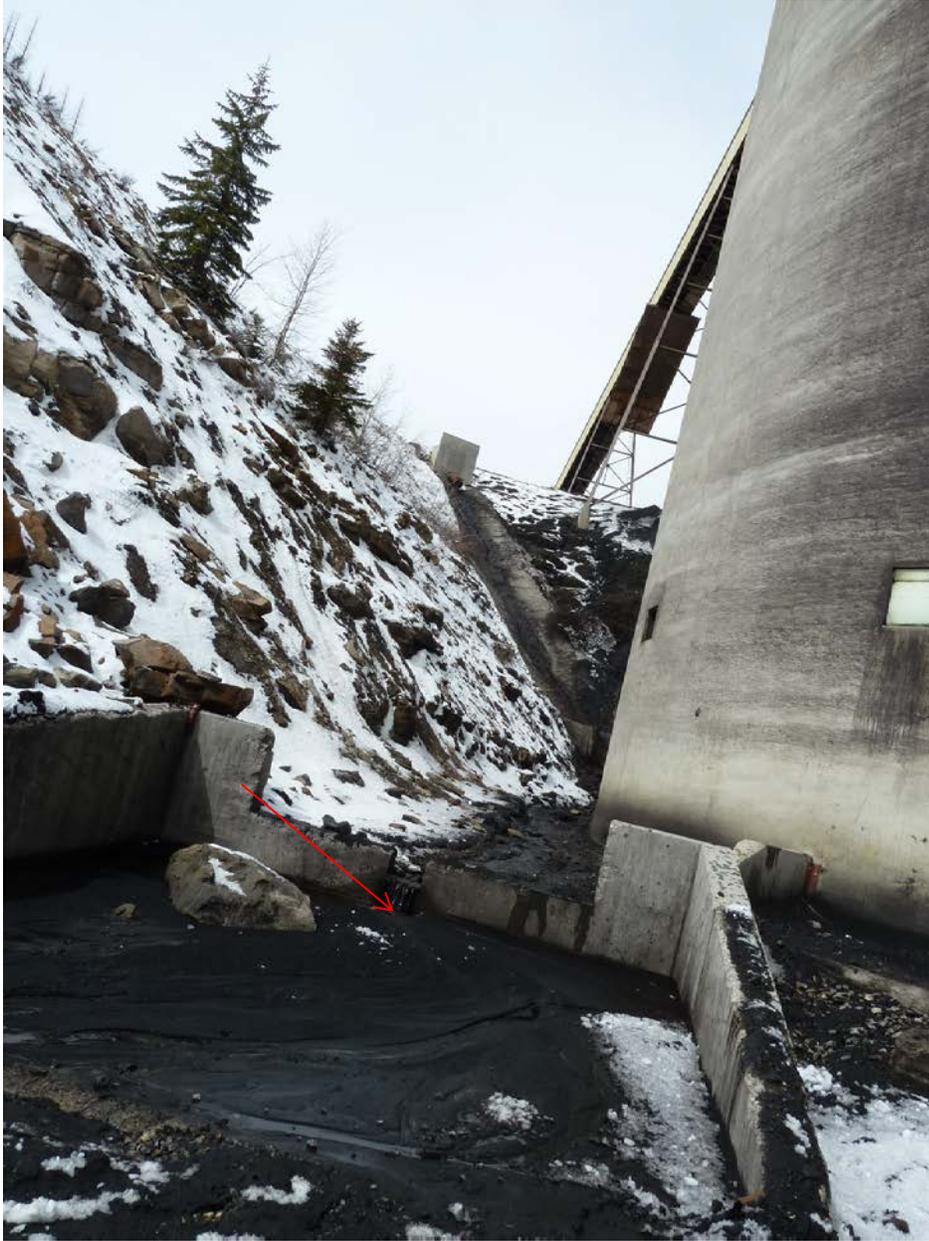
DD-6 and DD-7. From the main entrance to the sediment trap these appeared to be functioning as designed, no damage to concrete or any other part of the structures (Figure 4).

Sediment trap right after DD-7. This trap appeared to be functioning as designed and was close to needing to be emptied at the time of this inspection (Figure 4).

Figure 4 - DD-6 and DD-7, functioning as designed. Note the sediment trap filling in the foreground of the picture (red arrow at the inlet).

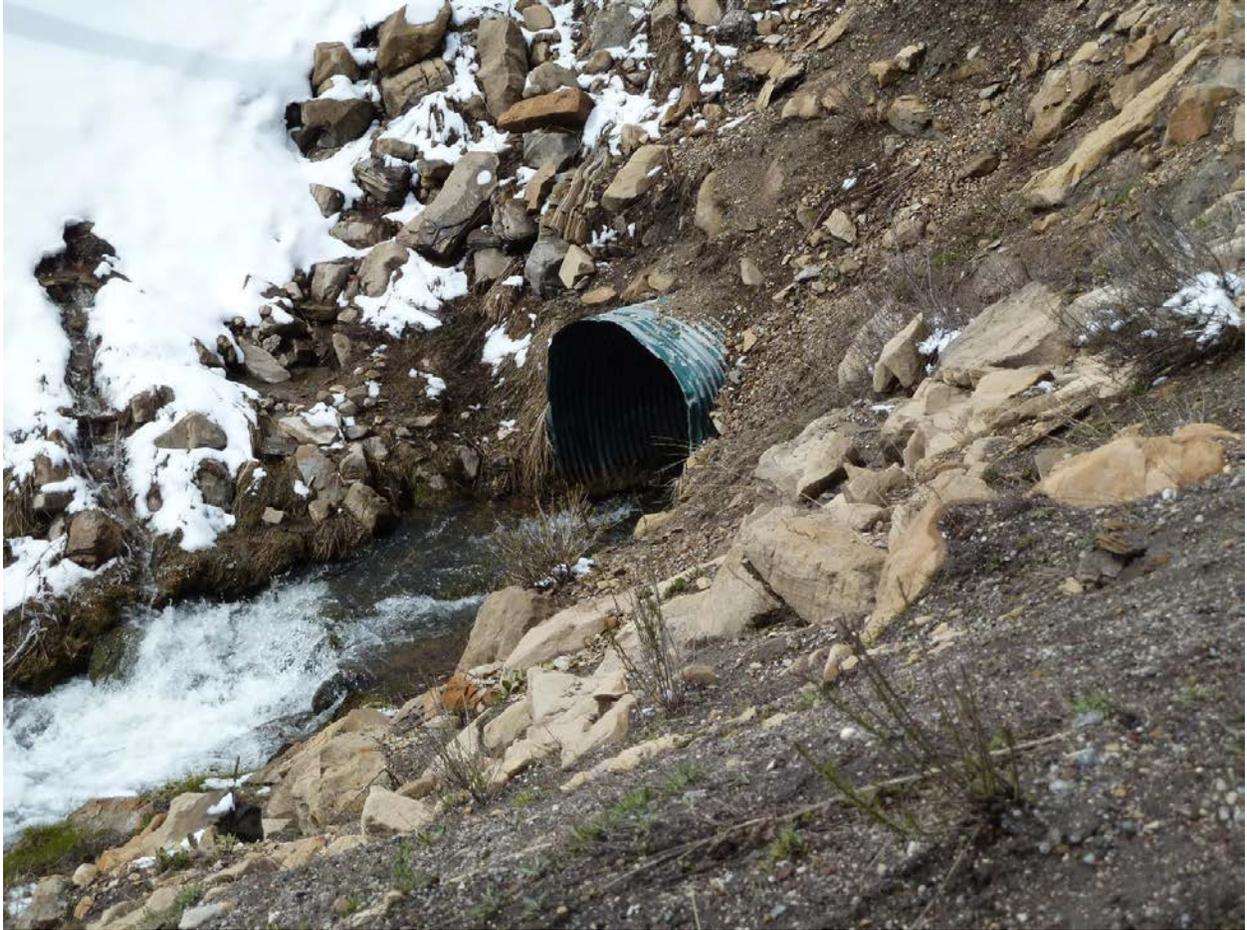
UC-9. This outlet appeared to be functioning as designed, with no undercutting, sediment buildup, or other compromising characteristics that would require maintenance (Figure 5).

Figure 5 - UC-9 outflow, clear, no maintenance appears to be needed.

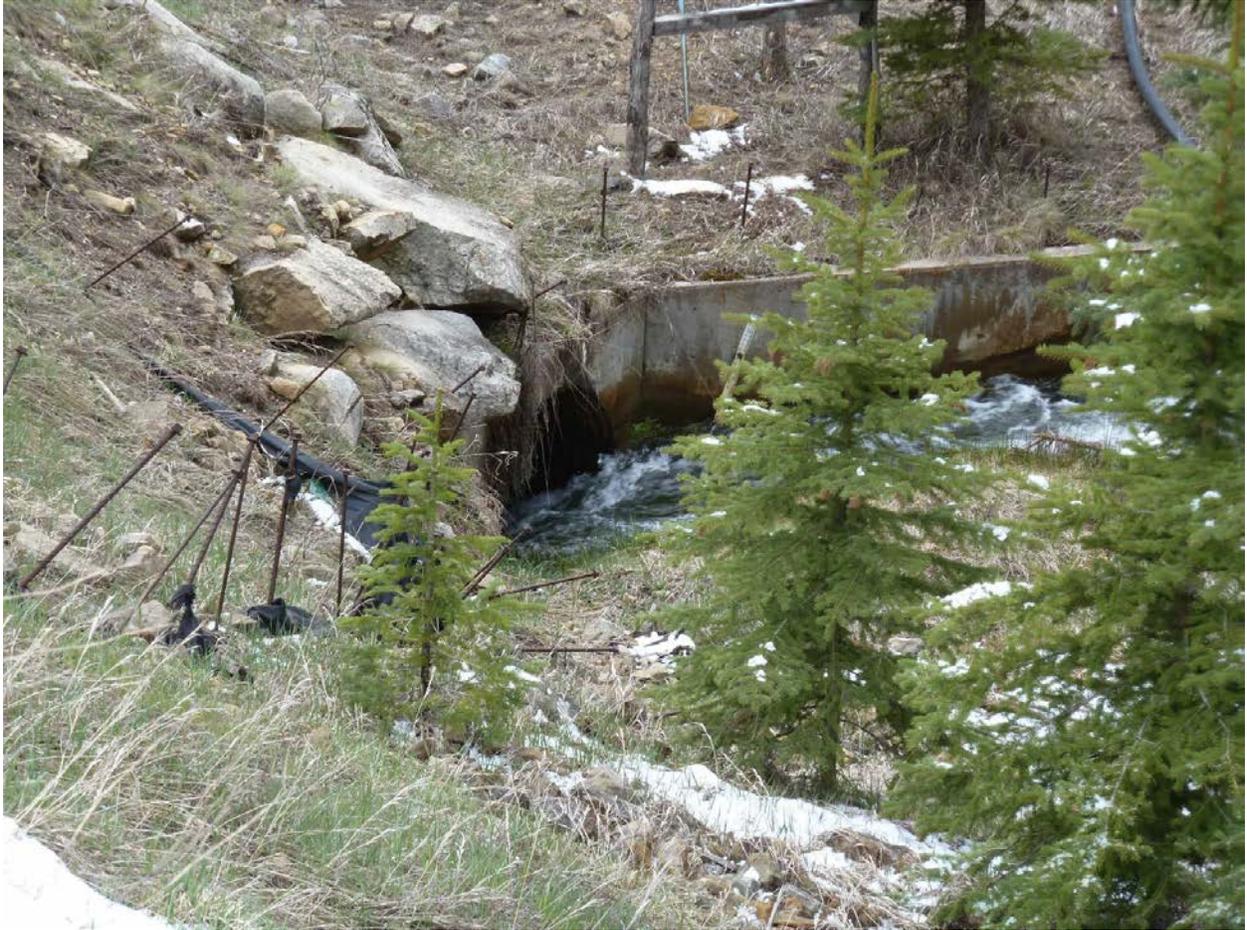
Unnamed Culvert inlet, for the undisturbed creek to bypass the facilities. Appeared clear and functioning as designed (Figure 6).

Figure 6 - Unnamed culvert that allows the undisturbed creek to bypass the Loadout Facilities. Appears to be clear and functioning as designed.

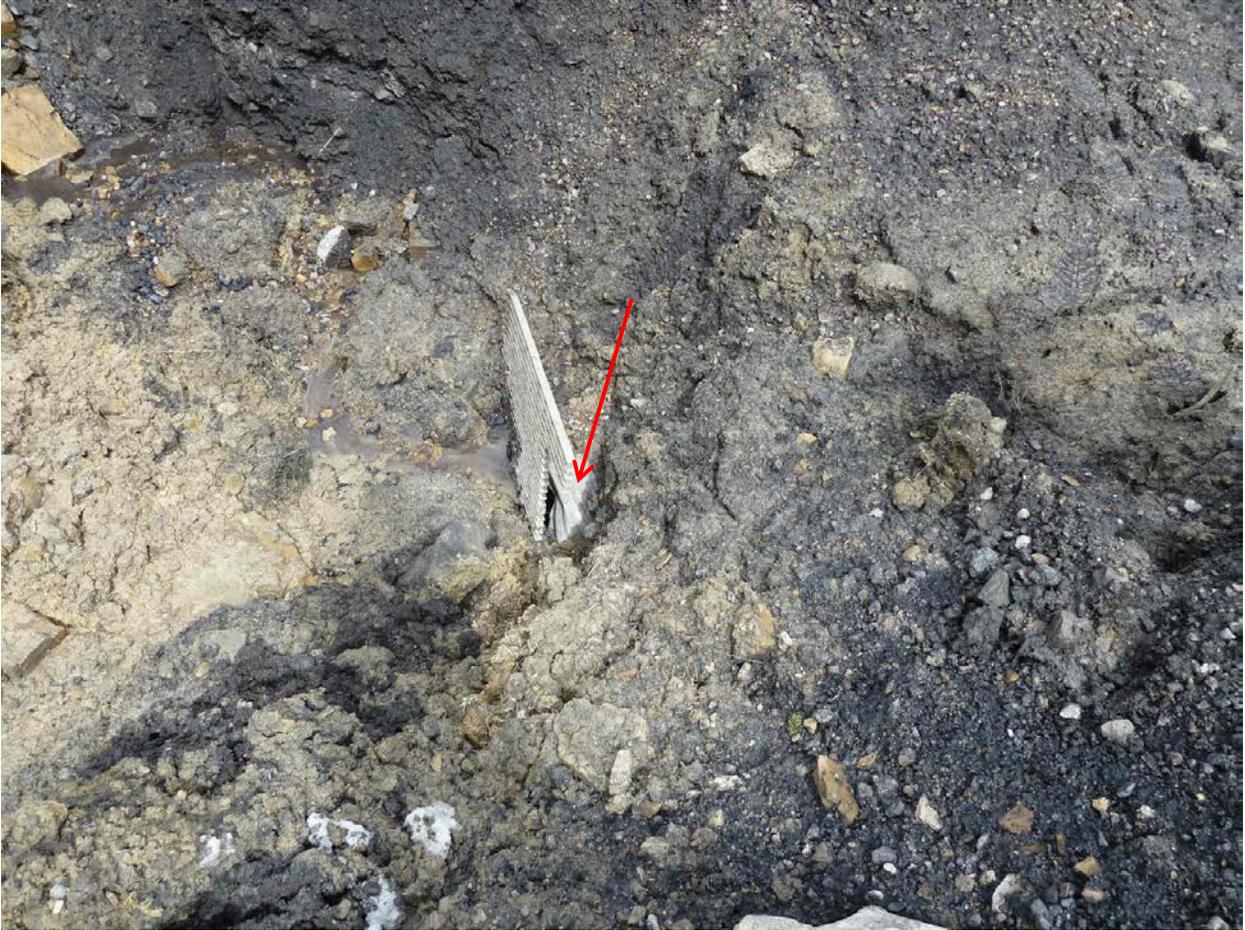
DC-2. This structure was in need of maintenance at the time of this inspection. It was clogged and should be cleared and the surrounding hill should be supported (Figures 7 and 8, with 8 showing the maintenance performed after this inspection on this inlet). The group spoke about this culvert inlet, and the operator stated there are plans to dig the hill back a bit and install gabion structures to prevent sediment clogging this inlet in the future. The outlet to this culvert was clear (Figure 9, top culvert).

Figure 7 - DC-2 at the Loadout Facilities. The inlet to this culvert was clogged (behind the grate in this picture, red arrow) and required maintenance.

Follow-up on this long term solution to this problem (e.g. installing gabion structures as the operator described) by DOGM is recommended.

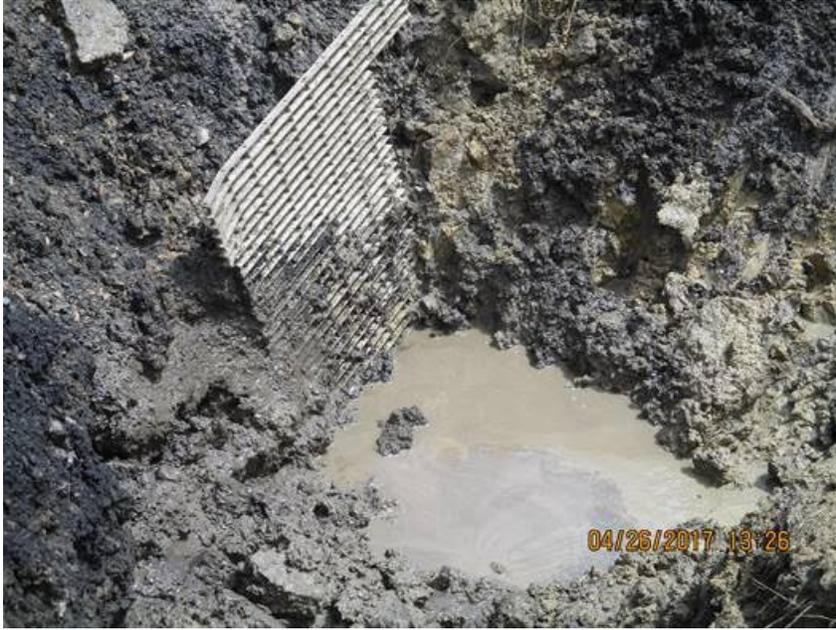
Figure 8 - DC-2 of the Loadout Facilities inlet cleared the right after the inspection. This maintenance will need to be regularly performed until erosion structures are installed. The operator mentioned there are plans to install gabion structures to prevent this erosion in the future.

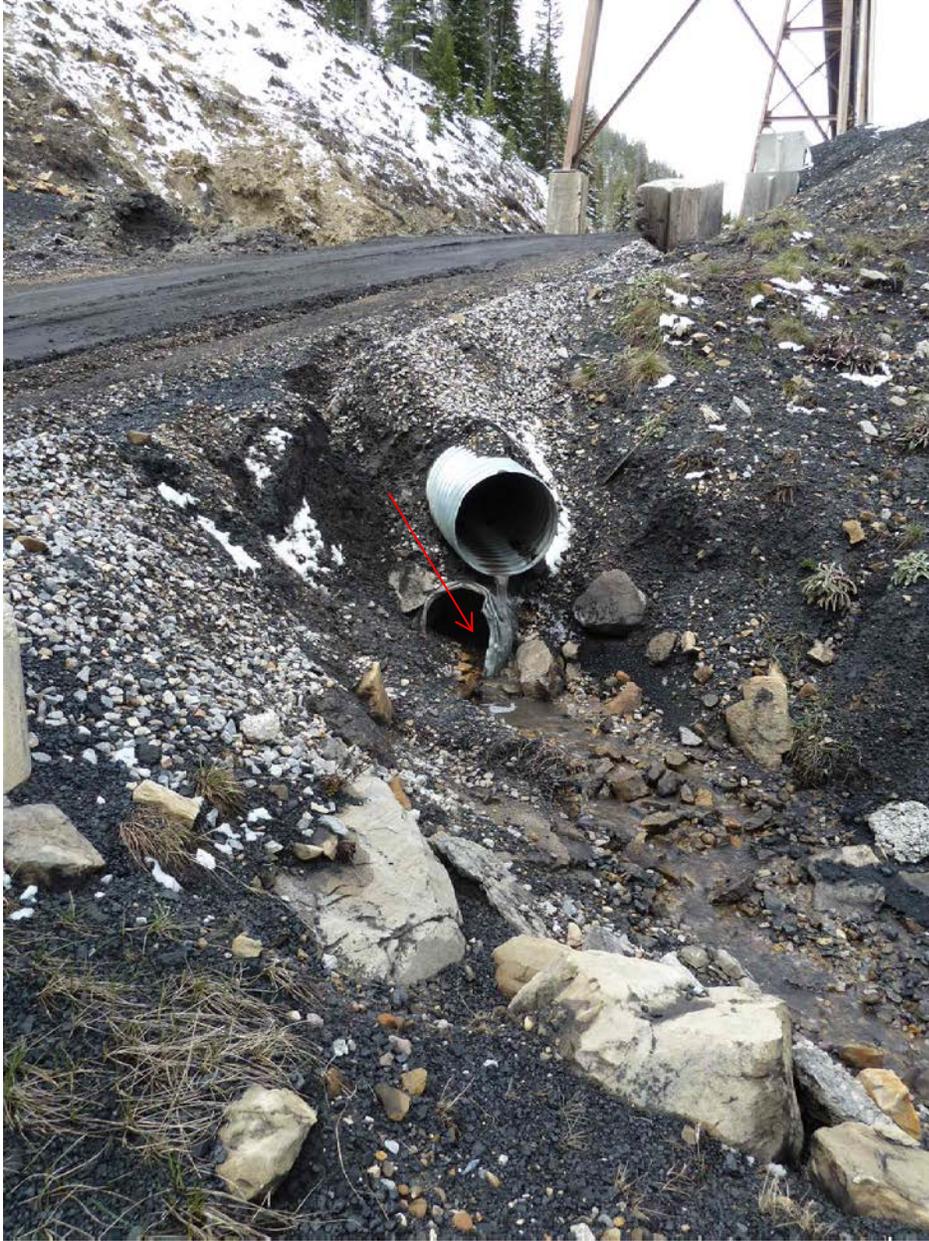
DC-3, 4, 5 outlet. This outlet was somewhat clogged and damaged (Figure 9, bottom culvert). Directly after the inspection, the operator cleared and opened up the culvert (Figure 12).

Figure 9 - Loadout Facilities, at the time of the inspection, DC-2 outlet (top culvert) and DC-2, 3, 4 outlet (bottom culvert). DC-2 outlet is clear with no maintenance needs. DC-3, 4, 5 outlet is a bit damaged and had sediment that should be cleared (red arrow).

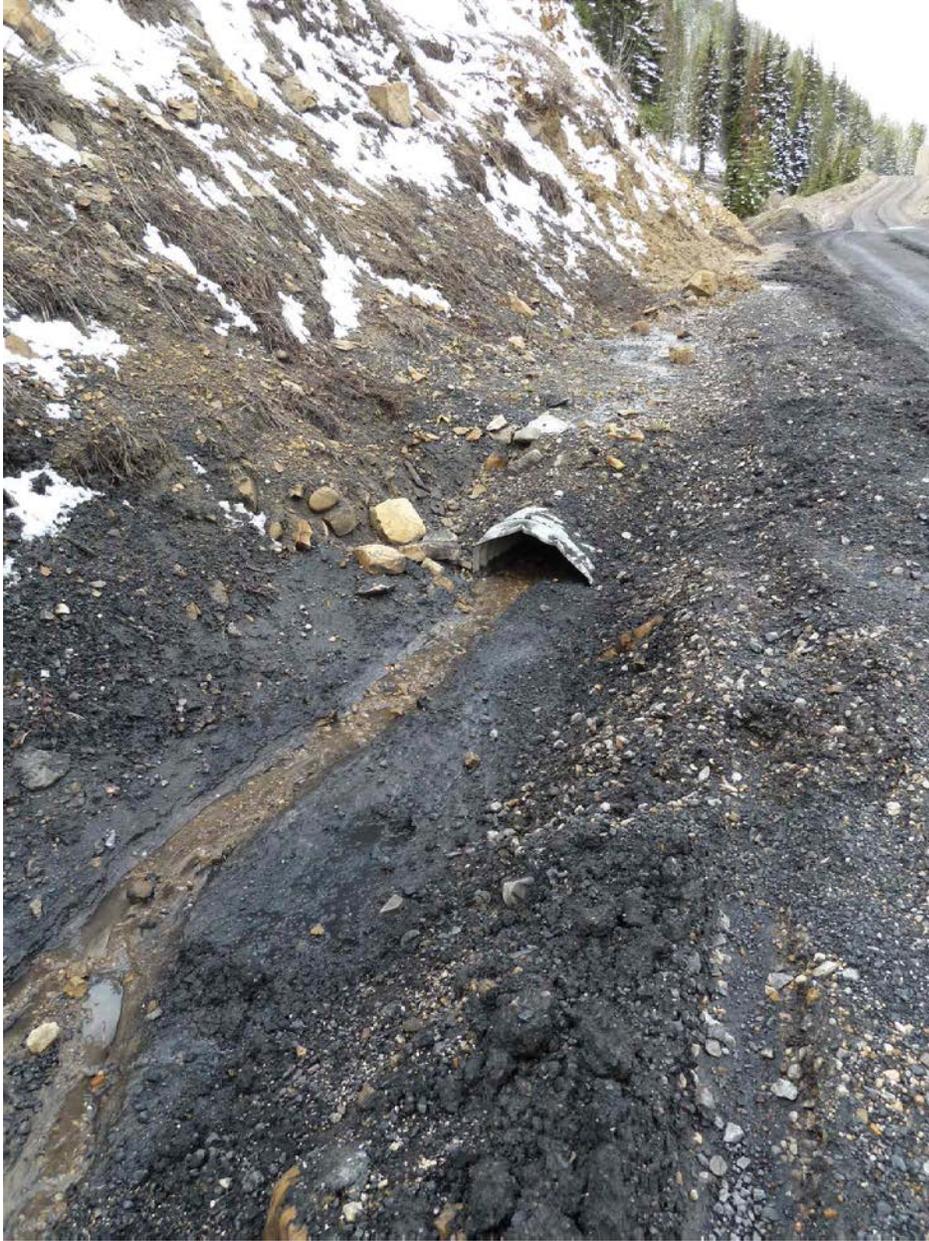
DC-1 outlet. This culvert outlet needed some maintenance; sediment buildup was partially blocking the flow of water (Figure 10). Maintenance was performed after the inspection and appears to have solved this problem (Figure 11).

Figure 10 - DC-1 outlet at the Loadout Facilities requiring some maintenance, as the culvert is significantly clogged.

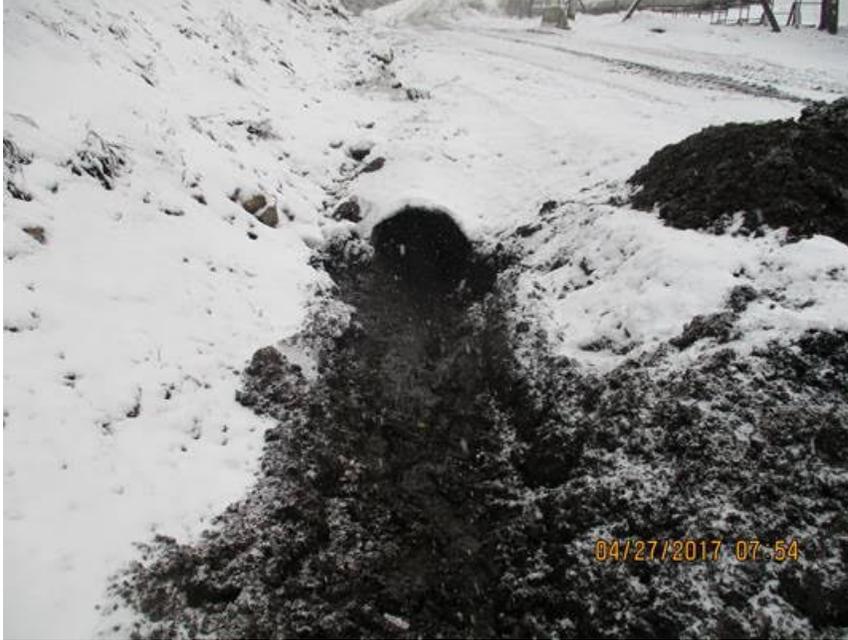
Figure 11 - DC-1 at the Loadout facilities after maintenance was performed after the inspection and appears to solve the problem; the outlet is clear.

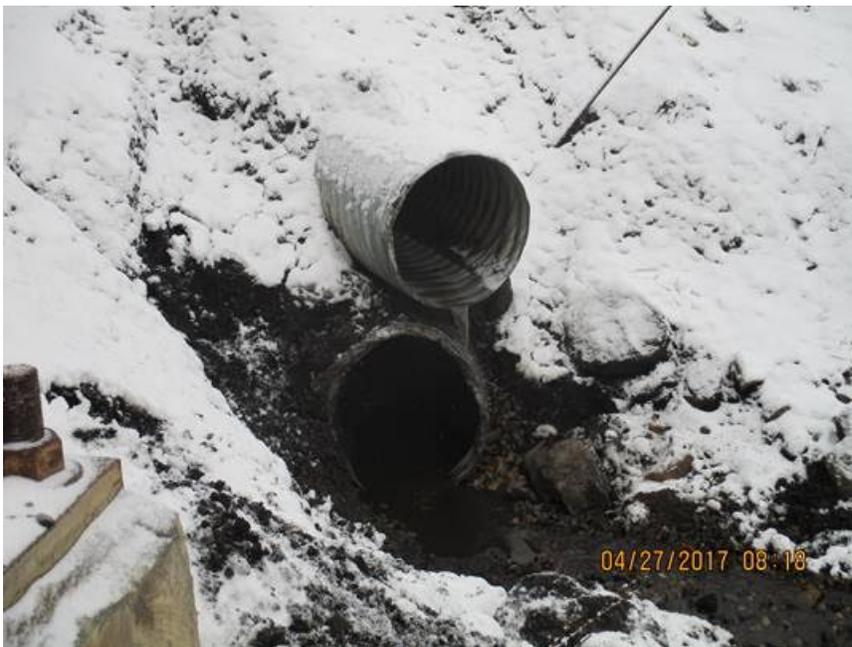
Figure 12 - Loadout Facilities DC-3, 4, 5 outlet (bottom culvert) maintenance performed. Damage to the culvert repaired and outlet cleared.

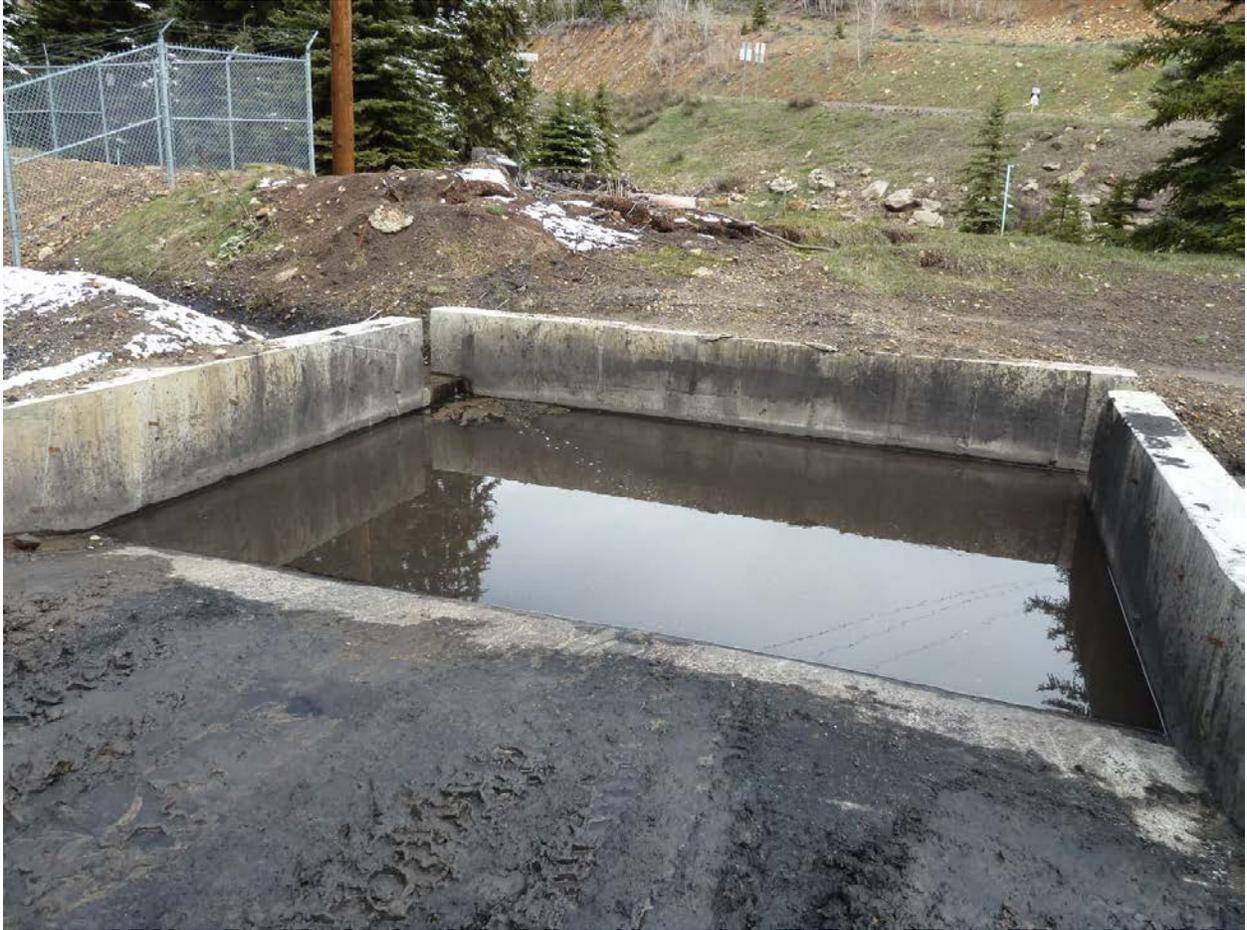
Sediment trap previous to the sediment pond (i.e. Hal's Clearout Trap). Appeared to be functioning as designed with no maintenance issues noted at the time of the inspection (Figure 13).

Figure 13 - Sediment trap at the Loadout Facilities, functioning as designed at the time of the inspection.

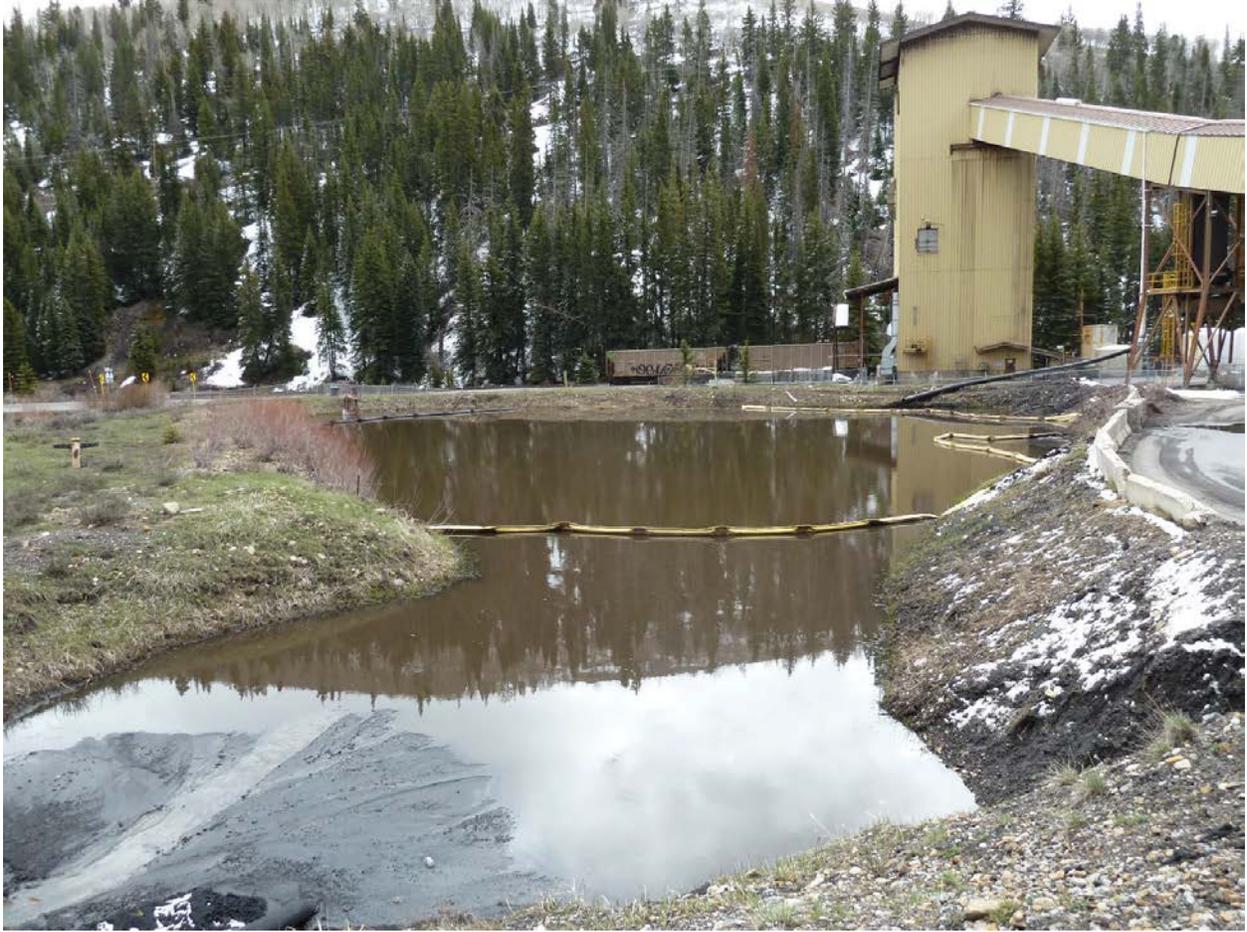
Figure 14 - Sediment pond at the Loadout Facilities, appears to be functioning as designed.
