IMPOUNDMENT INSPECTION AND CERTIFIED REPORT			
Permit Number	C/007/005	Report Date	January 30, 2018
Mine Name	Skyline Mine		
Company Name	Canyon Fuel Company		
Impoundment Identification	Impoundment Name	Mine Site Sediment Pond	
	Impoundment Number	001	
	UPDES Permit Number	UT0023540	
	MSHA ID Number	NA	
IMPOUNDMENT INSPECTION			
Inspection Date	December 30, 2017		
Inspected By	Craig Brown		
Reason for Inspection (Annual, Quarterly or Other Periodic Inspection, Critical Installation, or Completion of Construction)	Quarterly		
<p>1. Describe any appearance of any instability, structural weakness, or any other hazardous condition.</p> <p>No signs of instability were observed. No hazardous conditions were observed during the inspection of the pond. The pond was at capacity with water, but not discharging. The pond is incised, with all the banks appearing stable, with vegetation typically along a many of the banks. Particular attention was paid to the pond banks looking for signs of instability or structural weakness, drainage from the road located just west of the scales will continue to be monitored.</p>

IMPOUNDMENT INSPECTION AND CERTIFIED REPORT			
Permit Number	C/007/005	Report D

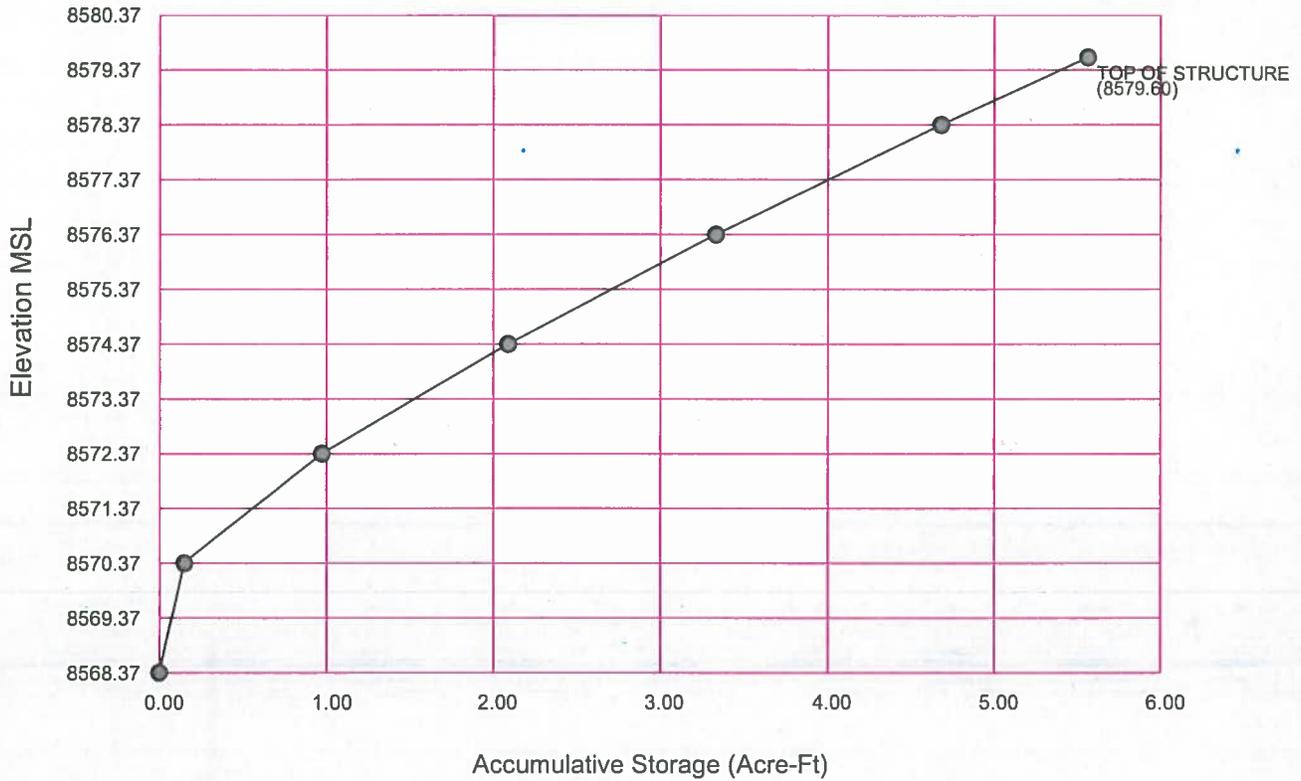
Stage Storage Curve

Sediment Control Structure No. 1

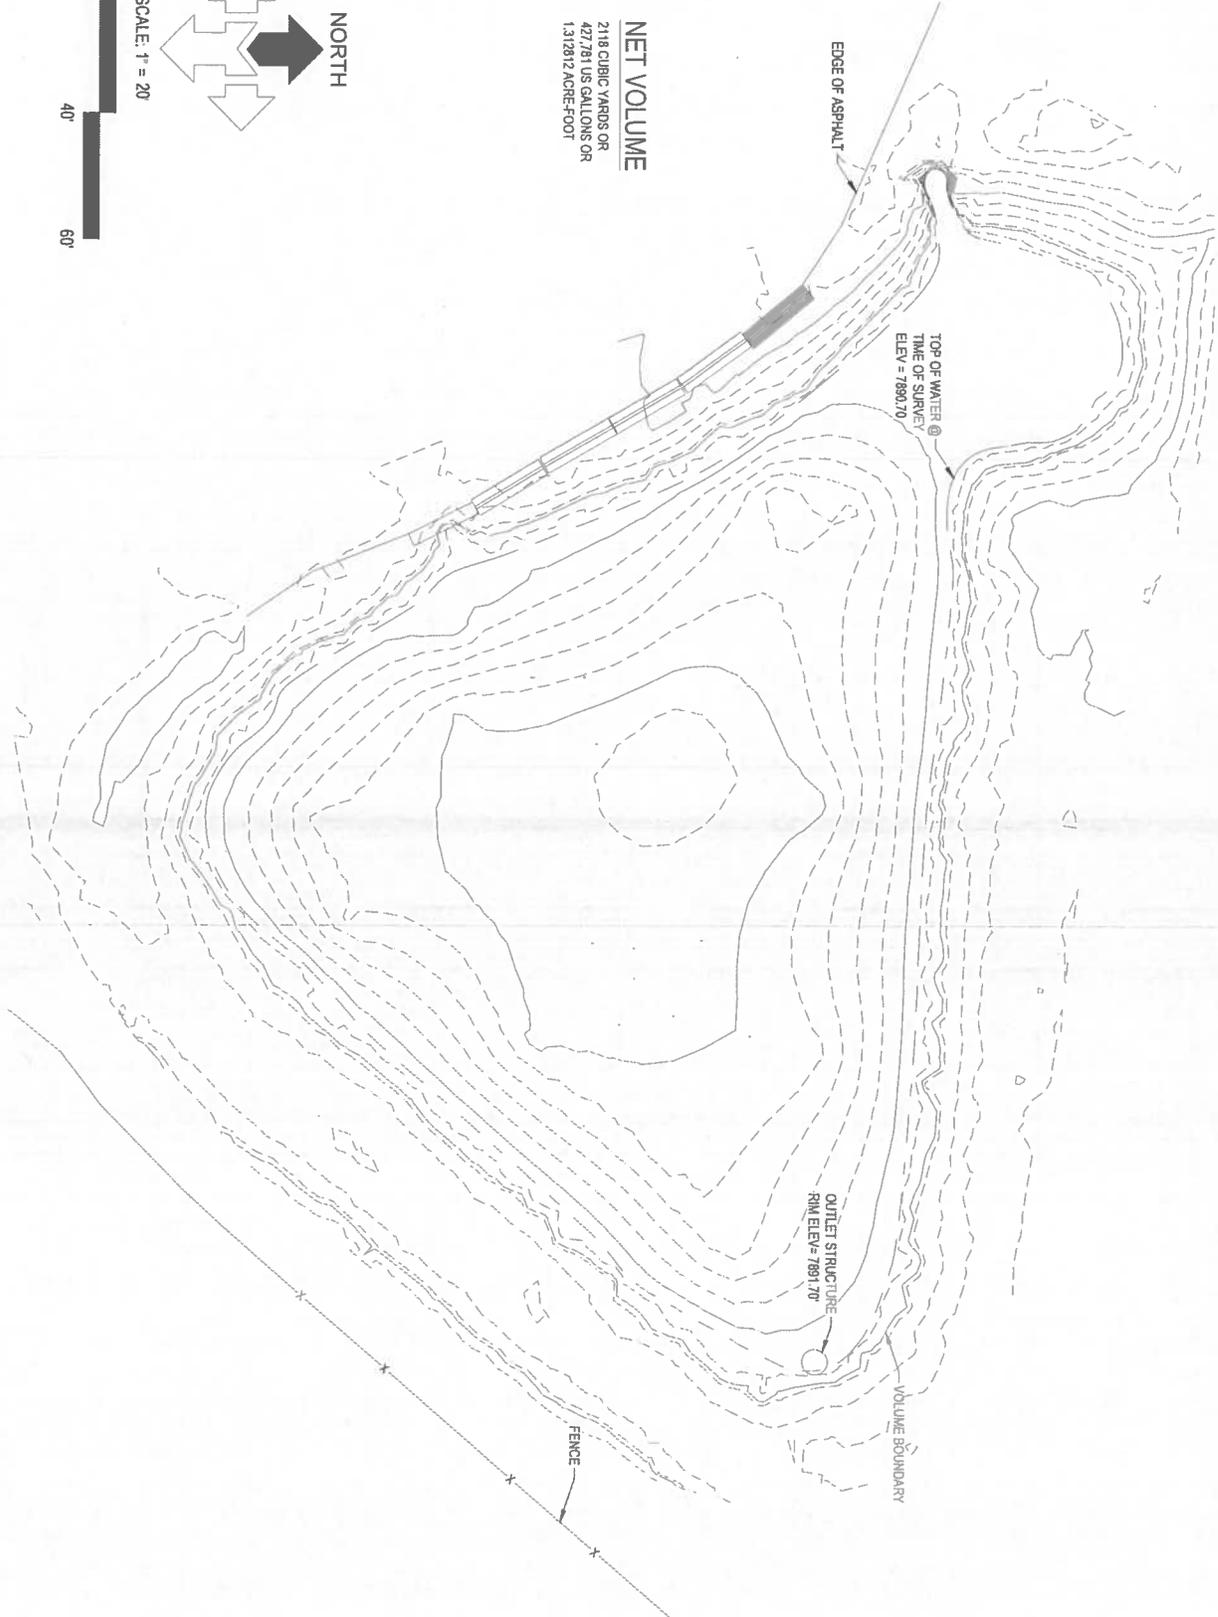
RAIL LOADOUT TAILINGS PONDS

NET VOLUME
 2118 CUBIC YARDS OR
 427,781 US GALLONS OR
 1,328 1/2 ACRE-FOOT

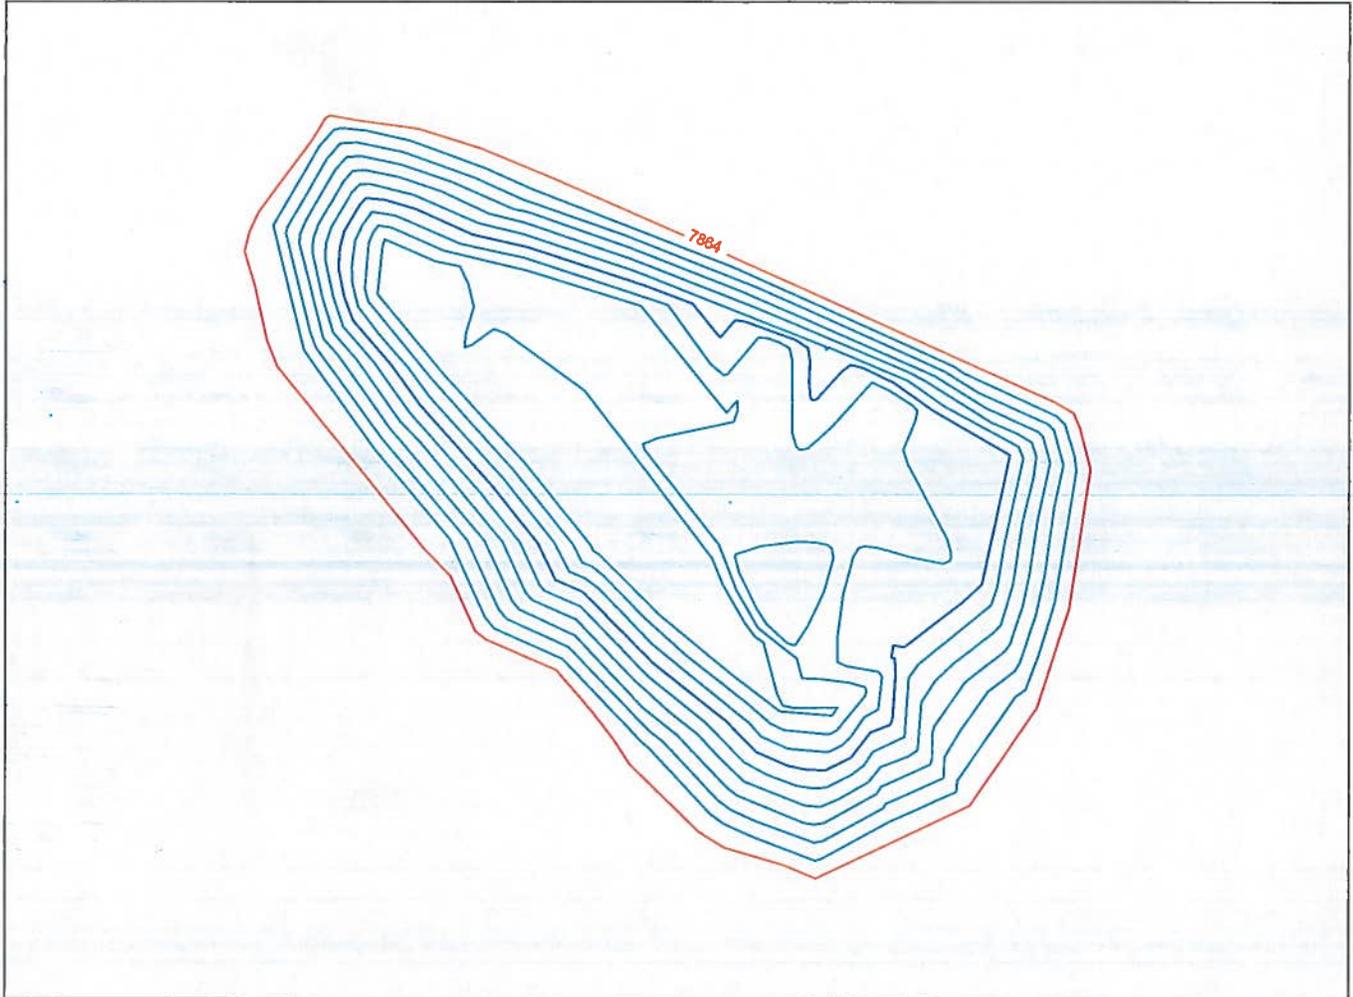
Maximum Spillway Containment Volume

Fill volume: 70,501.8 C.F., 2,611.18 C.Y.

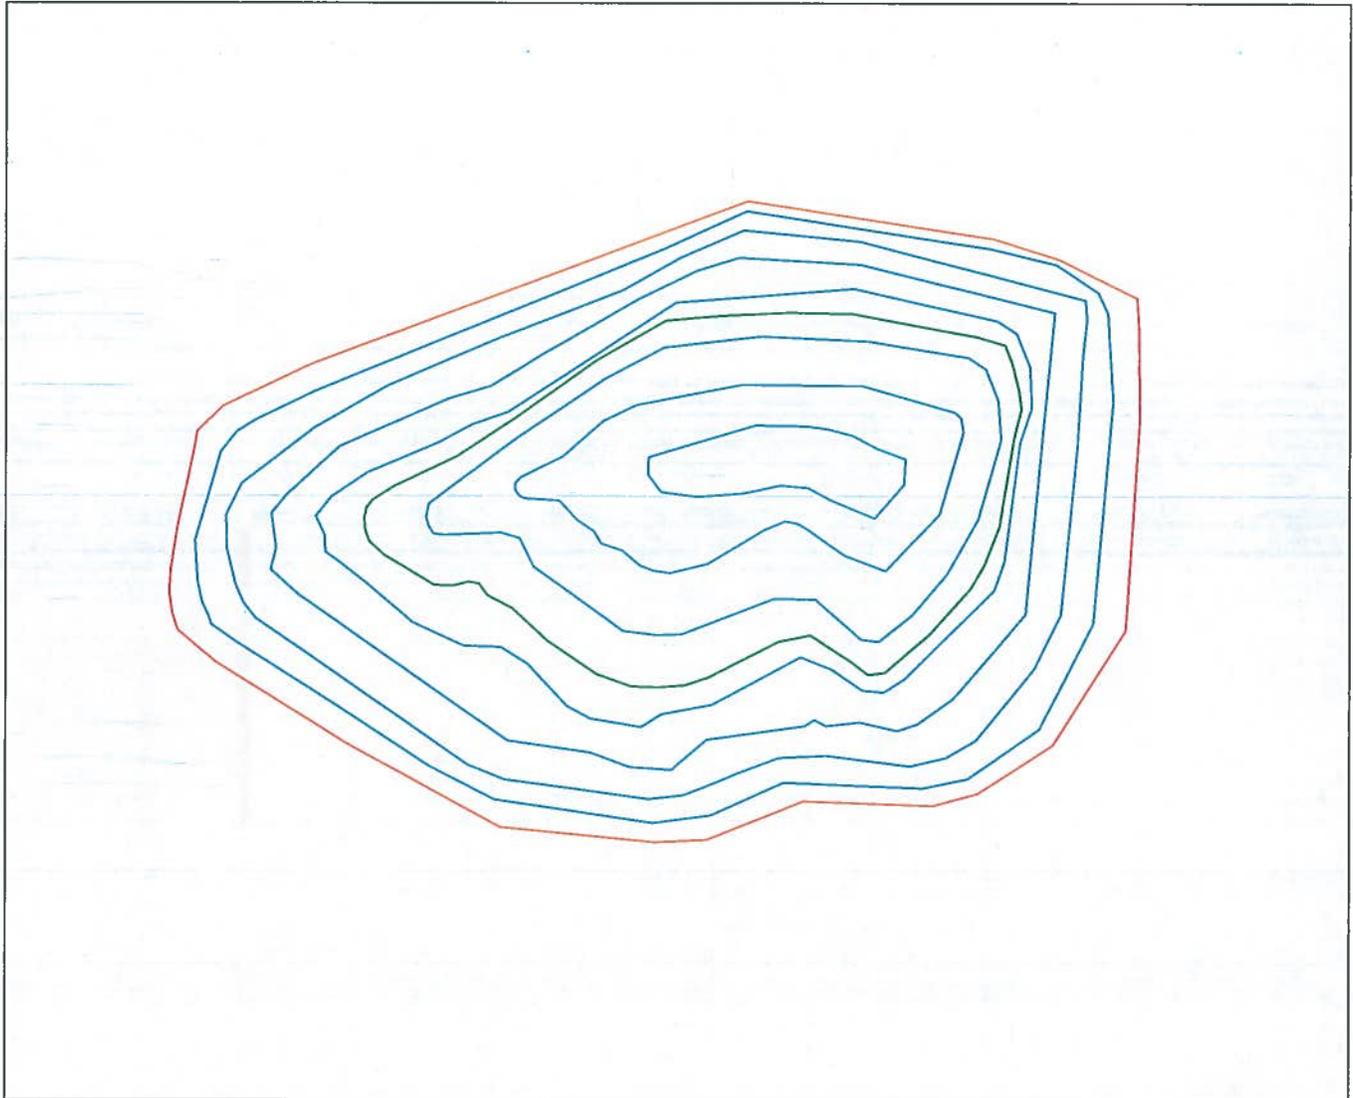
Maximum Spillway Containment Volume

Volume Report Thu Nov 9 08:57:51 2017
Comparing Grid: Y:\Survey\Sediment Ponds\004- WQ\171020 WQ Sed Pond\WQ Sed Pond Base.grd
and Grid: Y:\Survey\Sediment Ponds\004- WQ\171020 WQ Sed Pond\WQ Sed Pond Max.grd
Grid corner locations: 2084445.98,505302.85 to 2084526.04,505368.03
Grid resolution X: 200, Y: 200 Grid cell size X: 0.40, Y: 0.33
Area in Cut : 0.0 S.F., 0.00 Acres
Area in Fill: 1,680.7 S.F., 0.04 Acres
Total inclusion area: 1,680.7 S.F., 0.04 Acres
Cut to Fill ratio: 0.00
Average Fill Depth: 2.93
Max Fill Depth: 6.27
Cut (C.Y.) / Area (acres): 0.00
Fill (C.Y.) / Area (acres): 4719.94
Cut volume: 0.0 C.F., 0.00 C.Y.
Fill volume: 4,917.0 C.F., 182.11 C.Y.
