Inspection Report

Permit Number:	C0070005
Inspection Type:	COMPLETE
Inspection Date:	Thursday, May 21, 2020
Start Date/Time:	5/21/2020 9:00:00 AM
End Date/Time:	5/21/2020 2:00:00 PM
Last Inspection:	Thursday, March 19, 2020

Permitee: **CANYON FUEL COMPANY**
 Operator: **CANYON FUEL COMPANY**
 Site: **SKYLINE MINE**
 Address: **HC 35 BOX 380, HELPER UT 84526**
 County: **CARBON**
 Permit Type: **PERMANENT COAL PROGRAM**
 Permit Status: **ACTIVE**

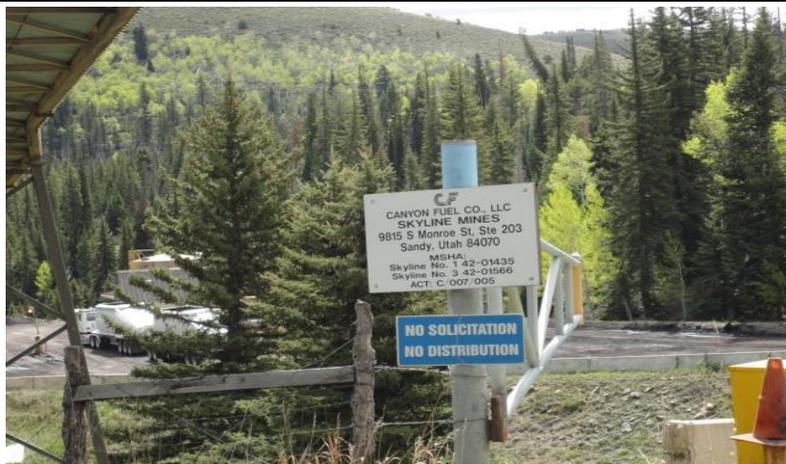
The identification sign at the mine entrance/parking lot was on the ground. The permittee said they will rehang the sign. The other entrances have the sign hanging and meet the requirements of the R645 Coal Rules.

PHOTO 1
Identification Sign

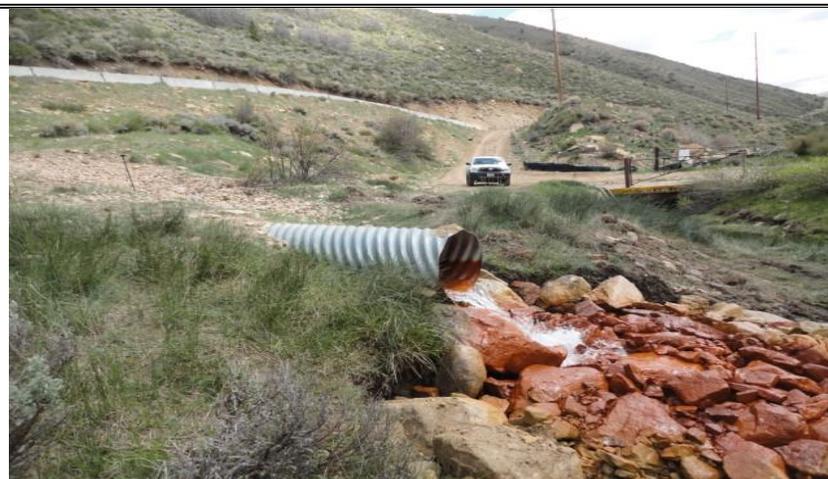
I inspected the Winter Quarter mine discharge. The mine was pumping approximately 1,200 gal/ min into the creek. The permittee measured the amount of water below the mine discharge in the creek being 6,500 gallon/minute. I inspected the creek below the mine and the water was clear not muddy, embankments were stable. I did not see any signs of erosion. The discharge are of the 1,200 gallons/minute was stable. See Photos.

PHOTO 2
Winter Quarters Discharge

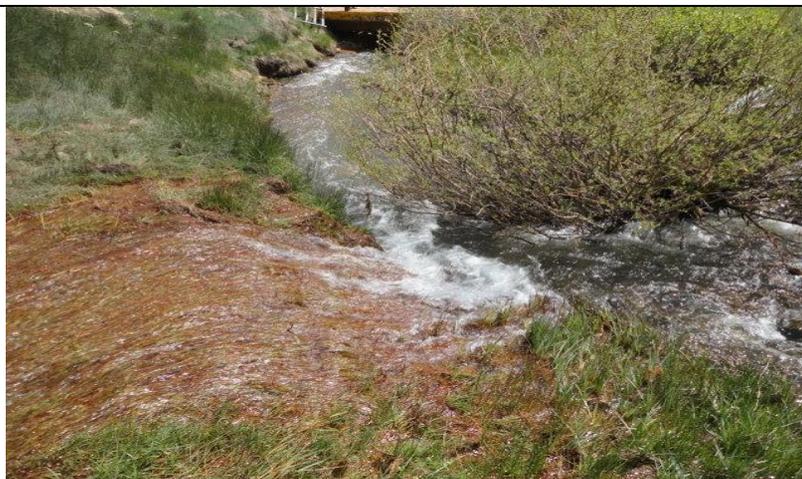
PHOTO 3
Winter Quarter Discharge into Creek

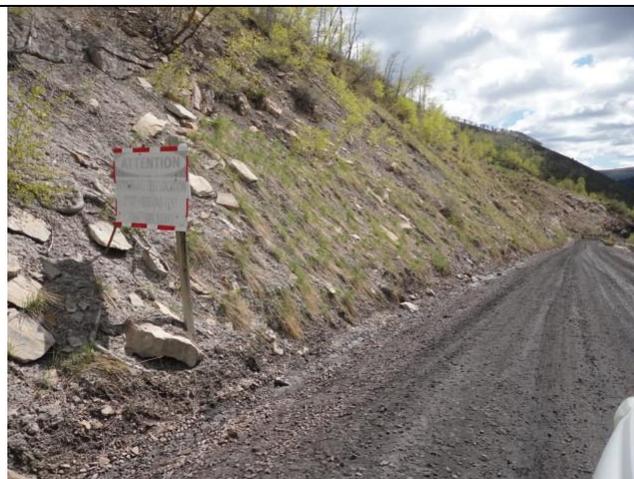
PHOTO 4
DD-2

I inspected diversions and culverts throughout the property. They were open and would function as design during a storm event. The several structures were recently re-graded and clean out of sediment. See photos
