State of Utah
 DEPARTMENT OF NATURAL RESOURCES
 MICHAEL R. STYLER
Executive Director
Division of Oil, Gas and Mining
 JOHN R. BAZA
Division Director

Inspection Report

Permit Number:	C0070005
Inspection Type:	PARTIAL
Inspection Date:	Tuesday, June 23, 2020
Start Date/Time:	6/23/2020 10:00:00 AM
End Date/Time:	6/23/2020 1:30:00 PM
Last Inspection:	Thursday, May 21, 2020

Permitee: **CANYON FUEL COMPANY**
 Operator: **CANYON FUEL COMPANY**
 Site: **SKYLINE MINE**
 Address: **HC 35 BOX 380, HELPER UT 84526**
 County: **CARBON**
 Permit Type: **PERMANENT COAL PROGRAM**
 Permit Status: **ACTIVE**

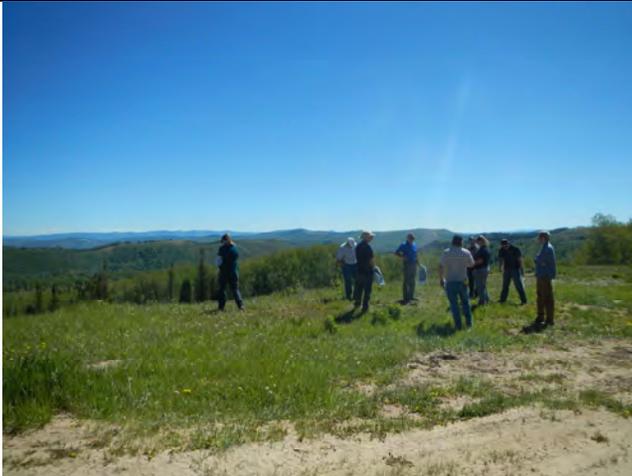
Trough Springs Ridge location

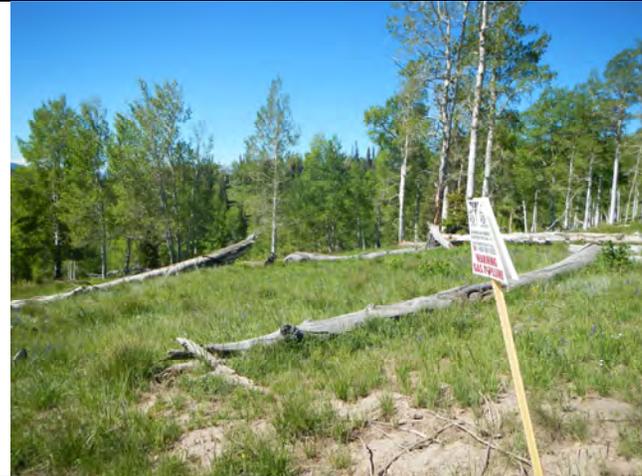
Gas line follows Trough Springs Ridge

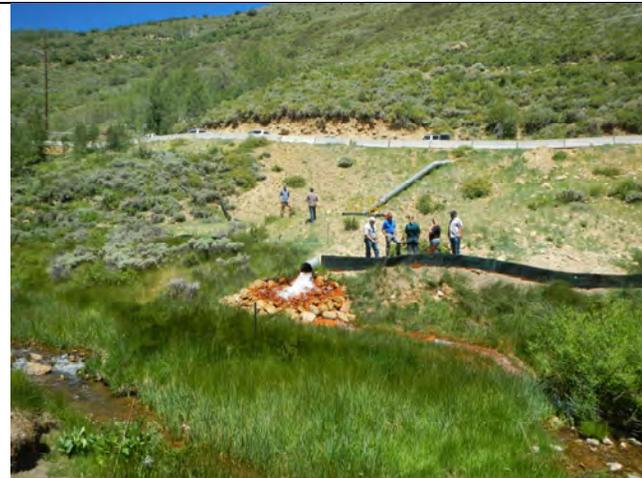
The recently modified outfall structure and pipeline installation for mine water discharge into Winter Quarters Creek was observed and photographed.

Winter Quarters UPDES discharge point

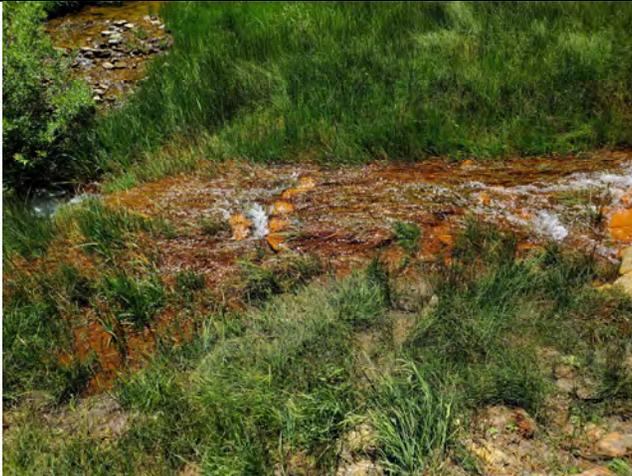
Mine water discharge flowing over the bank within the Ordinary High Water Mark

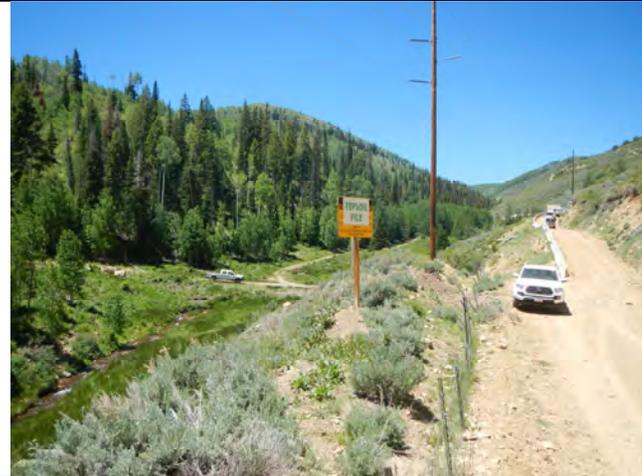
Winter Quarters topsoil stockpile

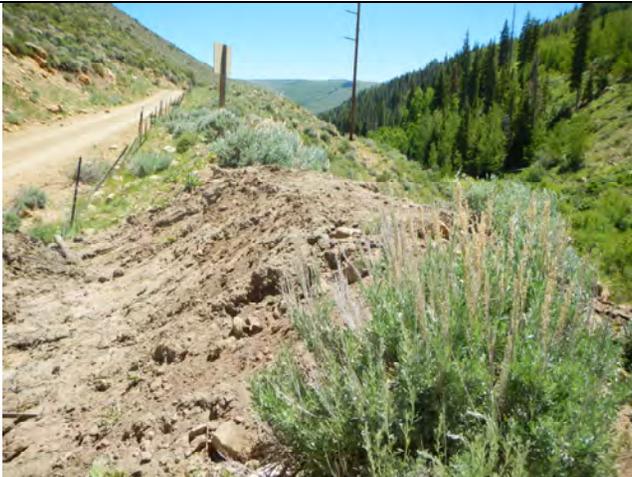
Topsoil will be salvaged from road cuts along the powerline corridor. Topsoil was salvaged from the new outfall structure on Winter Quarters Creek. This small volume of soil was added to the stockpile. It was seeded, but as yet there is no growth on the soil. The stockpile fence was cut in order to place the soil. The fenceline should be maintained. The soil should be monitored for plant emergence and reseeded if necessary this Fall.

Soil added to stockpile from UPDES point construction in 2020

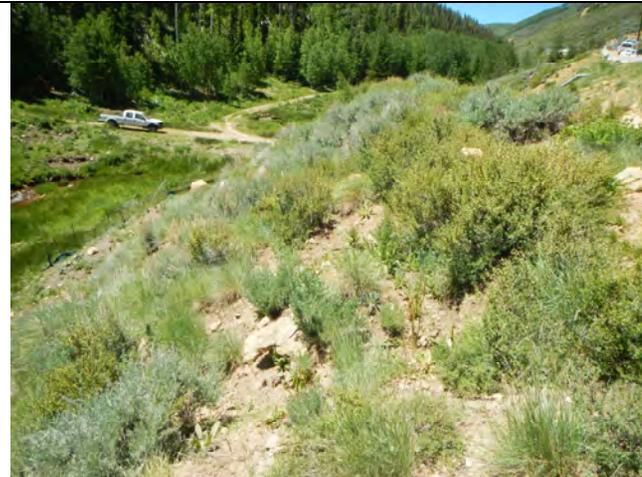
Stockpile vegetation
