ANNUAL SUBSIDENCE REPORT  
PLATEAU MINING COMPANY  
1983

## SUMMARY

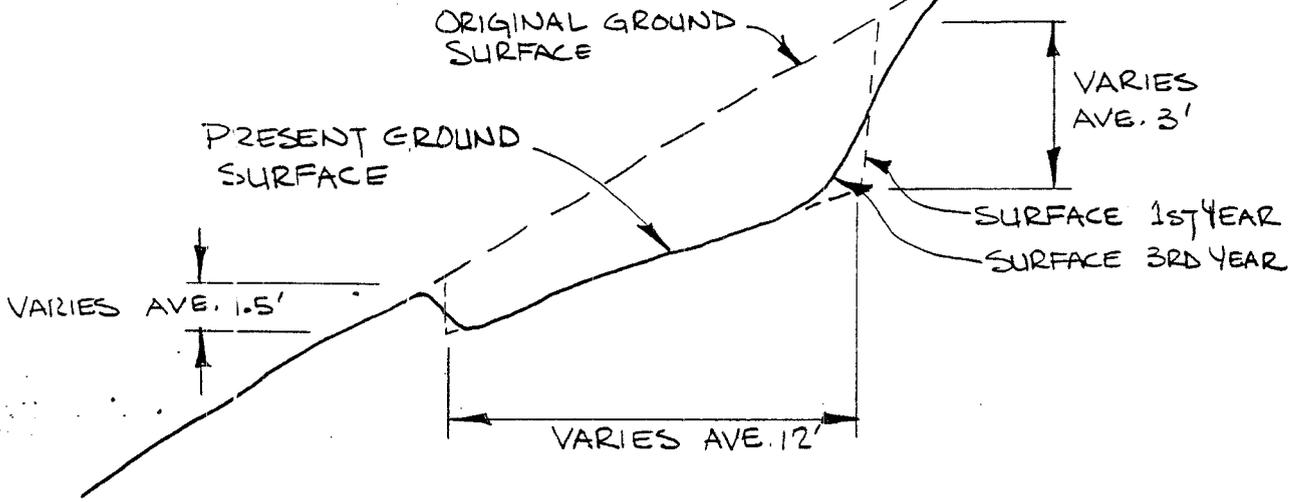
## SECTION A-A

Surface effects consist of tension cracks both parallel with the slope and at a diagonal, holes and one area that slumped. Cracks range in width from a few inches to 3 feet. Holes range from 2 feet to 10 feet in diameter. Cross sections A-A and B-B on Plate I give typical details of two areas as shown on Plate 12-2, Sheet 1 of 4.

There is considerable evidence that the soil displacements are healing themselves, the older the cracks, the more healing is evident. Soil at the edges of the displacements is migrating into the crack seeking the angle of repose, refer to Section A-A and Photograph No. 7. More photographs and site measurements to document healing processes will be taken in 1984.
