PLATEAU MINING COMPANY

March 6, 1986

In conformance with your phone call of March 3, we offer the following explanation of actions taken and plans for the future regarding the drainage problems recently experienced at Plateau.

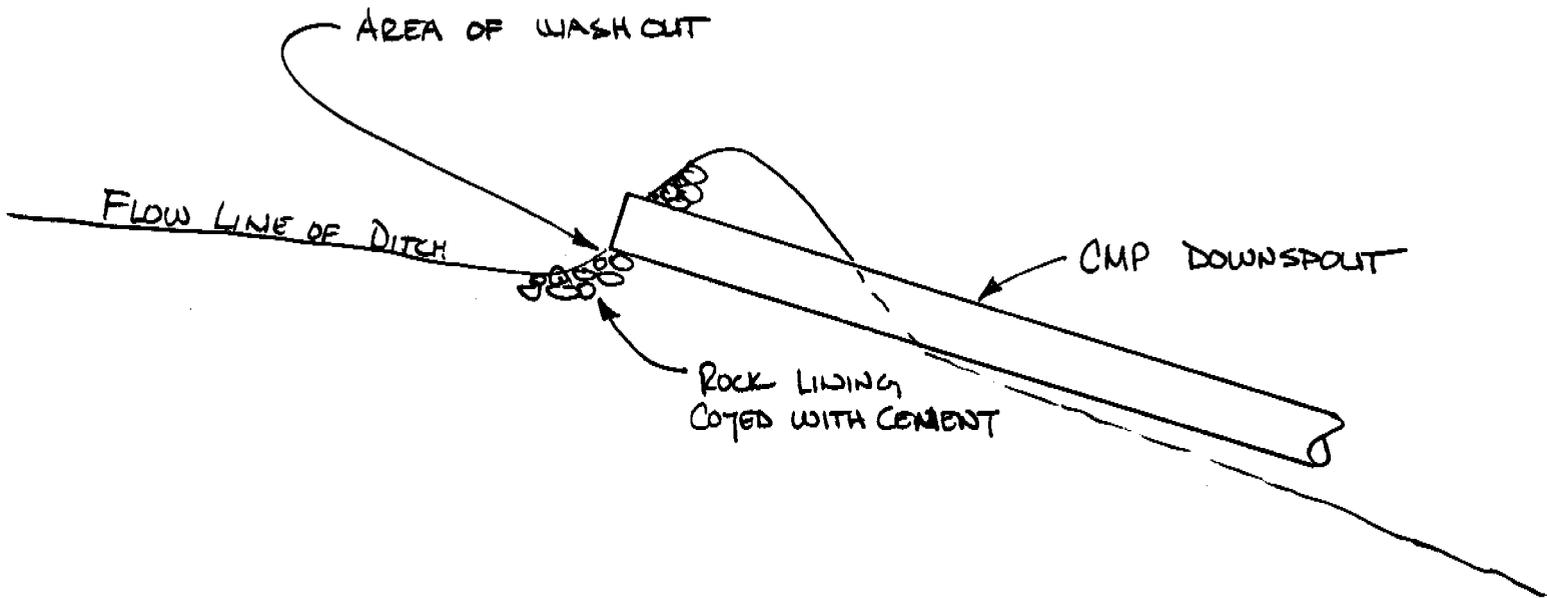
PRE - REPAIRS VIEW

The bypass ditch culvert at the subsoil stockpile had been partially washed out creating an erosion gully underneath the pipe. The unseasonably warm weather over the past two weeks had melted an unusually wet snowpack very rapidly creating many drainage problems on the property. In February alone, we received 51 inches of snow, containing 3.33 inches of water. A large portion of this water has run off over the past two weeks, creating our problems.

After the inspection by Tom Wright on Thursday the 27th, we took steps to plug off the leak under the inlet end of the above mentioned culvert. Cement was placed in the hole at the inlet end, which sealed off the leak and got the runoff flowing into the culvert. In addition, the downspout pipe which lies on the surface of the ground below the inlet end was secured to prevent it from collapsing into the erosion gully underneath the pipe, thus separating the pipe at a joint, creating additional problems.
