**SUBSIDENCE MONITORING REPORT**

**1989**

**STAR POINT MINES**

**ACT/007/006**

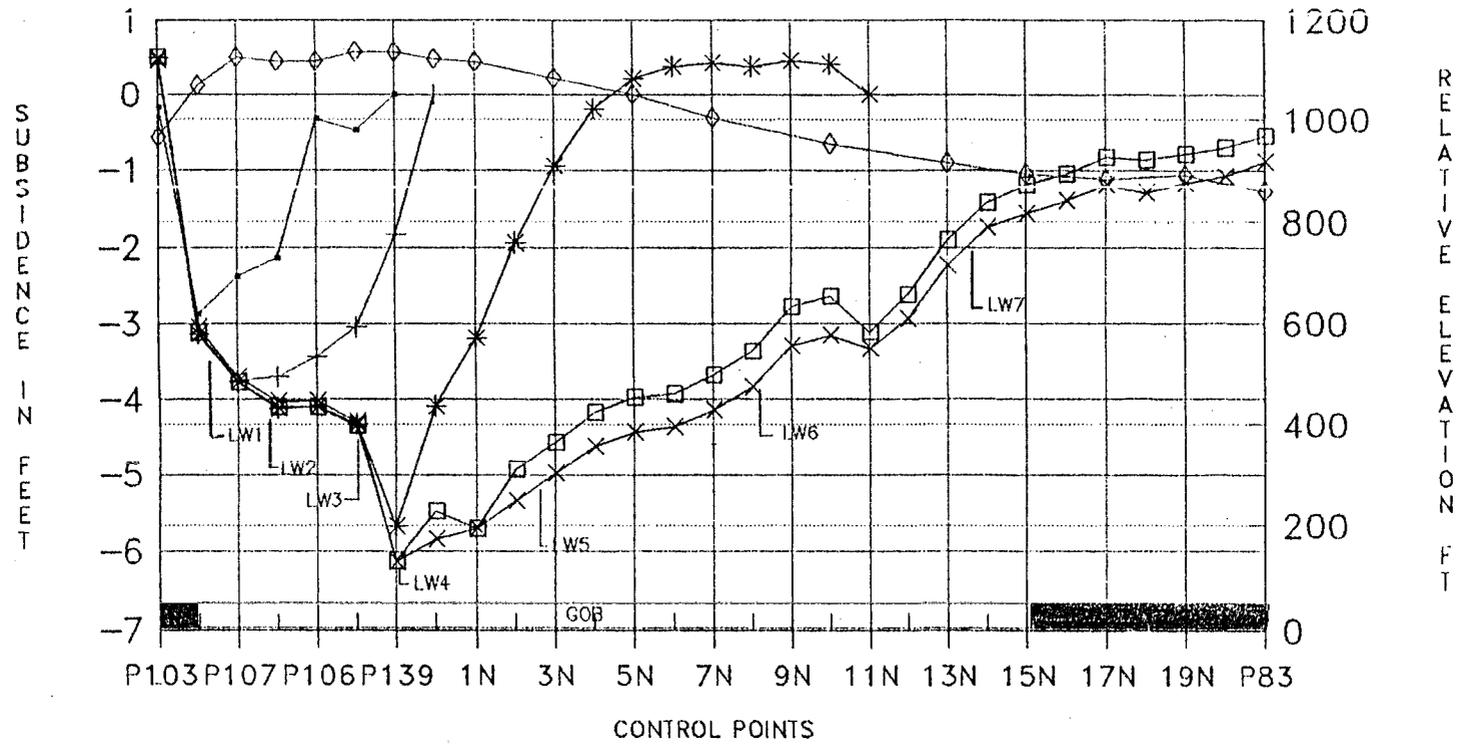
FIGURE 1  
CROSS SECTION A-A

As can be seen on Figures 2 and 3, subsidence appears to have stabilized, and reached near-maximum drop by the third year after mining. Figure 1 shows the subsidence profile diagonally through the seven longwall panels. The progression of subsidence can be seen to the north as successive panels were mined. Further drop in the longwall Panel 5, 6 and 7 area is expected for the next two years.

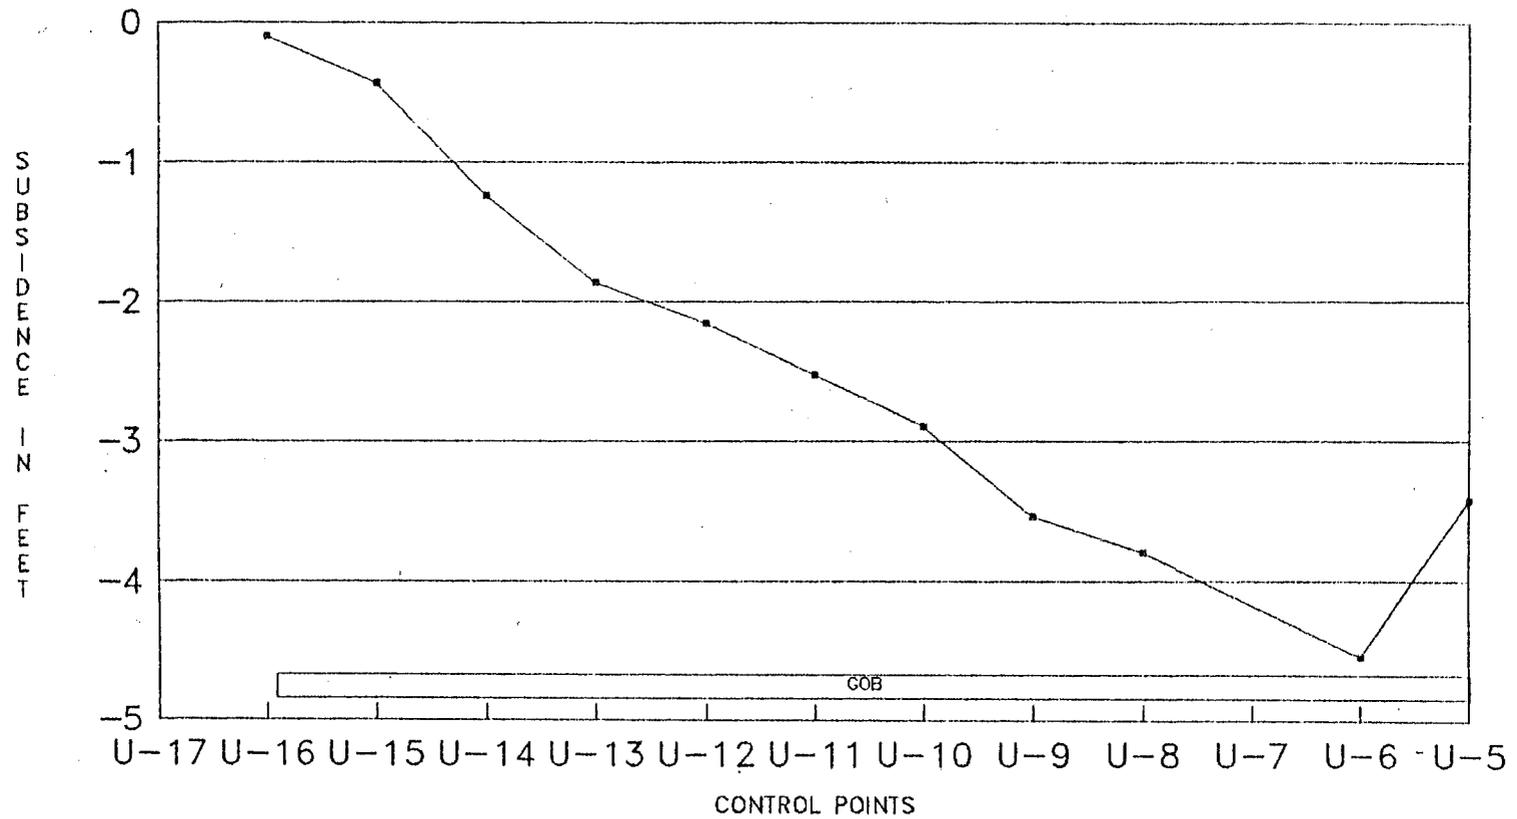
FIGURE 4  
CROSS SECTION D-D SECTION 18 NEAR STREAM

A cross section through Points U5-U17 in Section 18 (Figure 4) indicates a maximum vertical drop of 4.53 feet. Only one post-mining survey has been made of these points, therefore progression of subsidence cannot be plotted at this time.

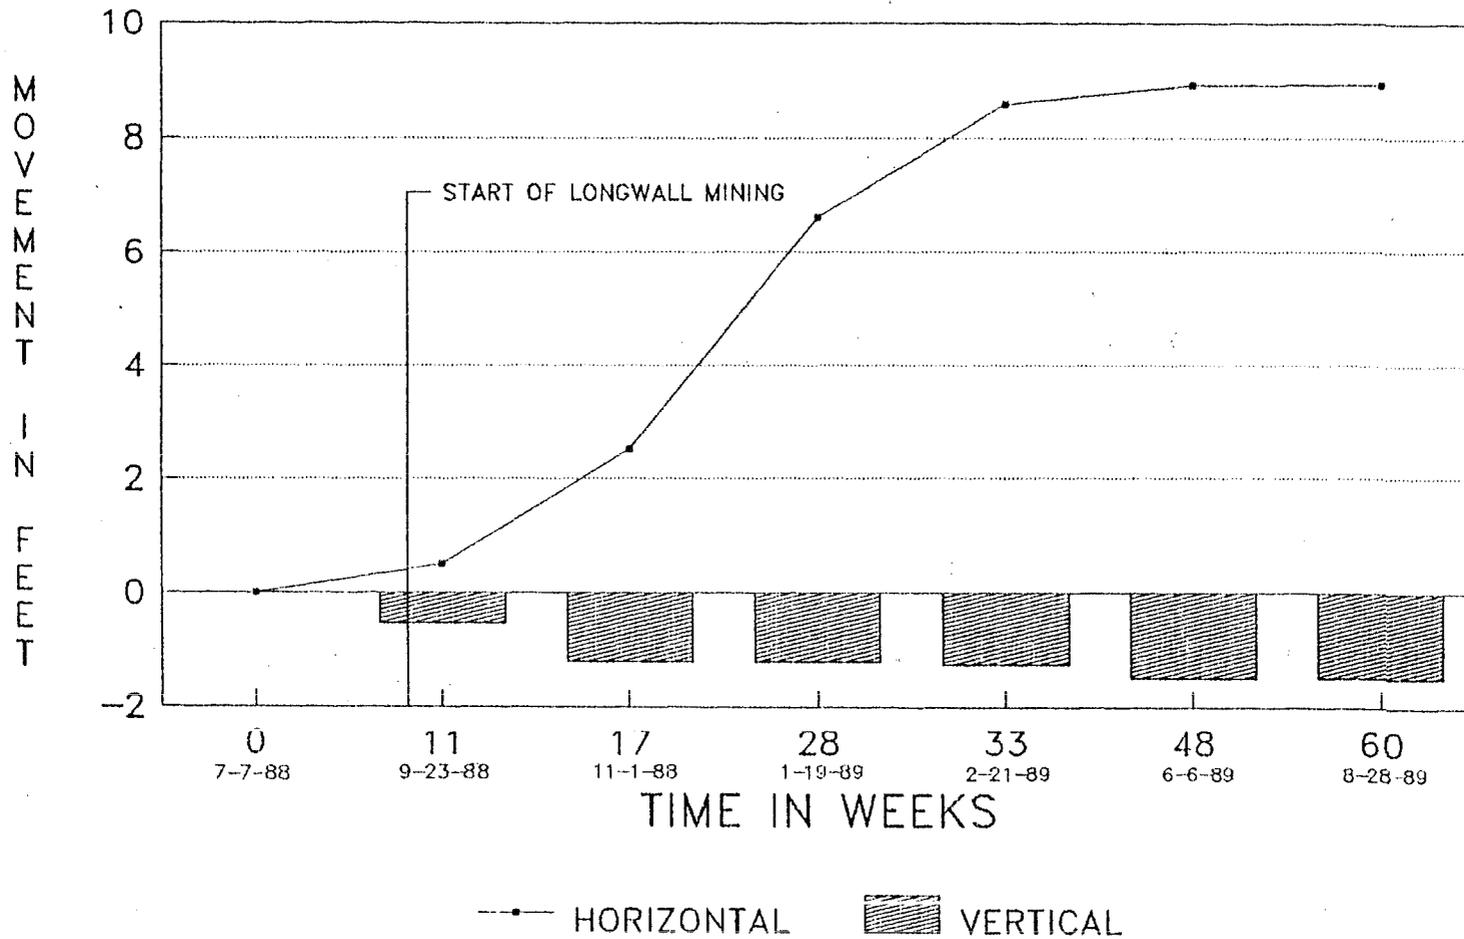
FIGURE 5  
U-NORTH SUBSIDENCE MONITORING  
HORIZONTAL AND VERTICAL MOVEMENT GRAPH  
STATION U1

U2, U3 and U4, Figures 5, 6, 7, and 8 respectively. Point U1, which is located directly above the north edge of longwall mining, shows the most vertical and horizontal movement. Point U4 is farthest from mining and shows the least movement.

A portion of the surface cracks near monitoring points U-1 and U-2 in Section 18 have been repaired to reduce the likelihood of accidents. The cracks were backfilled and the area was fenced. Signs were placed in the area warning the public of the potential danger of the unstable ground.

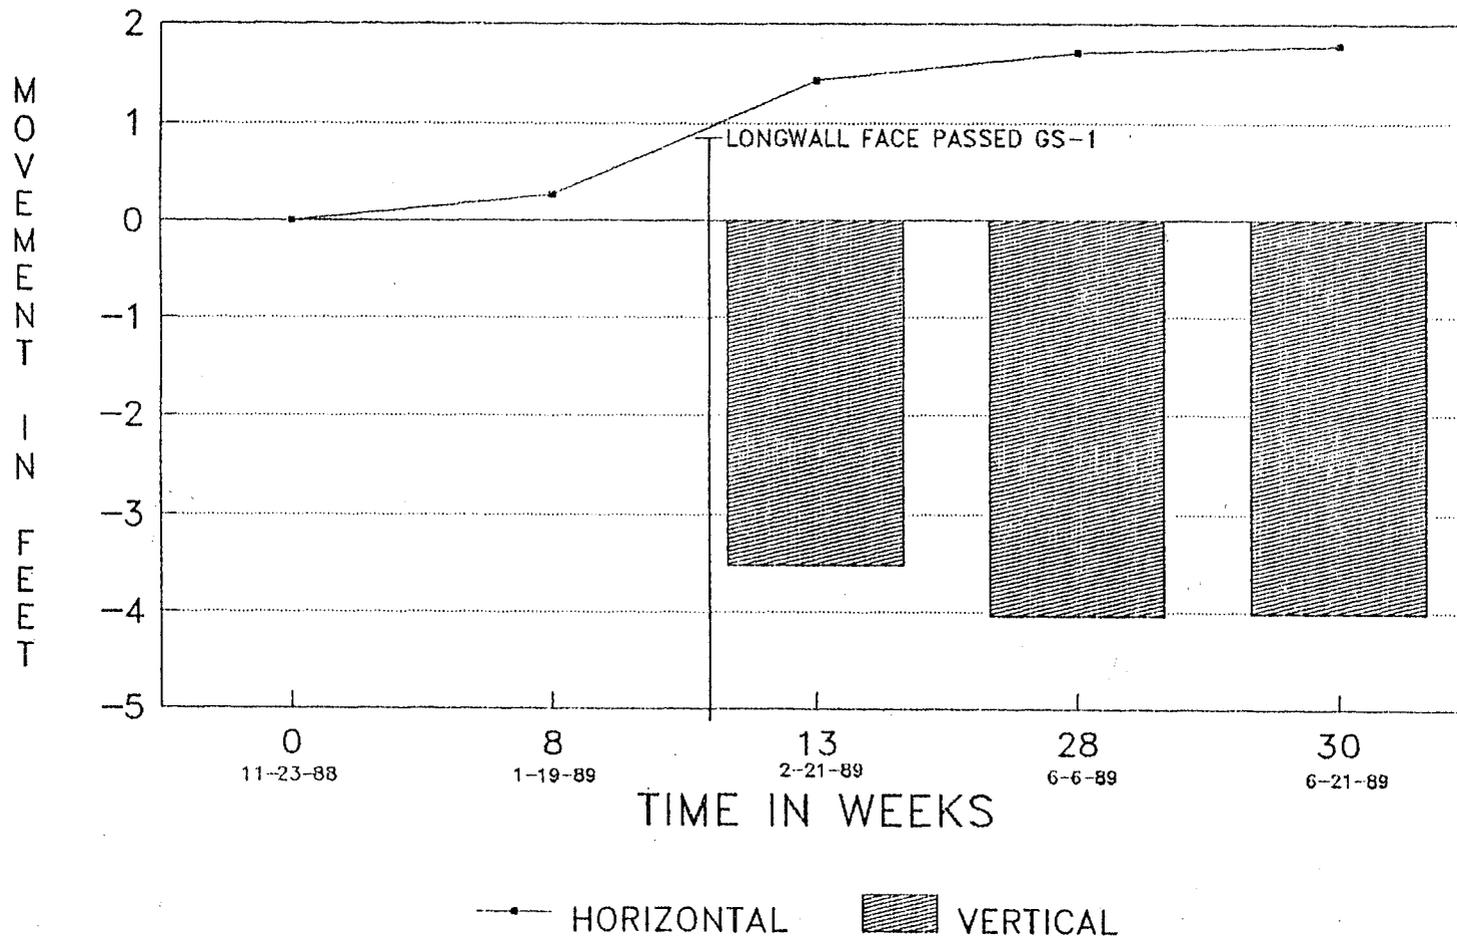
FIGURE 9  
U-NORTH SUBSIDENCE MONITORING  
HORIZONTAL AND VERTICAL MOVEMENT GRAPH  
STATION GS-1

A horizontal and vertical movement graph (figure 9) has been made of monitoring point GS-1 near the stream in Section 18.

Some stream water has been diverted into the mine near monitoring point GS-1. The stream at this location is small, averaging 13 gallons per minute. Springs and base flow from the canyon bottom recharge the stream below this point. Only a section of stream approximately 800 feet long has been affected. An important point to be learned from the study is whether mudstones and siltstones will expand and stop the downflow of stream water.
