SUBSIDENCE MONITORING REPORT

1988

STAR POINT MINES

CYPRUS PLATEAU MINING CORPORATION

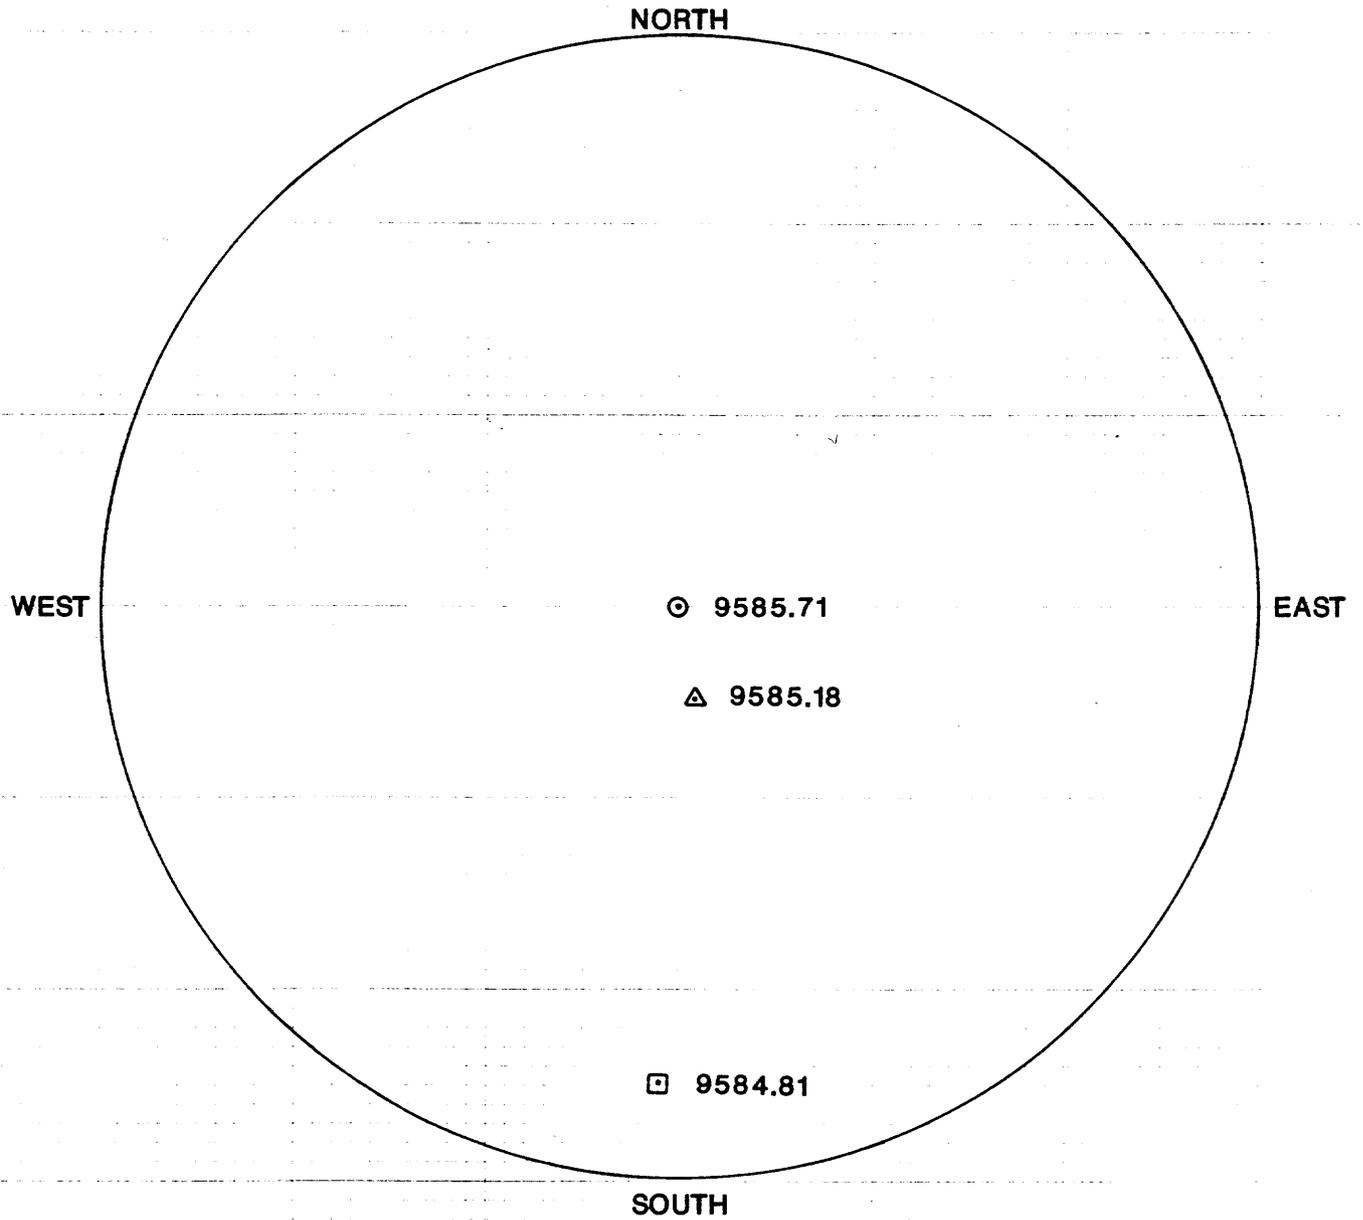
FIGURE 1
U-NORTH CLIFF SUBSIDENCE MONITORING
STATION U1
HORIZONTAL MOVEMENT PLOT

TOTAL VERTICAL SUBSIDENCE -0.90 FEET

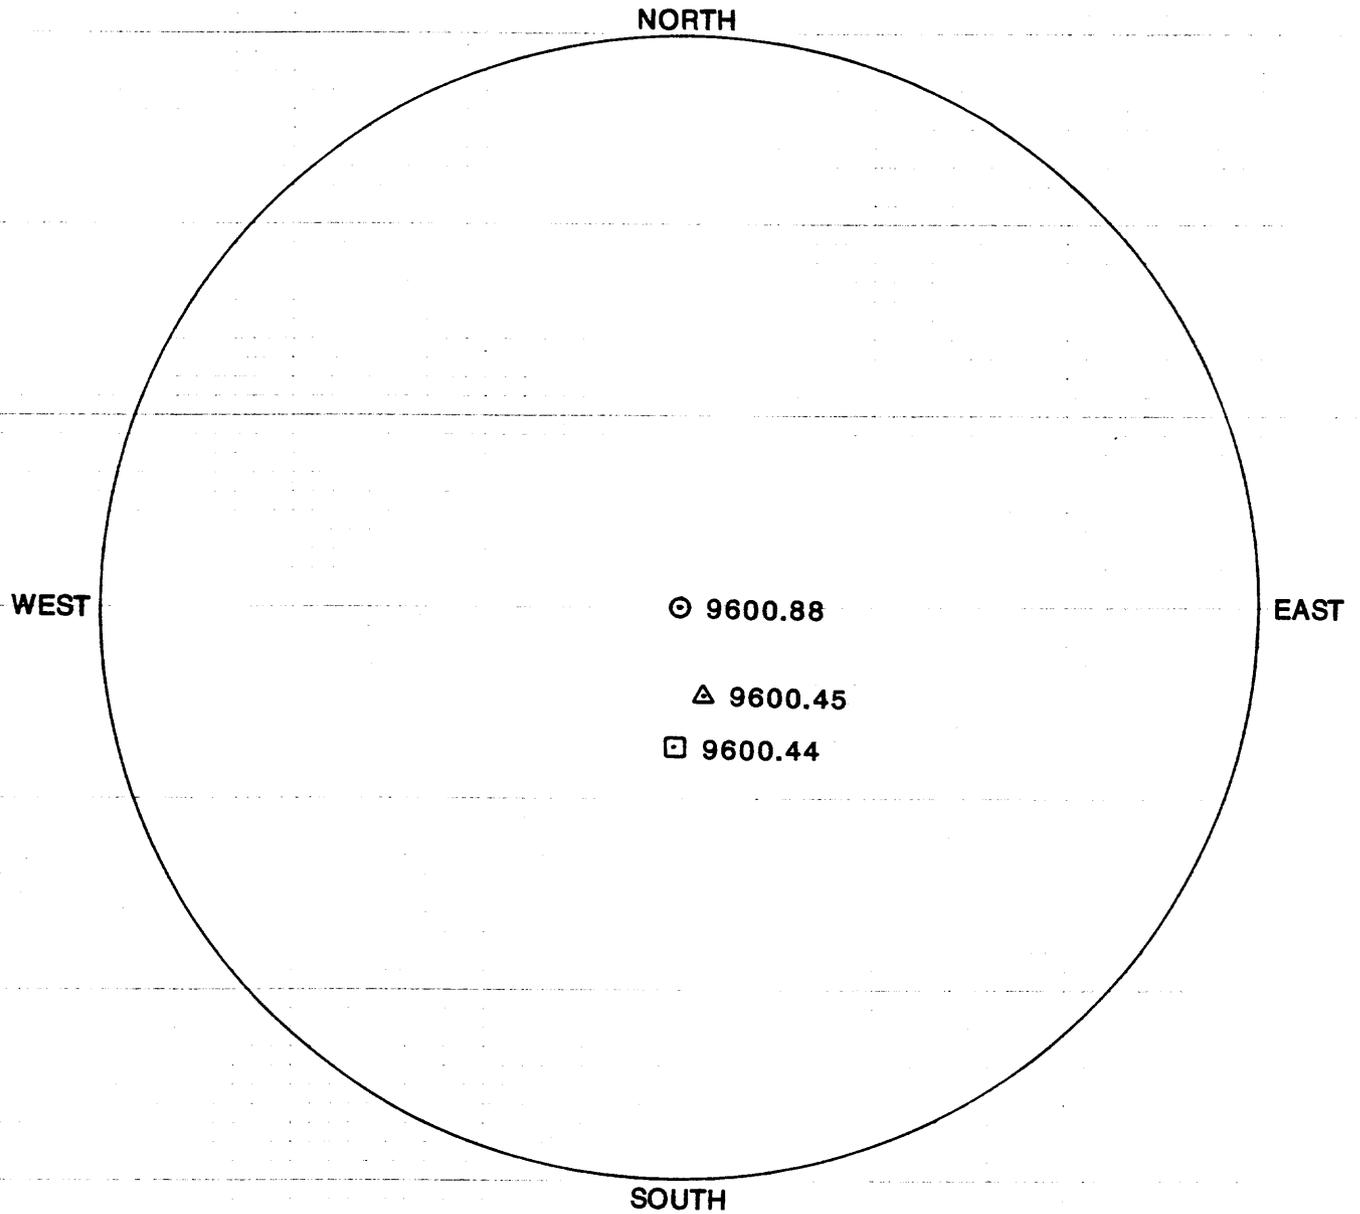
FIGURE 2
U-NORTH CLIFF SUBSIDENCE MONITORING
STATION U2
HORIZONTAL MOVEMENT PLOT

TOTAL VERTICAL SUBSIDENCE -0.44 FEET

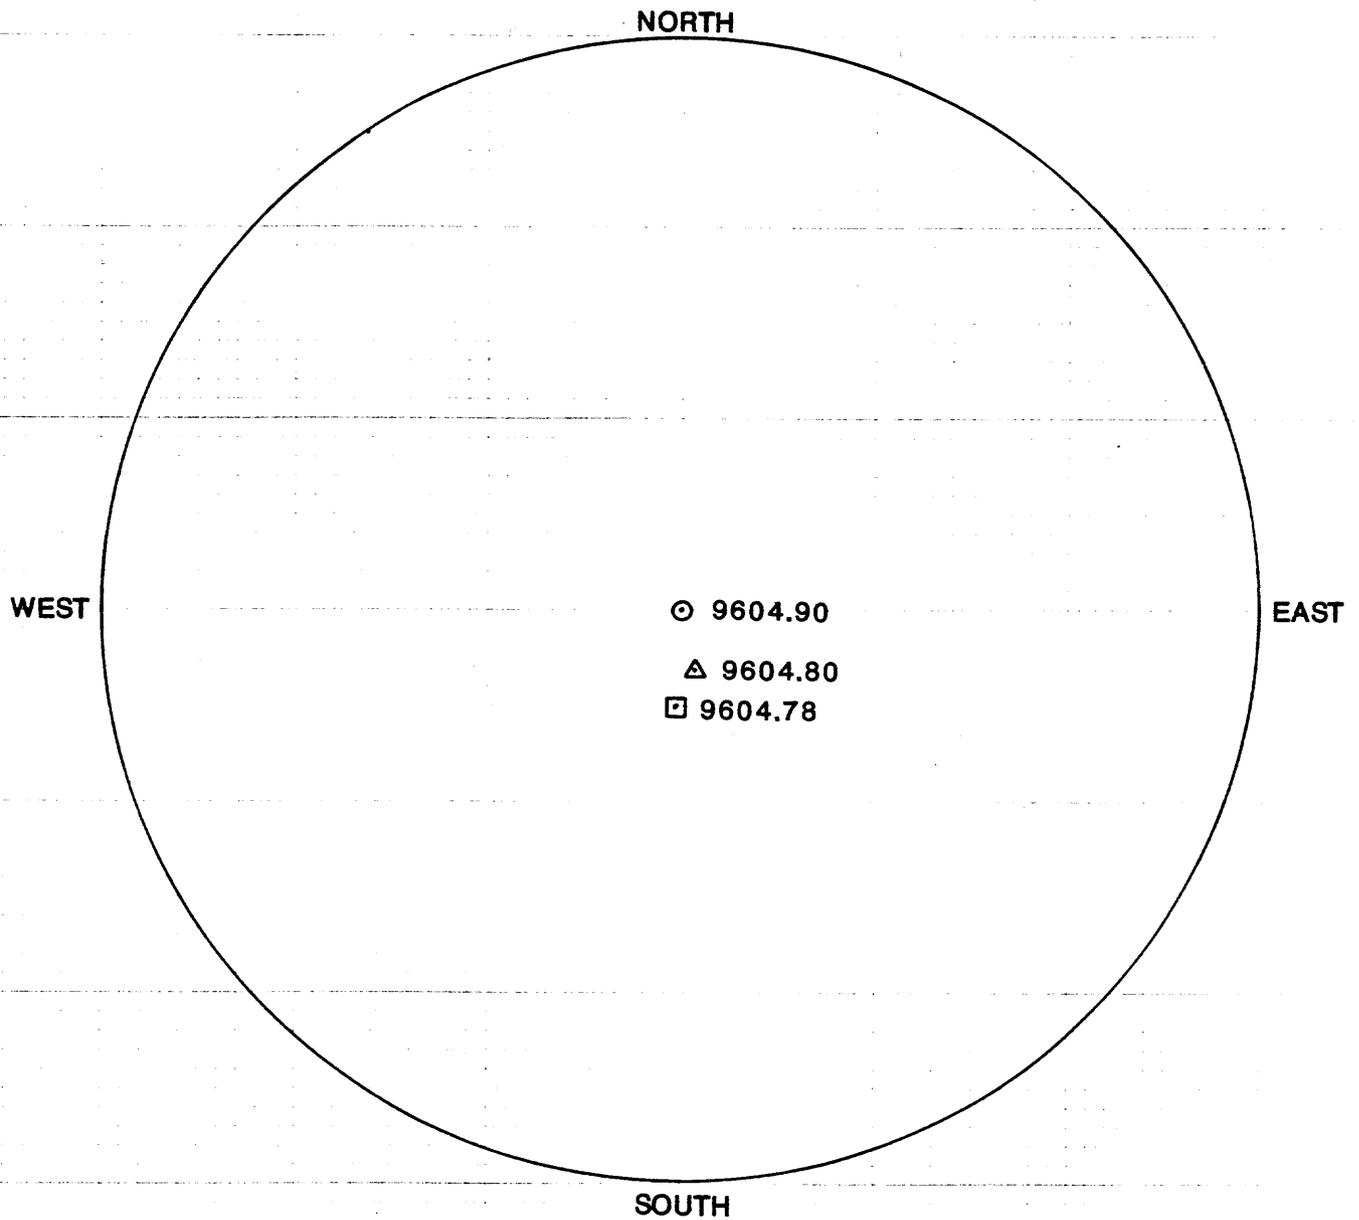
FIGURE 3
U-NORTH CLIFF SUBSIDENCE MONITORING
STATION U3
HORIZONTAL MOVEMENT PLOT

TOTAL VERTICAL SUBSIDENCE -0.12 FEET

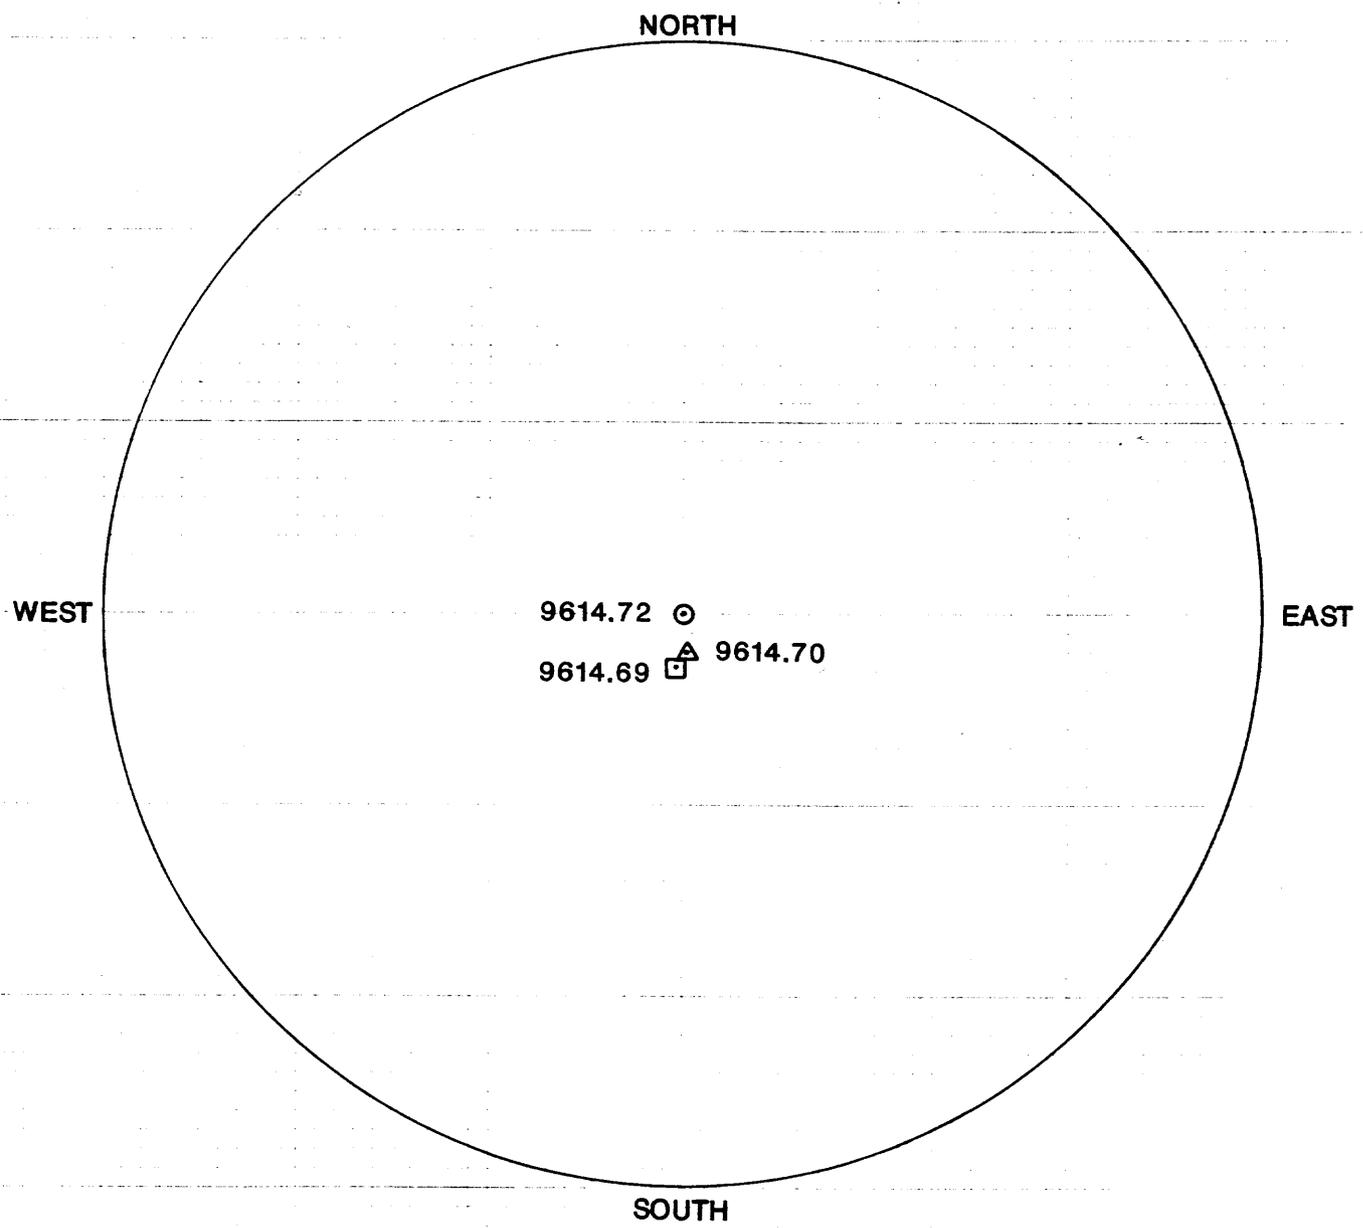
FIGURE 4
U-NORTH CLIFF SUBSIDENCE MONITORING
STATION U4

TOTAL VERTICAL SUBSIDENCE -0.03 FEET

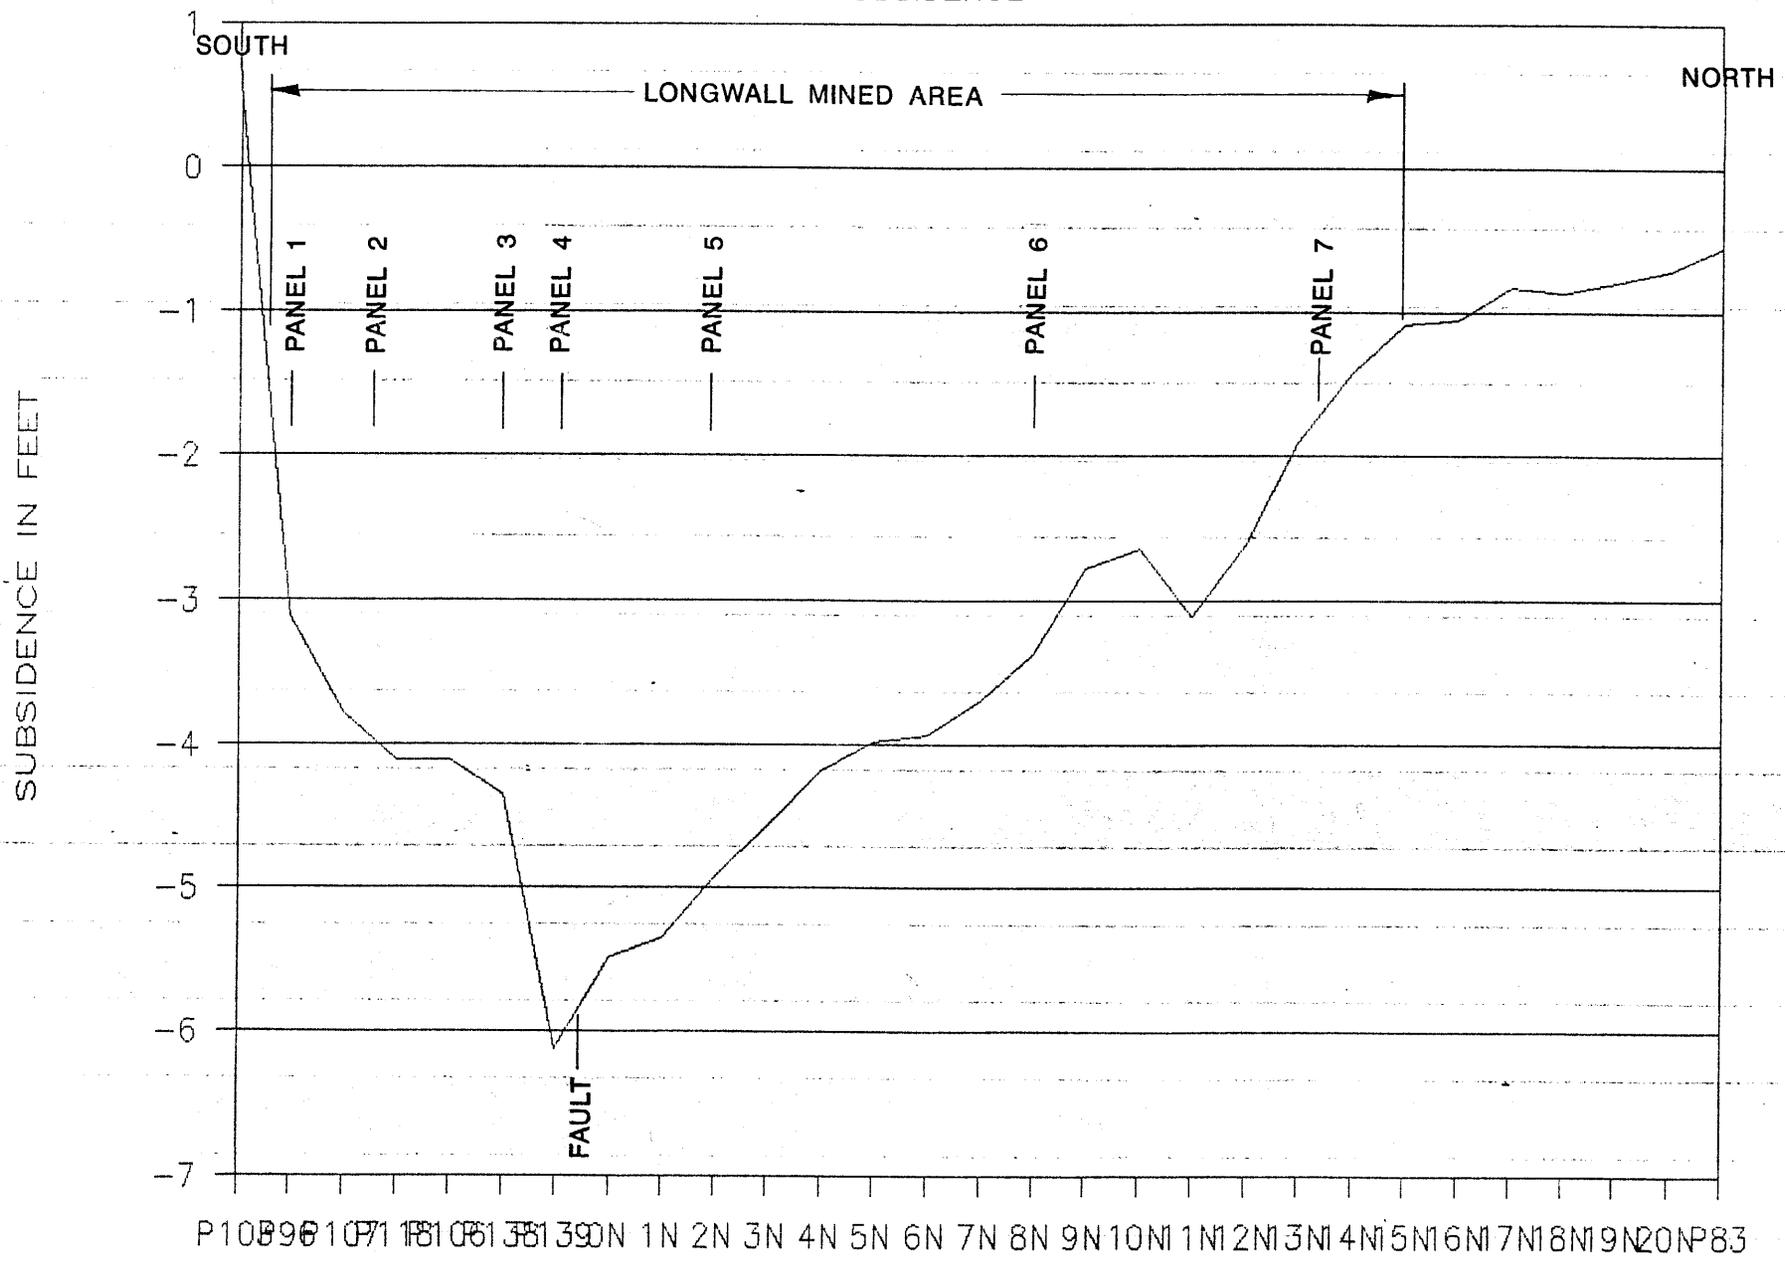
SECTION A-A PANELS 1-7 PROFILE

A cross-section through longwall panels 1-7 is included as Section A-A showing surface drop from a base of 0.
