DIVISION OF
ROLLINS, BROWN AND GUNNELL, INC.
OIL, GAS & MINING
PROFESSIONAL ENGINEERS

January 18, 1984

Plateau Mining Corporation
P.O. Box PMC
Price, UT 84501

A soil and foundation investigation has been completed for the existing haul roads at the Plateau Mine. The investigation was performed to determine the cause of the road instability at various locations along the existing alignment. The work has been completed in accordance with a written proposal submitted to your organization for the work, and the results of the investigation along with pertinent recommendations for corrective action are outlined in the following sections of this report.

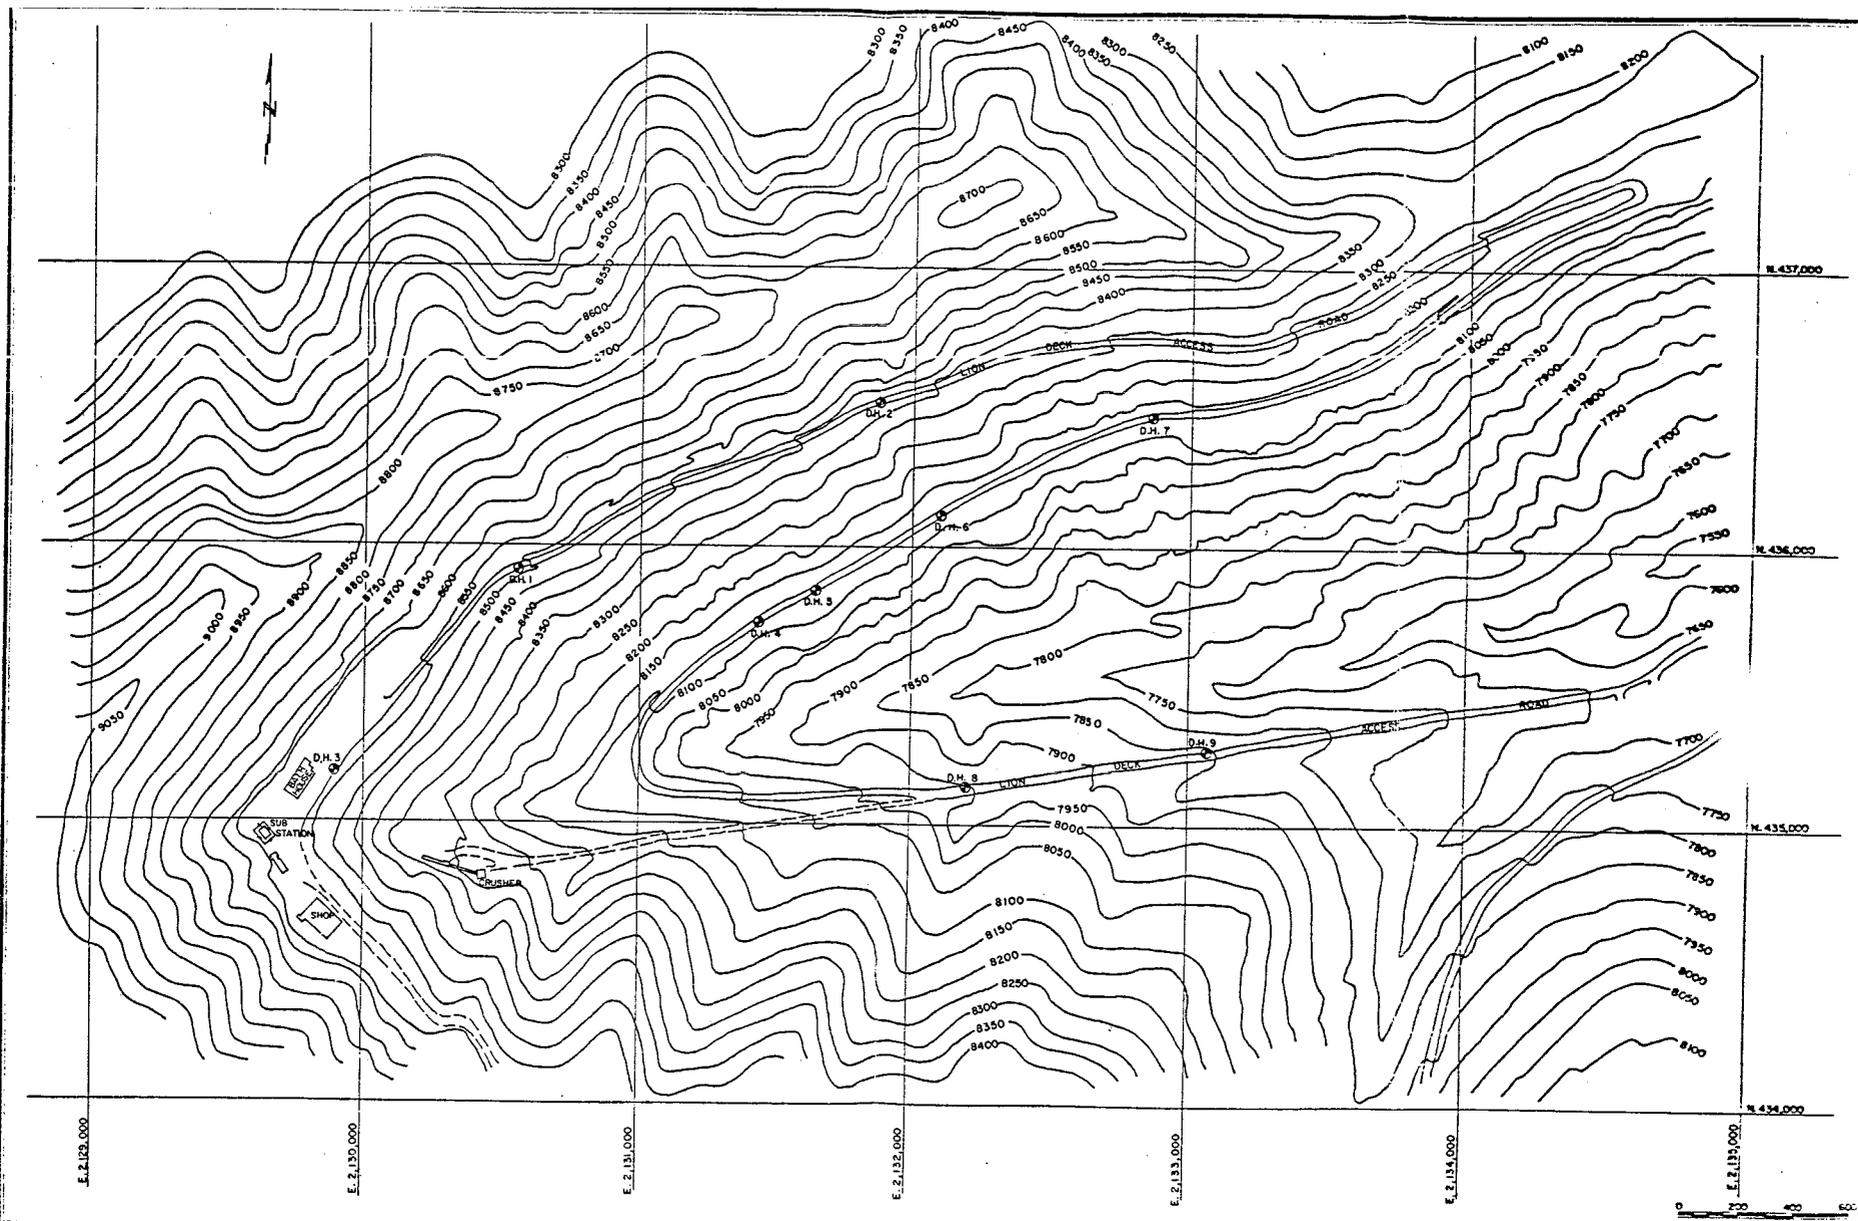
The existing haul road is located between the coal handling facilities and the mine approximately as shown in Figure No. 1. It will be noted that the haul road traverses the existing terrain in a switchback fashion and that most of the roadway consists on the consolidated portion of the geological formation.

In order to obtain an indication of the nature of the failure along the proposed alignment, nine test holes were drilled at locations where failure was incipient. The location of each of the test holes is presented in Figure No. 1. The test holes ranged in depth from 30 to 60 feet, and the logs for each of the test holes are presented in Figures 2 through 7.

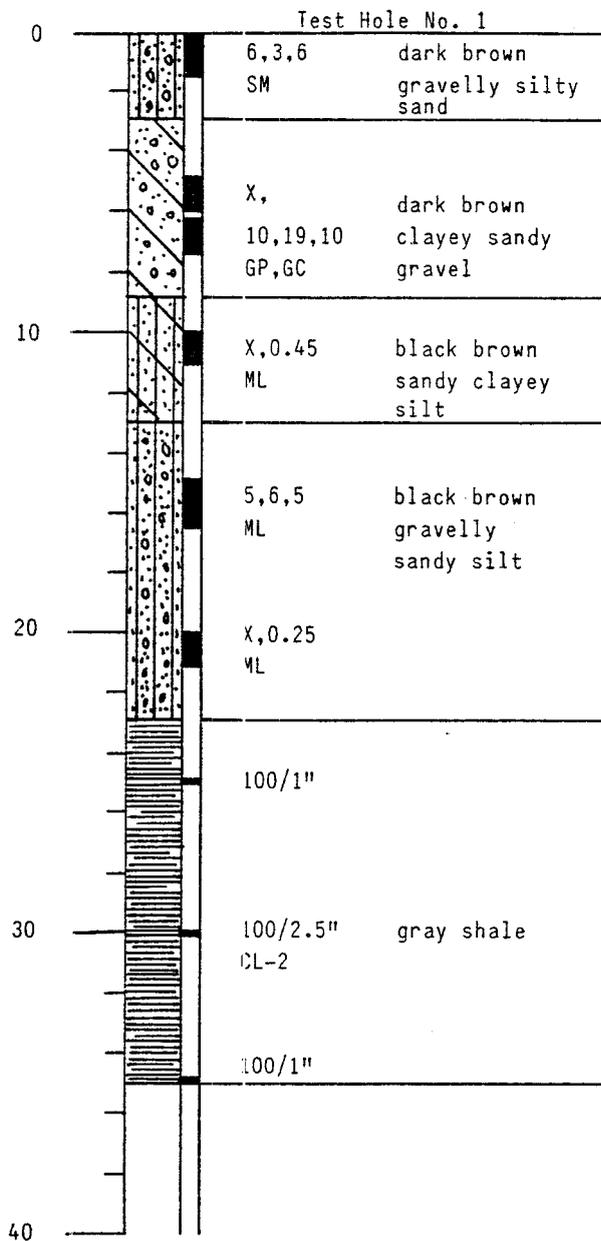
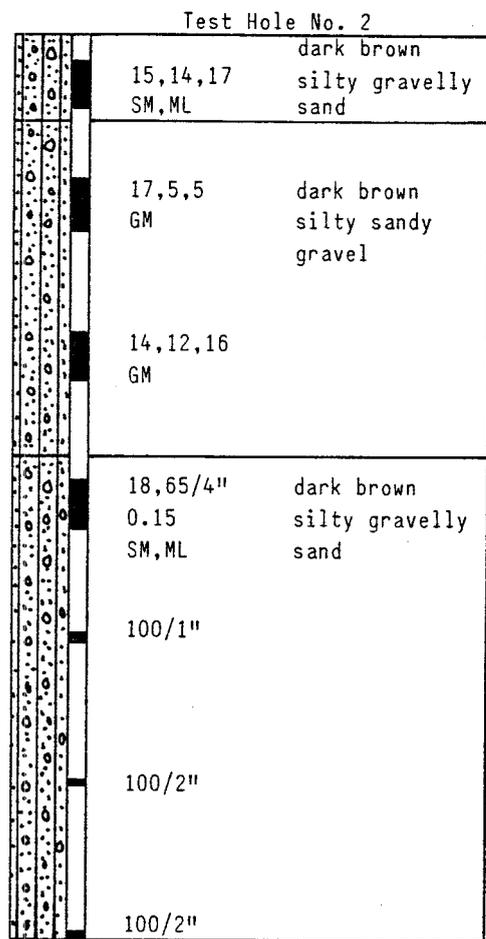
Figure No. 2

The characteristics of the fill material varies somewhat from test hole to test hole, which would be expected because of the stratified nature of the parent material. Test Holes 2, 3, 4, and 7 consisted predominantly of granular material, while Test Hole No. 8 consisted predominantly of cohesive material. In Test Holes 1 and 9, the upper portion of the profile consisted of granular material, while the lower portion of the fill material consisted of cohesive material. In Test Holes 5 and 6, the upper portion of the fill material consisted of cohesive soils, while the lower portion of the fill material consisted of granular-type material. In Test Holes 1, 4, 5, 6, and 7, the subsurface material beneath the fill consisted of shale. In Test Holes 2 and 3, the natural material below the fill consisted of sandstone, while in Test Holes 8 and 9, the test holes did not penetrate the natural material.

The subsurface material in Test Hole No. 1 consists of granular material in the upper portion of the fill material and cohesive material in the lower portion of the fill area. The shear strength parameters used in the stability analysis were based upon laboratory tests for the cohesive material and the standard penetration tests for the granular material. An average friction angle of 32 degrees was assumed for the material along the failure surface, along with a total unit weight of 120 pounds per cubic foot. The results of the stability analysis indicate a factor of safety of 1.15 for the failure surface shown in Figure No. 9.

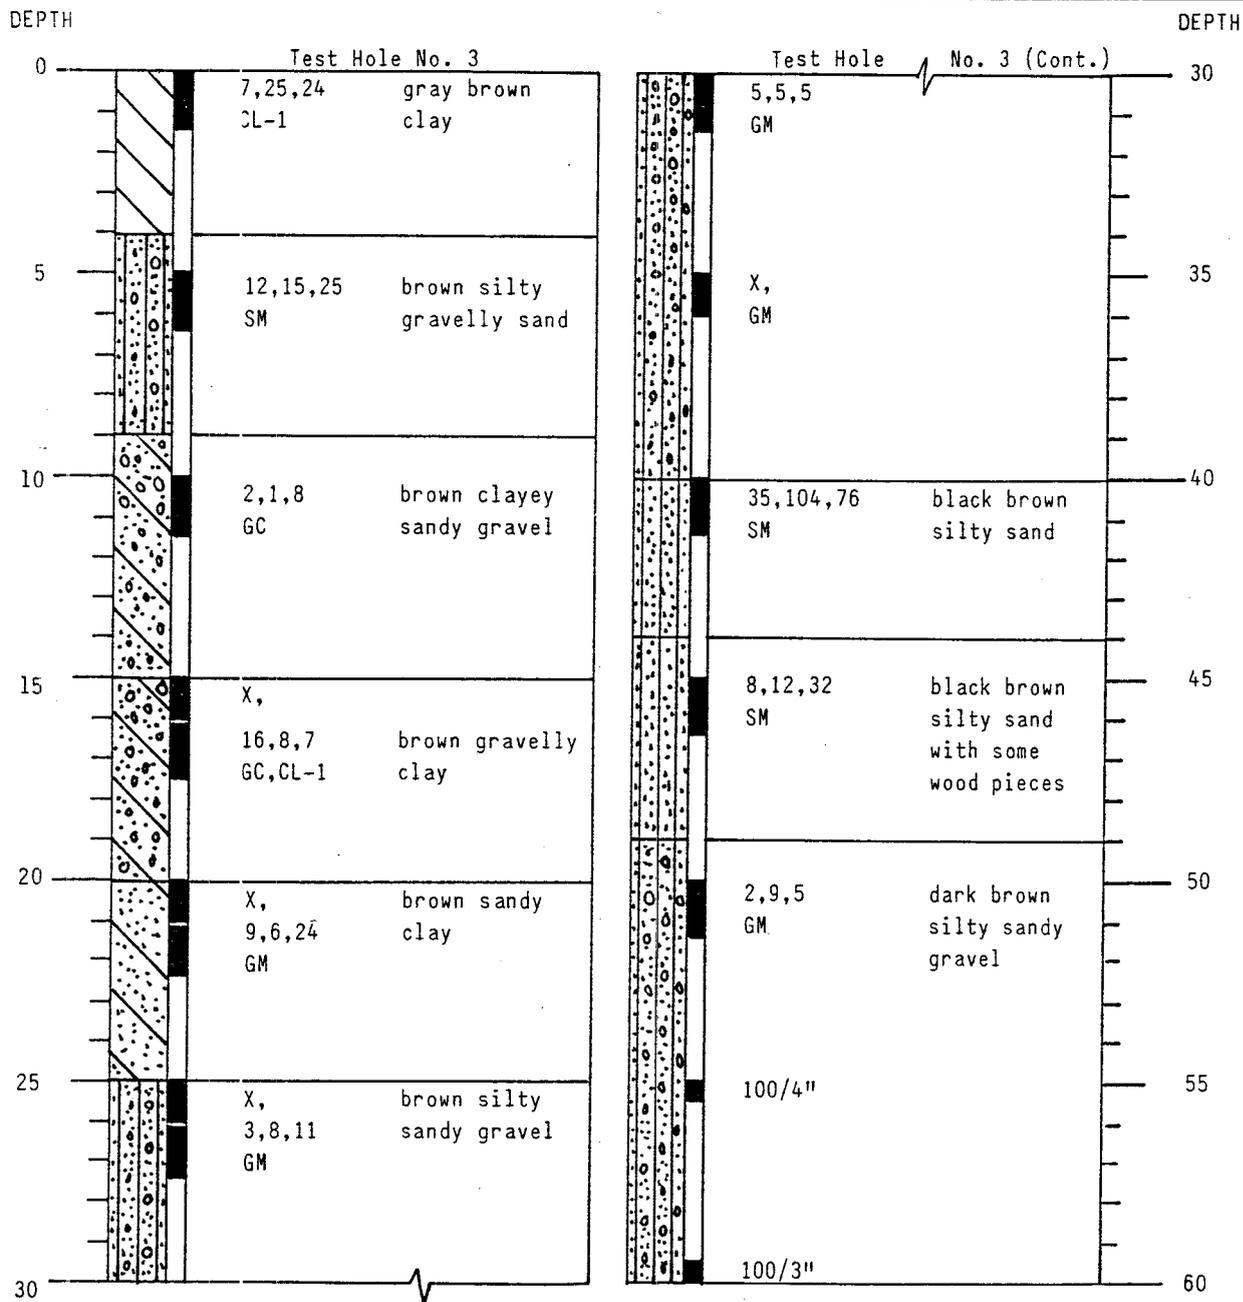
Figure No. 3

It should be noted that Test Hole No. 3 was drilled in front of the bath house and that the excavated area at this location is quite large. Test Hole No. 3 defines the characteristics of the subsurface material within the fill material at this location, and it will be observed that essentially all of the fill material is granular-type

soils. The natural ground surface in Test Hole No. 3 was encountered at a depth of about 53 feet below the existing grade, and the assumed failure surface for this area is presented in Figure No. 11. The shear strength parameters used in the stability analysis were based upon the results of the standard penetration tests performed in the granular material throughout the soil profile at this site. Since the granular material within the profile at this location is relatively loose, a friction angle of 31 degrees and a total unit weight of 120 pounds per cubic foot was used in the analysis. The results of the stability analysis indicate a factor of safety of 1.19.

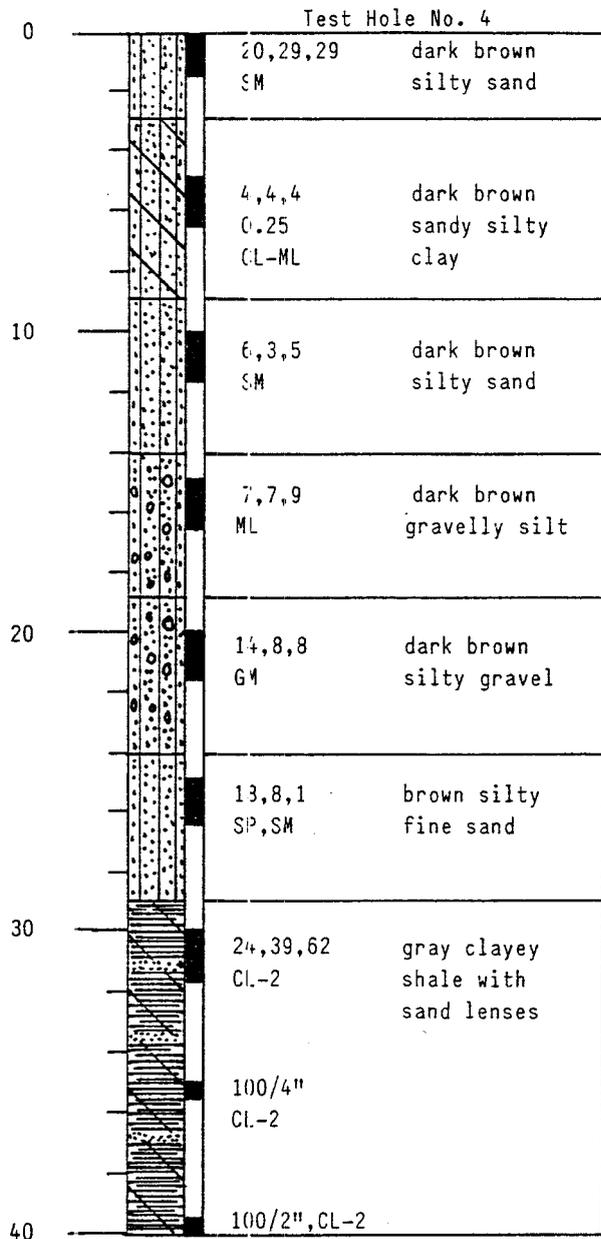
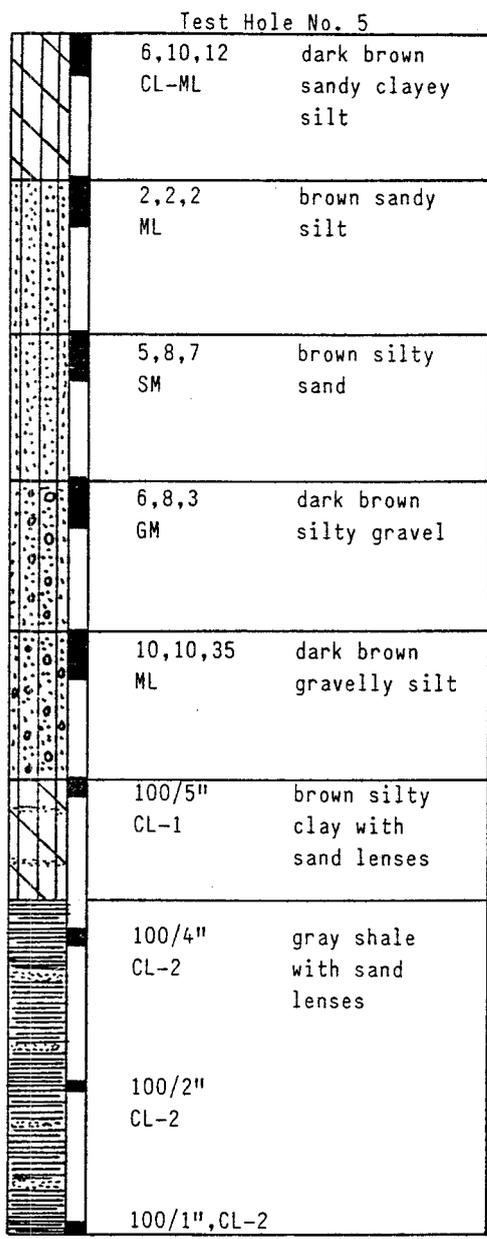
Figure No. 4

The characteristics of the subsurface material within the fill at this location consisted of interbedded layers of granular material and cohesive material. The assumed failure surface for the fill area at this location is presented in Figure No. 12. The results of the standard penetration test performed in the subsurface material at this site indicate that the subsurface soils are relatively loose, and as a consequence of this situation, a friction angle of 30 degrees and a total unit weight of 120 pounds per cubic foot were used in performing the analysis. The results of the stability computations indicate a factor of safety of 1.0. A factor of safety of 1.0 indicates that the subsurface material is in an incipient failure state. This fill areas has the lowest factor of safety of any of the slopes investigated during this study.

The fill material at this location is defined by the soil profile associated with Test Hole No. 5. The interface between the fill and the natural material appears to be located in the vicinity of 22 feet below the existing ground surface. Cohesive material predominates in the upper and lower portions of the fill with a zone of granular material in the center of the fill. The granular fill is in a relatively low density state, however the cohesive material appears to be in a relatively stiff condition. An overall friction angle of 31 degrees and a total unit weight of 120 pounds per cubic foot was used in the stability analysis for this slope. The failure surface associated with this slope is presented in Figure No. 13, and the results of the stability analysis indicate a factor of safety of about 1.2.

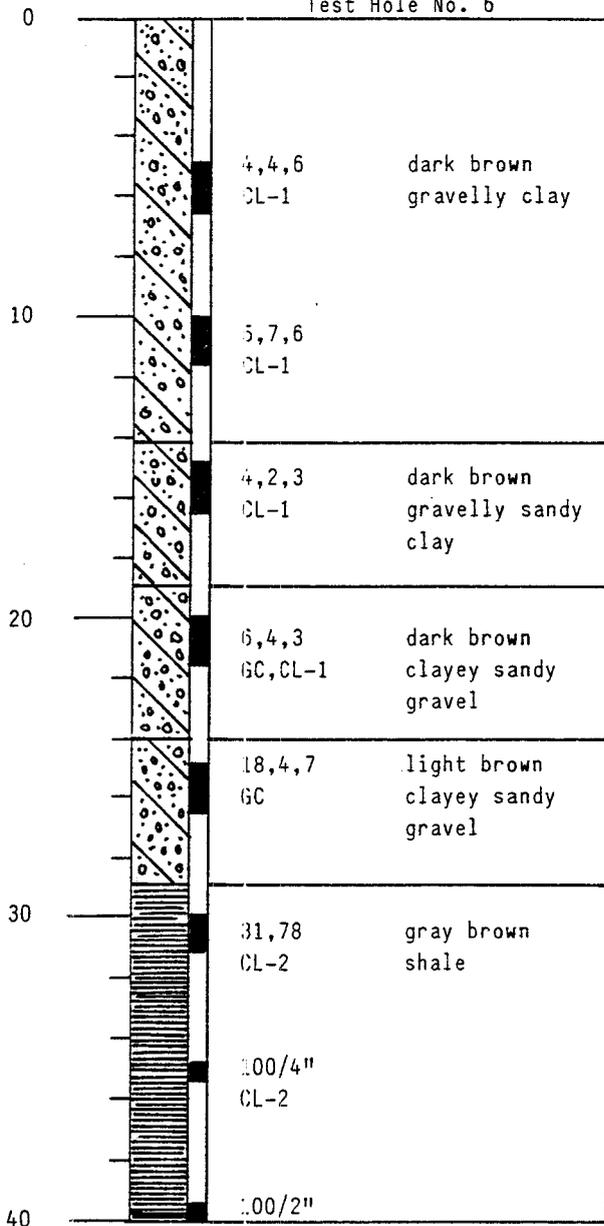
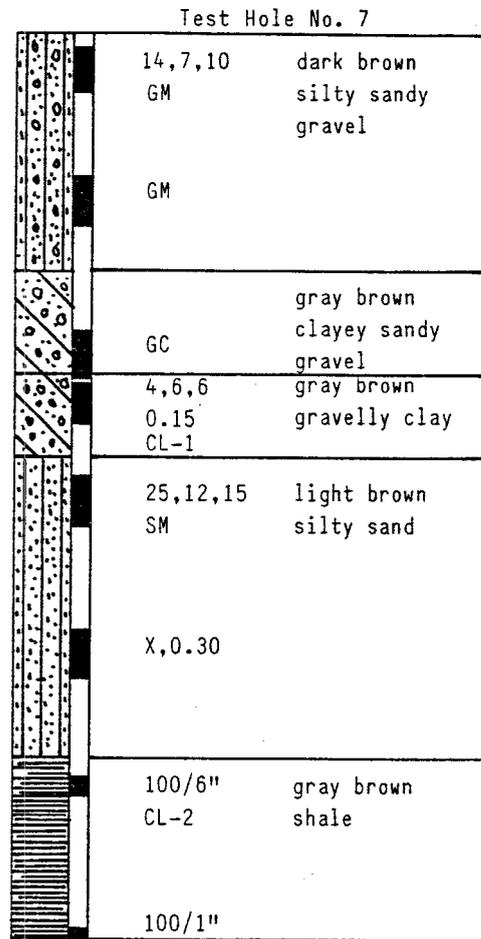
Figure No. 5

The soil profile defining the characteristics of the fill at this location consists predominantly of cohesive material in the upper 19 feet of the soil profile followed by granular material. The clay material appears to be in a medium-stiff condition, however the granular material is in a relatively loose state. The assumed failure plane for this location is presented in Figure No. 14, and the shear strength parameters used in the stability analysis assumes a friction angle of 29 degrees and a cohesion of 40 pounds per cubic foot. A total unit weight of 115 pounds per cubic foot has been used in the analysis. The results of the stability computations indicate a factor of safety of 1.0 for this location.

The subsurface material in Test Hole No. 7 is predominantly granular-type soils with some interbedded clay zones. The assumed failure surface for this location is presented in Figure No. 15, and it will be noted that the contact between the fill material and the underlying shale is about 24 feet below the roadway grade. The shear strength parameters used in this analysis are based primarily upon the results of the standard penetration tests performed in the test holes and a friction angle of 31 degrees and a total unit weight of 120 pounds per cubic foot have been used. The results of the stability analysis indicate a factor of safety of 1.25.

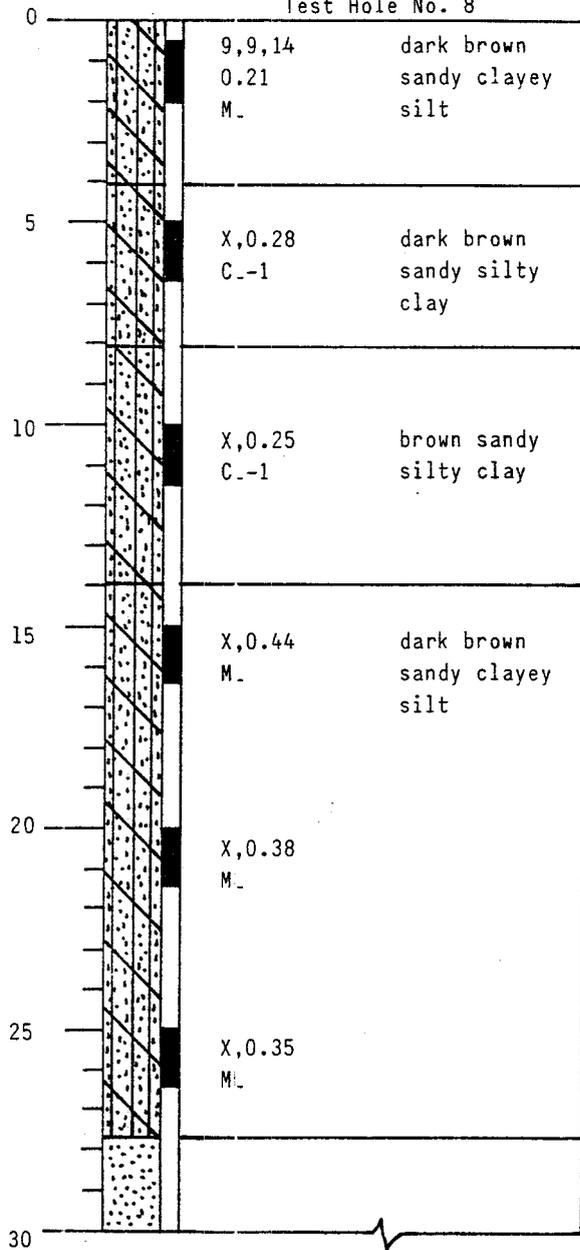
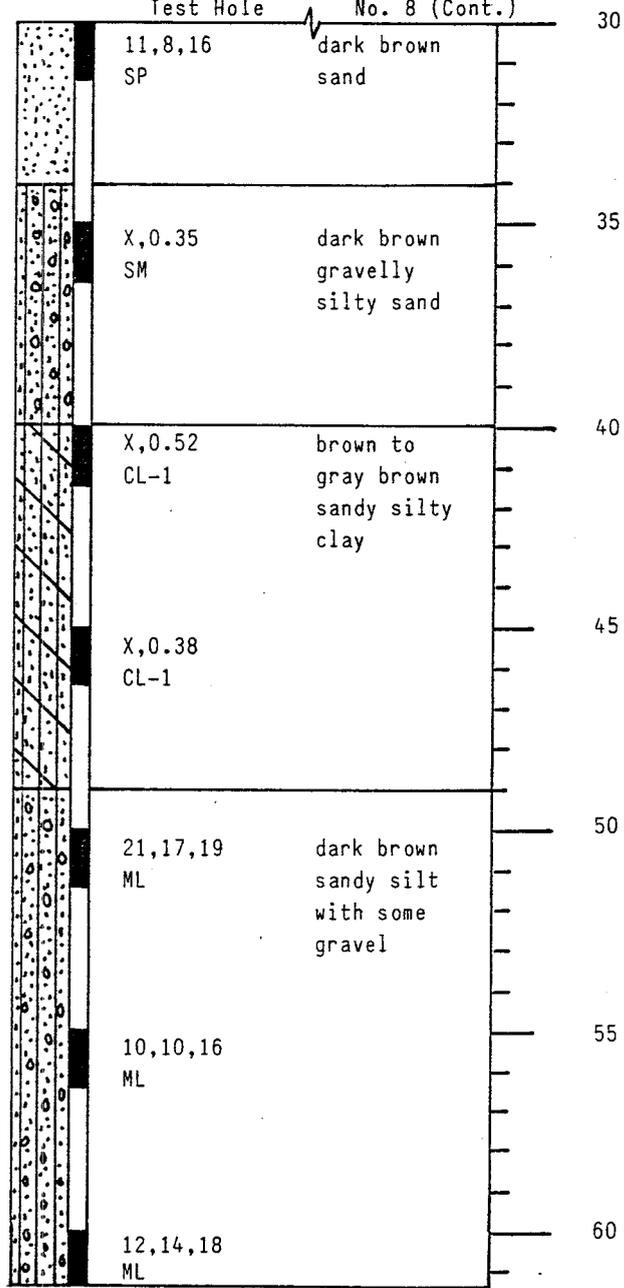
Figure No. 6

The characteristics of the fill material at Test Hole No. 8 consists essentially of cohesive material throughout the entire depth investigated. The assumed failure surface for a slope failure at this location is presented in Figure No. 16. The assumed failure surface at this location is strongly influenced by the natural slope downhill from the fill as well as the location of the failure surface in the pavement. The results of the field investigation indicate that the cohesive material within the soil profile at this location is in a medium-stiff condition. The shear strength parameters used in the stability analysis were based upon triaxial shear tests performed on representative samples of the cohesive material obtained in Test Hole No. 8. A friction angle of 32 degrees, along with a total unit weight of 115 pounds per cubic foot, was used in the stability computations. The results of the stability compu-

tations indicate a factor of safety of 1.6 for the existing slopes at this location.

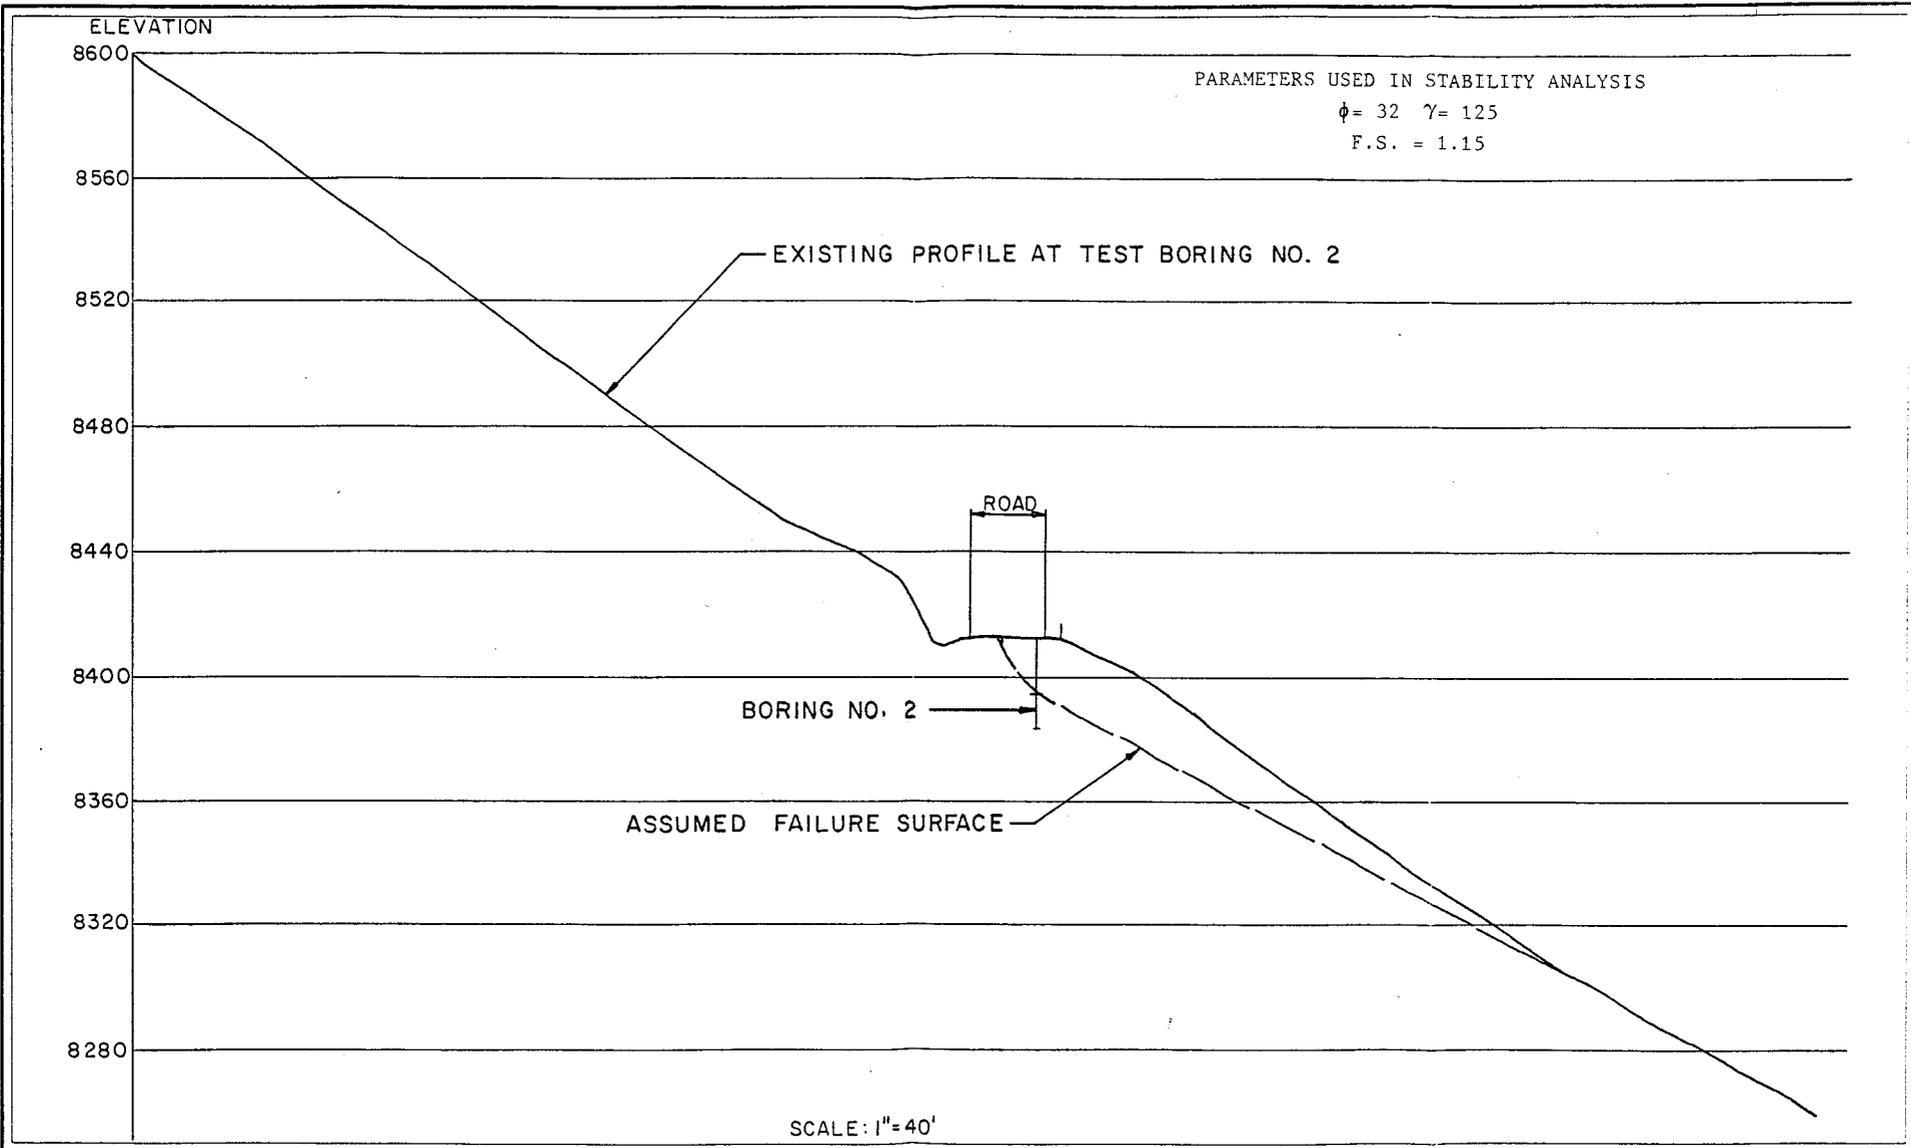
FIGURE
NO. 10

Test Hole No. 2 characterizes the subsurface material within the fill area in the vicinity of Test Hole No. 2, and it will be observed that all of the subsurface material within the fill area in this test hole is granular-type material. The assumed failure surface for the fill area for Test Hole No. 2 is presented in Figure No. 10. The shear strength parameters used in the stability analysis were based on the standard penetration values recorded in Test Hole No. 2 during the field investigation. A friction angle of 32 degrees was used for the granular material, along with a total unit weight of 125 pounds per cubic foot. The results of the stability analysis indicate a factor of safety of 1.15.

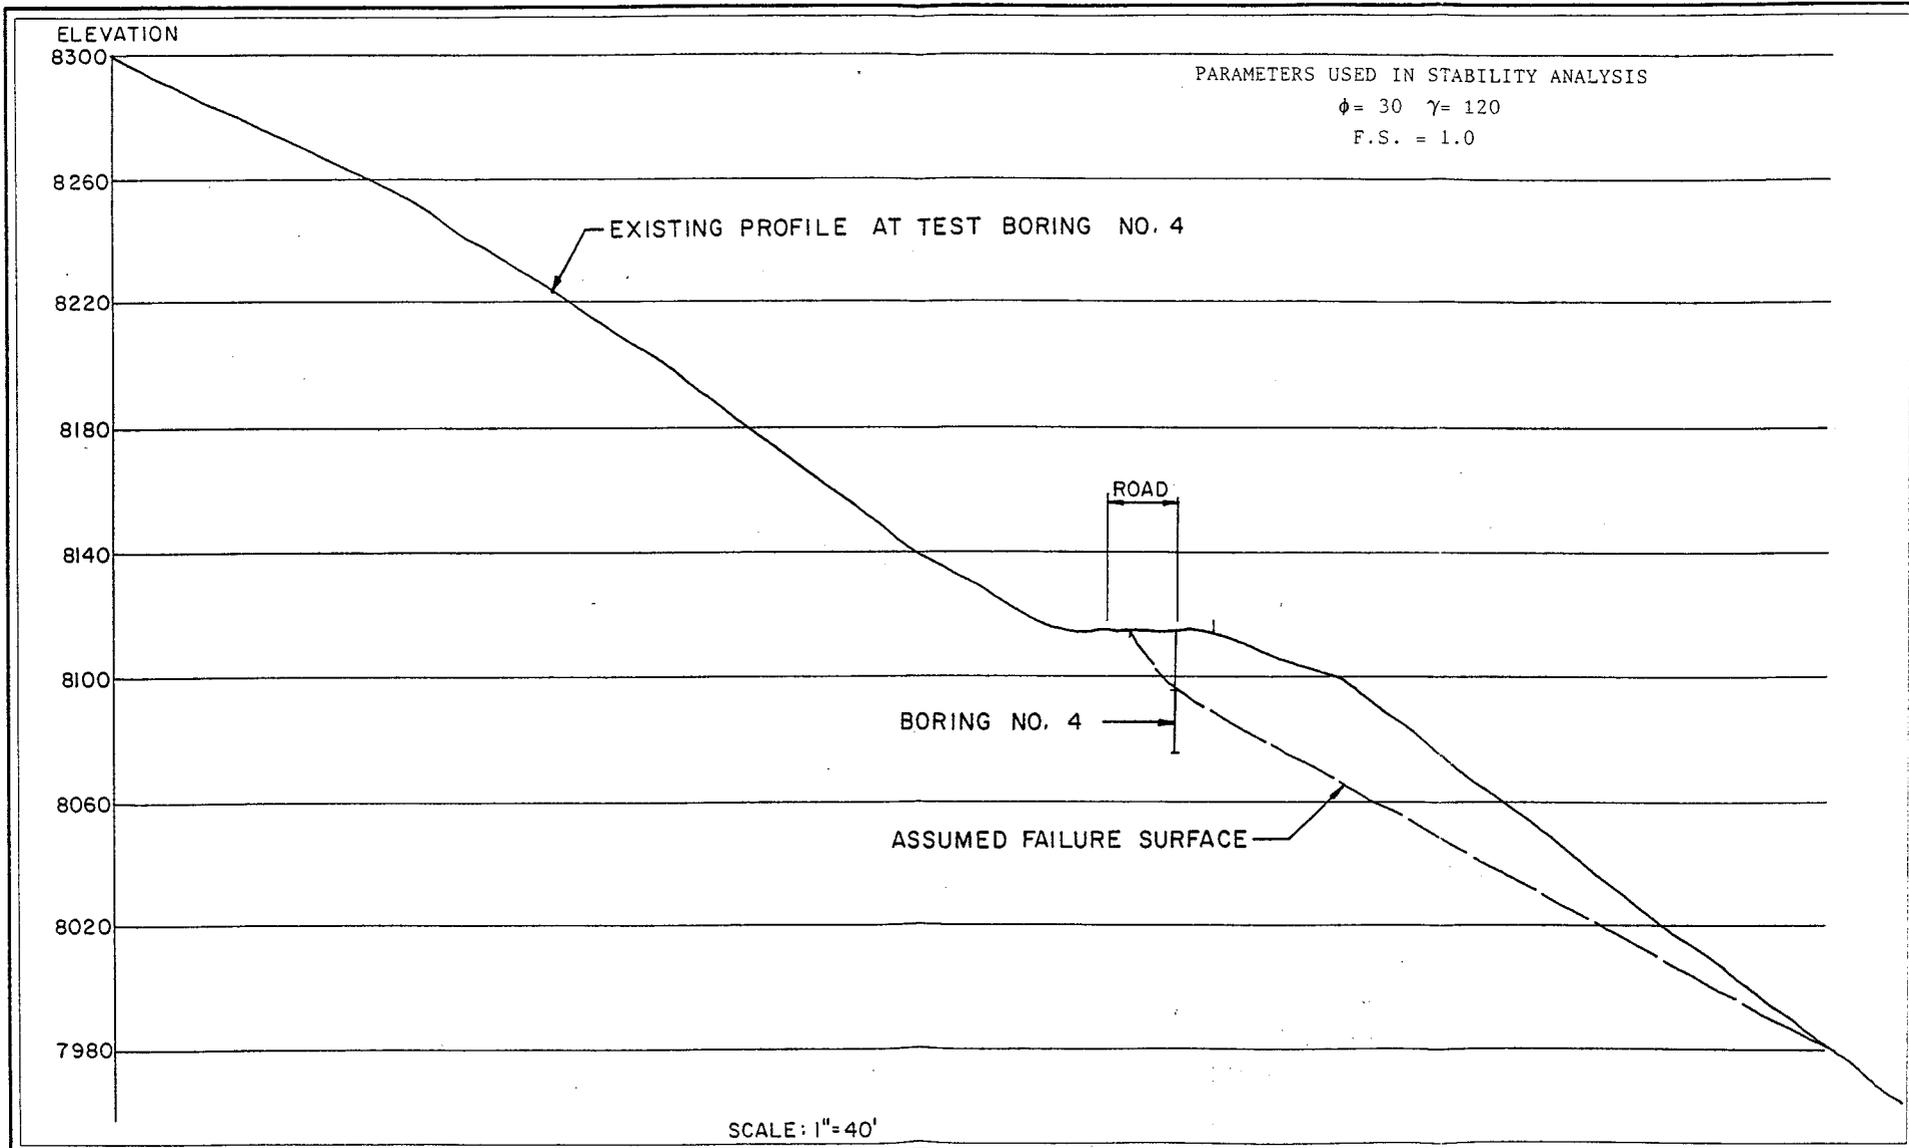
FIGURE
 NO. 12

The results of the stability analysis performed for each of the sites investigated indicated a factor of safety of greater than 1 for all locations, except at Borings 4 and 6. The factors of safety varied from about 1.19 to 1.6. Even at Borings 4 and 6, a factor of safety of greater than 1 would have been obtained if friction angles of 31 degrees had been used for the material at these locations. The natural angle of repose for most granular materials is in the vicinity of 1.4 horizontal to 1 vertical. The slopes associated with the fill zones are steeper, in some cases, and flatter than others than those slopes associated with the natural angle of repose. Since the factor of safety for each of the slopes is equal to or greater than 1 and since it is our opinion that the shear strength parameters used in the analysis are conservative, we believe that a slope failure is not the cause of the pavement failure at various locations along the existing alignment.

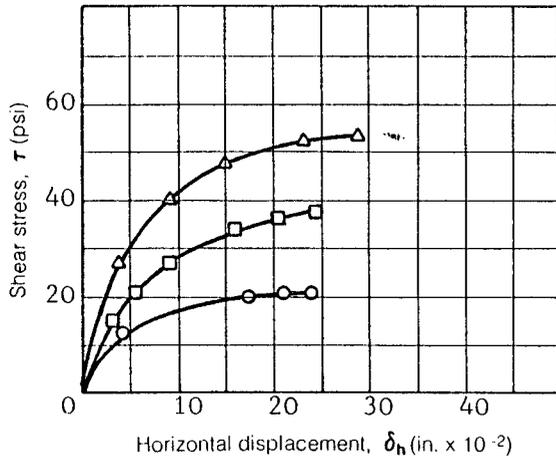
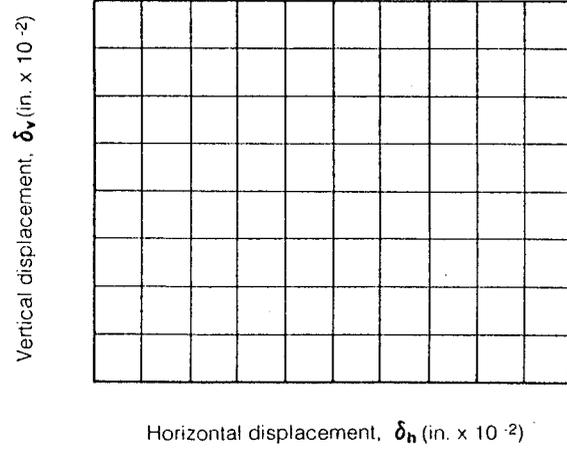
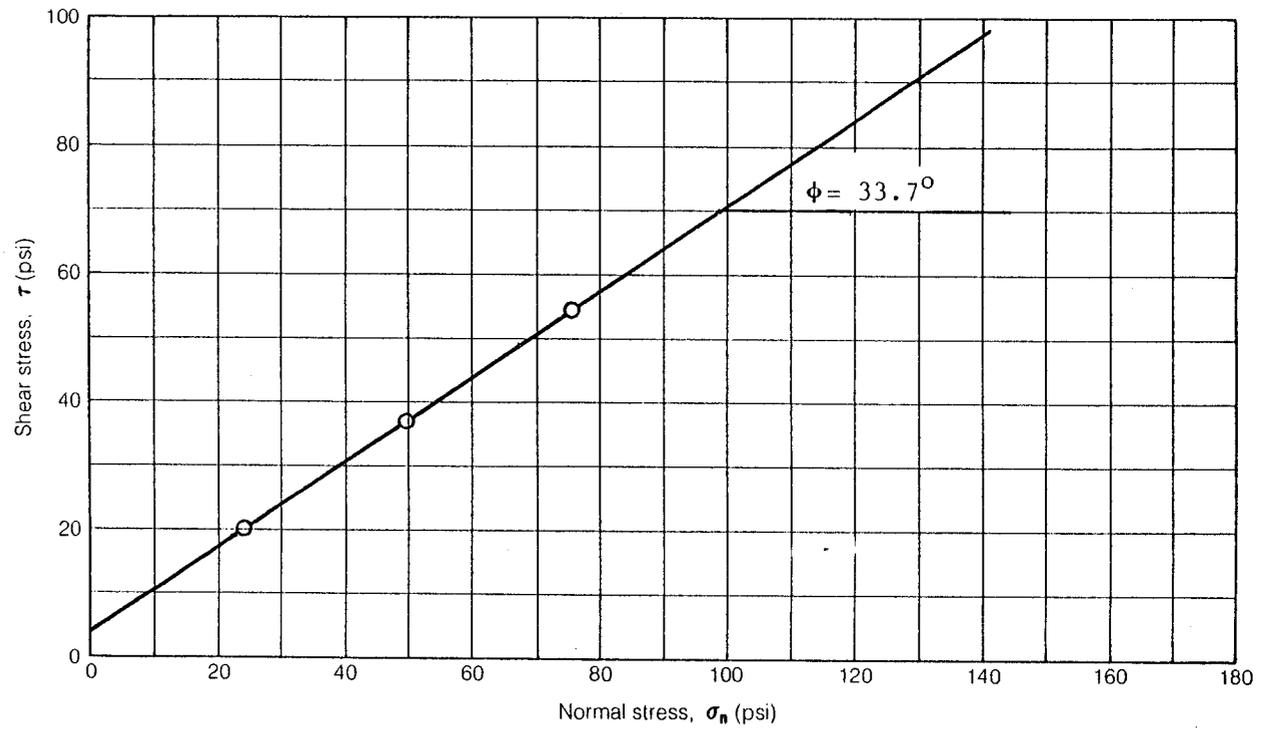
FIGURE NO. 18

In order to obtain an indication of the strength characteristics of the cohesive material in the fill throughout the roadway alignment, three consolidated drain direct shear tests were performed on representative samples obtained from Test Hole No. 1 at a depth of 20 to 21.5 feet below the ground surface. The results of these tests are presented in the form of a Mohr envelope in Figure No. 18, and it will be observed that a friction angle of 33.7 degrees and a cohesion of 4 pounds per square inch was obtained.

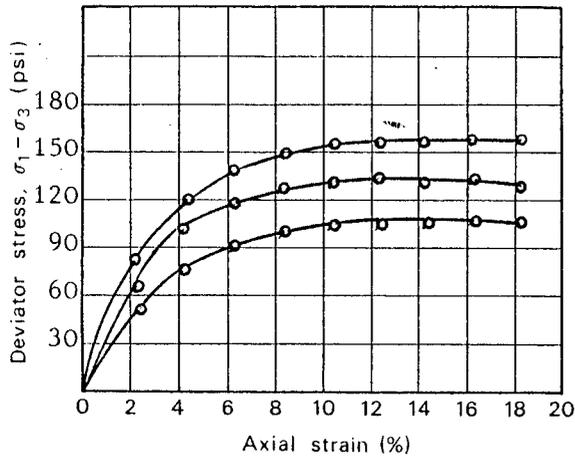
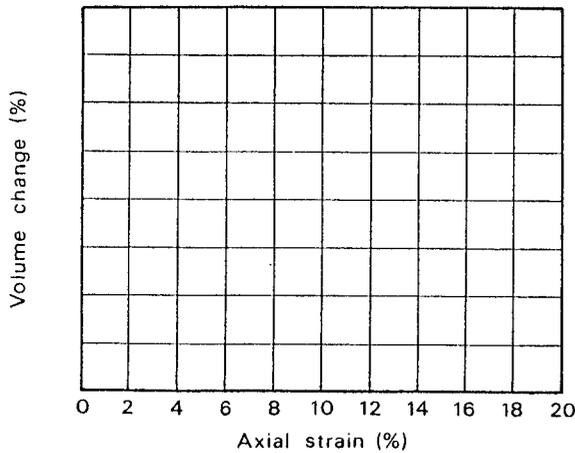
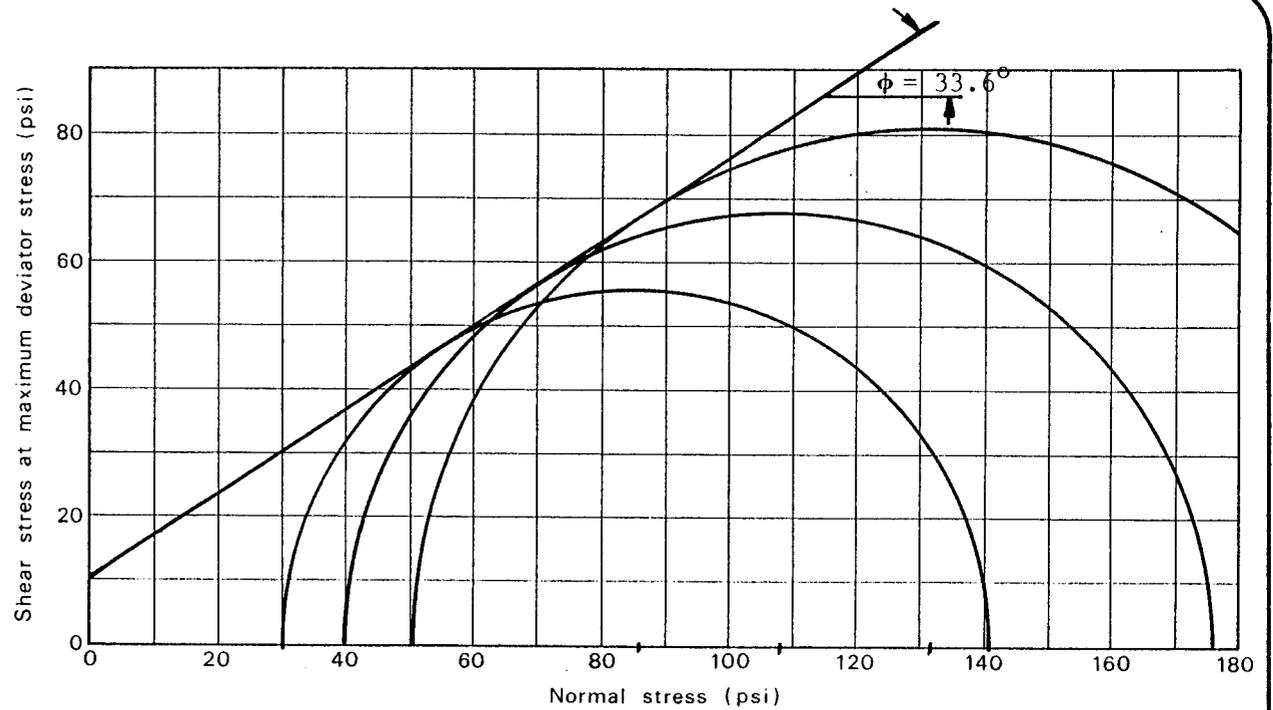
FIGURE
NO. 19

In order to evaluate the strength characteristics of the subsurface material in Test Hole No. 8, 6 consolidated drained triaxial shear tests were performed on representative samples obtained at depths of 5 feet to 11.5 feet and 40 feet to 46 feet in Test Hole No. 8. The results of these tests are presented in the form of a Mohr envelope in Figures 19 and 20. It will be noted that friction angles in the vicinity of 33.6 degrees and a cohesion of 10 psi was obtained for both of these samples. In performing the stability analysis, friction angles slightly smaller than the values obtained during the tests indicated above were used. It should also be noted that while some cohesion was obtained as shown in Figures 19 and 20, no cohesion values were assumed in the stability computations.
