SUBSIDENCE MONITORING REPORT  
1990  
STAR POINT MINE  
ACT/007/006

Cyprus Plateau Mining Corporation  
P.O. Box PMC  
Price, Utah 84501

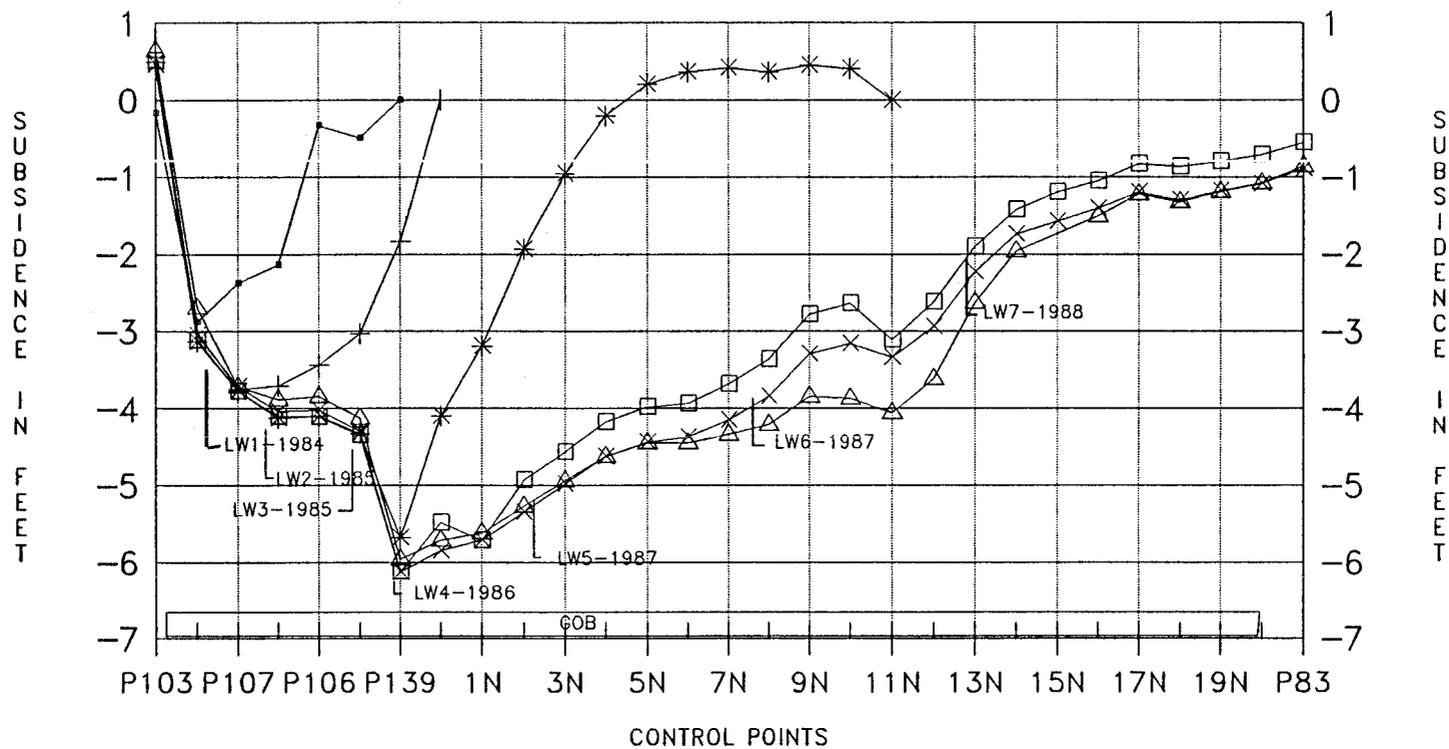
FIGURE 1  
CROSS SECTION A-A

As can be seen on Figures 2 and 3, subsidence has basically stopped at Panels 2 and 4. Subsidence reached its maximum during the third year after mining. Figure 1 shows the subsidence profile diagonally through the seven longwall panels. The progression of subsidence can be seen to the north as successive panels were mined. Further drop in the longwall Panel 5, 6 and 7 area is expected in the future, and should reach its maximum in 1991, three years after mining was completed in Panel 7.

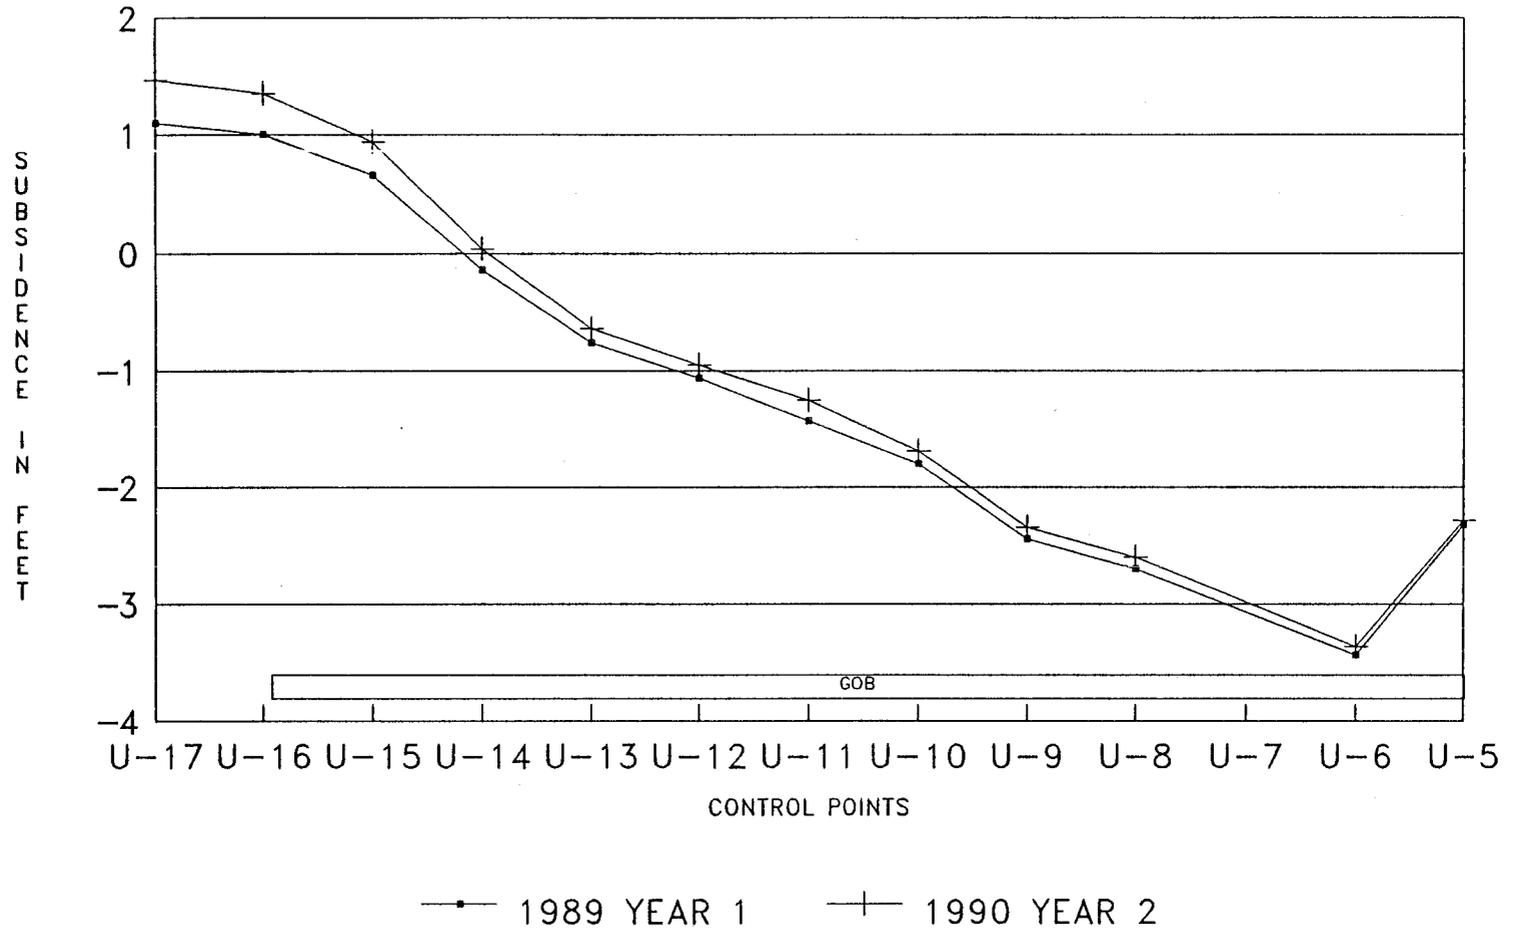
FIGURE 4  
U-NORTH NEAR-STREAM PROFILE

A cross section through Points U5-U17 in Section 18 (Figure 4) indicates a maximum vertical drop of 3.36 feet.

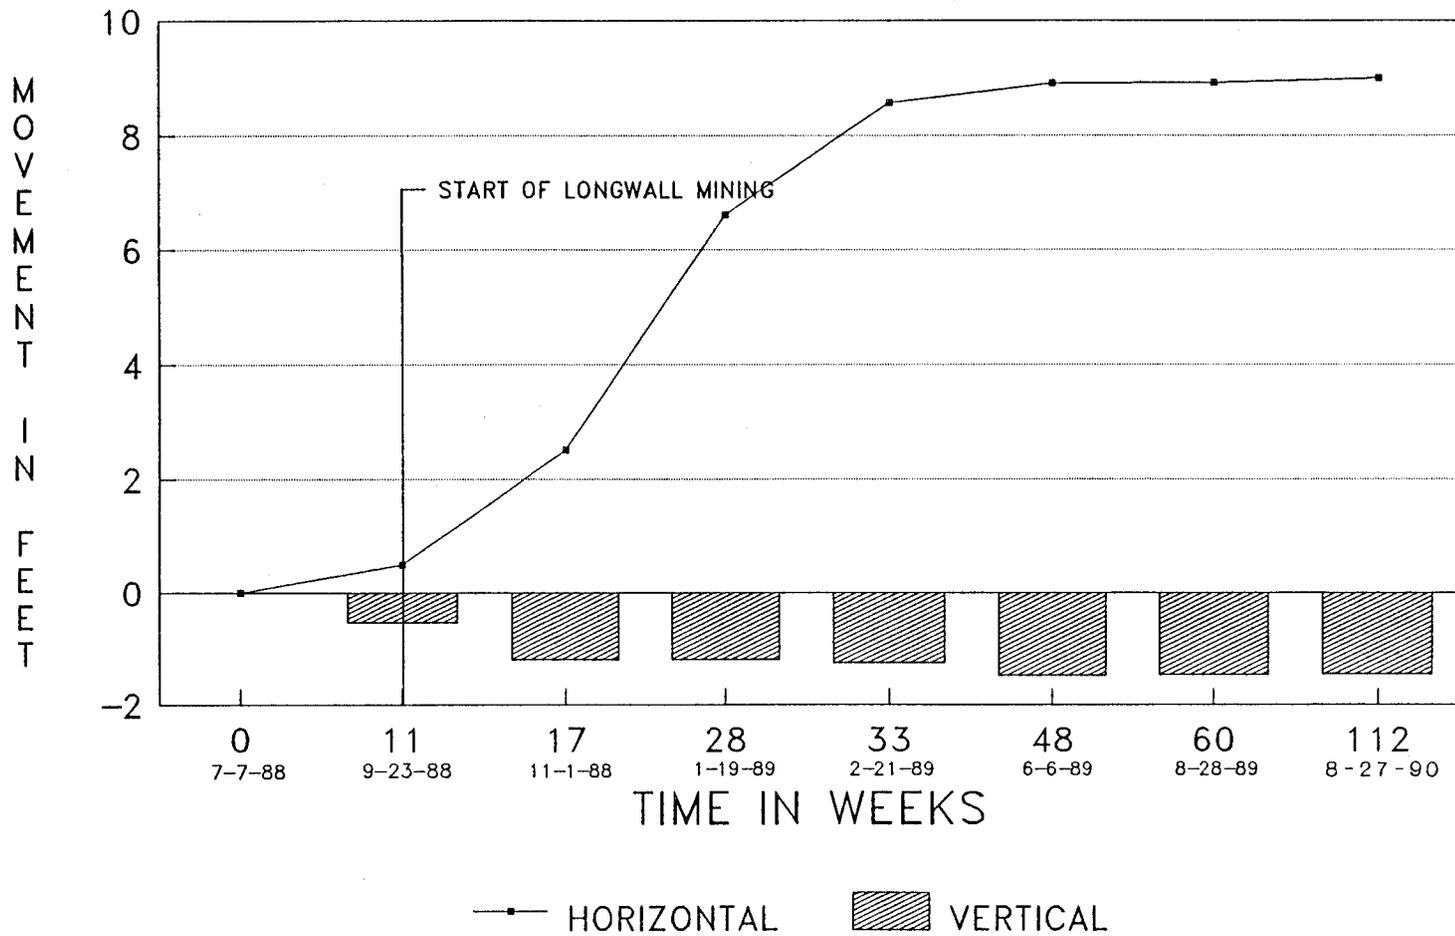
FIGURE 5  
U-NORTH SUBSIDENCE MONITORING  
HORIZONTAL AND VERTICAL MOVEMENT GRAPH  
STATION U1

Horizontal and vertical movement graphs have been made of monitoring points U1, U2, U3, and U4, Figures 5, 6, 7, and 8 respectively. Point U1, which is located directly above the north edge of longwall mining in the Wattis coal seam, shows the most vertical and horizontal movement. Point U4 is farthest from mining and shows the least movement.

A portion of the surface cracks near monitoring points U1 and U2 in Section 18 have been repaired to reduce the likelihood of accidents. The cracks were backfilled and the area fenced. Signs were placed in the area warning the public of the potential danger of the unstable ground. This area is fee land owned by the U.S. Fuel Company; Cyprus Plateau Mining Corporation has an agreement with U.S. Fuel which allows mining impacts.

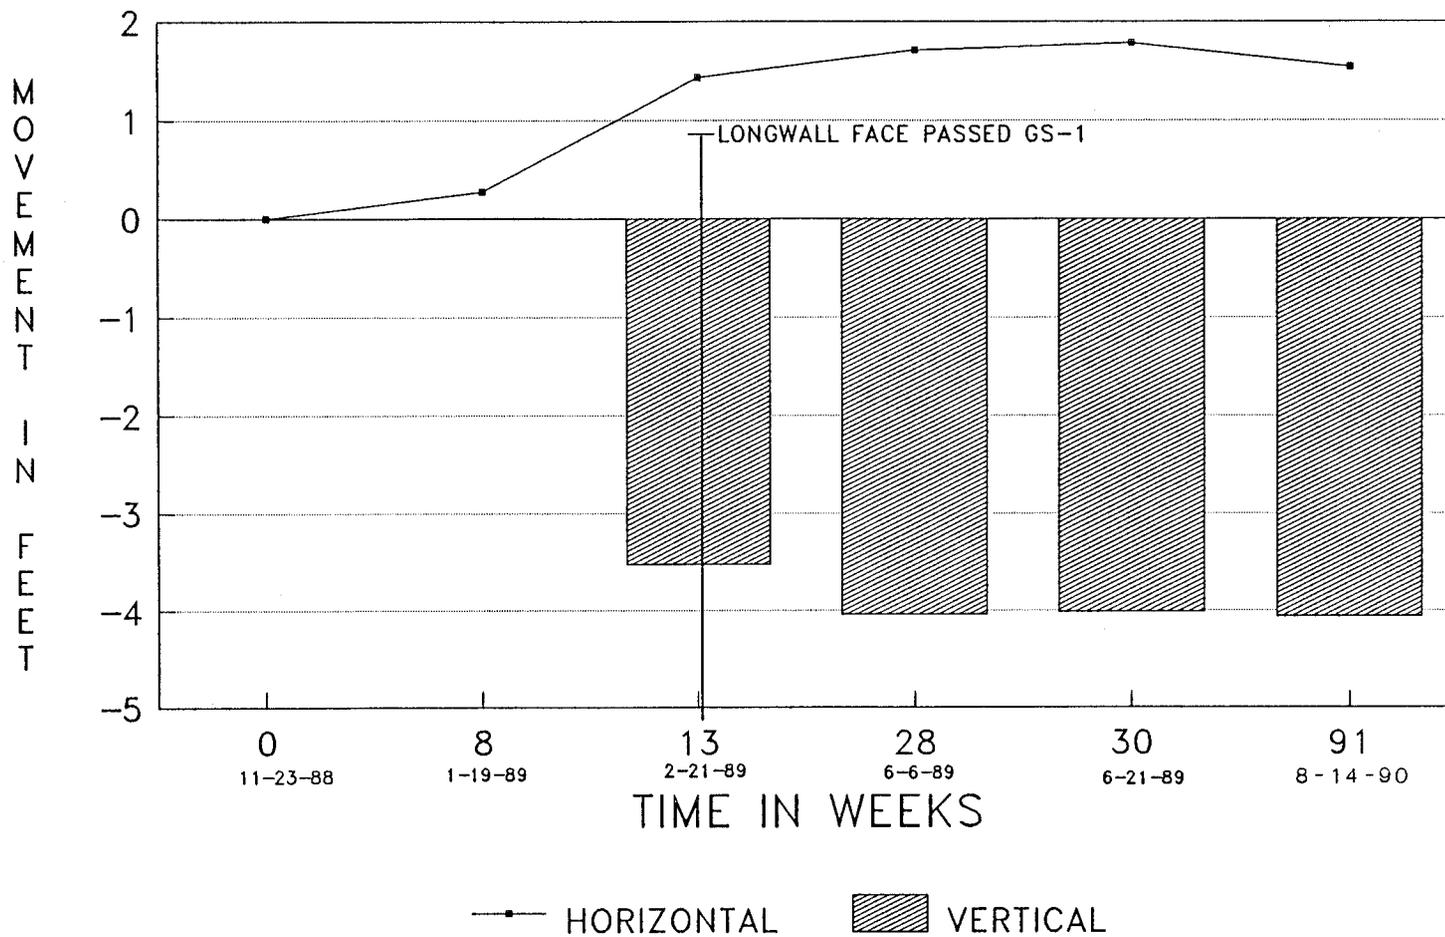
FIGURE 9  
U-NORTH SUBSIDENCE MONITORING  
HORIZONTAL AND VERTICAL MOVEMENT GRAPH  
STATION GS-1

A horizontal and vertical movement graph (Figure 9) has been made of monitoring point GS-1 near the stream in Section 18. Probably because of the shallow overburden at the GS-1 point location, maximum subsidence occurred within 15 weeks of the longwall face passing the point.

Some stream water has been diverted into the mine near monitoring point GS-1 because of subsidence. The stream at this location is small, averaging 13 gallons per minute. Springs and base flow from the canyon bottom recharge the stream below this point. Only a section of stream approximately 800 feet long has been affected. An important point to be learned from the study is whether mudstones and siltstones will expand and stop the downflow of stream water. Water rights in the stream are held by U.S. Fuel Company, with which Cyprus Plateau has an agreement allowing impacts due to mining.
