SUBSIDENCE MONITORING REPORT

1989

STAR POINT MINES

ACT/007/006

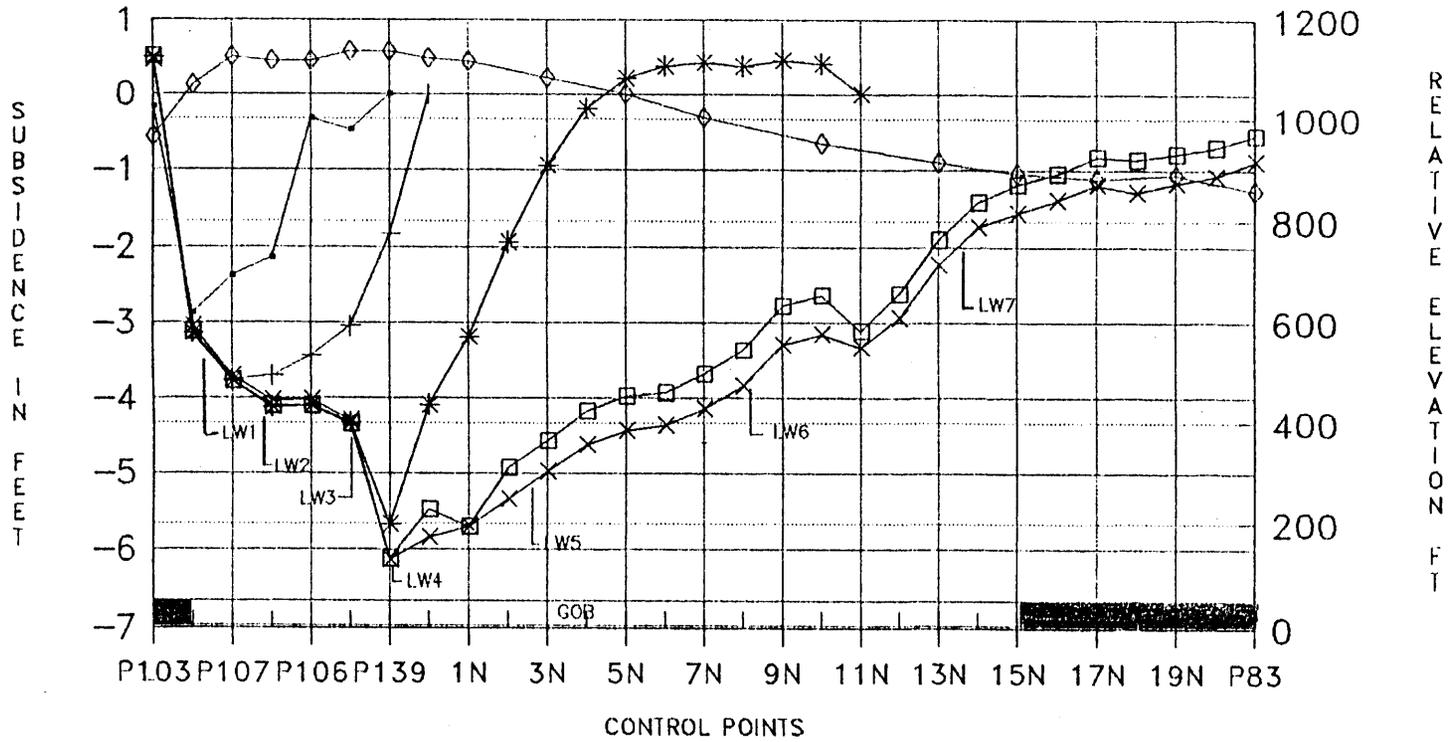
FIGURE 1
CROSS SECTION A-A

As can be seen on Figures 2 and 3, subsidence appears to have stabilized, and reached near-maximum drop by the third year after mining. Figure 1 shows the subsidence profile diagonally through the seven longwall panels. The progression of subsidence can be seen to the north as successive panels were mined. Further drop in the longwall Panel 5, 6 and 7 area is expected for the next two years.

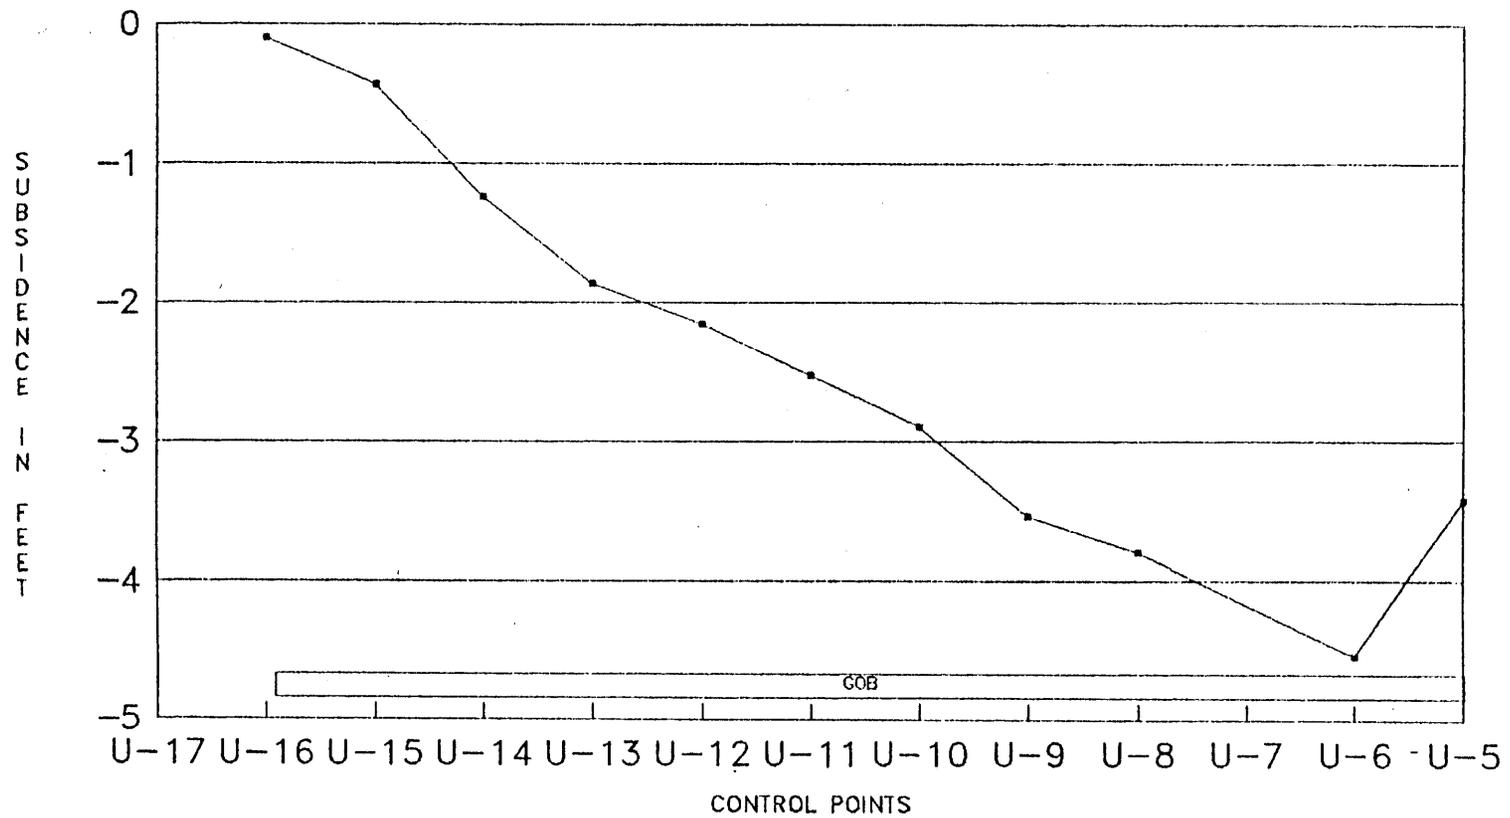
FIGURE 4
CROSS SECTION D-D SECTION 18 NEAR STREAM

A cross section through Points U5-U17 in Section 18 (Figure 4) indicates a maximum vertical drop of 4.53 feet. Only one post-mining survey has been made of these points, therefore progression of subsidence cannot be plotted at this time.

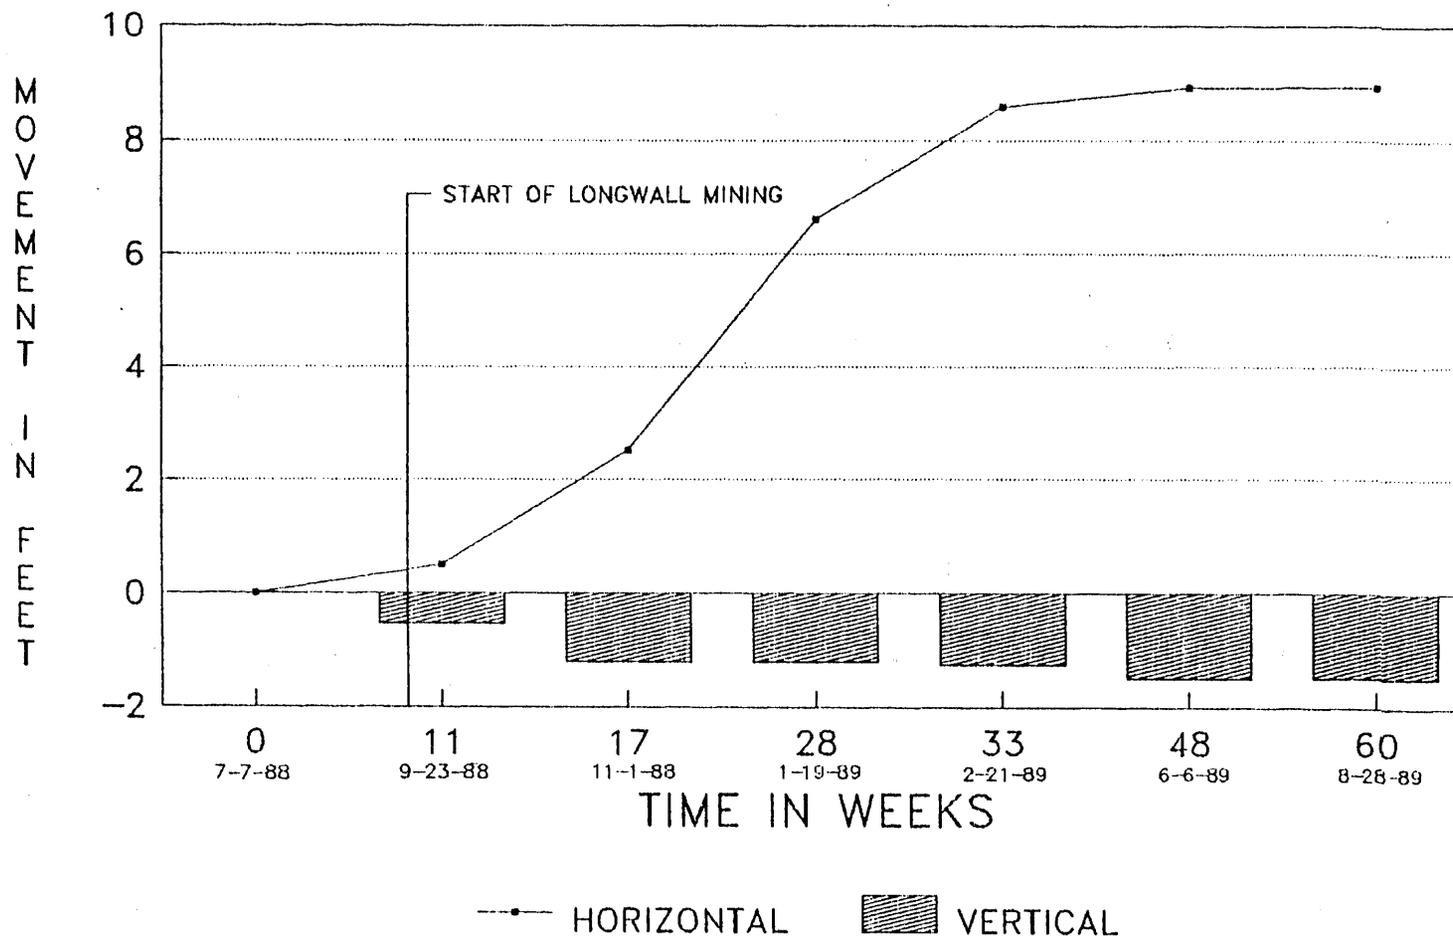
FIGURE 5
U-NORTH SUBSIDENCE MONITORING
HORIZONTAL AND VERTICAL MOVEMENT GRAPH
STATION U1

U2, U3 and U4, Figures 5, 6, 7, and 8 respectively. Point U1, which is located directly above the north edge of longwall mining, shows the most vertical and horizontal movement. Point U4 is farthest from mining and shows the least movement.

A portion of the surface cracks near monitoring points U-1 and U-2 in Section 18 have been repaired to reduce the likelihood of accidents. The cracks were backfilled and the area was fenced. Signs were placed in the area warning the public of the potential danger of the unstable ground.

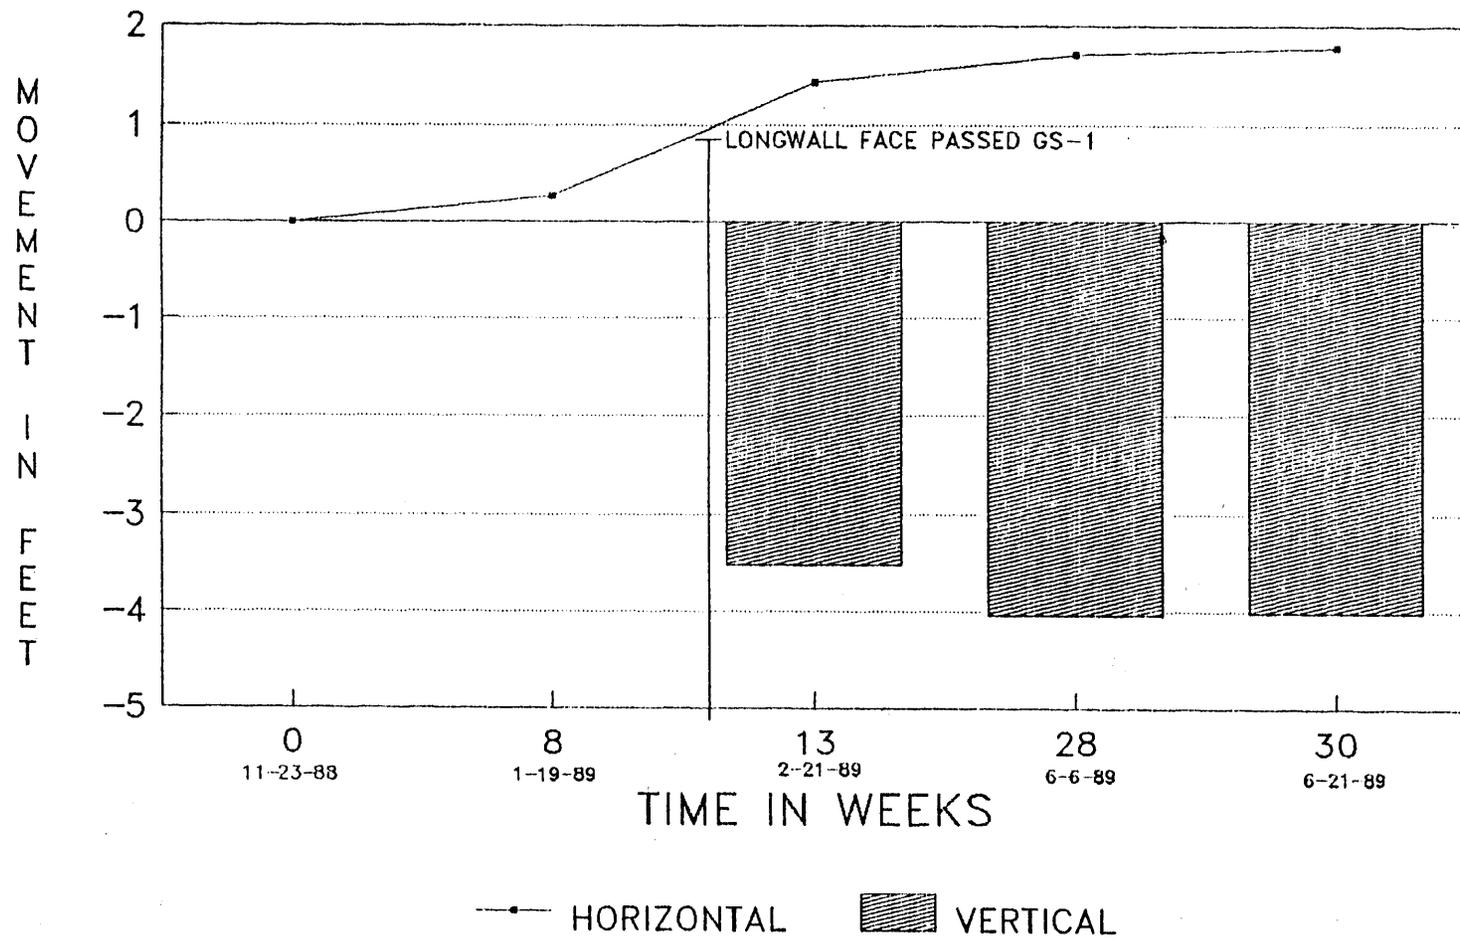
FIGURE 9
U-NORTH SUBSIDENCE MONITORING
HORIZONTAL AND VERTICAL MOVEMENT GRAPH
STATION GS-1

A horizontal and vertical movement graph (figure 9) has been made of monitoring point GS-1 near the stream in Section 18.

Some stream water has been diverted into the mine near monitoring point GS-1. The stream at this location is small, averaging 13 gallons per minute. Springs and base flow from the canyon bottom recharge the stream below this point. Only a section of stream approximately 800 feet long has been affected. An important point to be learned from the study is whether mudstones and siltstones will expand and stop the downflow of stream water.
