SUBSIDENCE MONITORING REPORT
1990
STAR POINT MINE
ACT/007/006

Cyprus Plateau Mining Corporation
P.O. Box PMC
Price, Utah 84501

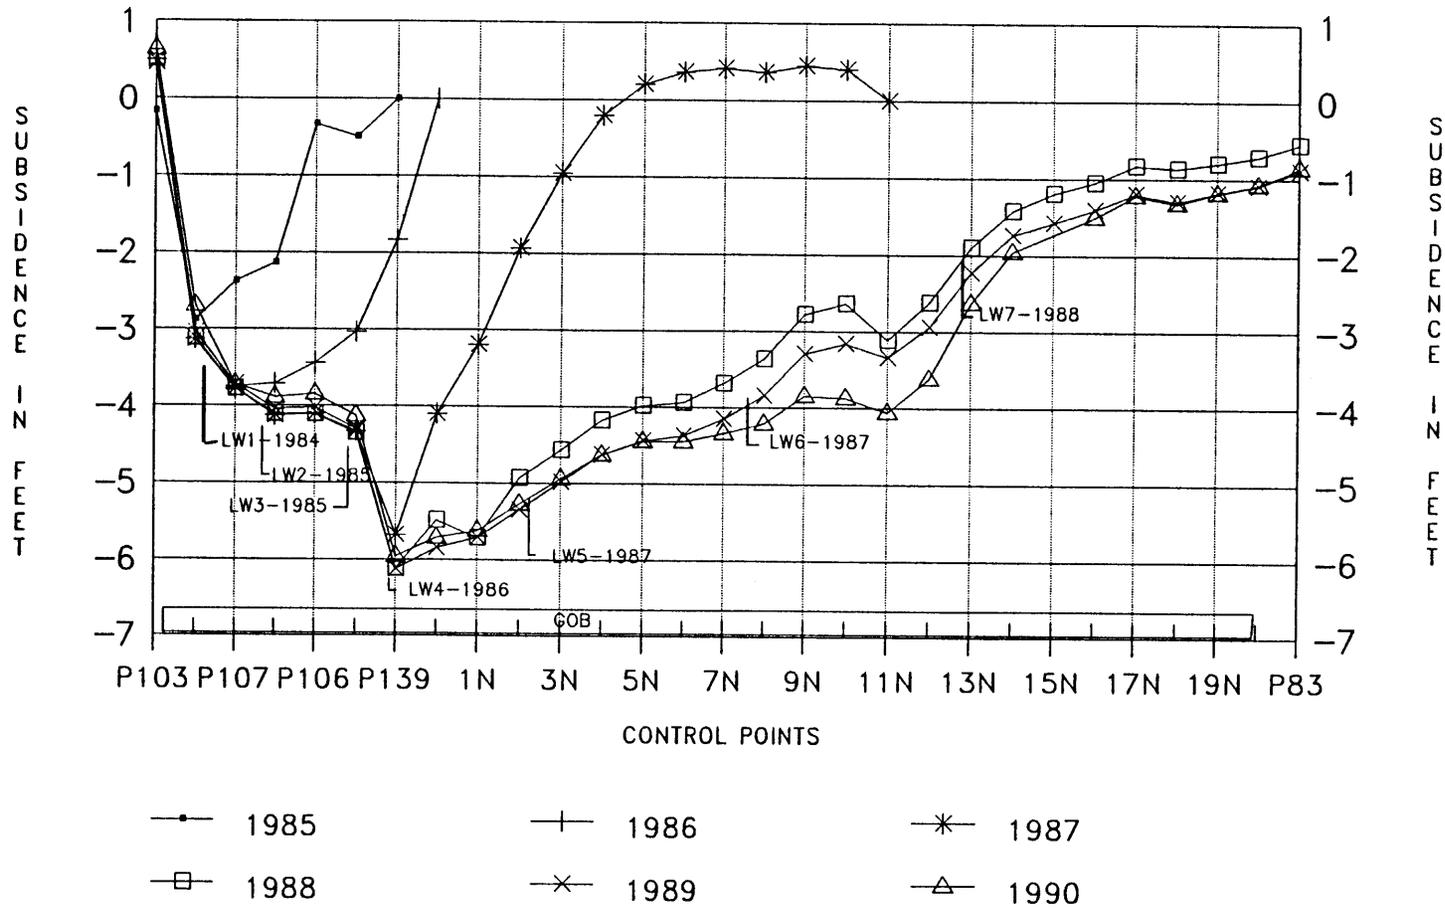
FIGURE 1
CROSS SECTION A-A

As can be seen on Figures 2 and 3, subsidence has basically stopped at Panels 2 and 4. Subsidence reached its maximum during the third year after mining. Figure 1 shows the subsidence profile diagonally through the seven longwall panels. The progression of subsidence can be seen to the north as successive panels were mined. Further drop in the longwall Panel 5, 6 and 7 area is expected in the future, and should reach its maximum in 1991, three years after mining was completed in Panel 7.

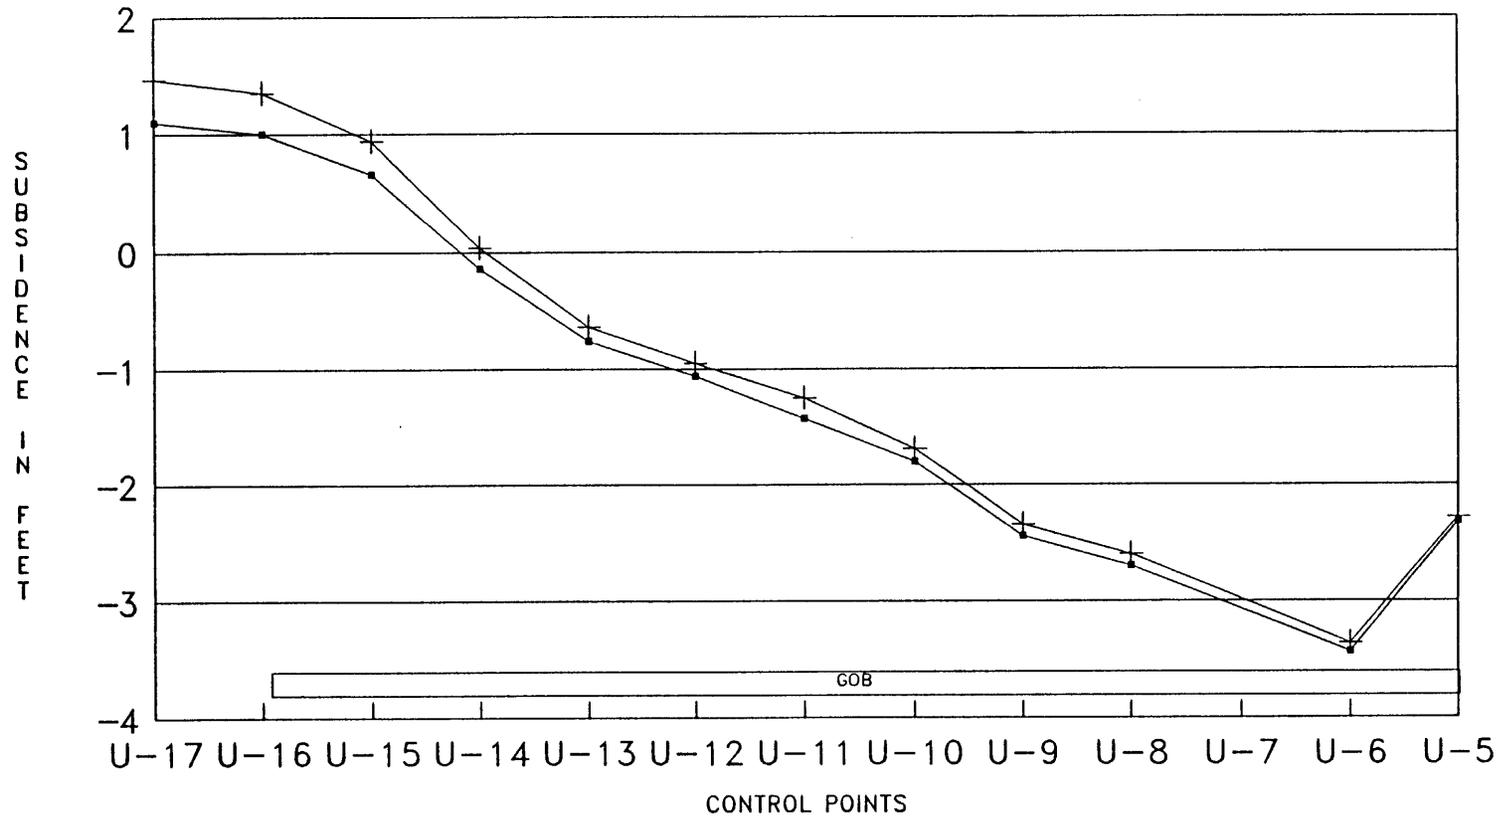
FIGURE 4
U-NORTH NEAR-STREAM PROFILE

A cross section through Points U5-U17 in Section 18 (Figure 4) indicates a maximum vertical drop of 3.36 feet.

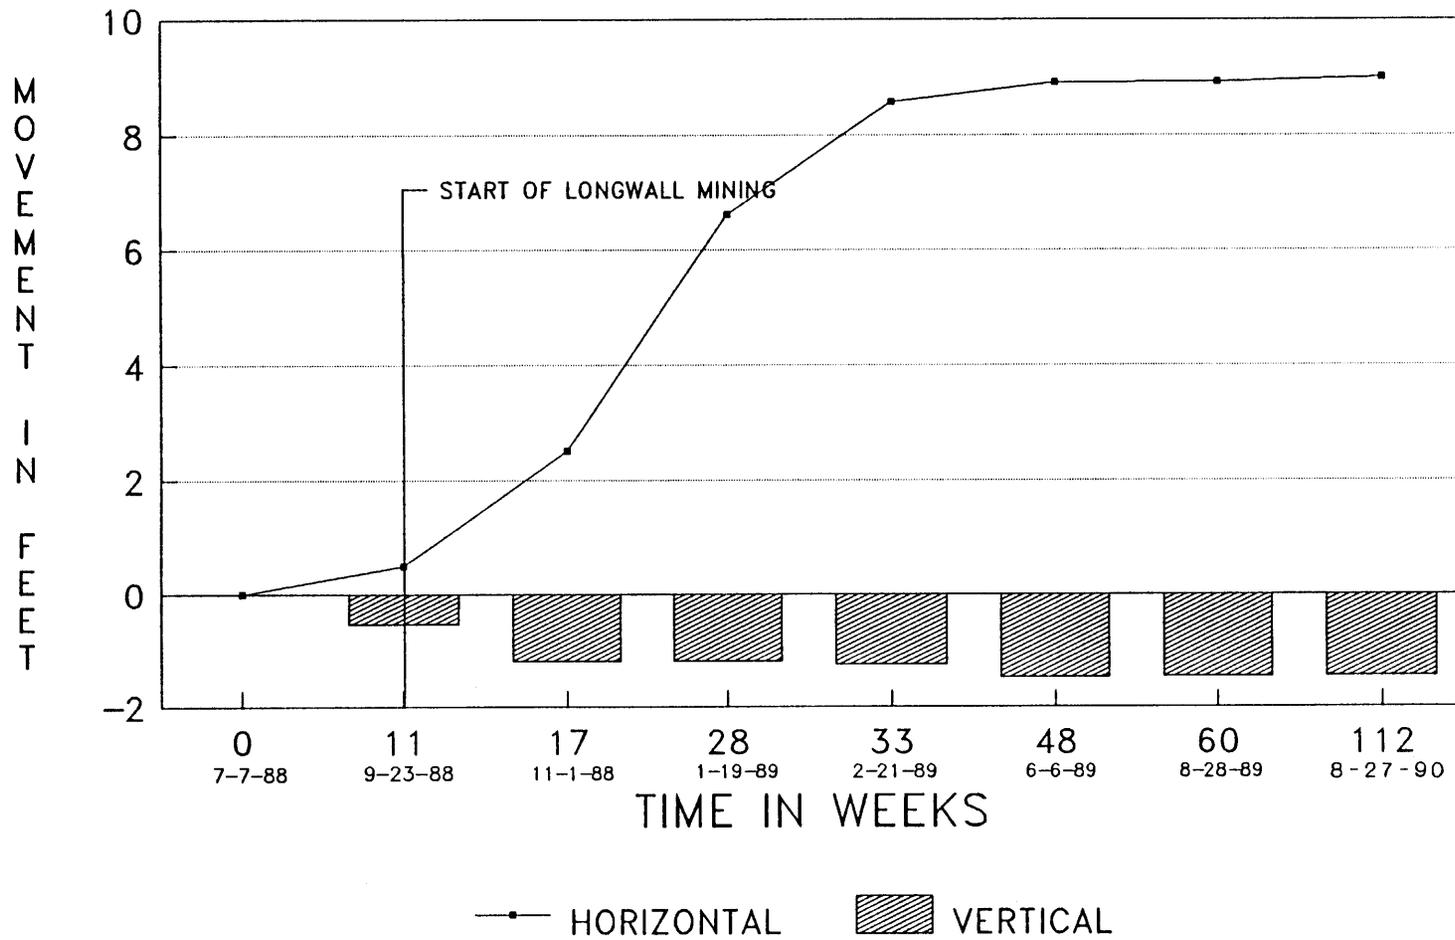
FIGURE 5
U-NORTH SUBSIDENCE MONITORING
HORIZONTAL AND VERTICAL MOVEMENT GRAPH
STATION U1

Horizontal and vertical movement graphs have been made of monitoring points U1, U2, U3, and U4, Figures 5, 6, 7, and 8 respectively. Point U1, which is located directly above the north edge of longwall mining in the Wattis coal seam, shows the most vertical and horizontal movement. Point U4 is farthest from mining and shows the least movement.

A portion of the surface cracks near monitoring points U1 and U2 in Section 18 have been repaired to reduce the likelihood of accidents. The cracks were backfilled and the area fenced. Signs were placed in the area warning the public of the potential danger of the unstable ground. This area is fee land owned by the U.S. Fuel Company; Cyprus Plateau Mining Corporation has an agreement with U.S. Fuel which allows mining impacts.

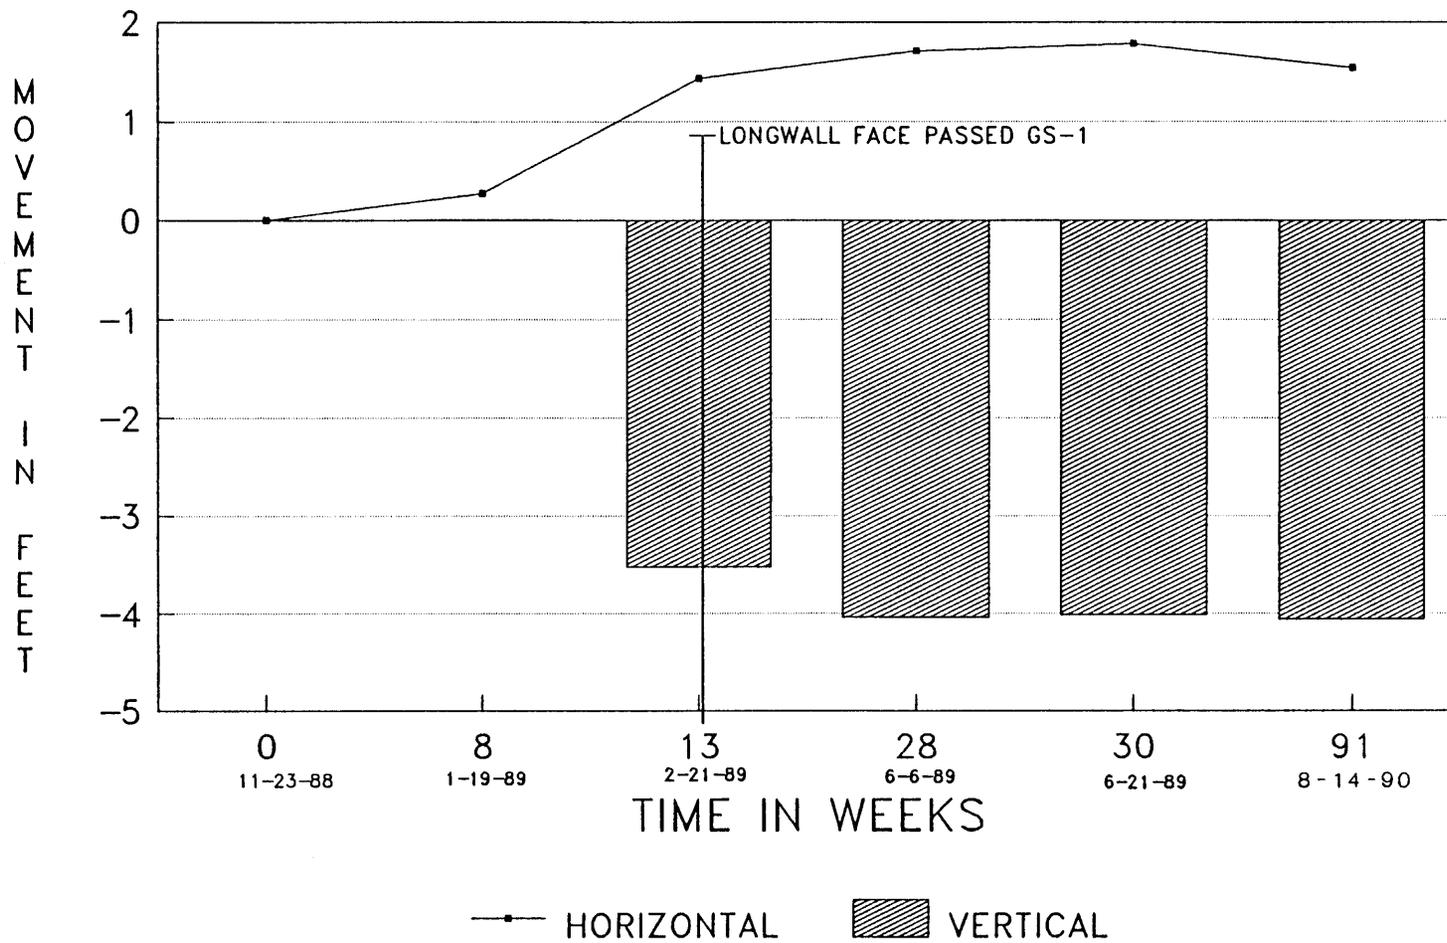
FIGURE 9
U-NORTH SUBSIDENCE MONITORING
HORIZONTAL AND VERTICAL MOVEMENT GRAPH
STATION GS-1

A horizontal and vertical movement graph (Figure 9) has been made of monitoring point GS-1 near the stream in Section 18. Probably because of the shallow overburden at the GS-1 point location, maximum subsidence occurred within 15 weeks of the longwall face passing the point.

Some stream water has been diverted into the mine near monitoring point GS-1 because of subsidence. The stream at this location is small, averaging 13 gallons per minute. Springs and base flow from the canyon bottom recharge the stream below this point. Only a section of stream approximately 800 feet long has been affected. An important point to be learned from the study is whether mudstones and siltstones will expand and stop the downflow of stream water. Water rights in the stream are held by U.S. Fuel Company, with which Cyprus Plateau has an agreement allowing impacts due to mining.
