**SUBSIDENCE MONITORING REPORT
1991
STAR POINT MINE
ACT/007/006**

**Cyprus Plateau Mining Corporation
P.O. Box PMC
Price, Utah 84501**

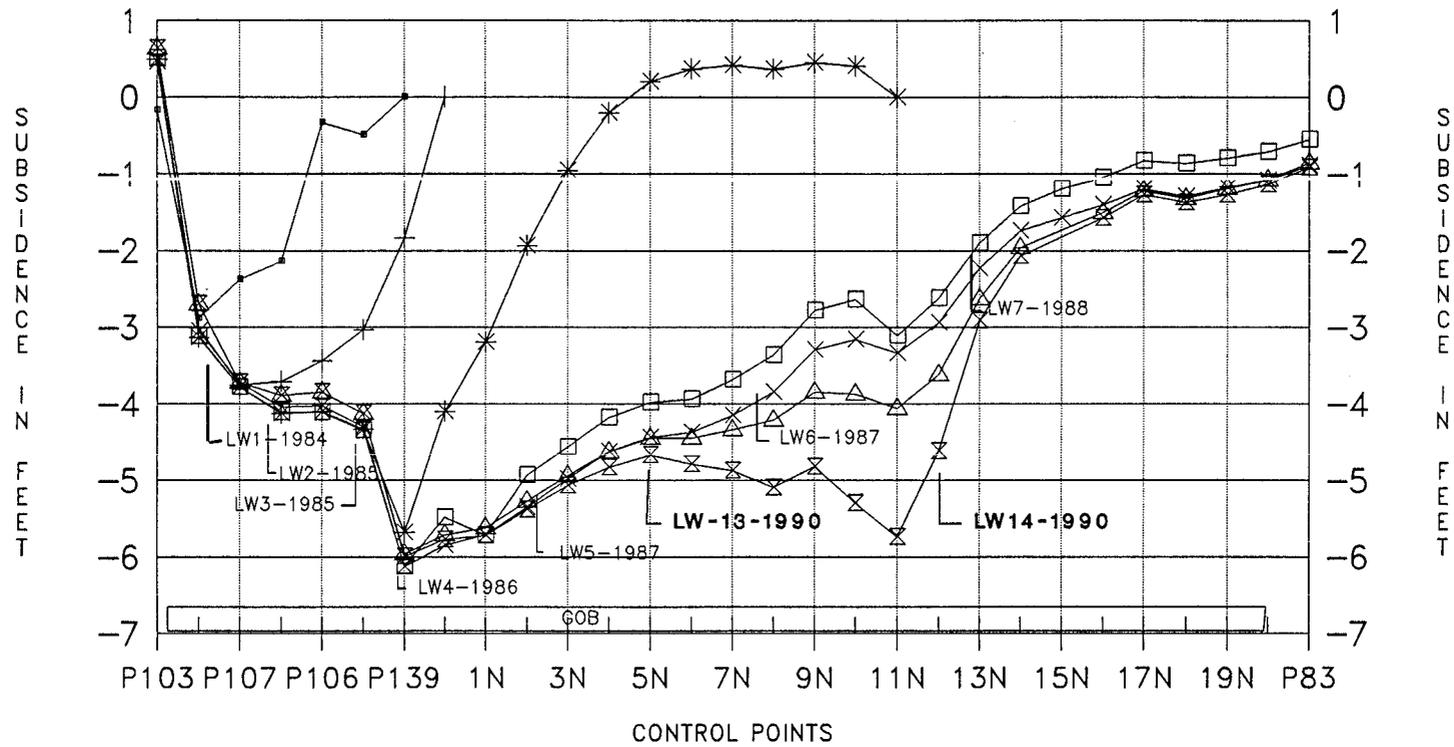
FIGURE 1
CROSS SECTION A-A

Two short longwall panels mined in the Third Seam in 1990 continued to cause the land surface in the northern half of the 7 panel area to subside as can be seen on Figure 1.

As can be seen on Figures 2 and 3, subsidence has basically stopped at Panels 2 and 4. Subsidence reached its maximum during the third year after mining. Figure 1 shows the subsidence profile diagonally through the seven longwall panels. The progression of subsidence can be seen to the north as successive panels were mined.

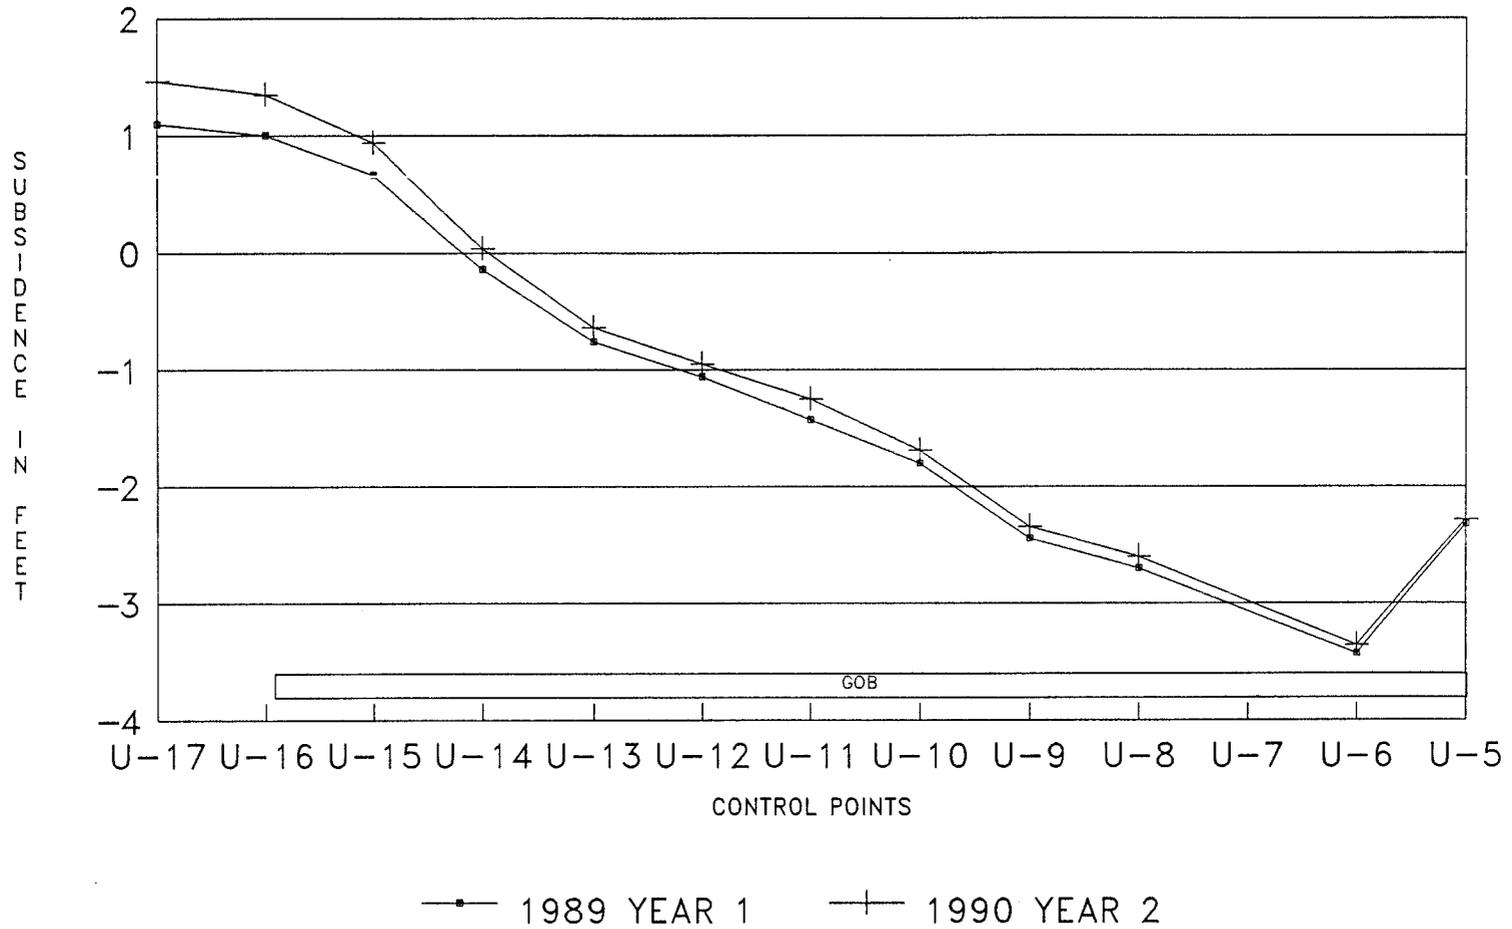
FIGURE 4
U-NORTH NEAR-STREAM PROFILE

A cross section through Points U5-U17 in Section 18 (Figure 4) indicates a maximum vertical drop of 3.36 feet. These monitoring points were not monitored in 1991 due to hazardous conditions. Stabilization of the overburden since mining in the Third Seam should allow monitoring again in 1992.

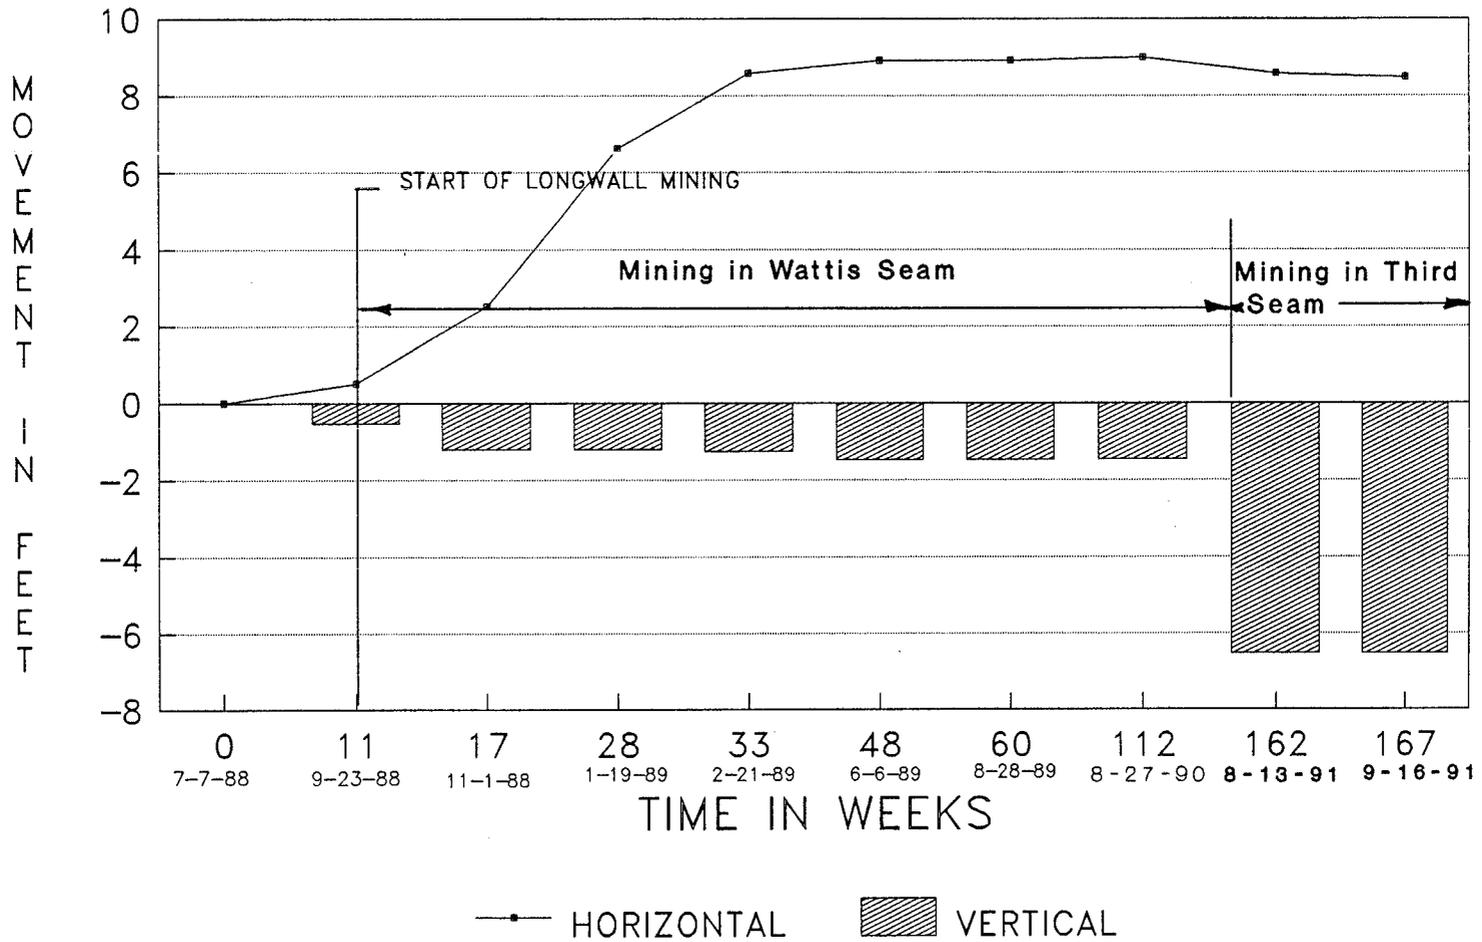
FIGURE 5
 U-NORTH SUBSIDENCE MONITORING
 HORIZONTAL AND VERTICAL MOVEMENT GRAPH
 STATION U1

Horizontal and vertical movement graphs have been made of monitoring points U1, U2, U3, and U4, Figures 5, 6, 7, and 8 respectively. Point U1, which is located directly above the north edge of longwall mining in the Wattis coal seam, shows the most vertical and horizontal movement. Point U4 is farthest from mining and shows the least movement.

A portion of the surface cracks near monitoring points U1 and U2 in Section 18 have been repaired to reduce the likelihood of accidents. The cracks were backfilled and the area fenced. Signs were placed in the area warning the public of the potential danger of the unstable ground. This area is fee land owned by the U.S. Fuel Company; Cyprus Plateau Mining Corporation has an agreement with U.S. Fuel which allows mining impacts.

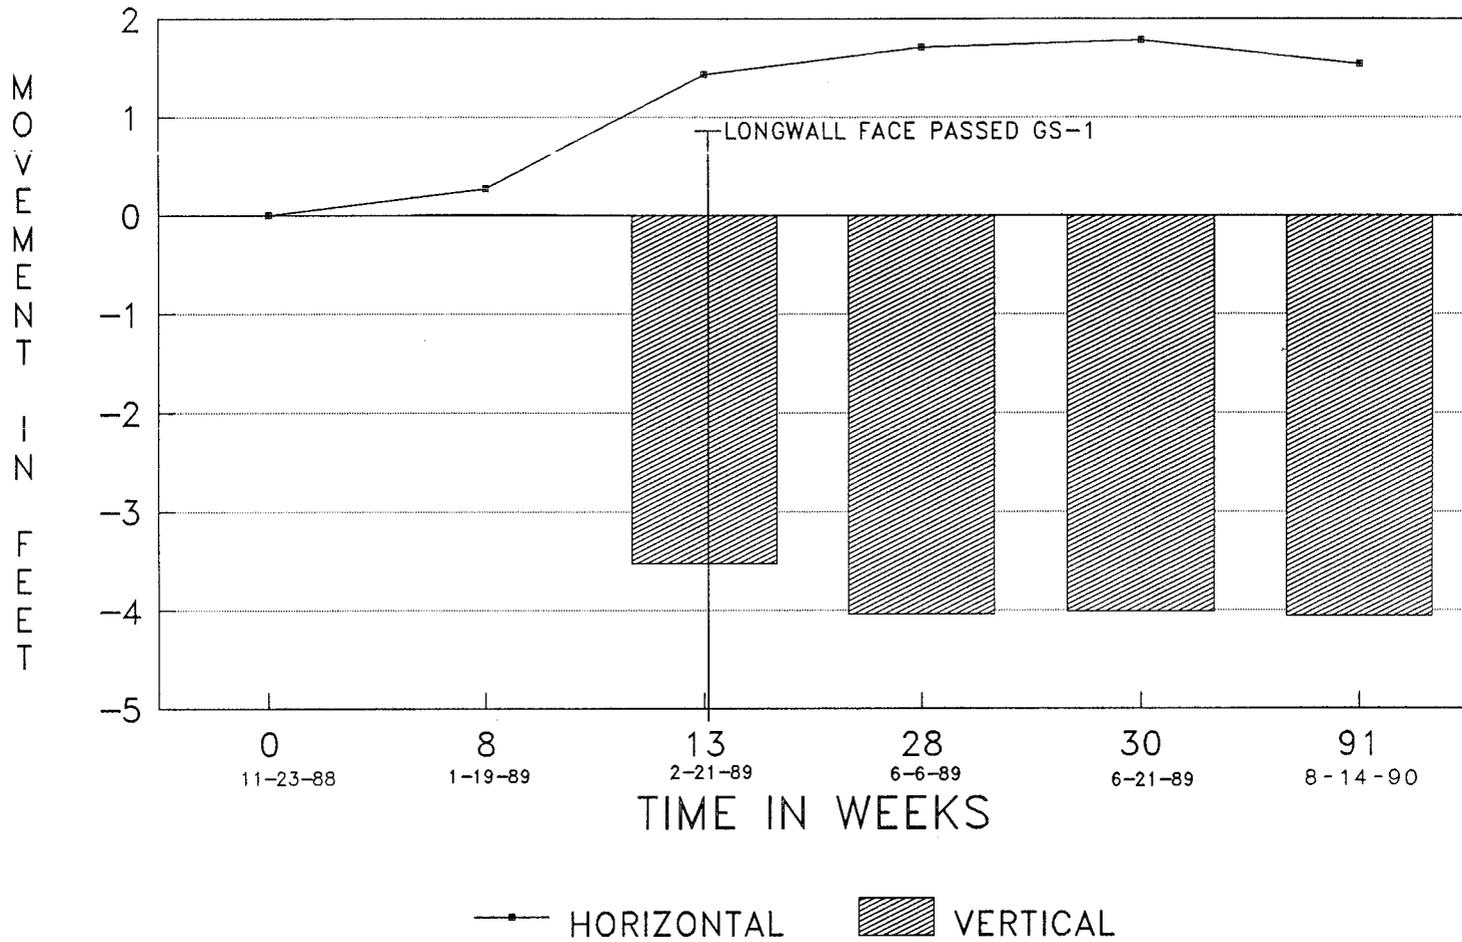
FIGURE 9
U-NORTH SUBSIDENCE MONITORING
HORIZONTAL AND VERTICAL MOVEMENT GRAPH
STATION GS-1

A horizontal and vertical movement graph (Figure 9) has been made of monitoring point GS-1 near the stream in Section 18. Probably because of the shallow overburden at the GS-1 point location, maximum subsidence occurred within 15 weeks of the longwall face passing the point. This monitoring point was not surveyed in 1991 because of the hazardous condition previously discussed.

Some stream water has been diverted into the mine near monitoring point GS-1 because of subsidence. The stream at this location is small, averaging 13 gallons per minute. Springs and base flow from the canyon bottom recharge the stream below this point. A section of stream approximately 800 feet long has been affected. An important point to be learned from the study is whether mudstones and siltstones will expand and stop the downflow of stream water. Water rights in the stream are held by U.S. Fuel Company, with which Cyprus Plateau has an agreement allowing impacts due to mining.
