SUBSIDENCE MONITORING REPORT
1991
STAR POINT MINE
ACT/007/006

Cyprus Plateau Mining Corporation
P.O. Box PMC
Price, Utah 84501

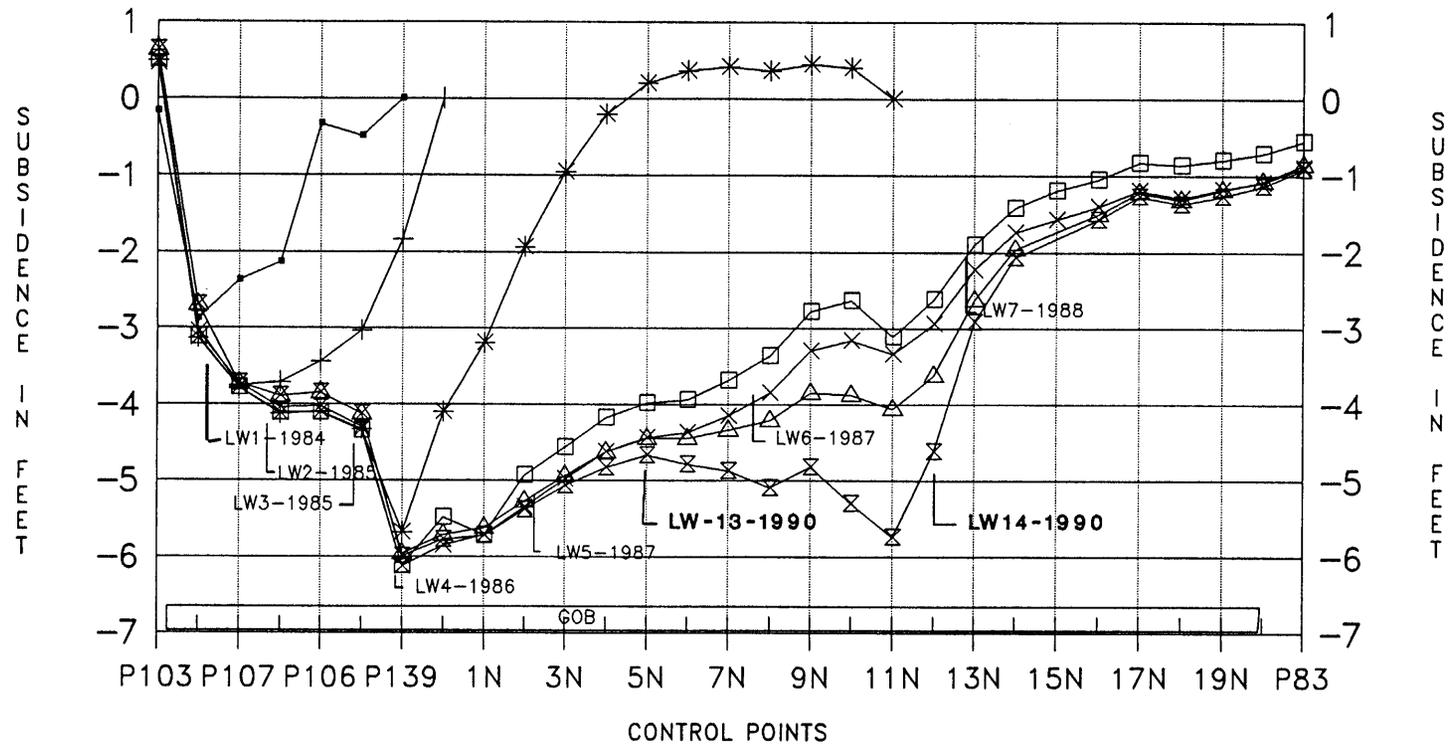
FIGURE 1
CROSS SECTION A-A

Two short longwall panels mined in the Third Seam in 1990 continued to cause the land surface in the northern half of the 7 panel area to subside as can be seen on Figure 1.

As can be seen on Figures 2 and 3, subsidence has basically stopped at Panels 2 and 4. Subsidence reached its maximum during the third year after mining. Figure 1 shows the subsidence profile diagonally through the seven longwall panels. The progression of subsidence can be seen to the north as successive panels were mined.

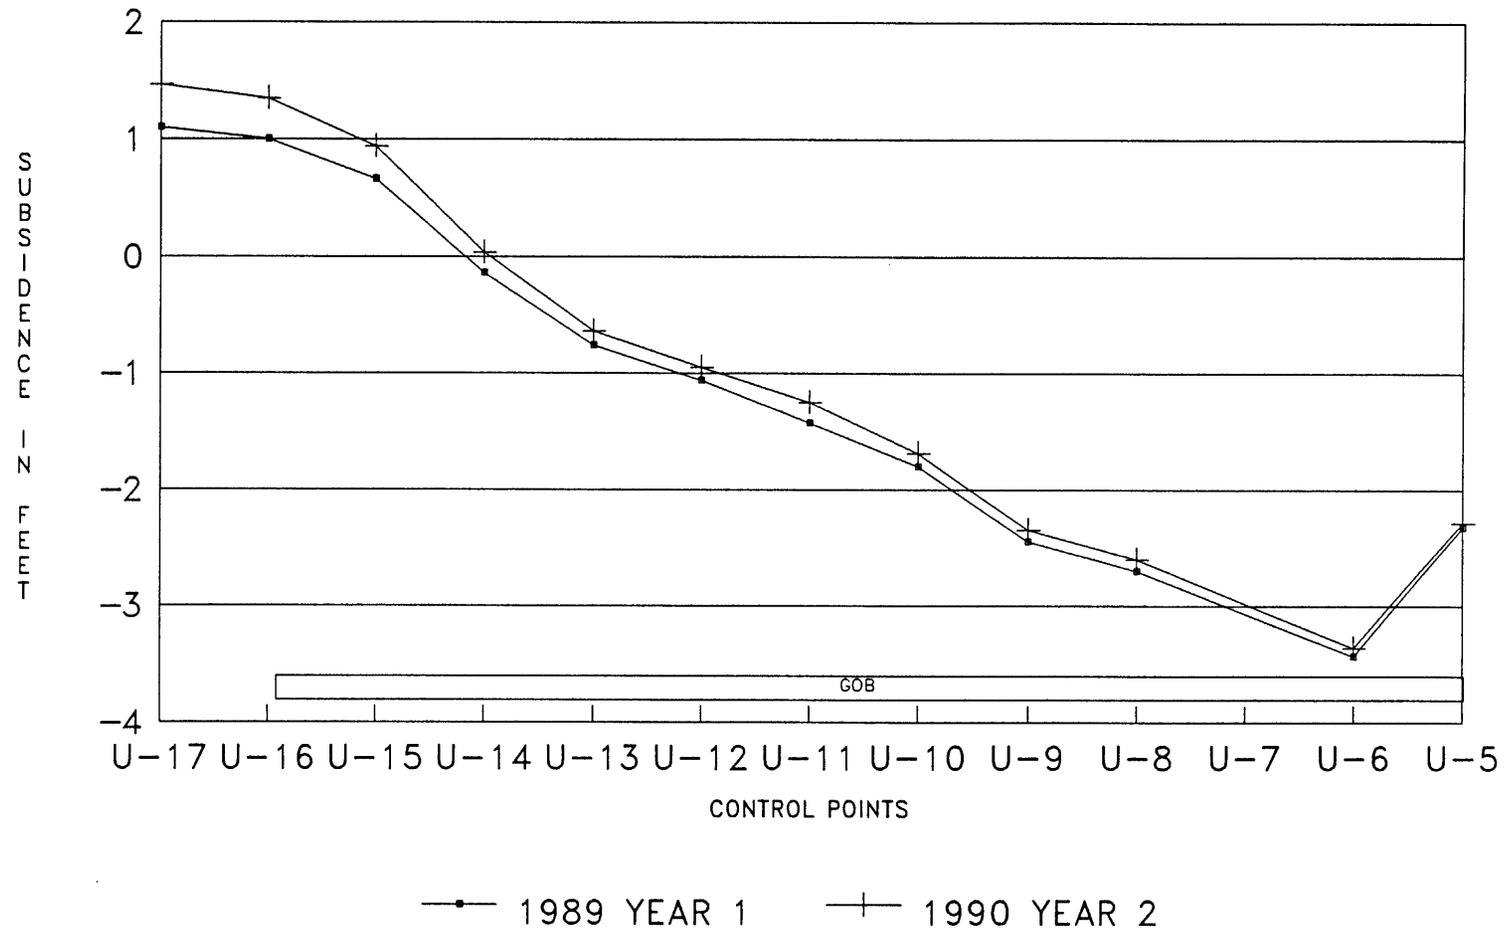
FIGURE 4
U-NORTH NEAR-STREAM PROFILE

A cross section through Points U5-U17 in Section 18 (Figure 4) indicates a maximum vertical drop of 3.36 feet. These monitoring points were not monitored in 1991 due to hazardous conditions. Stabilization of the overburden since mining in the Third Seam should allow monitoring again in 1992.

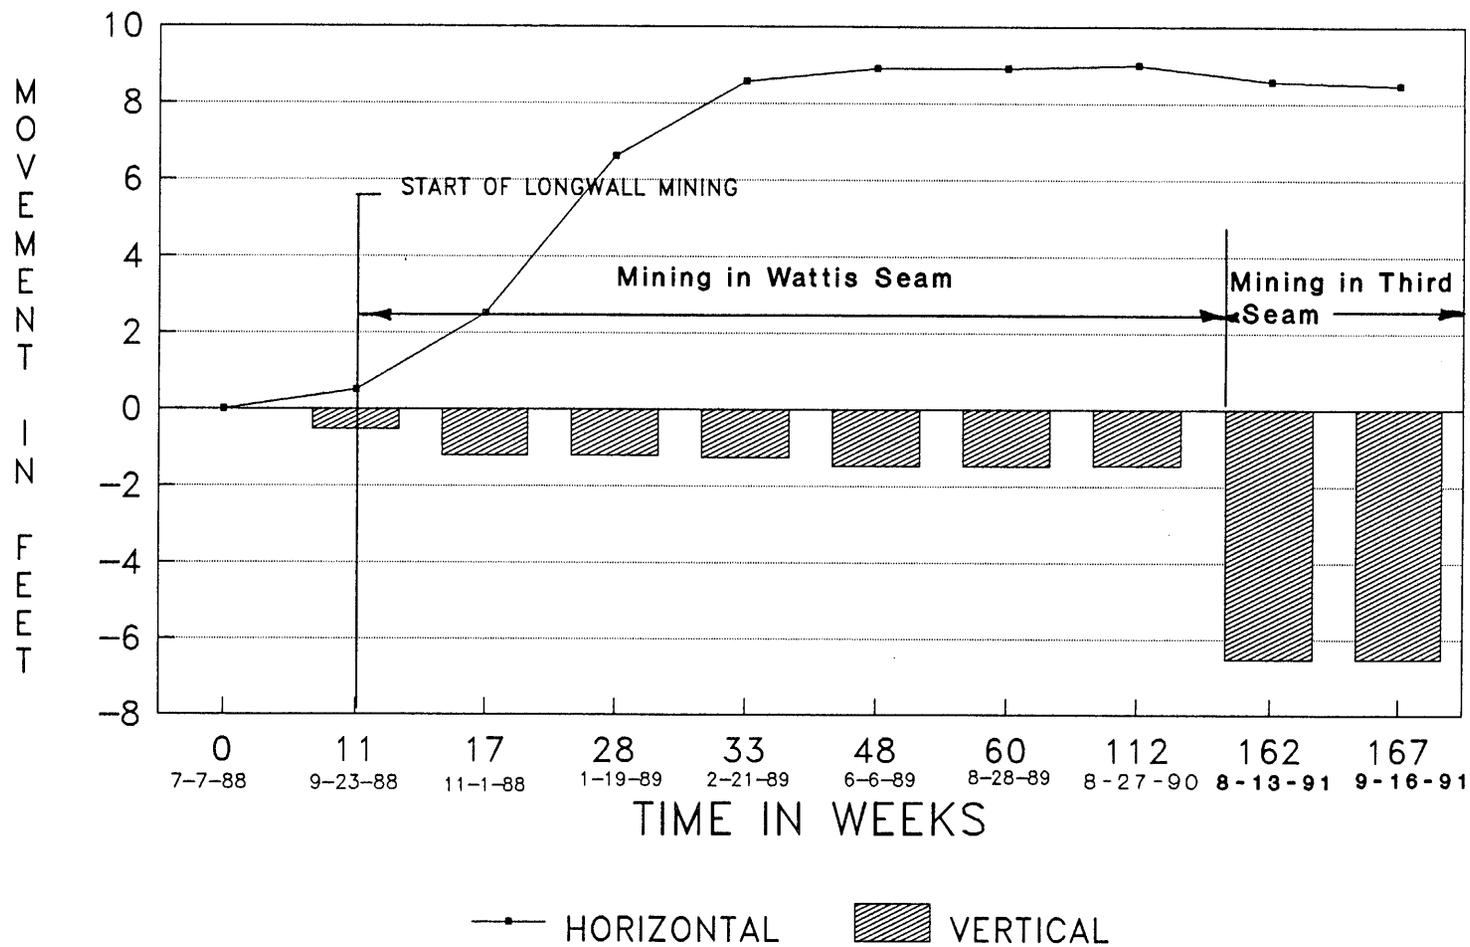
FIGURE 5
 U-NORTH SUBSIDENCE MONITORING
 HORIZONTAL AND VERTICAL MOVEMENT GRAPH
 STATION U1

Horizontal and vertical movement graphs have been made of monitoring points U1, U2, U3, and U4, Figures 5, 6, 7, and 8 respectively. Point U1, which is located directly above the north edge of longwall mining in the Wattis coal seam, shows the most vertical and horizontal movement. Point U4 is farthest from mining and shows the least movement.

A portion of the surface cracks near monitoring points U1 and U2 in Section 18 have been repaired to reduce the likelihood of accidents. The cracks were backfilled and the area fenced. Signs were placed in the area warning the public of the potential danger of the unstable ground. This area is fee land owned by the U.S. Fuel Company; Cyprus Plateau Mining Corporation has an agreement with U.S. Fuel which allows mining impacts.

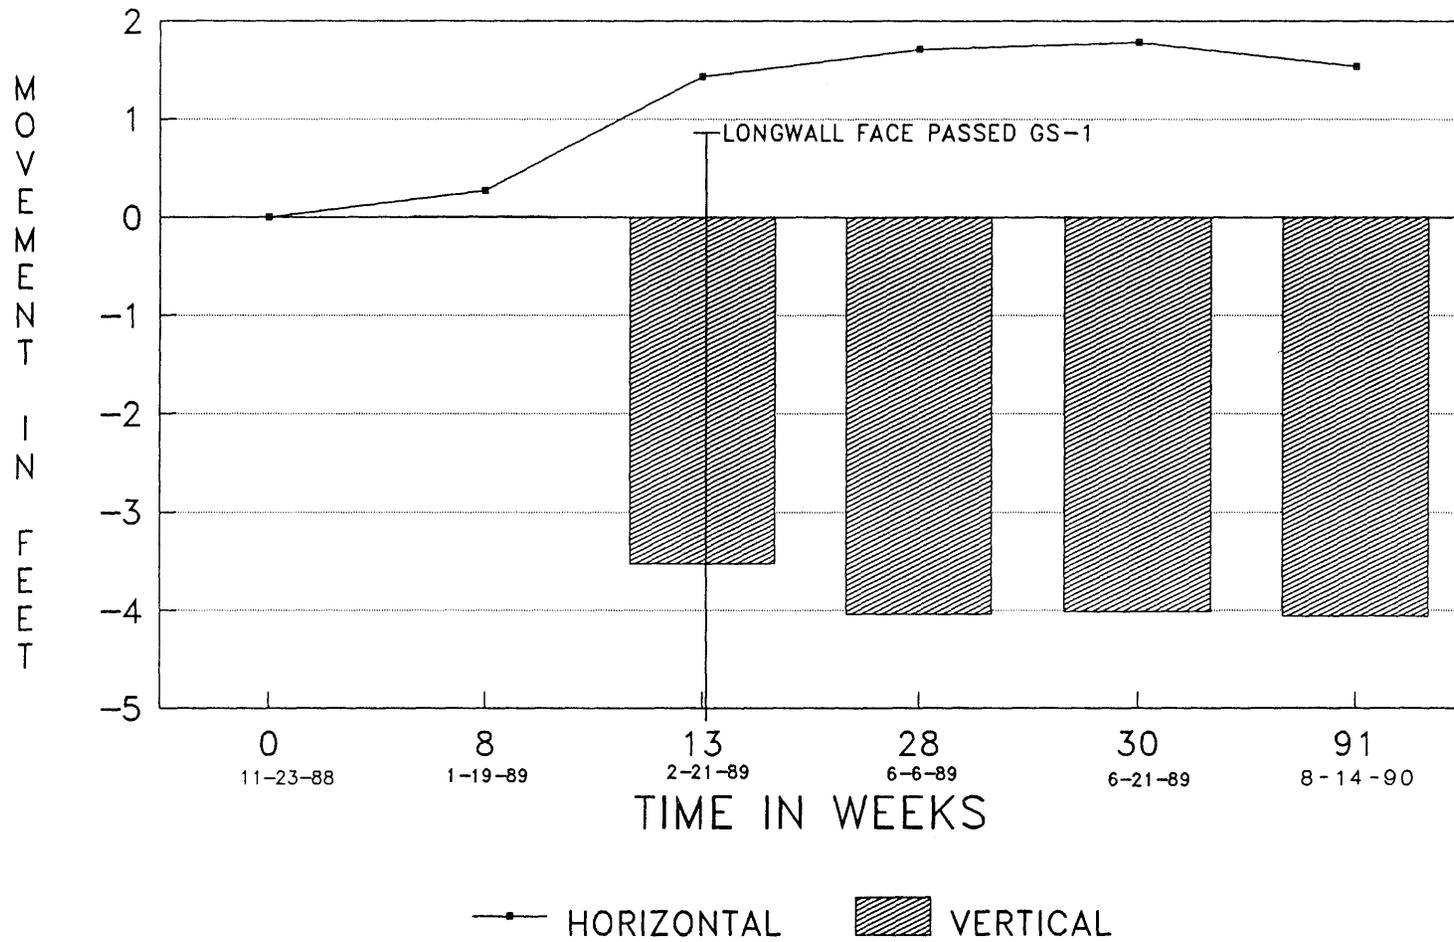
FIGURE 9
U-NORTH SUBSIDENCE MONITORING
HORIZONTAL AND VERTICAL MOVEMENT GRAPH
STATION GS-1

A horizontal and vertical movement graph (Figure 9) has been made of monitoring point GS-1 near the stream in Section 18. Probably because of the shallow overburden at the GS-1 point location, maximum subsidence occurred within 15 weeks of the longwall face passing the point. This monitoring point was not surveyed in 1991 because of the hazardous condition previously discussed.

Some stream water has been diverted into the mine near monitoring point GS-1 because of subsidence. The stream at this location is small, averaging 13 gallons per minute. Springs and base flow from the canyon bottom recharge the stream below this point. A section of stream approximately 800 feet long has been affected. An important point to be learned from the study is whether mudstones and siltstones will expand and stop the downflow of stream water. Water rights in the stream are held by U.S. Fuel Company, with which Cyprus Plateau has an agreement allowing impacts due to mining.
