RE: Summary of Facts Regarding Violation N92-26-2-1, Cyprus Plateau Mining Company, Star Point Mine, ACT/007/006, Folder #2, Carbon County, Utah

Here is a briefing report on NOV N92-26-2-1:

NOV-92-26-2-1

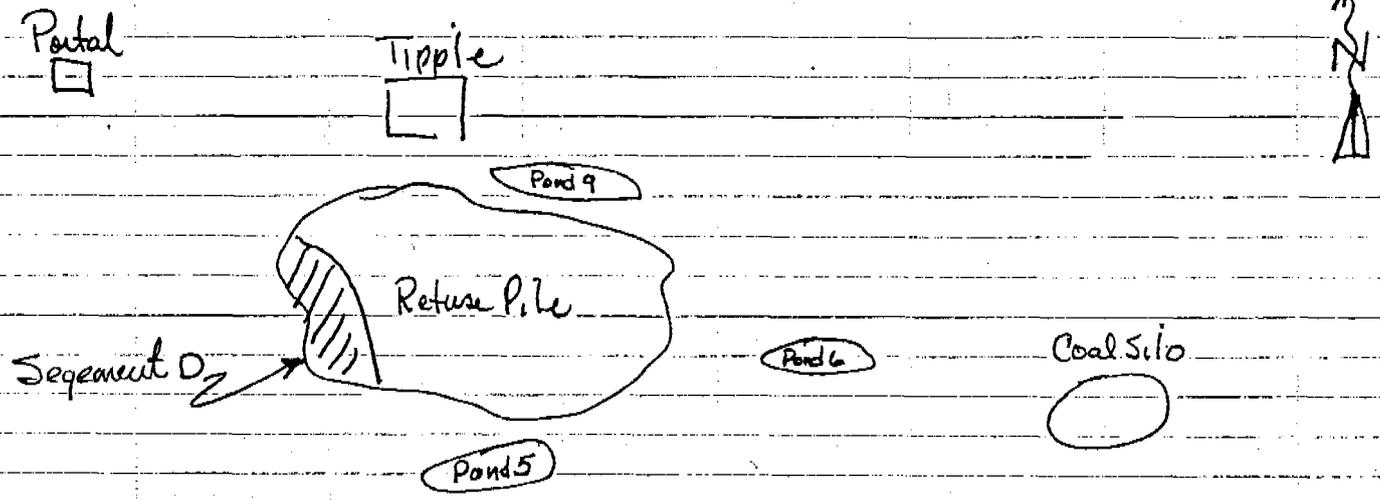
I. General layout

- A.** Southwesterly portion of the refuse pile (see attached sketch).

- B. The major drainage on the refuse pile is in a southerly direction with minor drainage to north and east and hardly any to the west at this time.
- C. The refuse pile relief is more pronounced on the south than on the north. The four refuse drainage segments are readily identifiable on the south and difficult to discern on the north.

The cause of the problem was that the operator constructed a four foot berm and failed to construct a diversion ditch, culvert or other method to discharge the surface runoff. There is a potential to impound water to the height of the berm which may be a safety hazard to men and equipment and may result in refuse slope failure and instability. No runoff was impounded at the time of inspection nor any sign of previous impounding. However, the potential to impound water cannot be refuted.

- B. On the other hand, the operator constructed a berm and culvert to discharge surface runoff from segment B. It is axiomatic from the drainage pattern and topographic relief that after the berm was constructed on the S.W., segment D runoff would impound next to the berm since a "stabilized channel was not constructed at the time the berm was constructed." Therefore, it is my opinion that the operator did not do complete headwork before he started the handwork. In essence, he solved one problem but created another problem.

Design, secure approval, and construct a stabilized channel. Solutions on the refuse pile have taken a piece at a time. At this time, suggest all the issues be brought on the table for a comprehensive solution. I, too, took one piece, i.e., the S.W. segment, but recognize the voice of others should be brought forward and the total problems discussed after the instant piece is adjudicated in the facts of violation hearing.

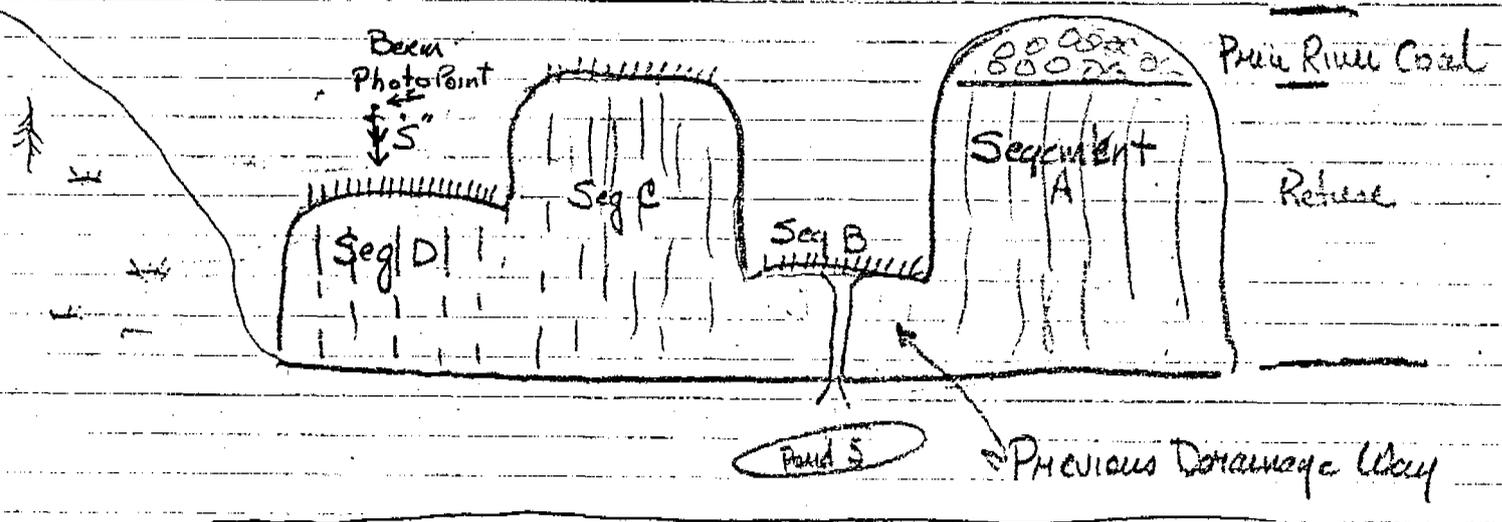
II. Southern Pile Cross Section (Done By Recall)

Segment A & C - 2 segment pile prior to 1988

Segment B - Expanded Pile In Drainage Way

Segment D - Expanded Pile To West
