**SUBSIDENCE MONITORING REPORT
1993
STAR POINT MINE
ACT/007/006**

**Cyprus Plateau Mining Corporation
P.O. Box PMC
Price, Utah 84501**

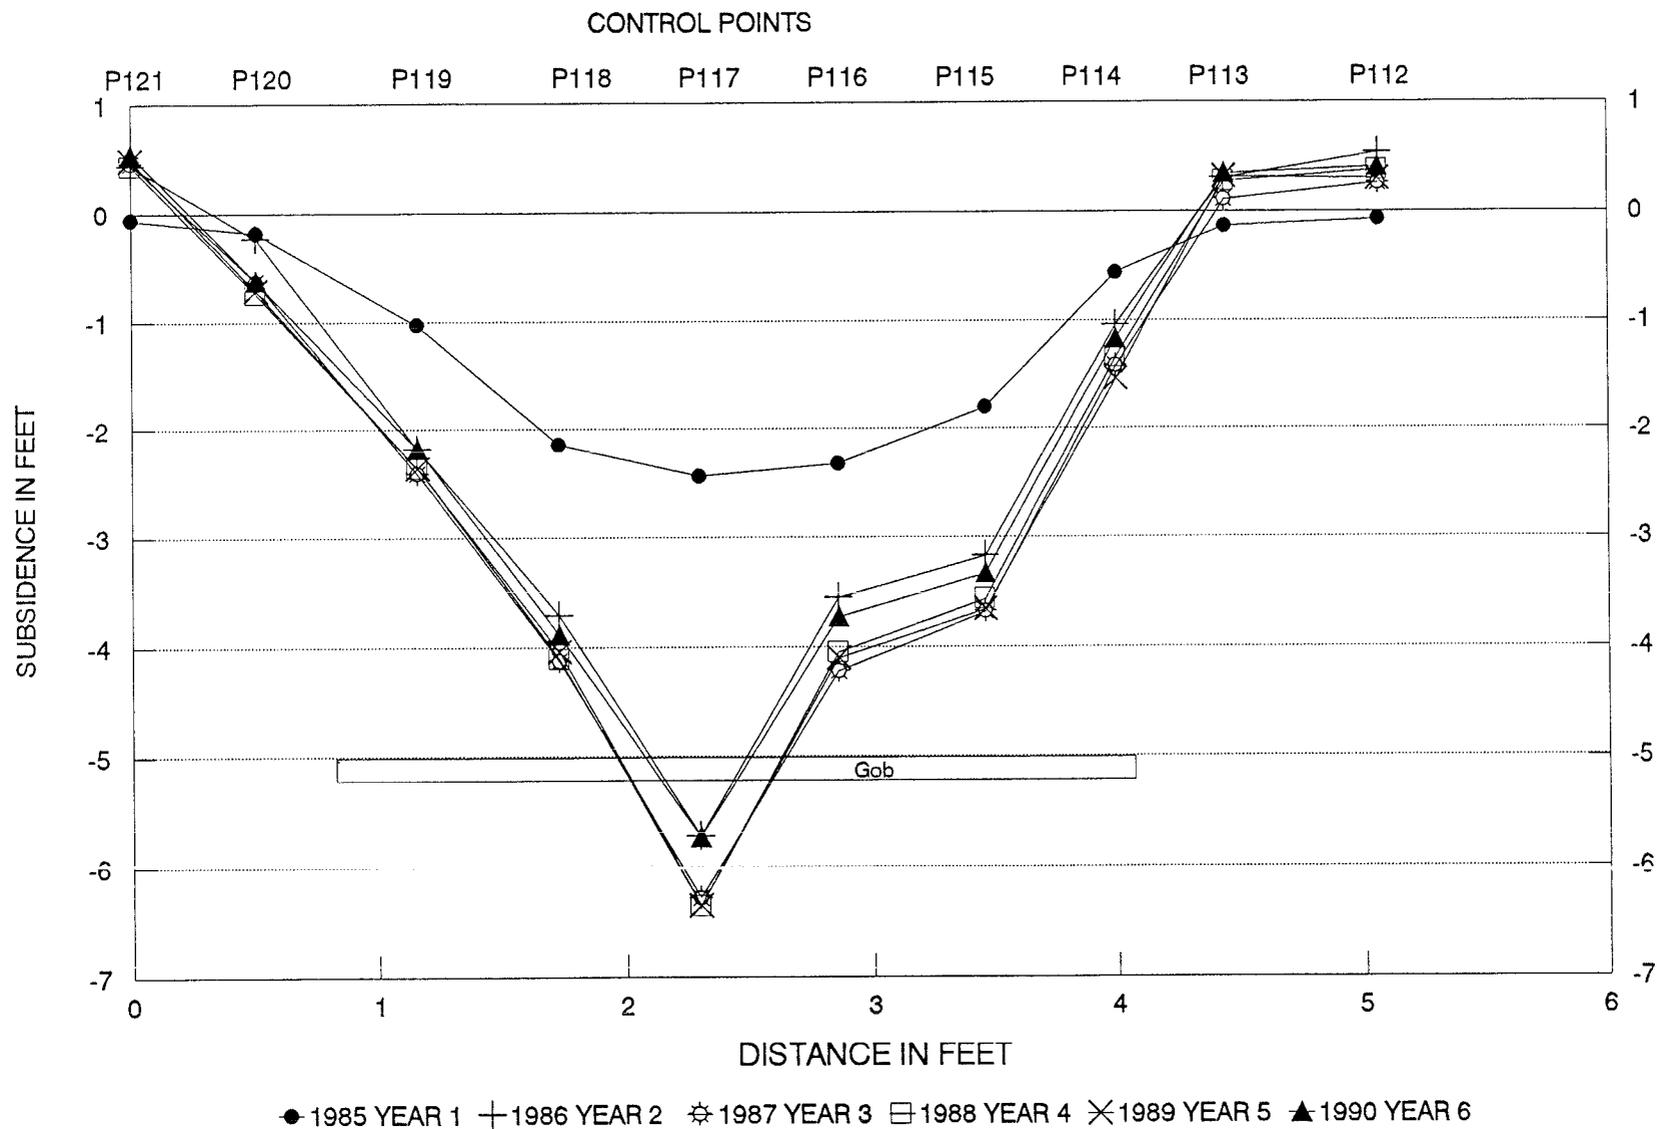
FIGURE 2
CROSS SECTION B-B LONGWALL PANEL 2

Cross sections have been plotted through Panels 1-7, 13 and 14 (Figure 1), Panel 2 (Figure 2), and Panel 4 (Figure 3). Cross Section F-F has been plotted of monitoring points U-18 through U-32 (Figure 10) showing the angle of draw at this location of 15 degrees. Please refer to Map 521.121e for cross section locations.

As can be seen on Figures 1, 2, and 3, subsidence has stopped above the longwall panels in the area of longwall panels 1-7 and 13 and 14. Subsidence reached its maximum during the third year after mining. Figure 1 shows the subsidence profile diagonally through the nine longwall panels. The progression of subsidence can be seen to the north as successive panels were mined.

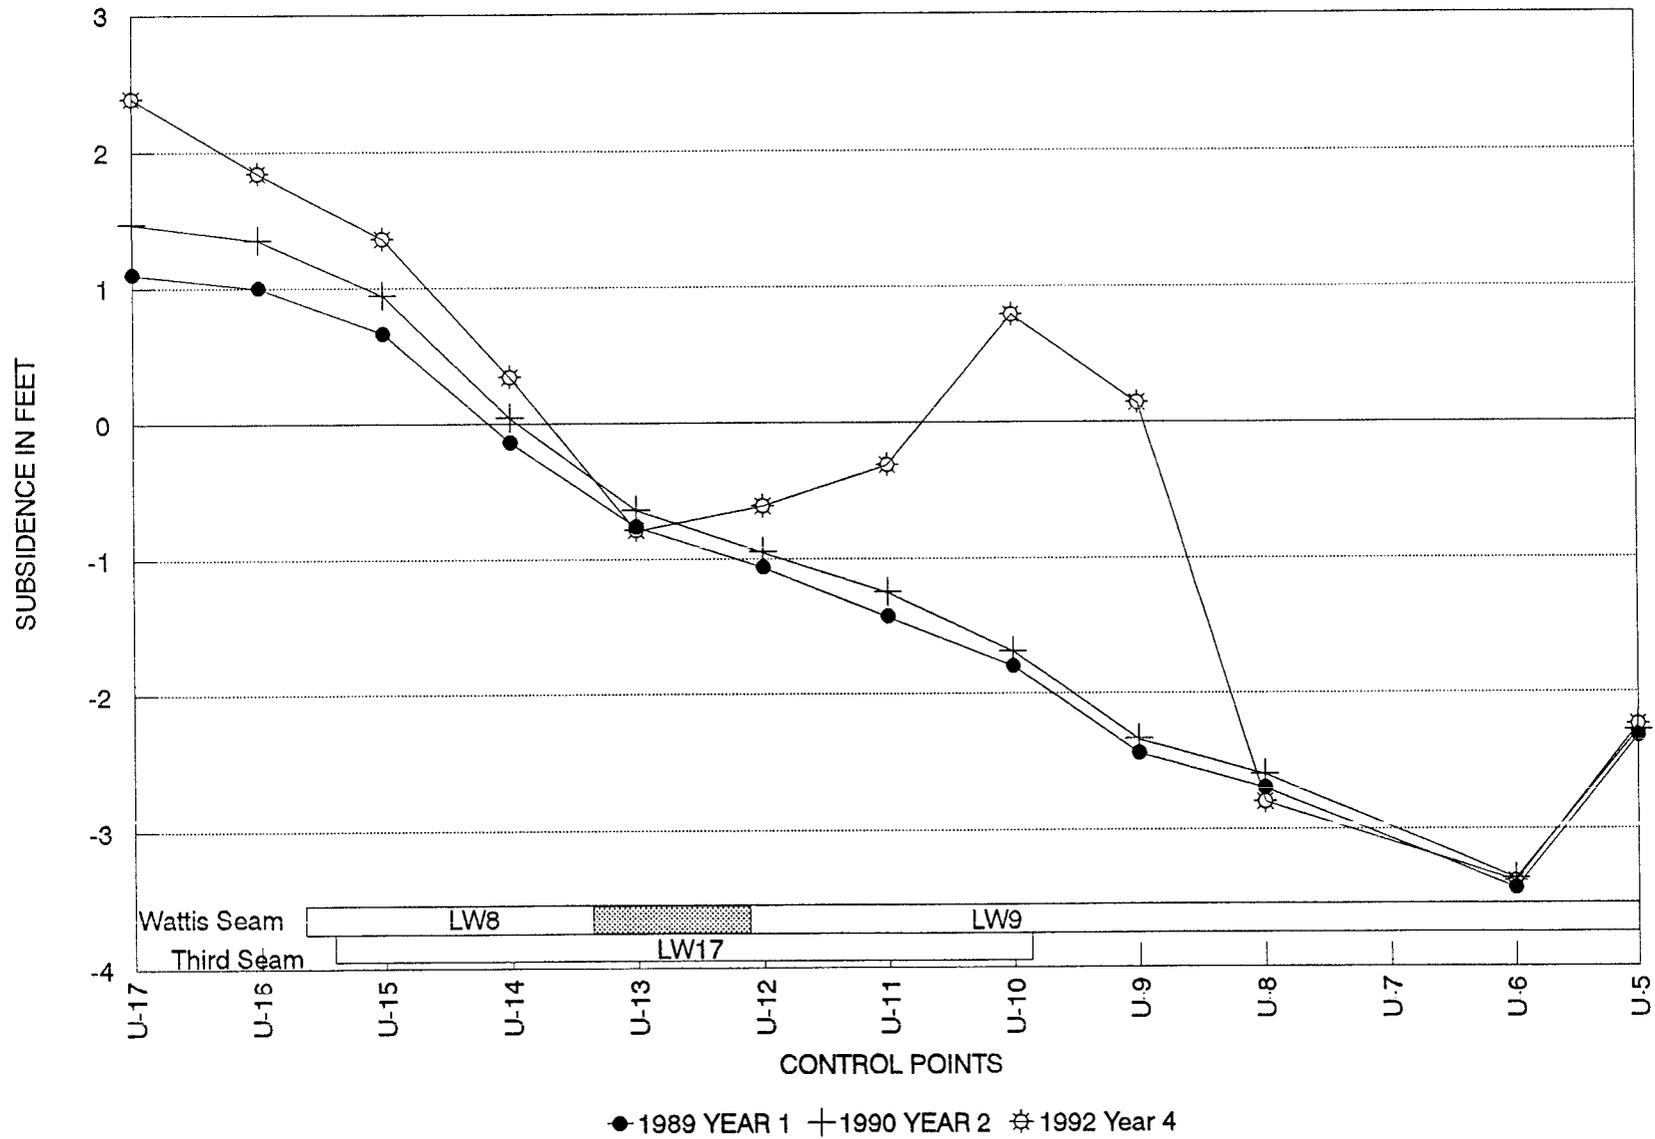
FIGURE 4
U-NORTH NEAR-STREAM PROFILE

A cross section through Points U5-U17 in Section 18 (Figure 4) indicates a maximum vertical drop of 3.4 feet. These monitoring points were not monitored in 1991 due to hazardous conditions but, were monitored again in 1992. They were not monitored in 1993 due to hazardous conditions. As can be seen on the cross section, mining of longwall panels 16 and 17 in the Third Seam caused additional movement.

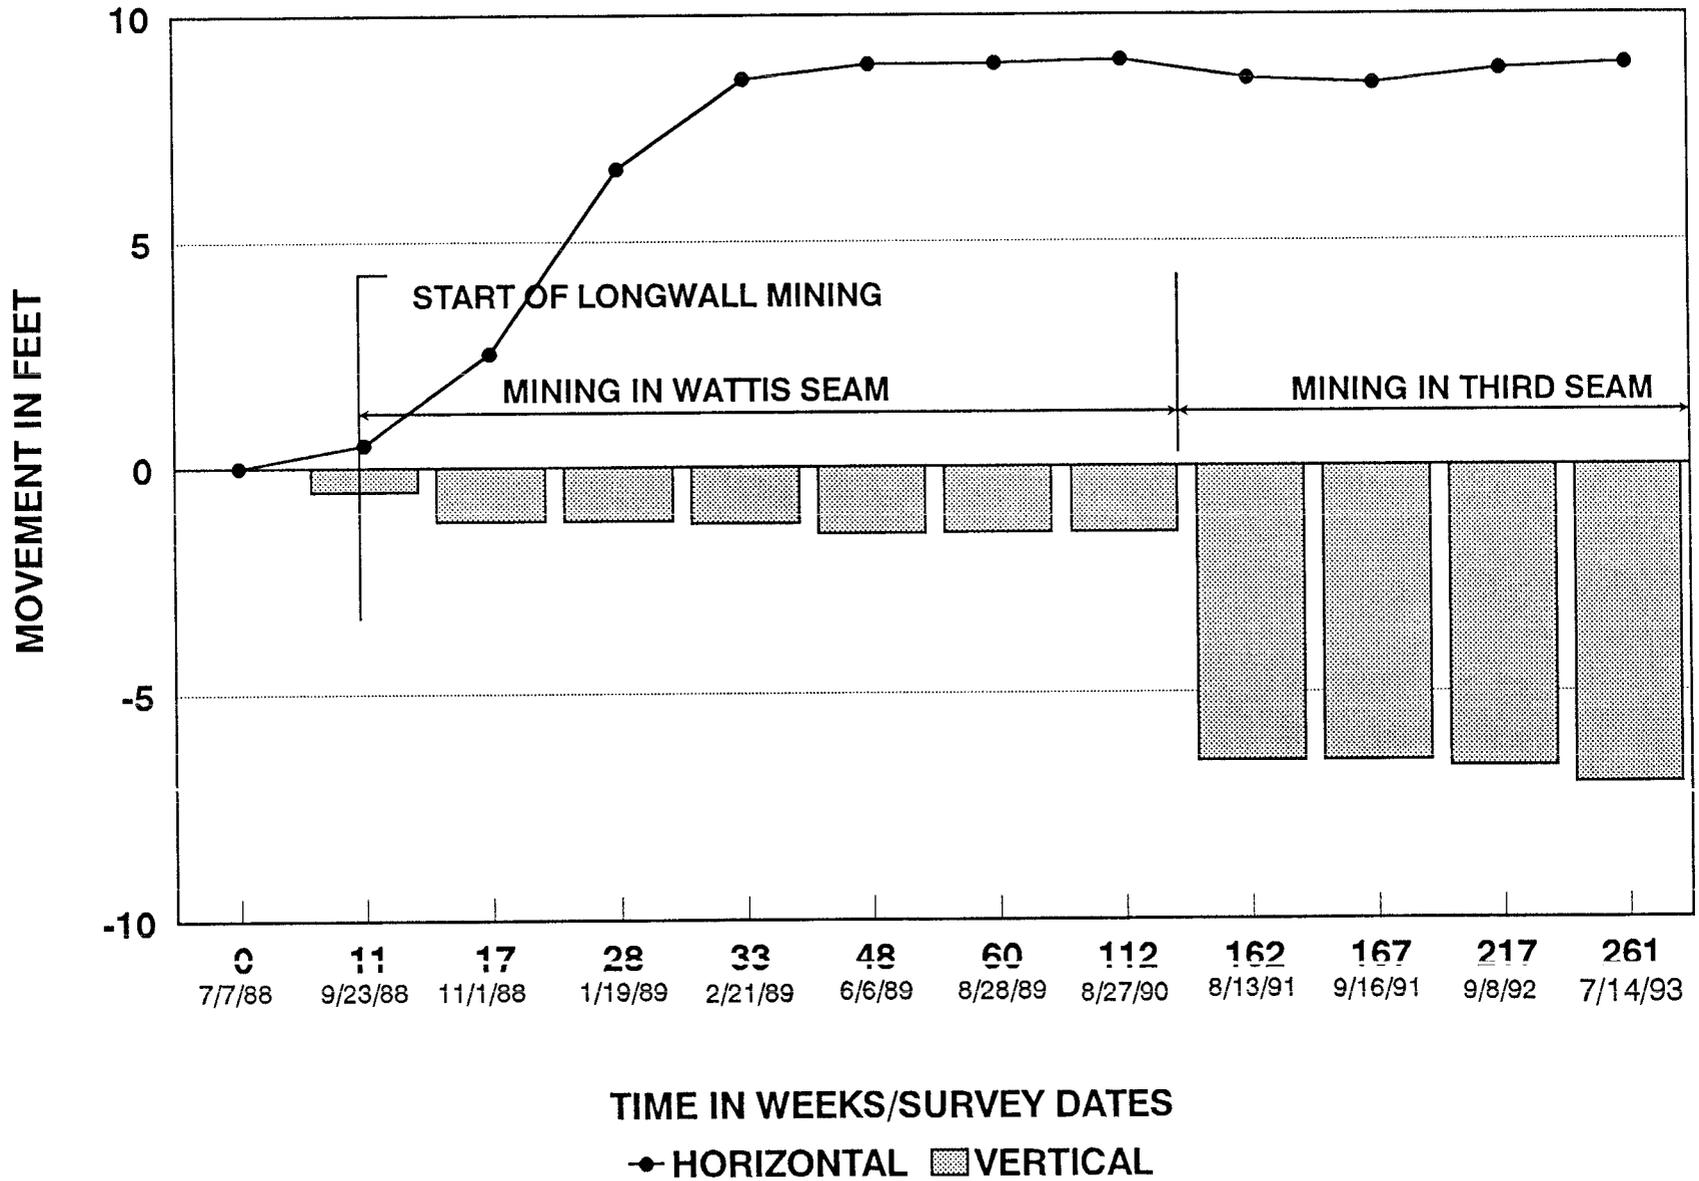
FIGURE 5
 U-NORTH SUBSIDENCE MONITORING
 HORIZONTAL AND VERTICAL MOVEMENT GRAPH
 STATION U1

Horizontal and vertical movement graphs have been made of monitoring points U1, U2, U3, and U4, Figures 5, 6, 7, and 8 respectively. Point U1, which is located directly above the north edge of longwall mining in the Wattis coal seam, shows the most vertical and horizontal movement. Point U4 which is located north of mining in the Wattis Seam and at the north edge of mining in the Third Seam shows the least movement.

A portion of the surface cracks near monitoring points U1 and U2 in Section 18 have been repaired to reduce the likelihood of accidents. The cracks were backfilled and the area fenced. Signs were placed in the area warning the public of the potential danger of the unstable ground. This area is fee land owned by the U.S. Fuel Company; Cyprus Plateau Mining Corporation has an agreement with U.S. Fuel which allows mining impacts.

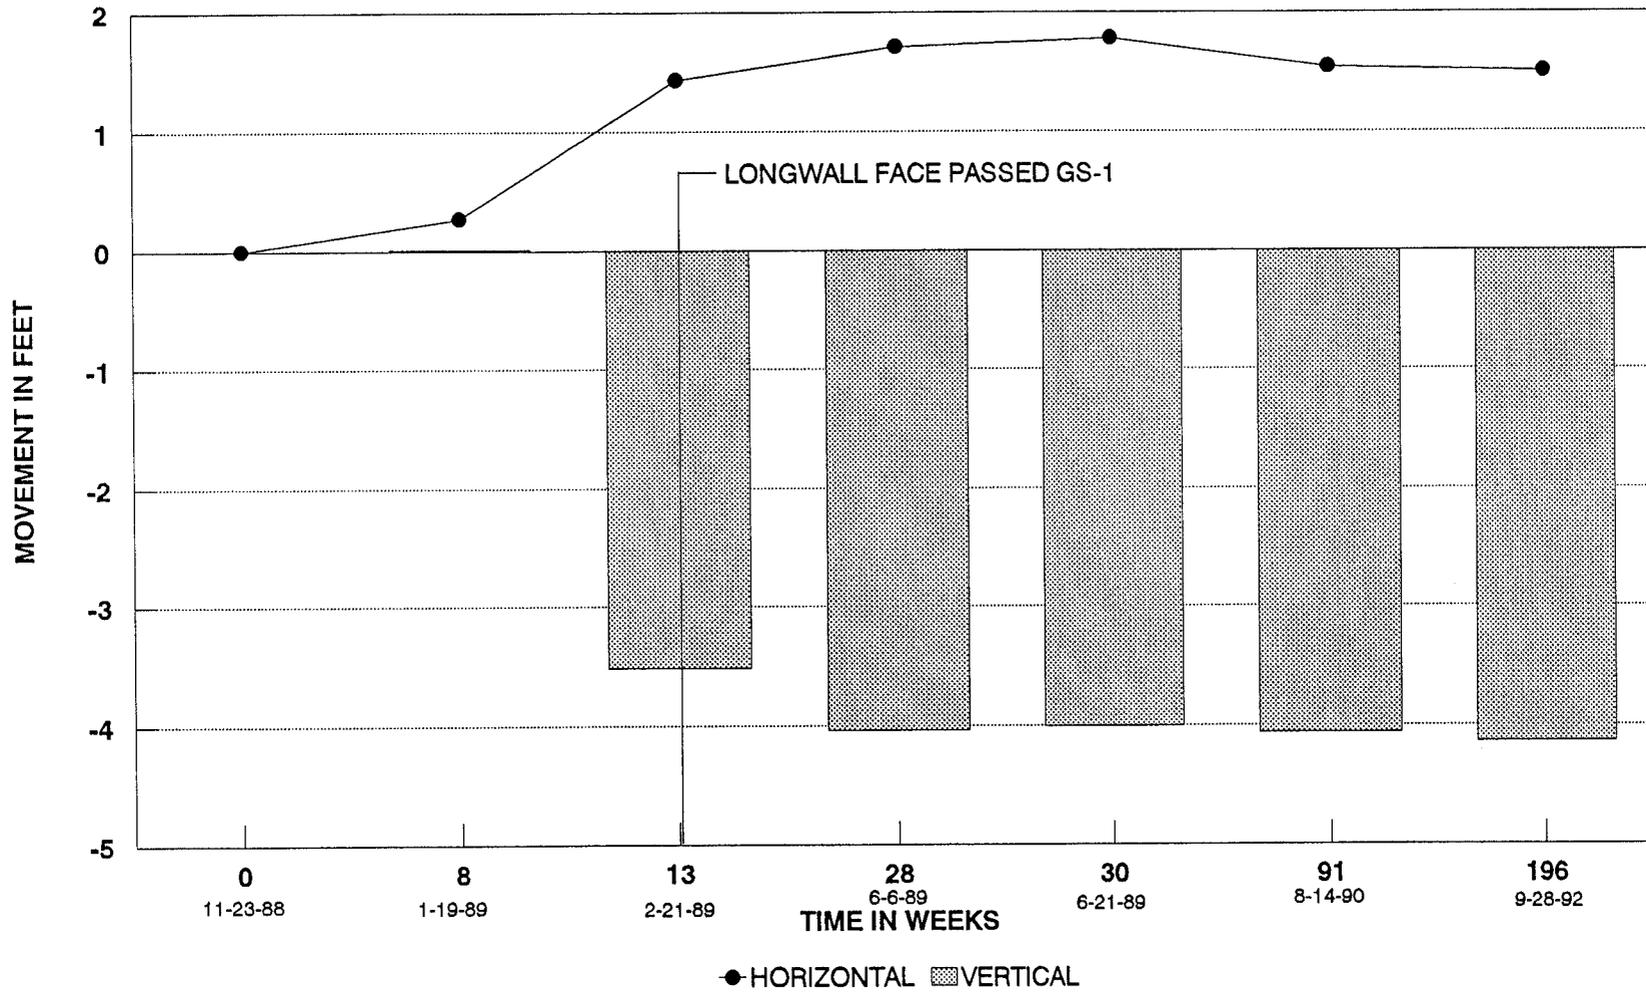
FIGURE 9
STATION GS-1 U-NORTH
HORIZONTAL AND VERTICAL MOVEMENT GRAPH

A horizontal and vertical movement graph (Figure 9) has been plotted of monitoring point GS-1 near the stream in Section 18. Probably because of the shallow overburden at the GS-1 point location, maximum subsidence occurred within 15 weeks of the longwall face passing the point. This monitoring point was not surveyed

in 1991 and 1993 because of the hazardous condition previously discussed but, was surveyed in 1992. Mining of the Third seam was approximately 220 feet away and appears to have had only minor additional impact on this point.

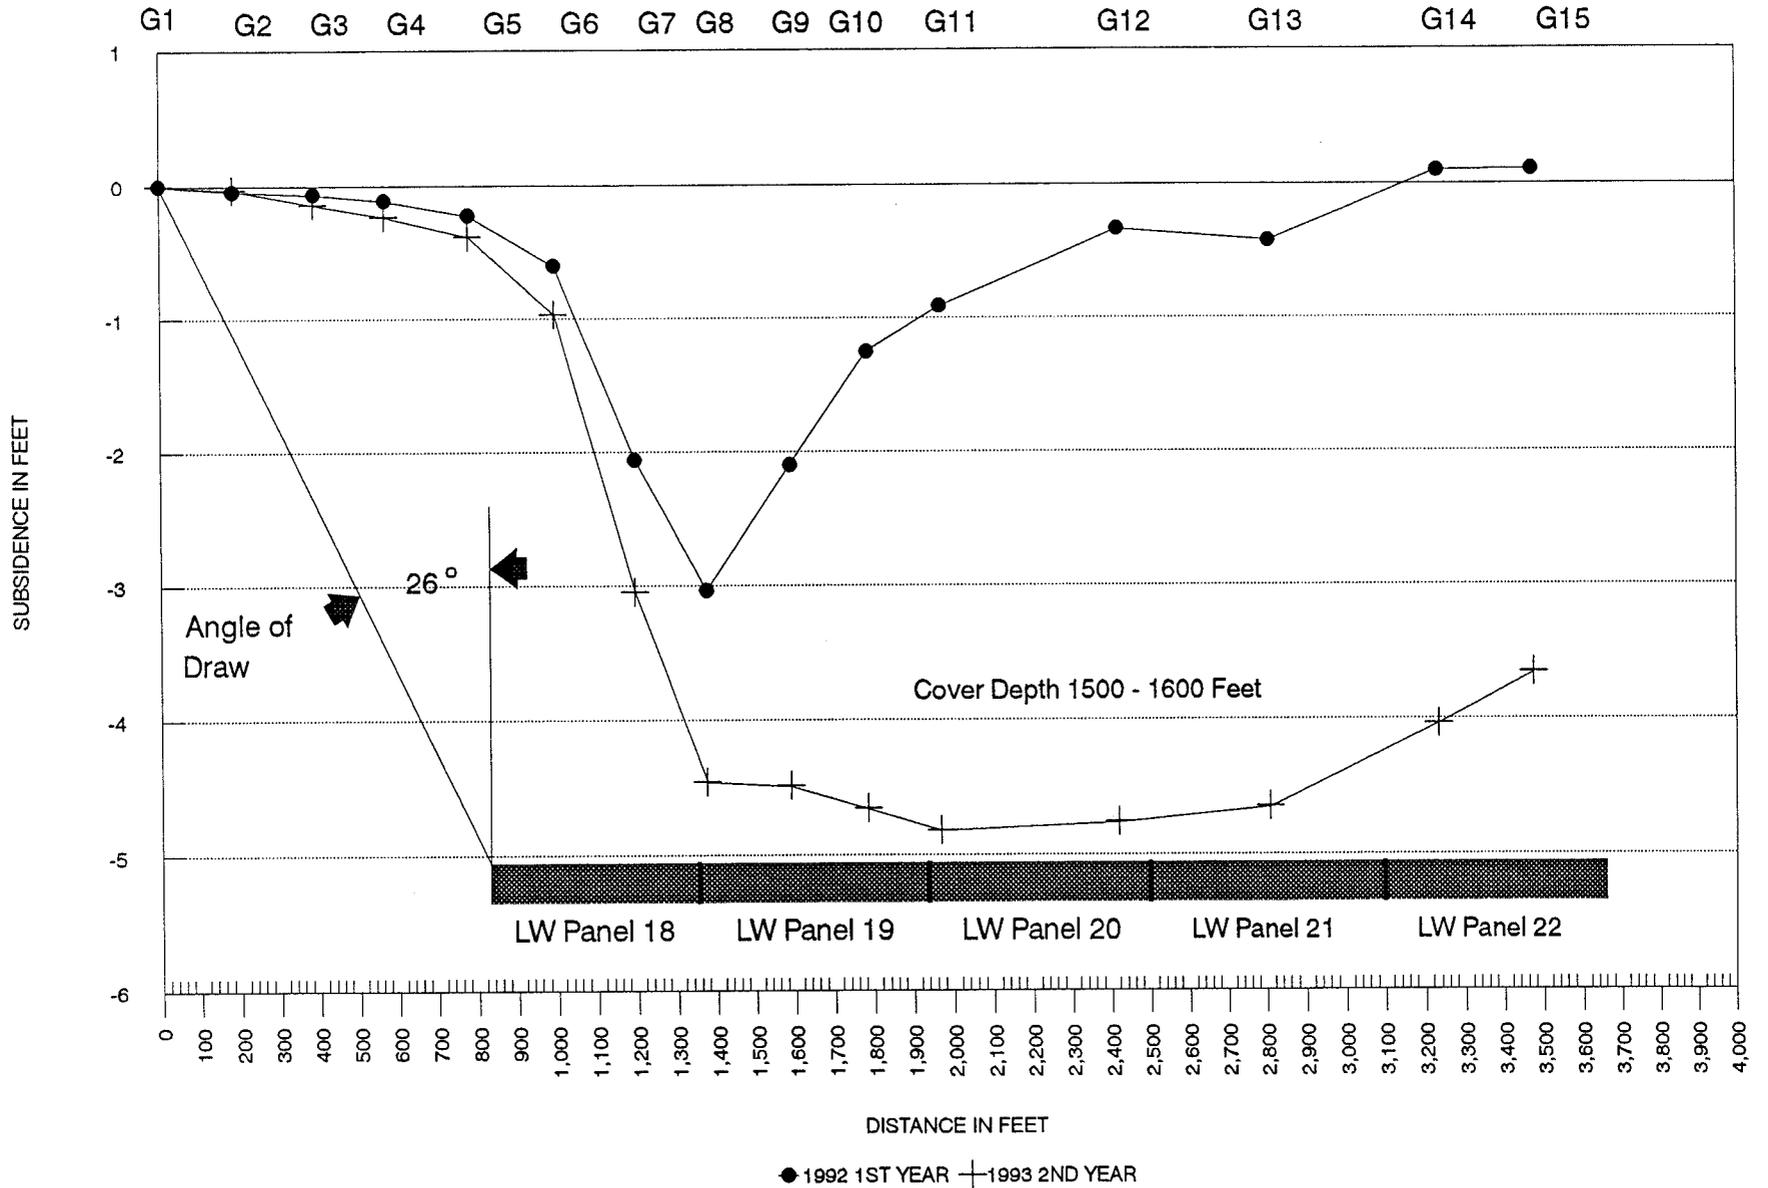
FIGURE 11 CROSS SECTION D-D

Mining in 1993 included approximately 40% of longwall panel 21, all of panels 22, 23, 24, and 97% of panel 25 as shown on Map W-4. Monitoring points G1 through G19 as shown on Map 521.121f were surveyed for vertical movement. Cross sections D-D (Figure 11) and E-E (Figure 12) were plotted from the data at these monitoring points. As can be seen on the cross sections, maximum subsidence was nearly 5 feet.

As shown on Cross Sections D-D and E-E, the angle of draw at these locations is 26 degrees and 24 degrees respectively.
