SUBSIDENCE MONITORING REPORT  
1993  
STAR POINT MINE  
ACT/007/006

Cyprus Plateau Mining Corporation  
P.O. Box PMC  
Price, Utah 84501

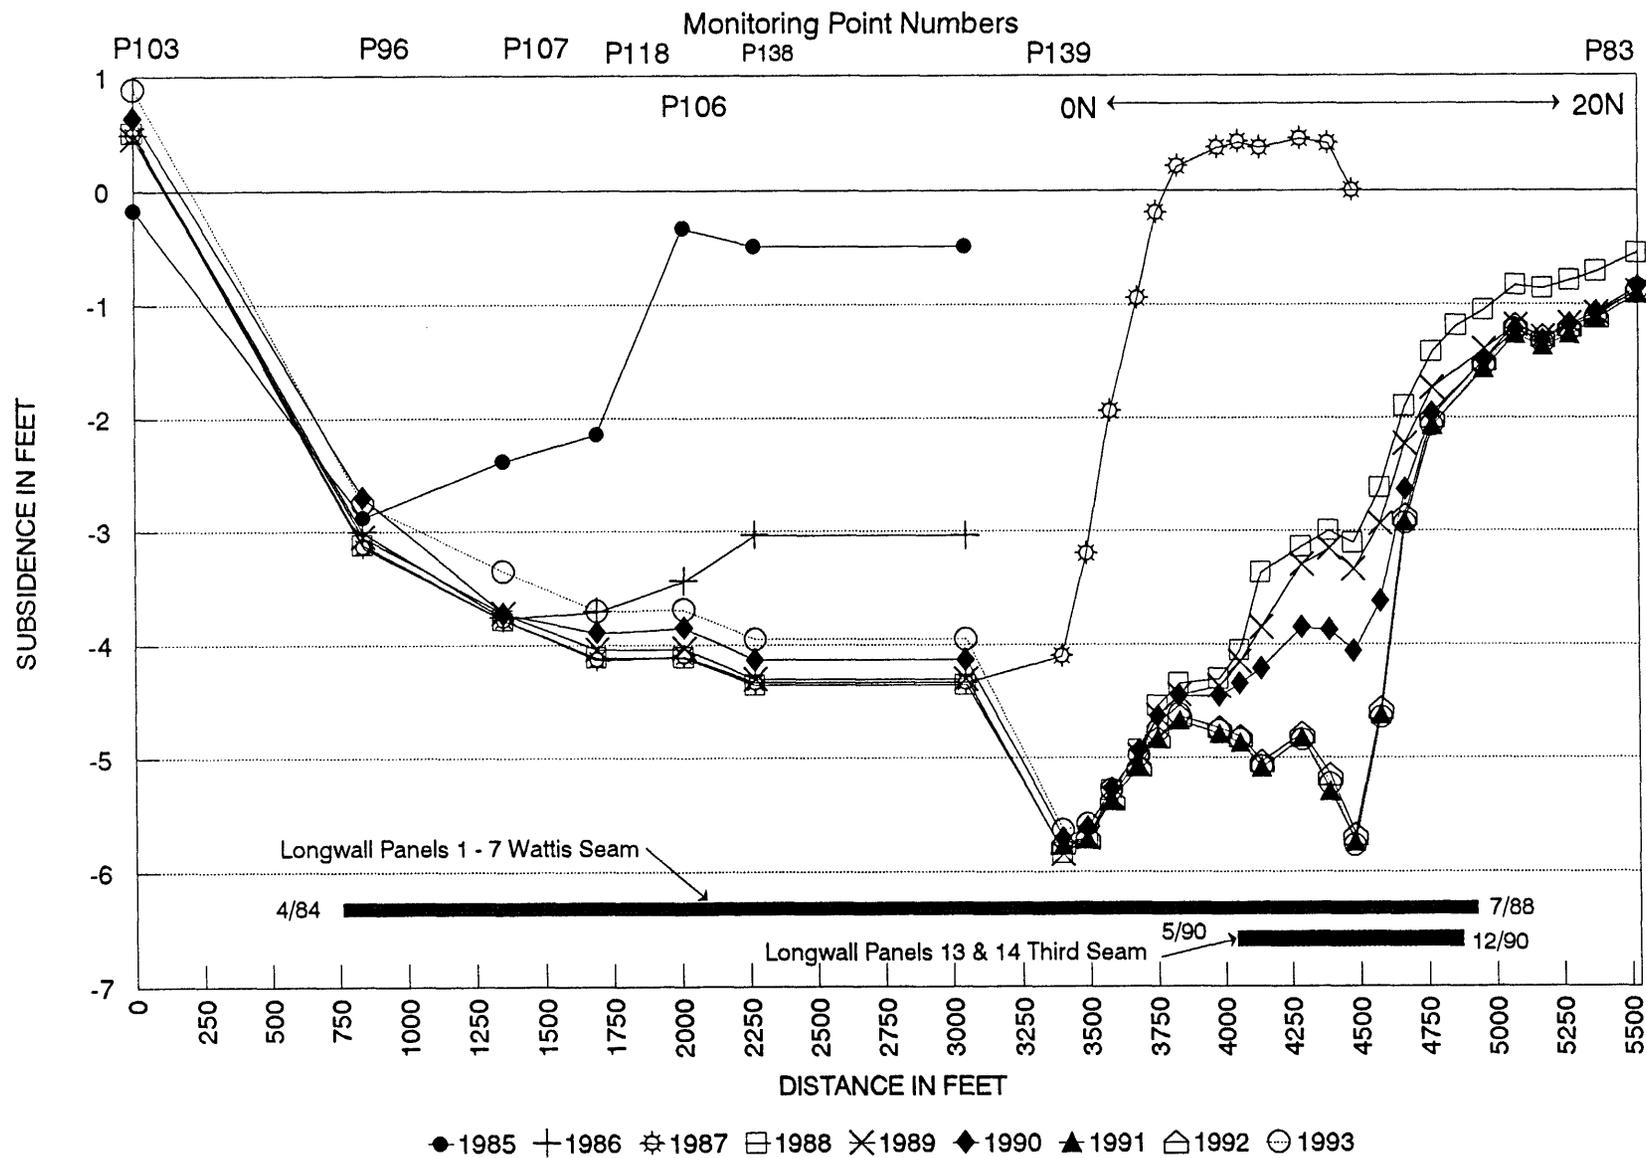
FIGURE 1  
CROSS SECTION A-A

As can be seen on Figures 1, 2, and 3, subsidence has stopped above the longwall panels in the area of longwall panels 1-7 and 13 and 14. Subsidence reached its maximum during the third year after mining. Figure 1 shows the subsidence profile diagonally through the nine longwall panels. The progression of subsidence can be seen to the north as successive panels were mined.

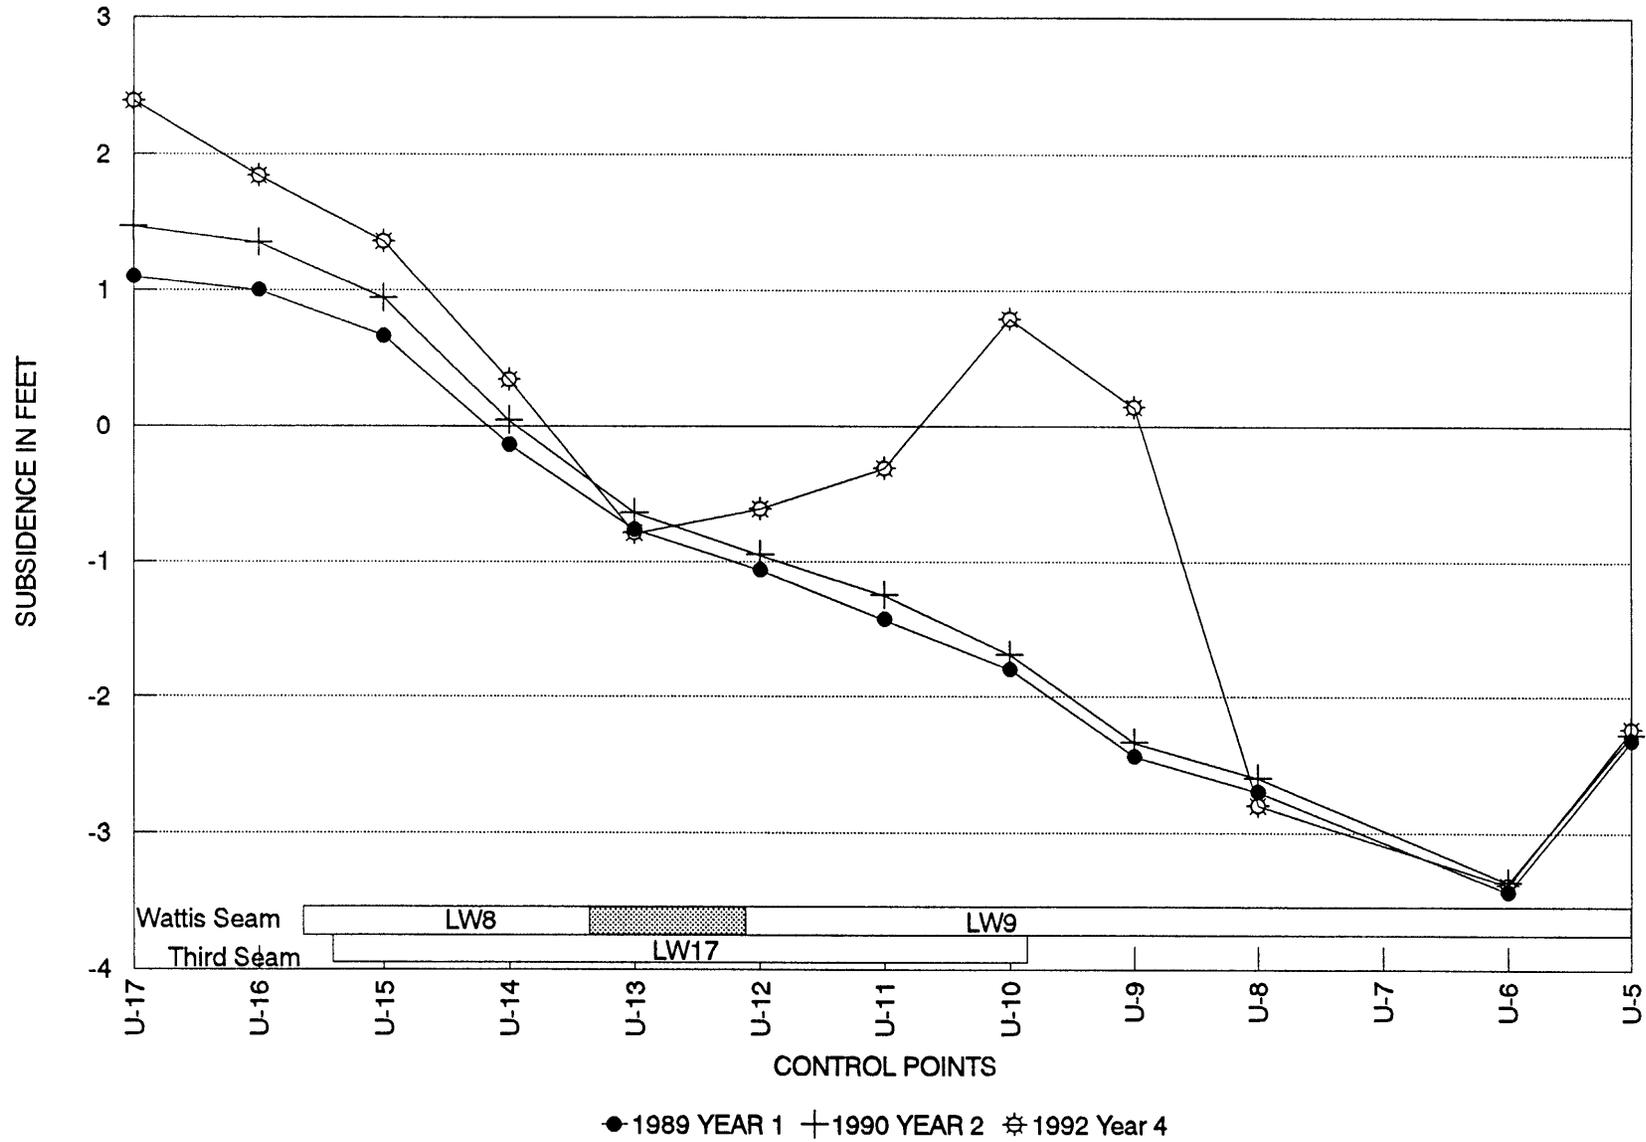
FIGURE 4  
U-NORTH NEAR-STREAM PROFILE

A cross section through Points U5-U17 in Section 18 (Figure 4) indicates a maximum vertical drop of 3.4 feet. These monitoring points were not monitored in 1991 due to hazardous conditions but, were monitored again in 1992. They were not monitored in 1993 due to hazardous conditions. As can be seen on the cross section, mining of longwall panels 16 and 17 in the Third Seam caused additional movement.

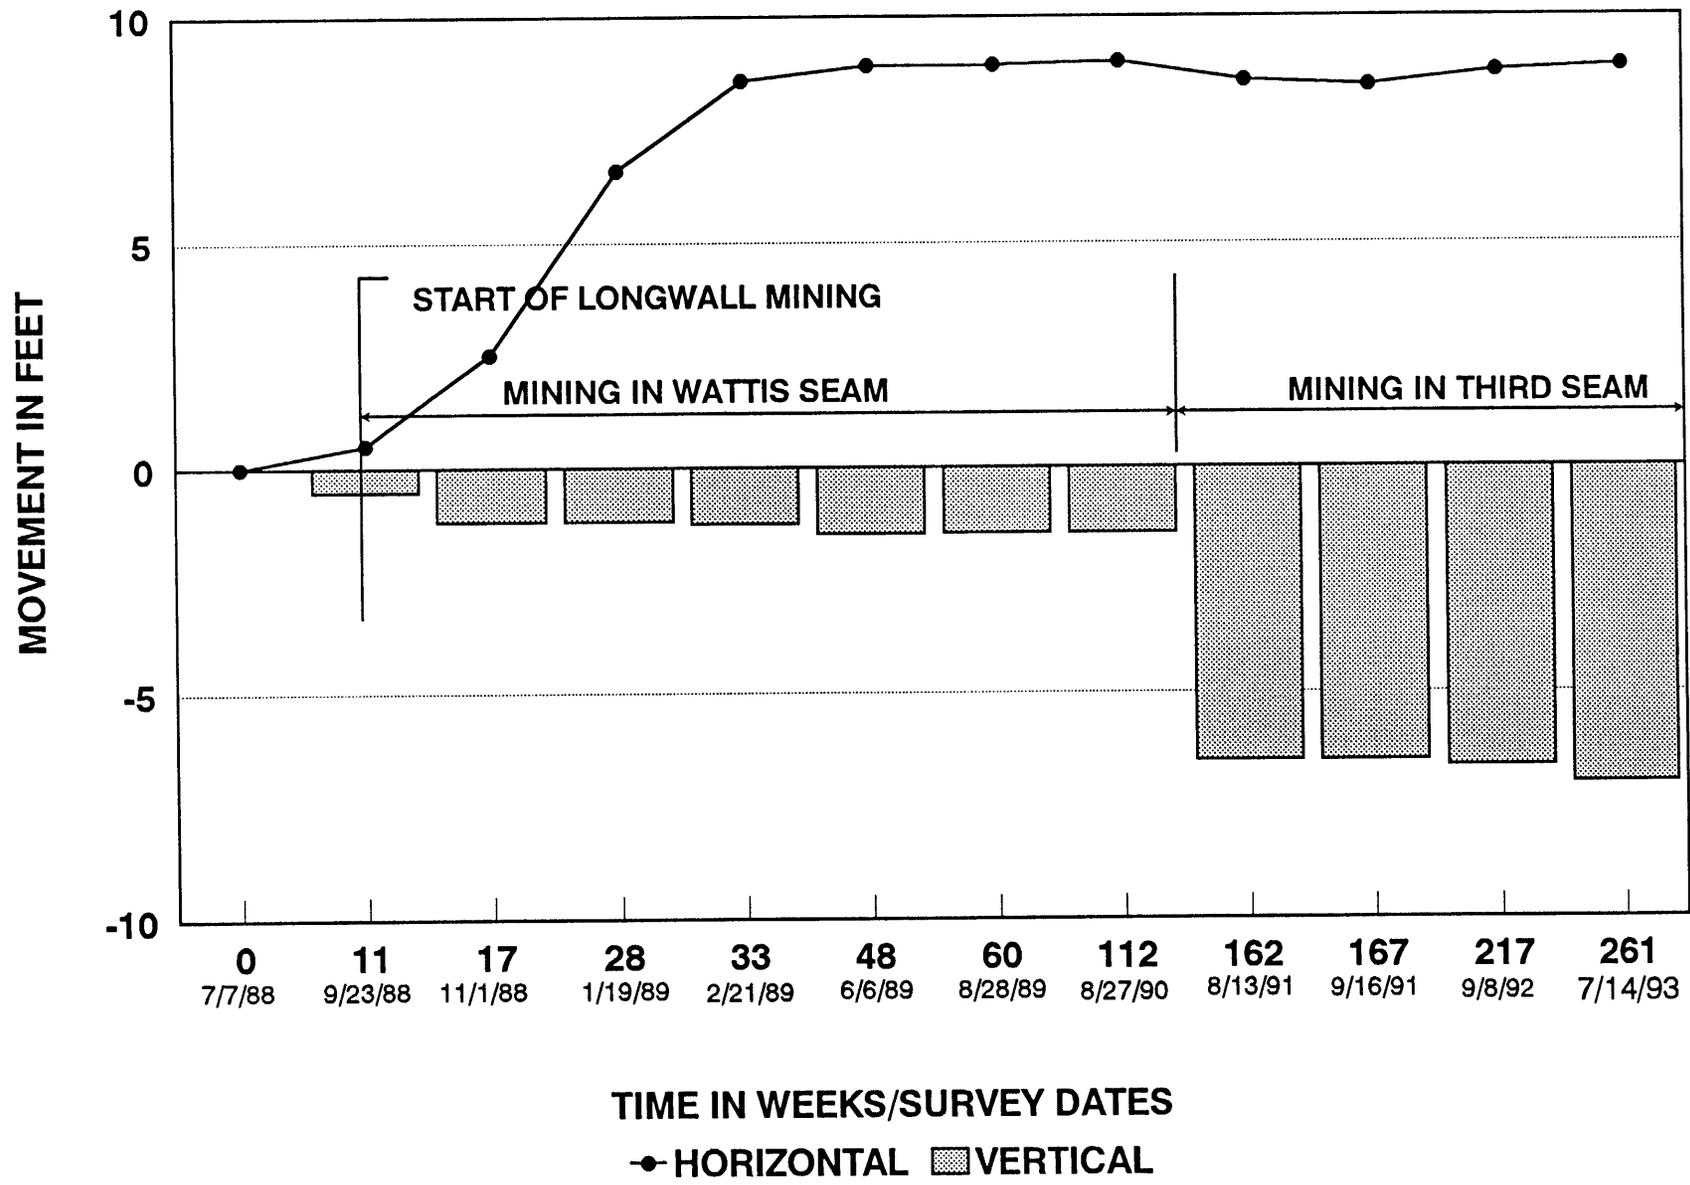
**FIGURE 5**  
**U-NORTH SUBSIDENCE MONITORING**  
**HORIZONTAL AND VERTICAL MOVEMENT GRAPH**  
**STATION U1**

Horizontal and vertical movement graphs have been made of monitoring points U1, U2, U3, and U4, Figures 5, 6, 7, and 8 respectively. Point U1, which is located directly above the north edge of longwall mining in the Wattis coal seam, shows the most vertical and horizontal movement. Point U4 which is located north of mining in the Wattis Seam and at the north edge of mining in the Third Seam shows the least movement.

A portion of the surface cracks near monitoring points U1 and U2 in Section 18 have been repaired to reduce the likelihood of accidents. The cracks were backfilled and the area fenced. Signs were placed in the area warning the public of the potential danger of the unstable ground. This area is fee land owned by the U.S. Fuel Company; Cyprus Plateau Mining Corporation has an agreement with U.S. Fuel which allows mining impacts.

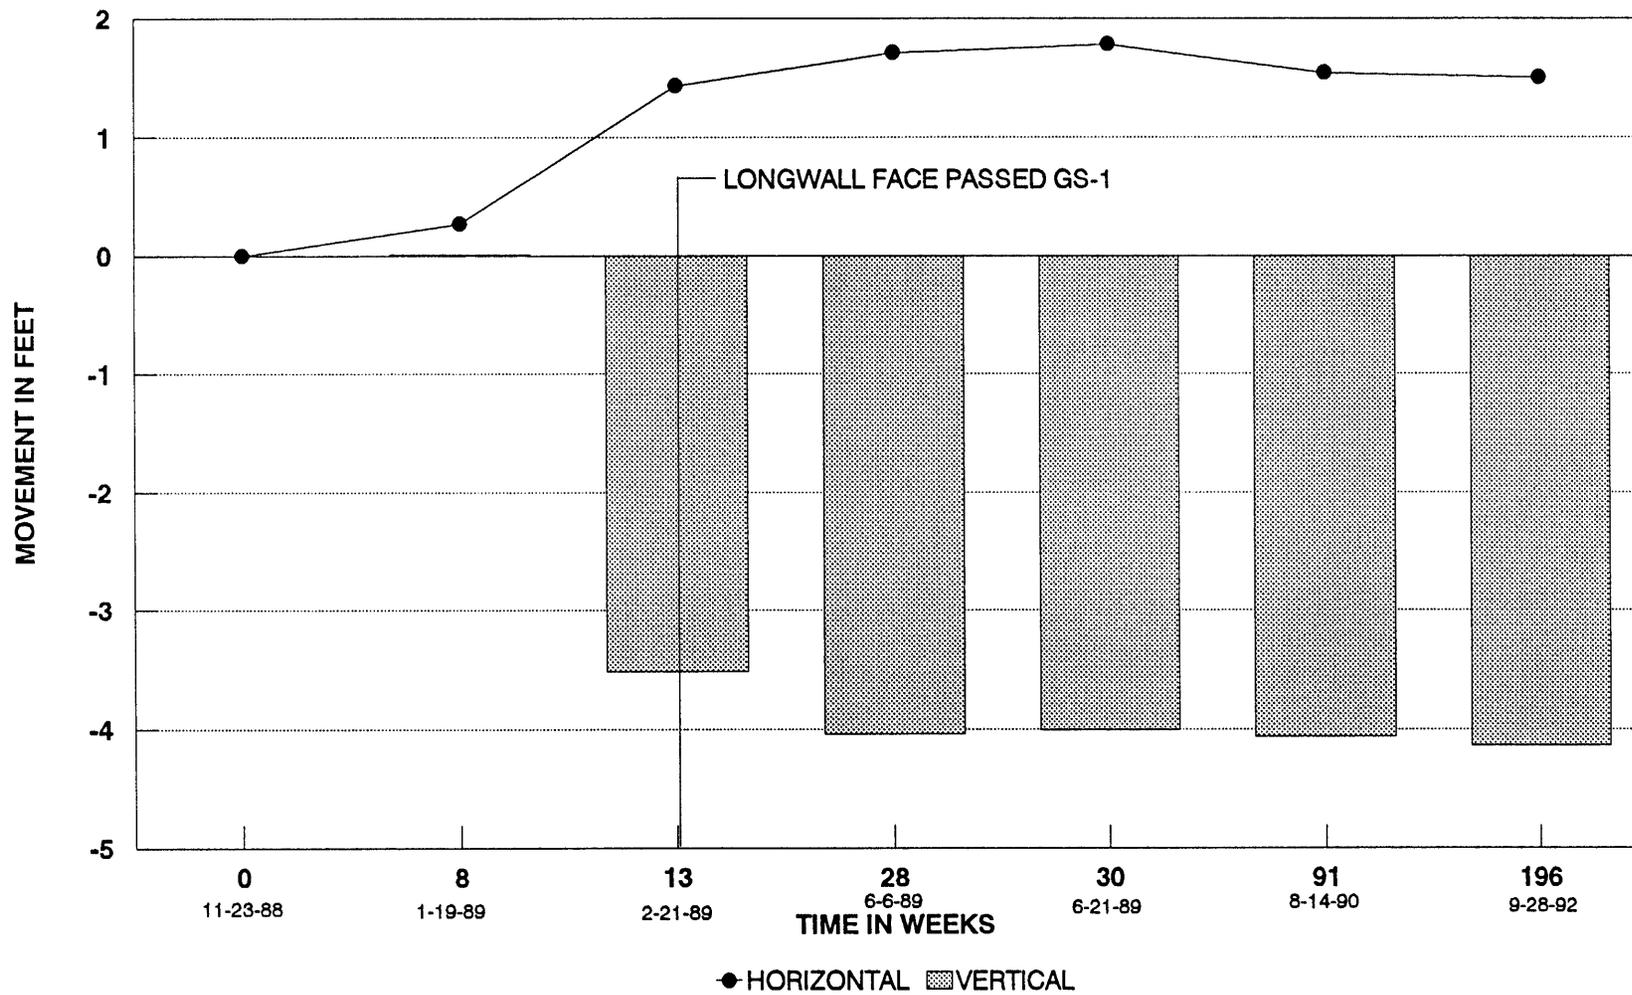
FIGURE 9  
STATION GS-1 U-NORTH  
HORIZONTAL AND VERTICAL MOVEMENT GRAPH

A horizontal and vertical movement graph (Figure 9) has been plotted of monitoring point GS-1 near the stream in Section 18. Probably because of the shallow overburden at the GS-1 point location, maximum subsidence occurred within 15 weeks of the longwall face passing the point. This monitoring point was not surveyed

in 1991 and 1993 because of the hazardous condition previously discussed but, was surveyed in 1992. Mining of the Third seam was approximately 220 feet away and appears to have had only minor additional impact on this point.

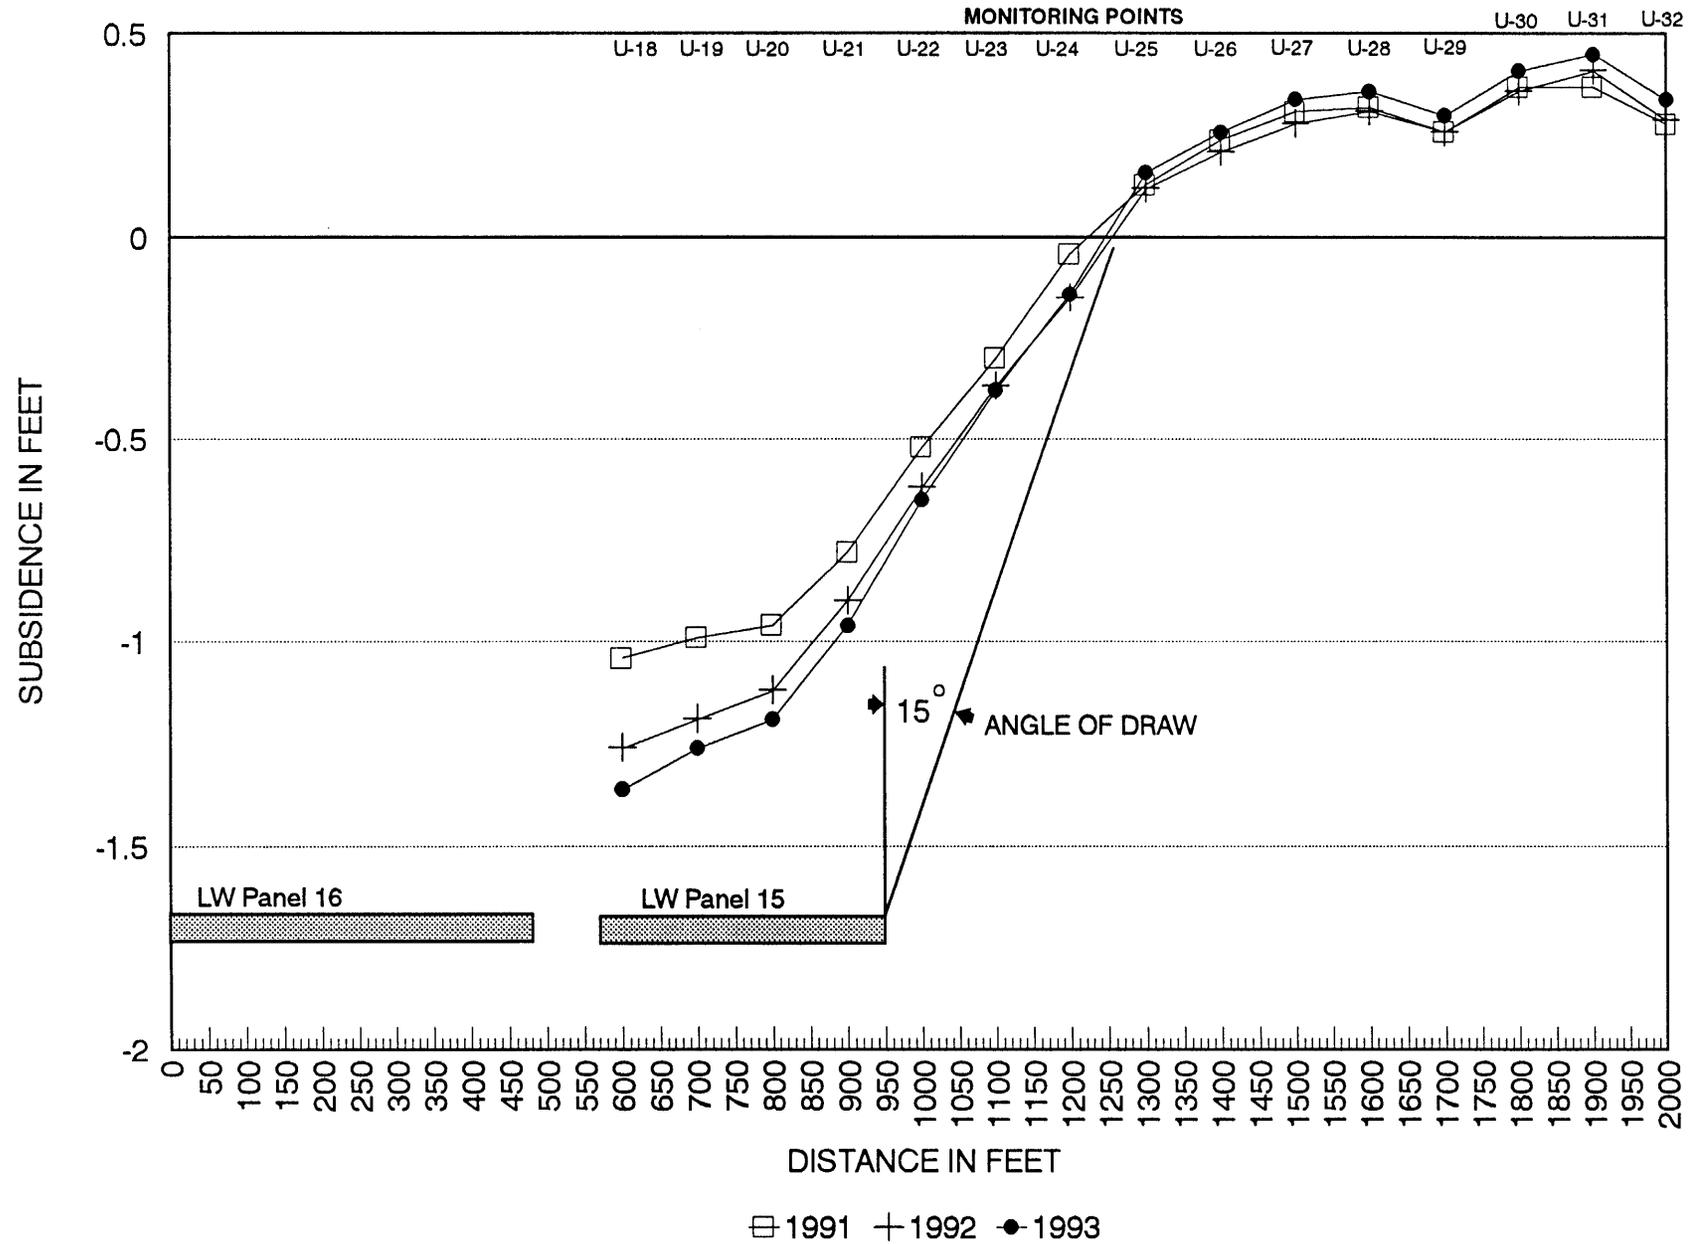
FIGURE 10  
CROSS SECTION F-F

Cross sections have been plotted through Panels 1-7, 13 and 14 (Figure 1), Panel 2 (Figure 2), and Panel 4 (Figure 3). Cross Section F-F has been plotted of monitoring points U-18 through U-32 (Figure 10) showing the angle of draw at this location of 15 degrees. Please refer to Map 521.121e for cross section locations.

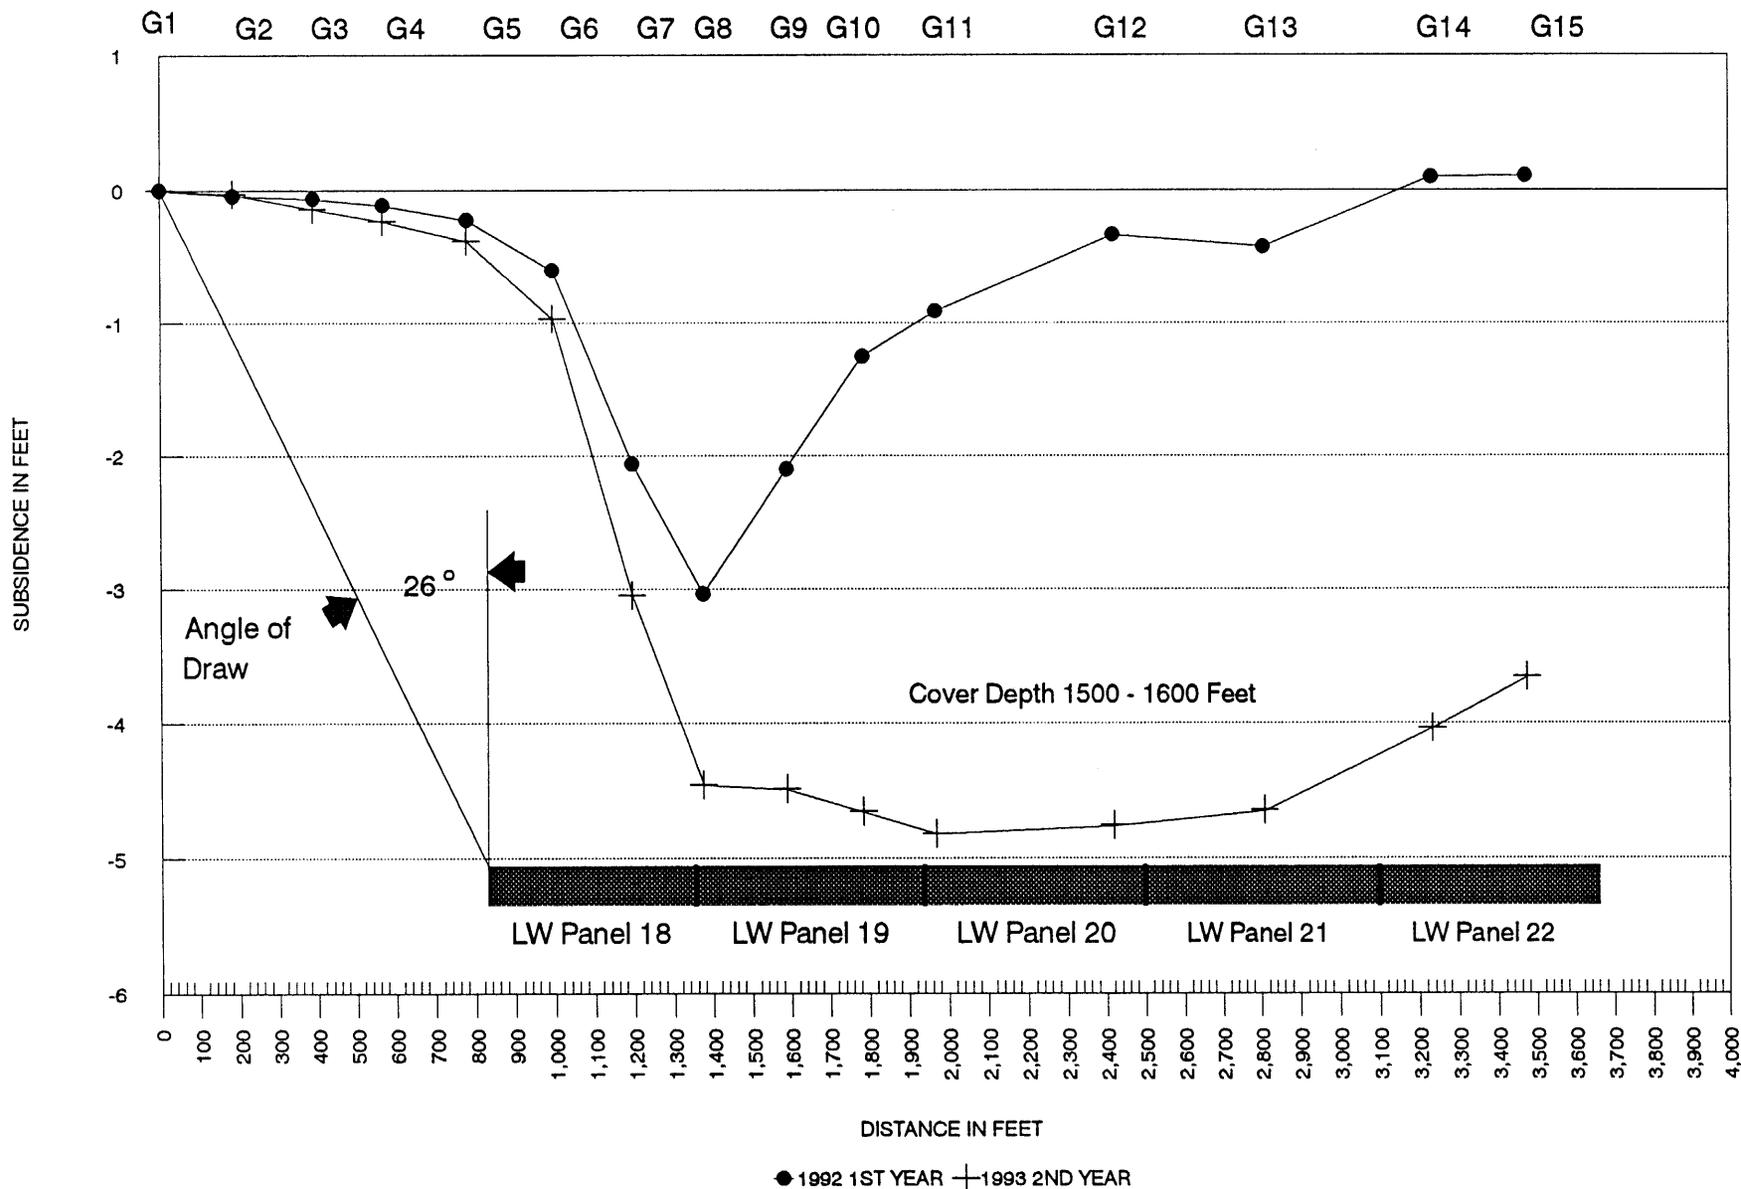
FIGURE 11  
CROSS SECTION D-D

Mining in 1993 included approximately 40% of longwall panel 21, all of panels 22, 23, 24, and 97% of panel 25 as shown on Map W-4. Monitoring points G1 through G19 as shown on Map 521.121f were surveyed for vertical movement. Cross sections D-D (Figure 11) and E-E (Figure 12) were plotted from the data at these monitoring points. As can be seen on the cross sections, maximum subsidence was nearly 5 feet.

As shown on Cross Sections D-D and E-E, the angle of draw at these locations is 26 degrees and 24 degrees respectively.

If visual inspection of the area west of longwall panels 18 through 22 finds any surface impacts to the Wild Cattle Hollow Stream channel, the layout of future panels will be adjusted to provide protection to the stream. Panels 23 through 30 have been designed using an angle of draw of 26 degrees from the stream channel to protect the stream.
