SUBSIDENCE MONITORING REPORT  
1994  
STAR POINT MINE  
ACT/007/006

Cyprus Plateau Mining Corporation  
P.O. Box PMC  
Price, Utah 84501

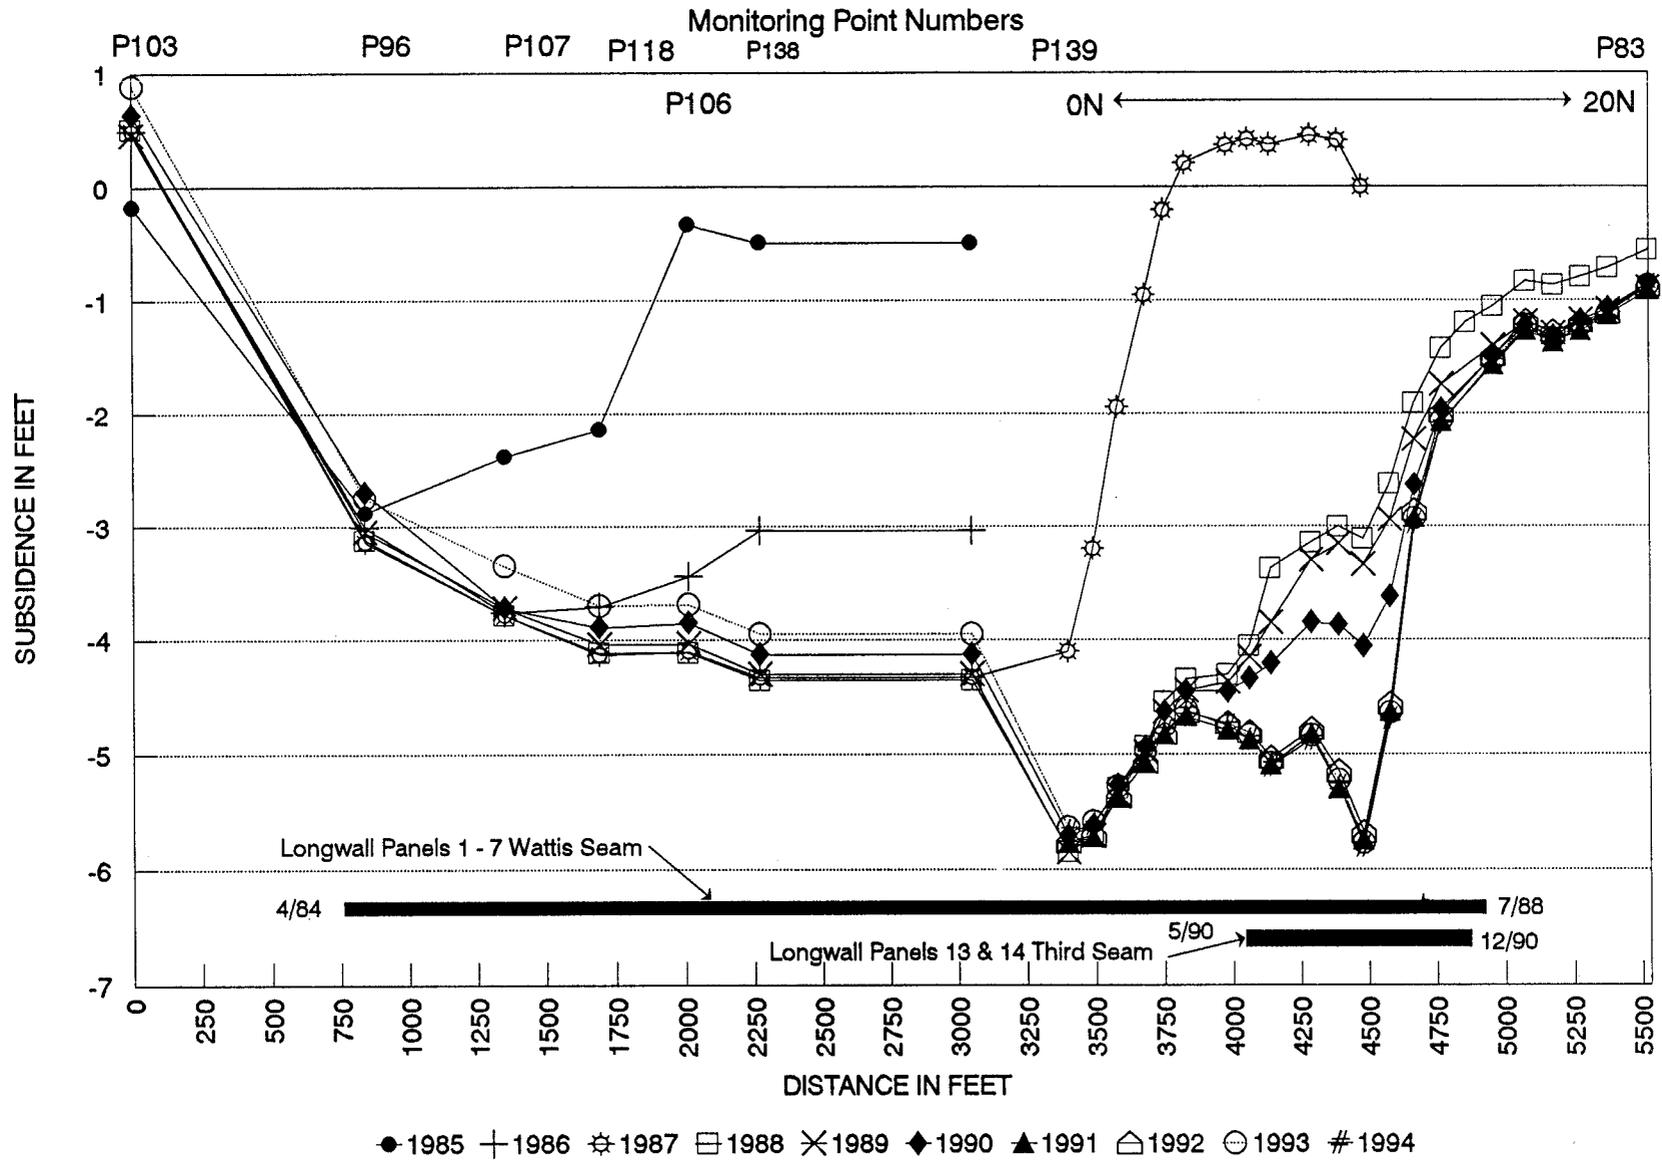
# FIGURE 1 CROSS SECTION A-A

Cross sections have been plotted through Panels 1-7, 13 and 14 (Figure 1), Panel 2 (Figure 2), and Panel 4 (Figure 3). Cross Section F-F has been plotted of monitoring points U-18 through U-32 (Figure 10) showing the angle of draw at this location of 15 degrees. Please refer to Map 521.121e for cross section locations.

As can be seen on Figures 1, 2, and 3, subsidence has stopped above the longwall panels in the area of longwall panels 1-7 and 13 and 14. Subsidence reached its maximum during the third year after mining. Figure 1 shows the subsidence profile diagonally through the nine longwall panels. The progression of subsidence can be seen to the north as successive panels were mined.

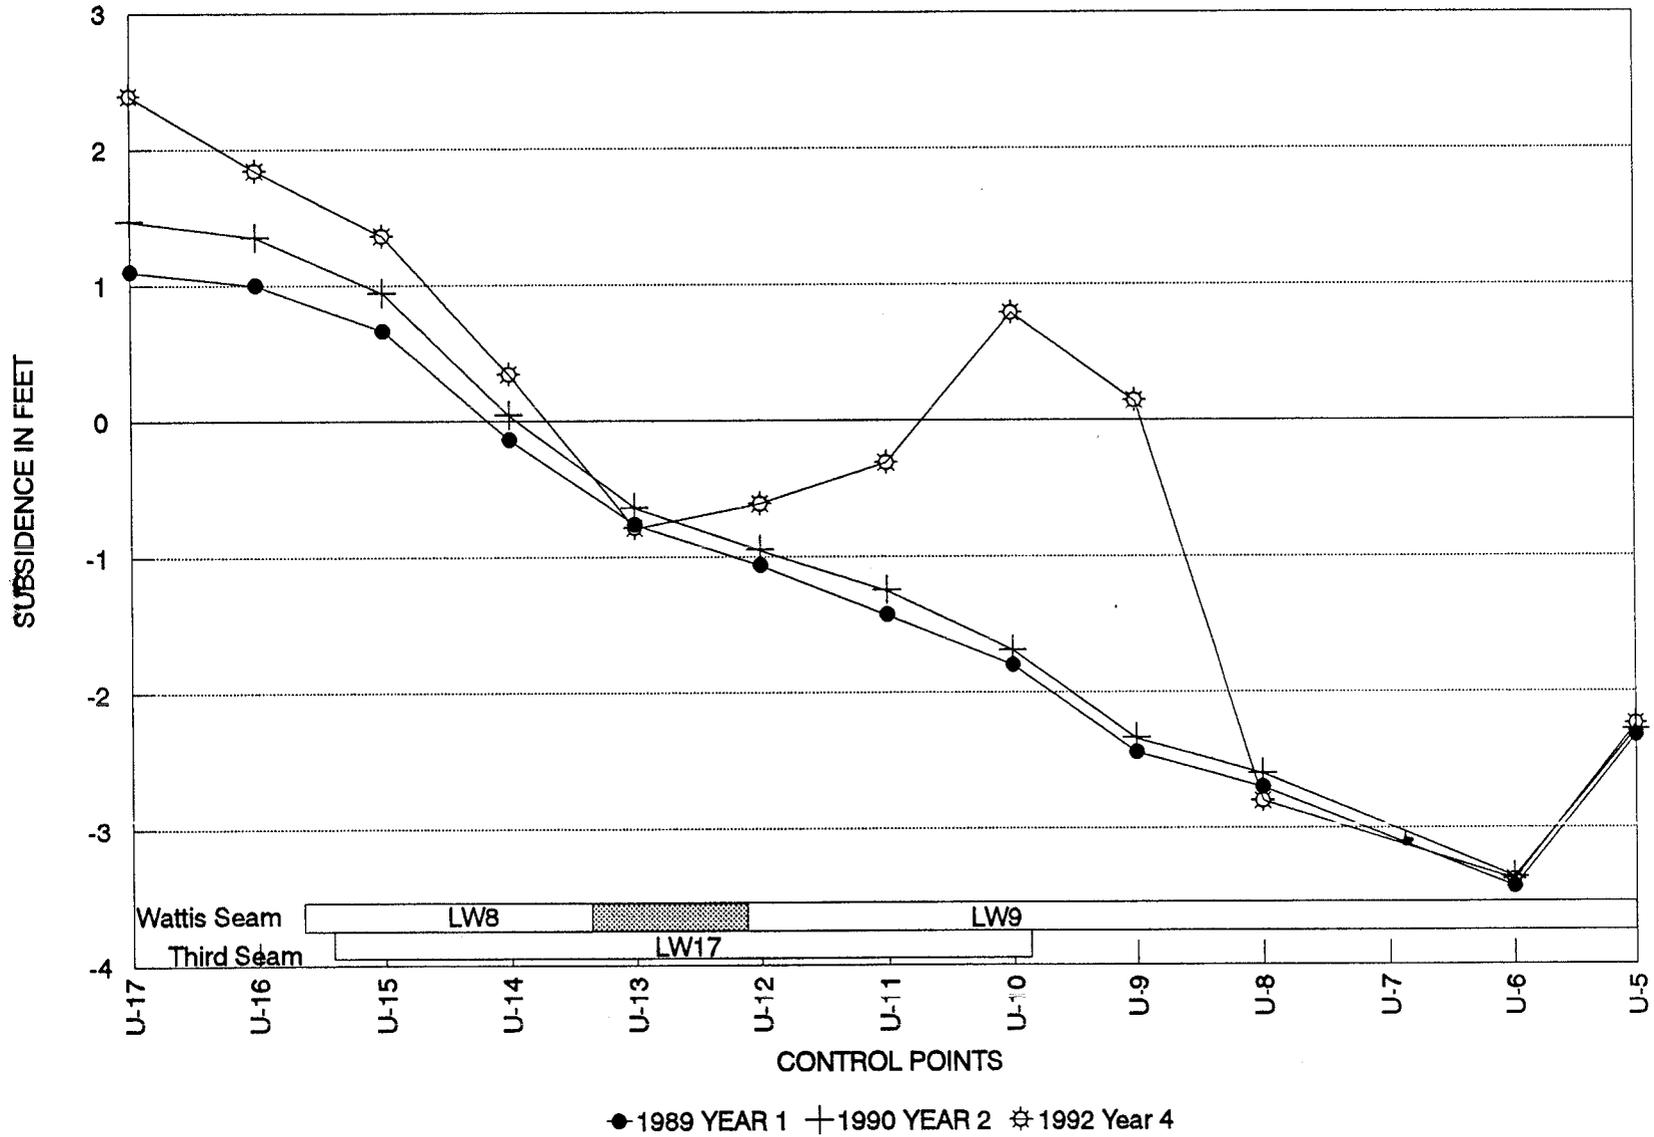
FIGURE 4  
U-NORTH NEAR-STREAM PROFILE

A cross section through Points U5-U17 in Section 18 (Figure 4) indicates a maximum vertical drop of 3.4 feet. These monitoring points were not monitored in 1991 due to hazardous conditions but, were monitored again in 1992. They were not monitored in 1993 due to hazardous conditions. As can be seen on the cross section, mining of longwall panels 16 and 17 in the Third Seam caused additional movement.

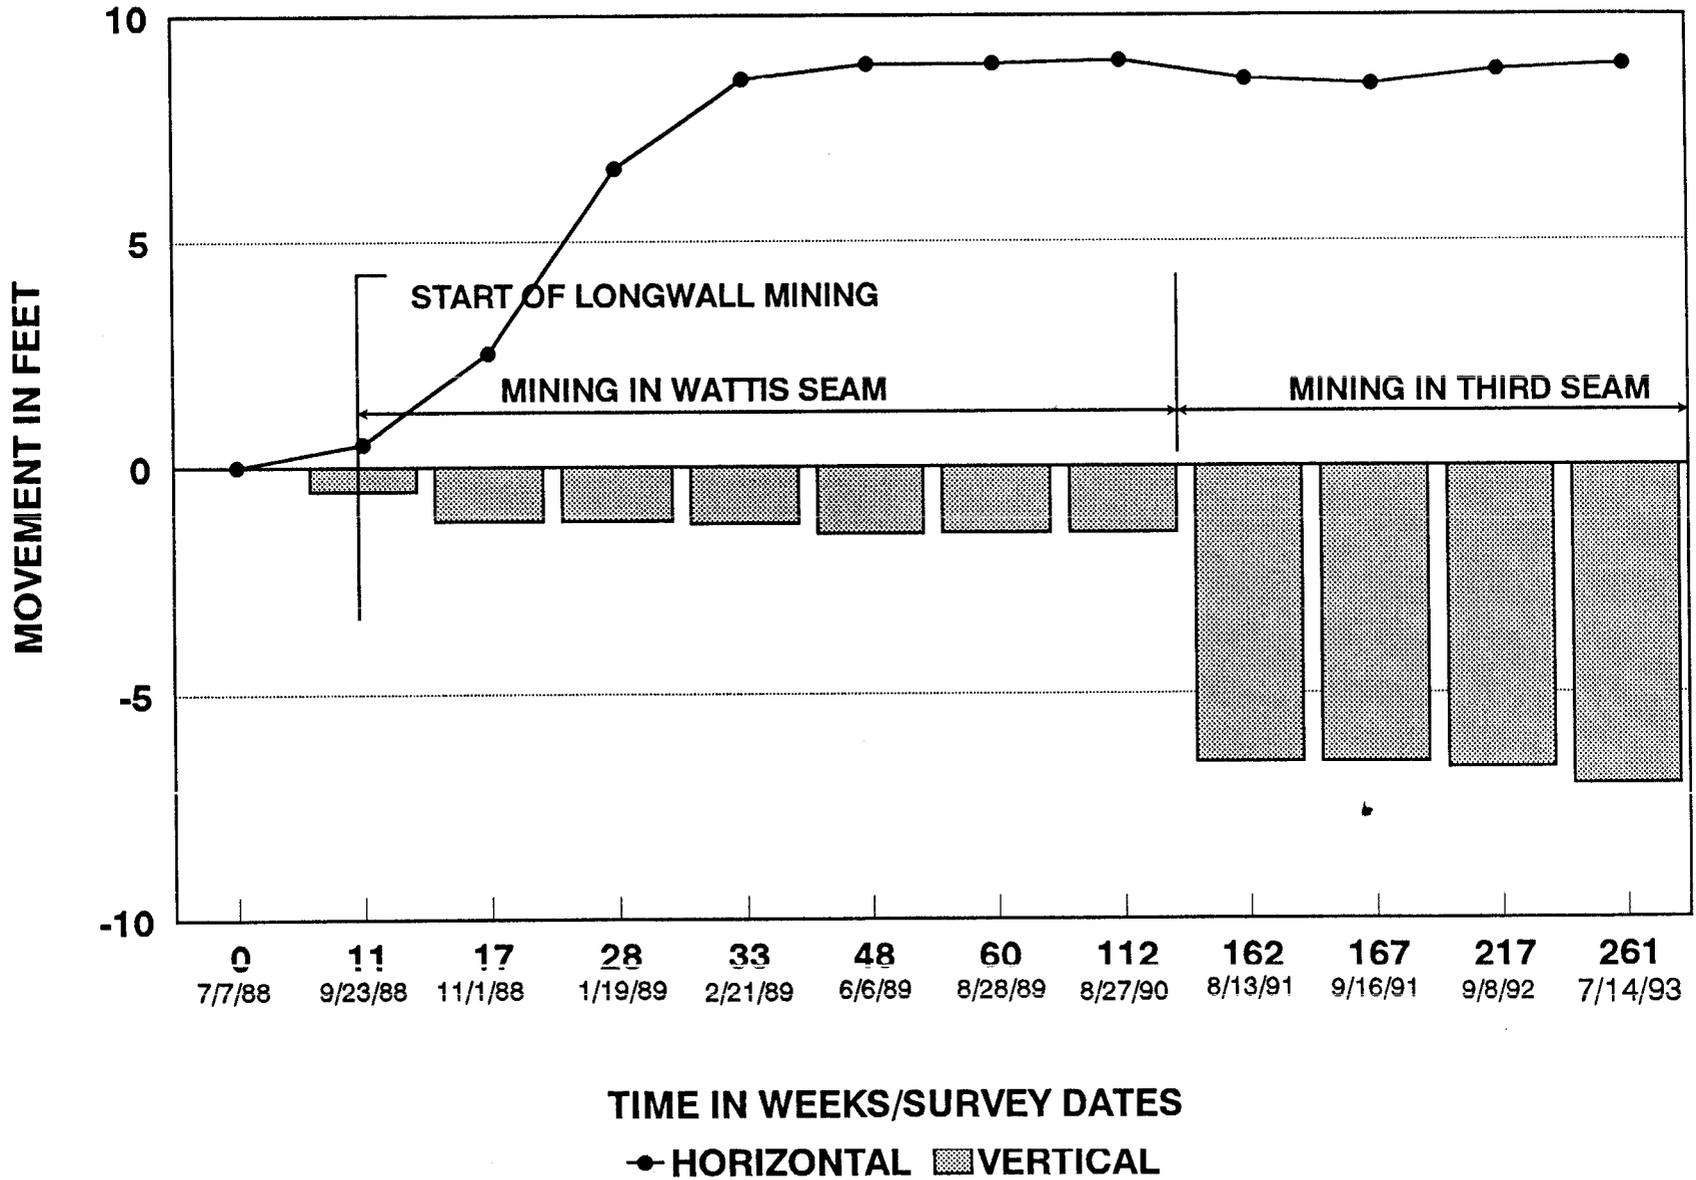
**FIGURE 5**  
**U-NORTH SUBSIDENCE MONITORING**  
**HORIZONTAL AND VERTICAL MOVEMENT GRAPH**  
**STATION U1**

Horizontal and vertical movement graphs have been made of monitoring points U1, U2, U3, and U4, Figures 5, 6, 7, and 8 respectively. Point U1, which is located directly above the north edge of longwall mining in the Wattis coal seam, shows the most vertical and horizontal movement. Point U4 which is located north of mining in the Wattis Seam and at the north edge of mining in the Third Seam shows the least movement.

A portion of the surface cracks near monitoring points U1 and U2 in Section 18 have been repaired to reduce the likelihood of accidents. The cracks were backfilled and the area fenced. Signs were placed in the area warning the public of the potential danger of the unstable ground. This area is fee land owned by the U.S. Fuel Company; Cyprus Plateau Mining Corporation has an agreement with U.S. Fuel which allows mining impacts.

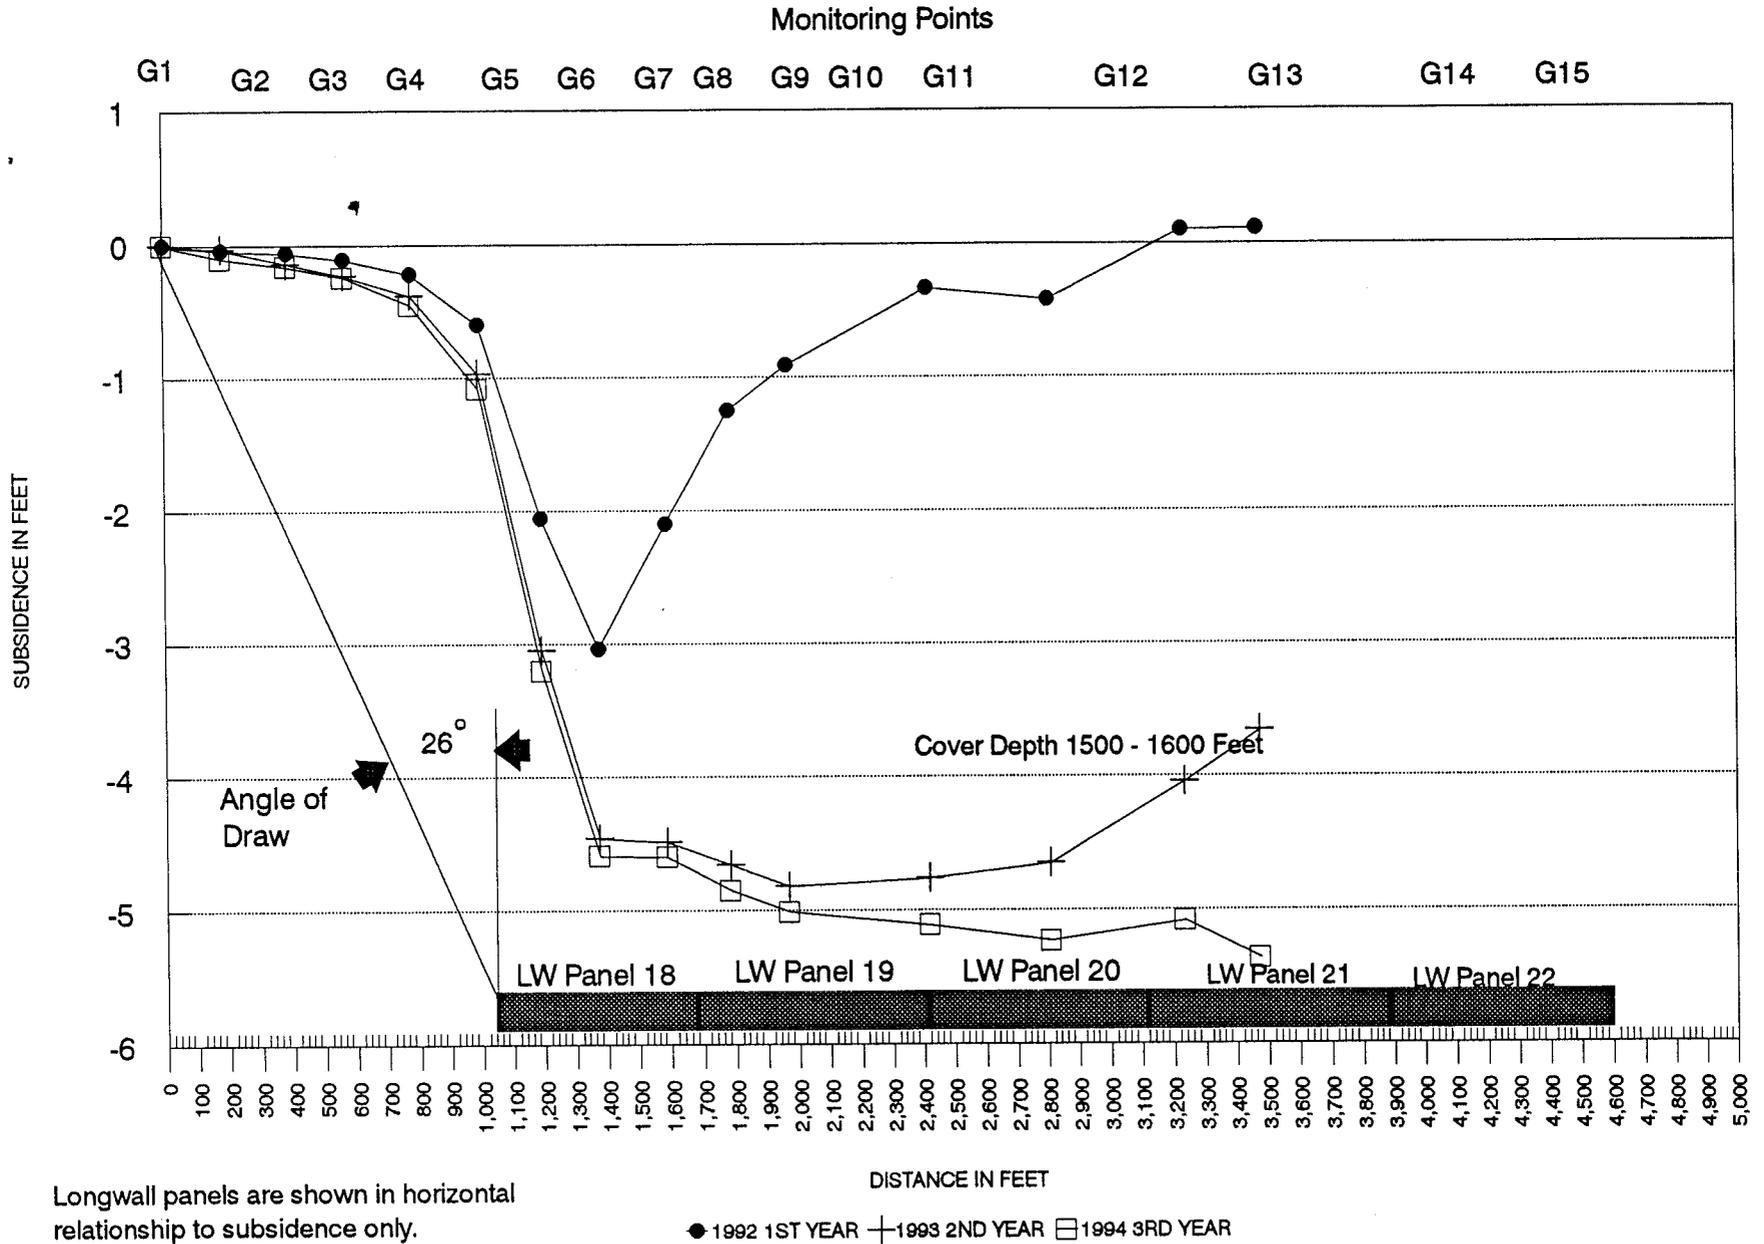
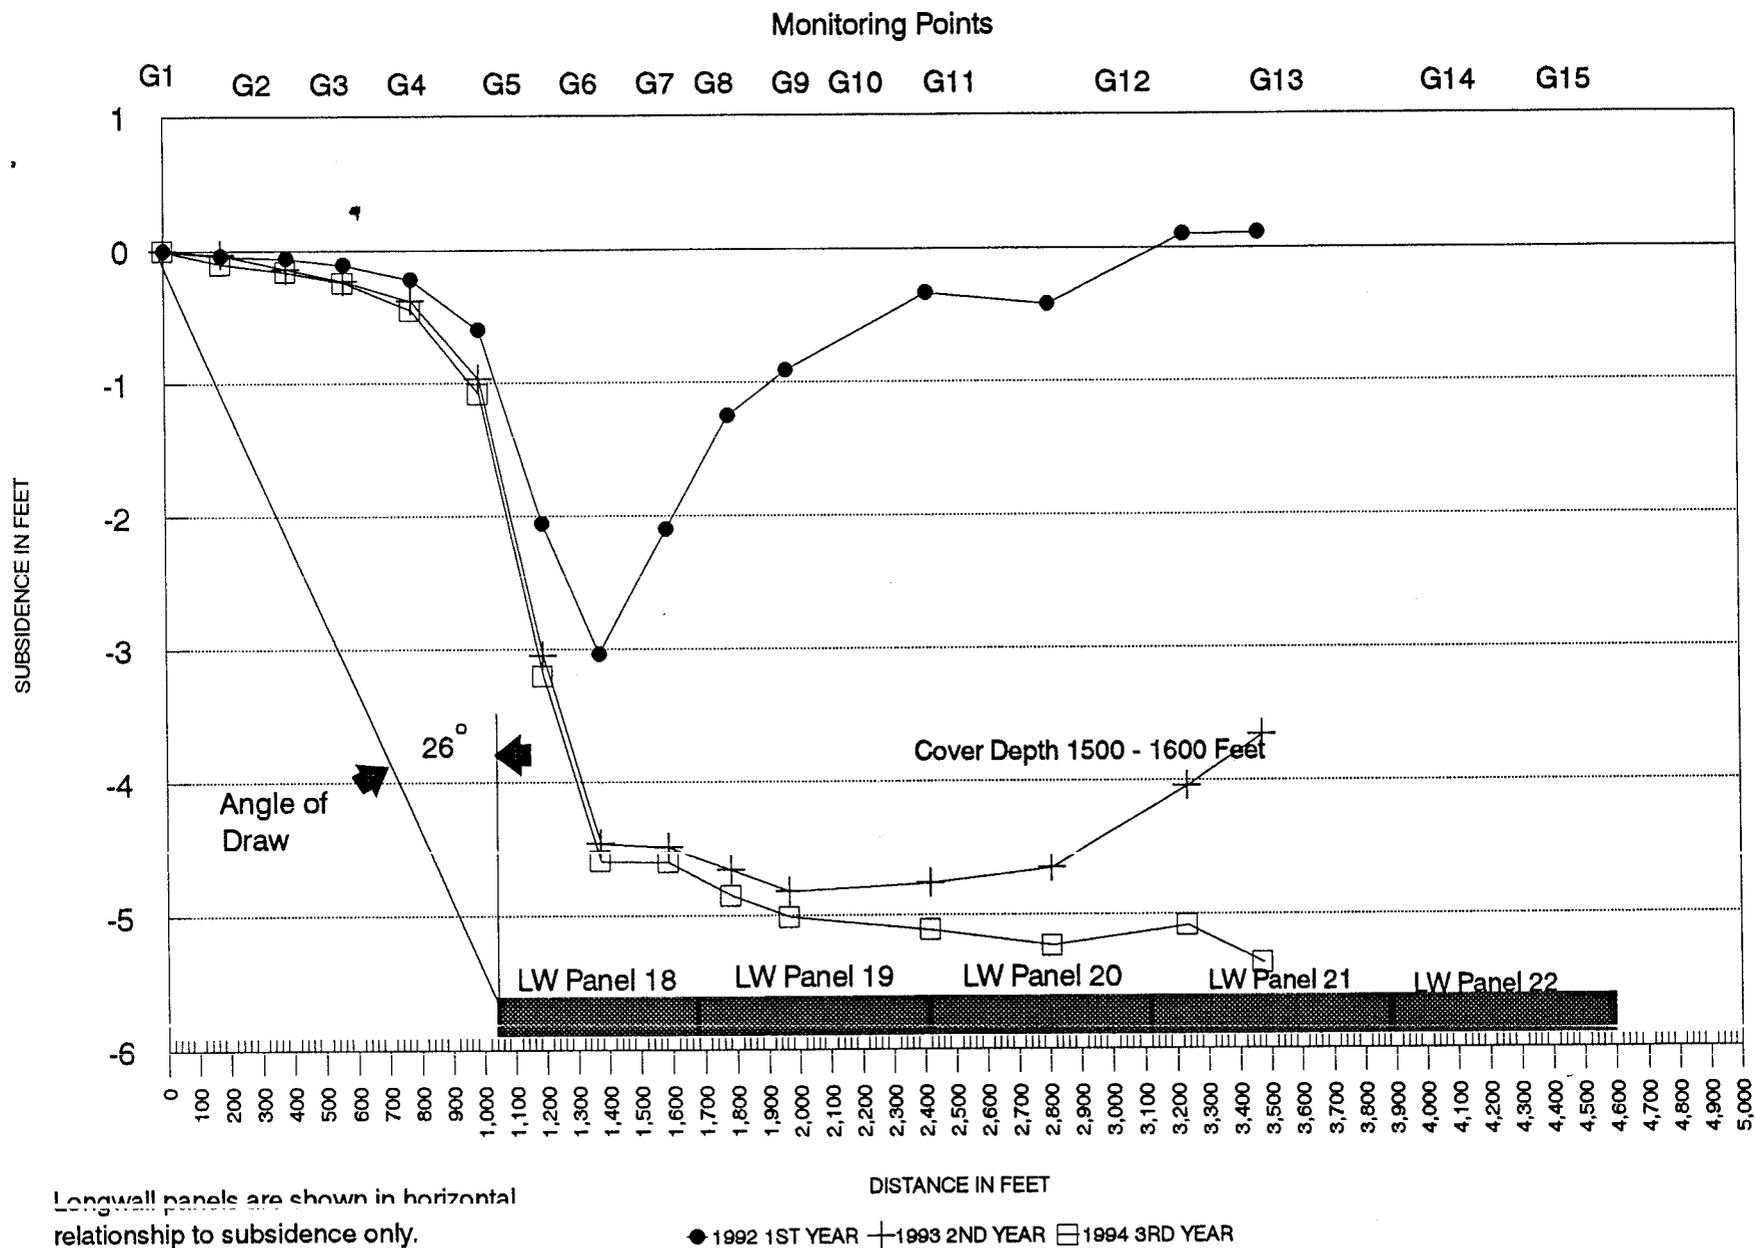
# FIGURE 11 CROSS SECTION D-D

Monitoring points G1 through G-1 through G-43 as shown on Map 521.121f were surveyed for vertical movement. Cross Sections D-D (Figure 11), E-E (Figure 12), G-G, and H-H were plotted from the data at these monitoring points. As can be seen on the cross sections, maximum subsidence is 5.36 feet at monitoring station G-15 feet.

As shown on Cross Sections D-D and E-E, the angle of draw at these locations is 26 degrees and 24 degrees respectively. Not enough data are available at Cross Sections G-G and H-H to calculate the angle of draw at these locations.
