SUBSIDENCE MONITORING REPORT  
1994  
STAR POINT MINE  
ACT/007/006

Cyprus Plateau Mining Corporation  
P.O. Box PMC  
Price, Utah 84501

## **INTRODUCTION**

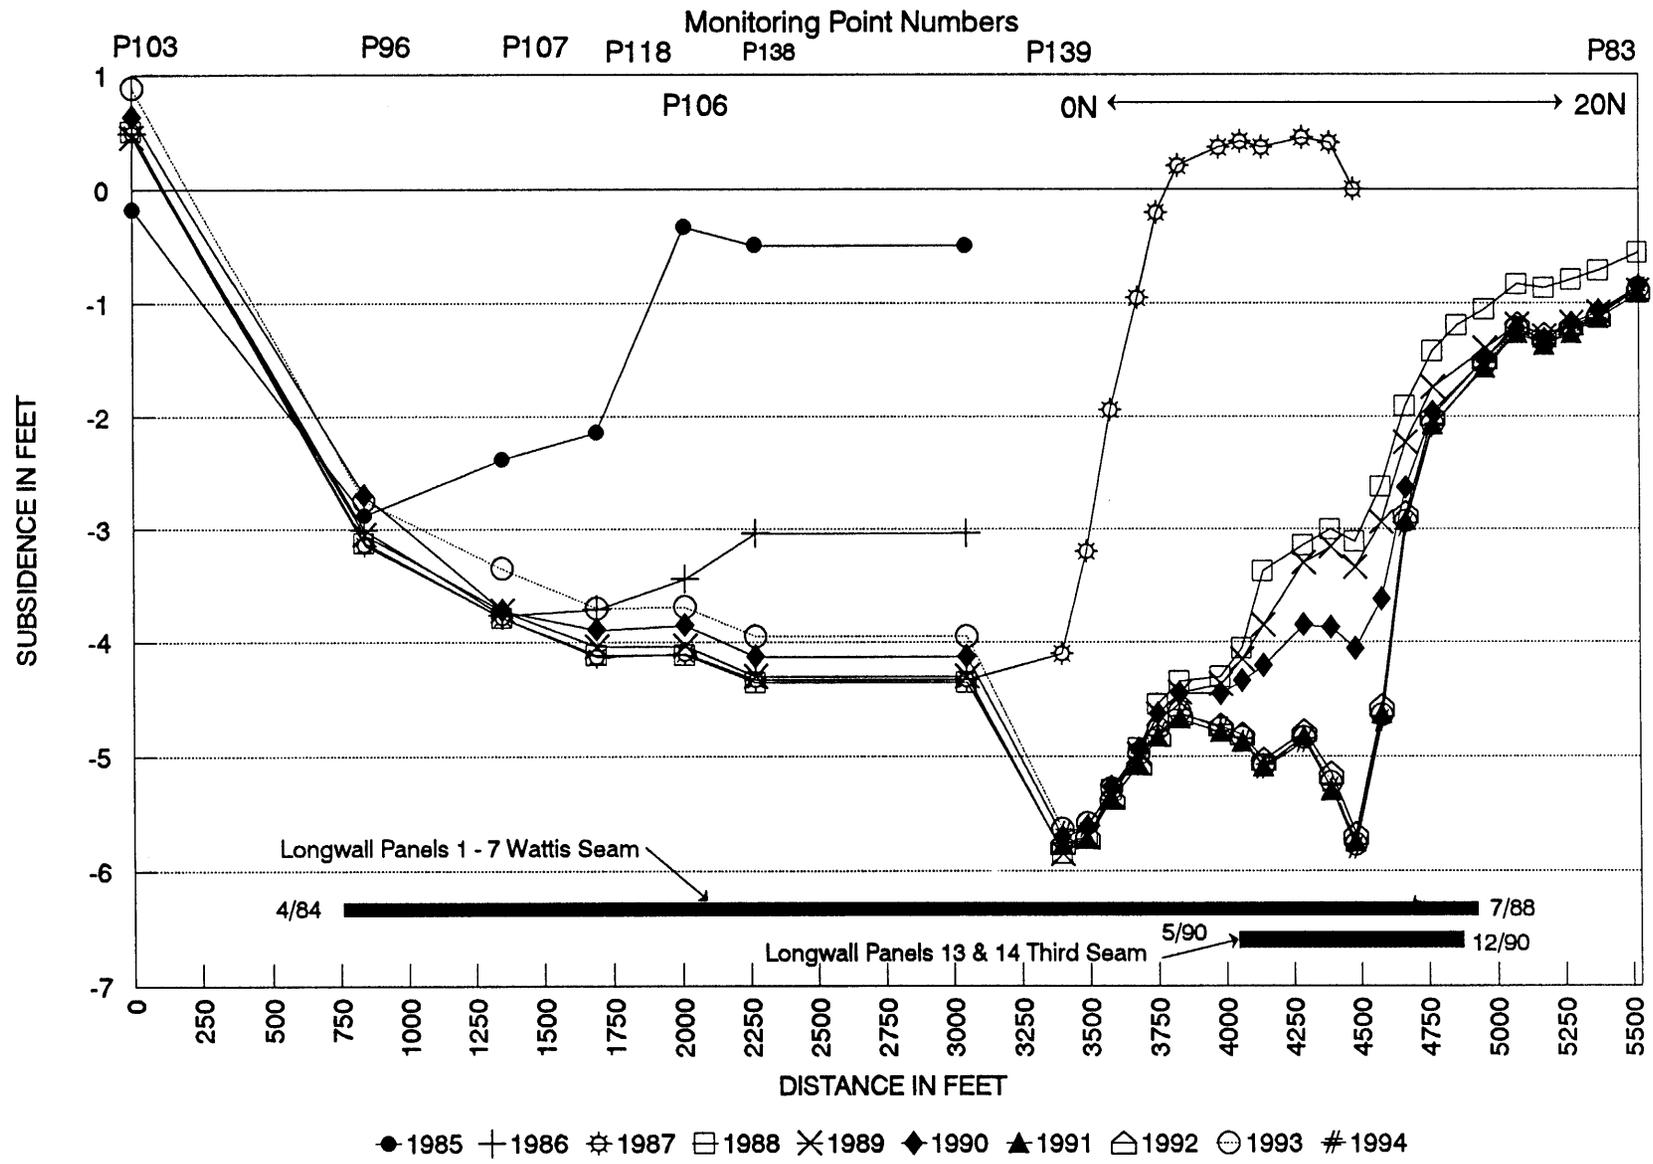
# FIGURE 1 CROSS SECTION A-A

Cross sections have been plotted through Panels 1-7, 13 and 14 (Figure 1), Panel 2 (Figure 2), and Panel 4 (Figure 3). Cross Section F-F has been plotted of monitoring points U-18 through U-32 (Figure 10) showing the angle of draw at this location of 15 degrees. Please refer to Map 521.121e for cross section locations.

As can be seen on Figures 1, 2, and 3, subsidence has stopped above the longwall panels in the area of longwall panels 1-7 and 13 and 14. Subsidence reached its maximum during the third year after mining. Figure 1 shows the subsidence profile diagonally through the nine longwall panels. The progression of subsidence can be seen to the north as successive panels were mined.

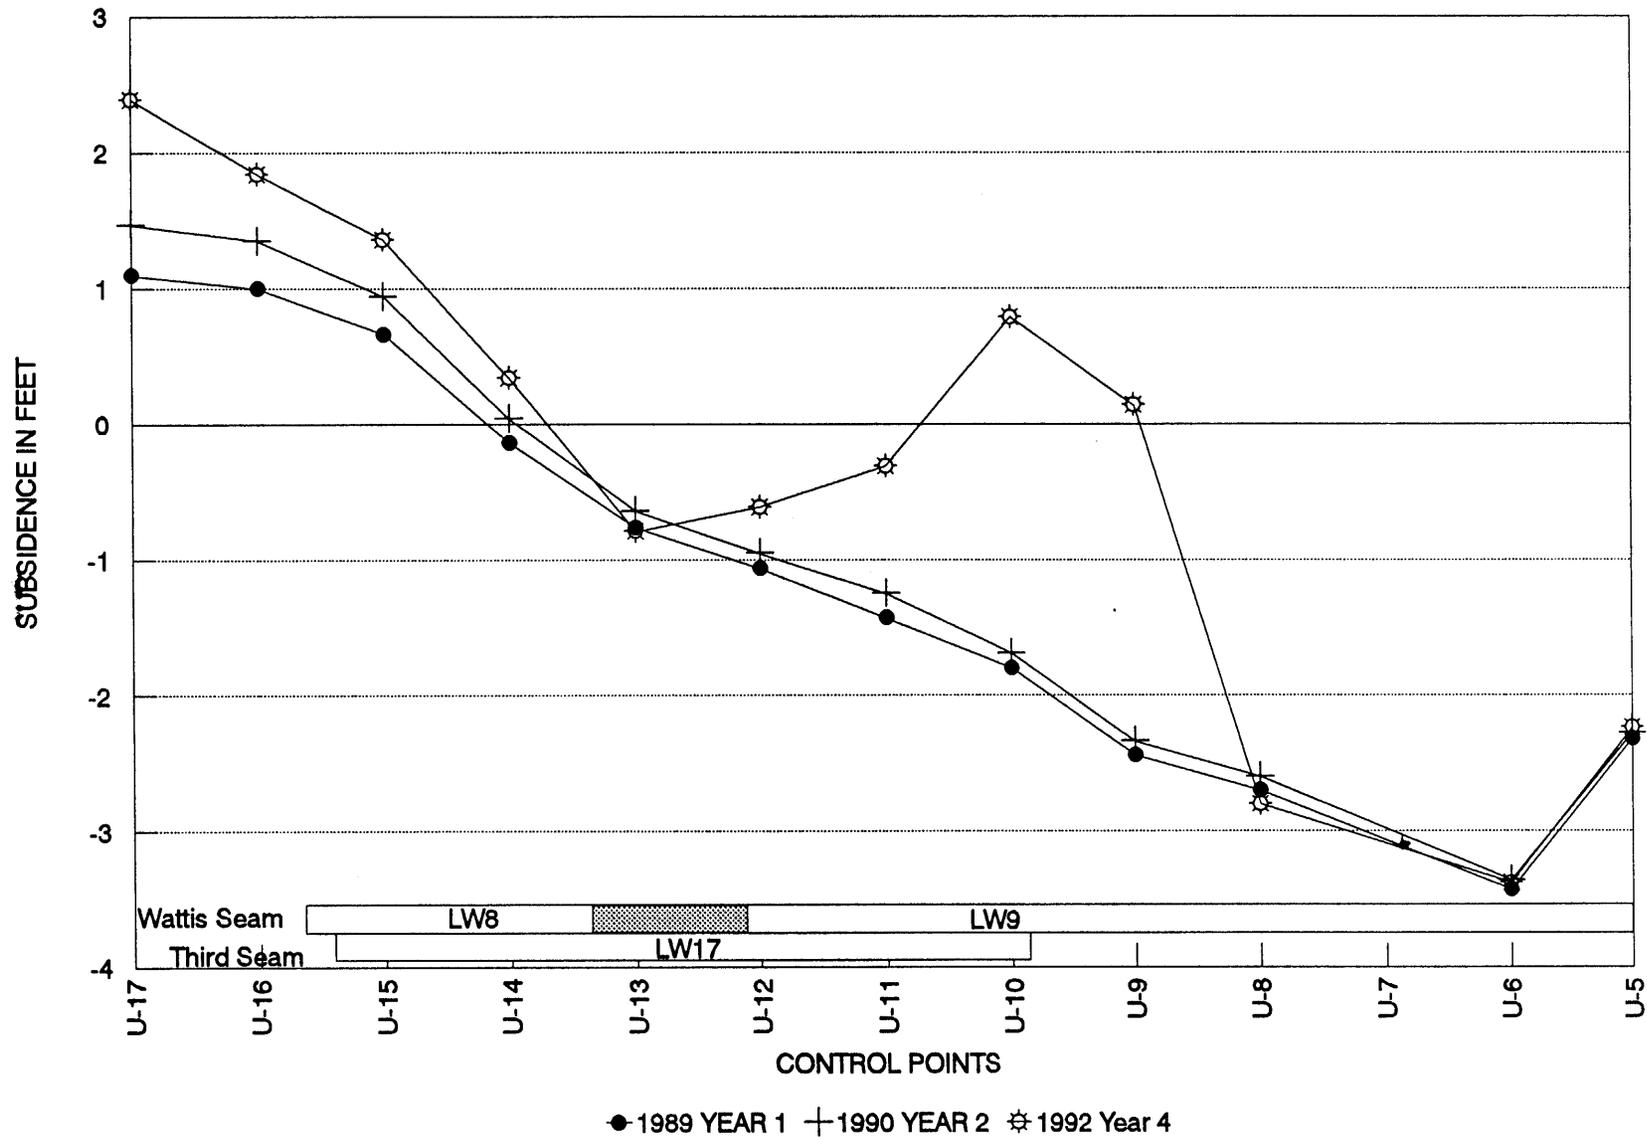
FIGURE 4  
U-NORTH NEAR-STREAM PROFILE

A cross section through Points U5-U17 in Section 18 (Figure 4) indicates a maximum vertical drop of 3.4 feet. These monitoring points were not monitored in 1991 due to hazardous conditions but, were monitored again in 1992. They were not monitored in 1993 due to hazardous conditions. As can be seen on the cross section, mining of longwall panels 16 and 17 in the Third Seam caused additional movement.

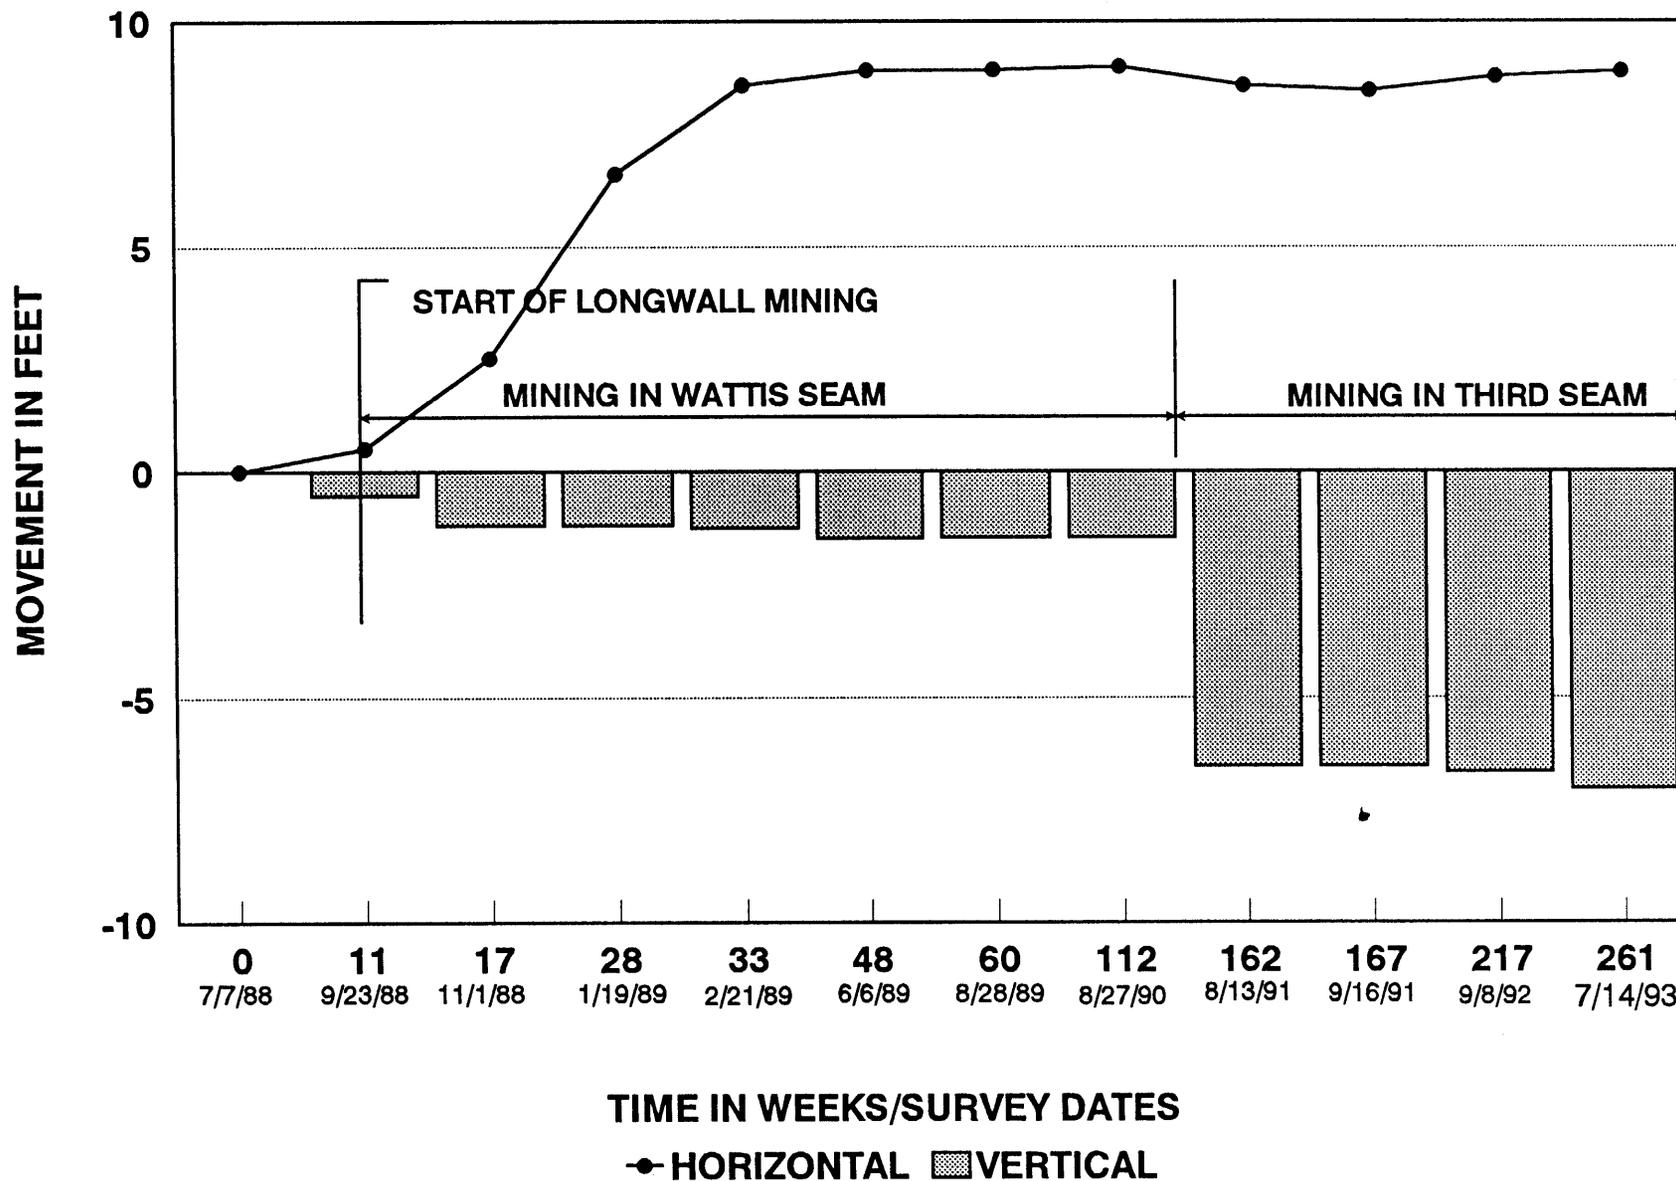
U-NORTH SUBSIDENCE MONITORING  
HORIZONTAL AND VERTICAL MOVEMENT GRAPH  
STATION U1

Horizontal and vertical movement graphs have been made of monitoring points U1, U2, U3, and U4, Figures 5, 6, 7, and 8 respectively. Point U1, which is located directly above the north edge of longwall mining in the Wattis coal seam, shows the most vertical and horizontal movement. Point U4 which is located north of mining in the Wattis Seam and at the north edge of mining in the Third Seam shows the least movement.

A portion of the surface cracks near monitoring points U1 and U2 in Section 18 have been repaired to reduce the likelihood of accidents. The cracks were backfilled and the area fenced. Signs were placed in the area warning the public of the potential danger of the unstable ground. This area is fee land owned by the U.S. Fuel Company; Cyprus Plateau Mining Corporation has an agreement with U.S. Fuel which allows mining impacts.

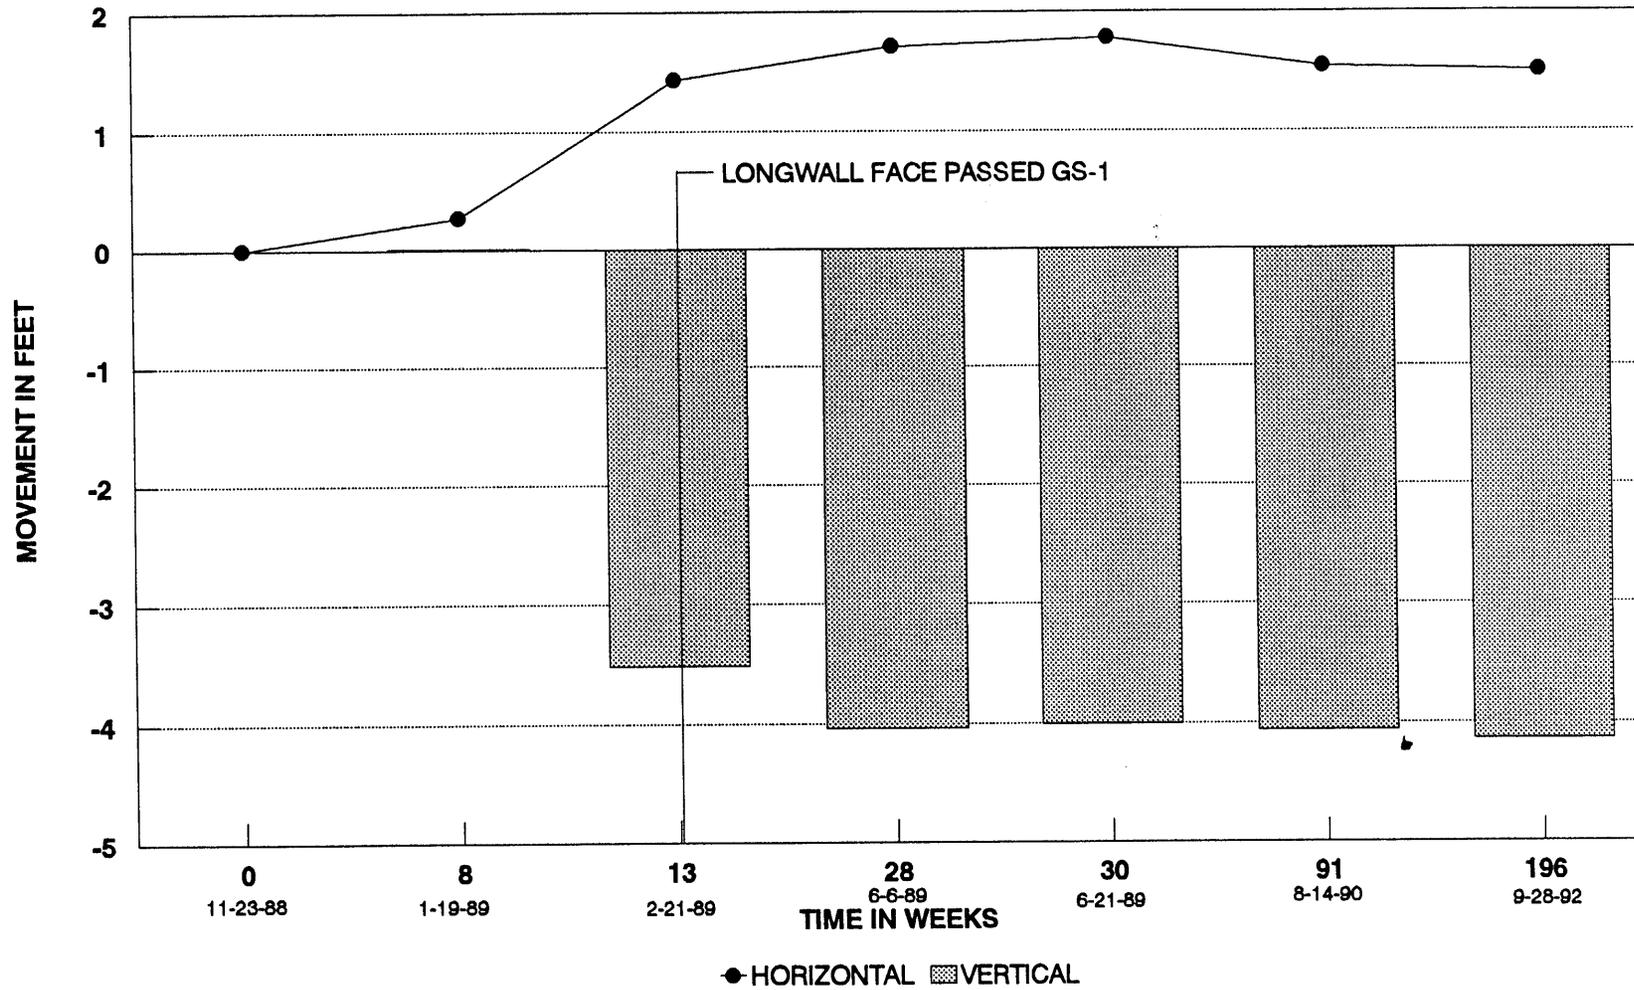
FIGURE 9  
STATION GS-1 U-NORTH  
HORIZONTAL AND VERTICAL MOVEMENT GRAPH

A horizontal and vertical movement graph (Figure 9) has been plotted of monitoring point GS-1 near the stream in Section 18. Probably because of the shallow overburden at the GS-1 point location, maximum subsidence occurred within 15 weeks of the longwall face passing the point. This monitoring point was not surveyed in 1991 and 1993 because of the hazardous condition previously discussed but, was surveyed in 1992. Mining of the Third seam was approximately 220 feet away and appears to have had only minor additional impact on this point.

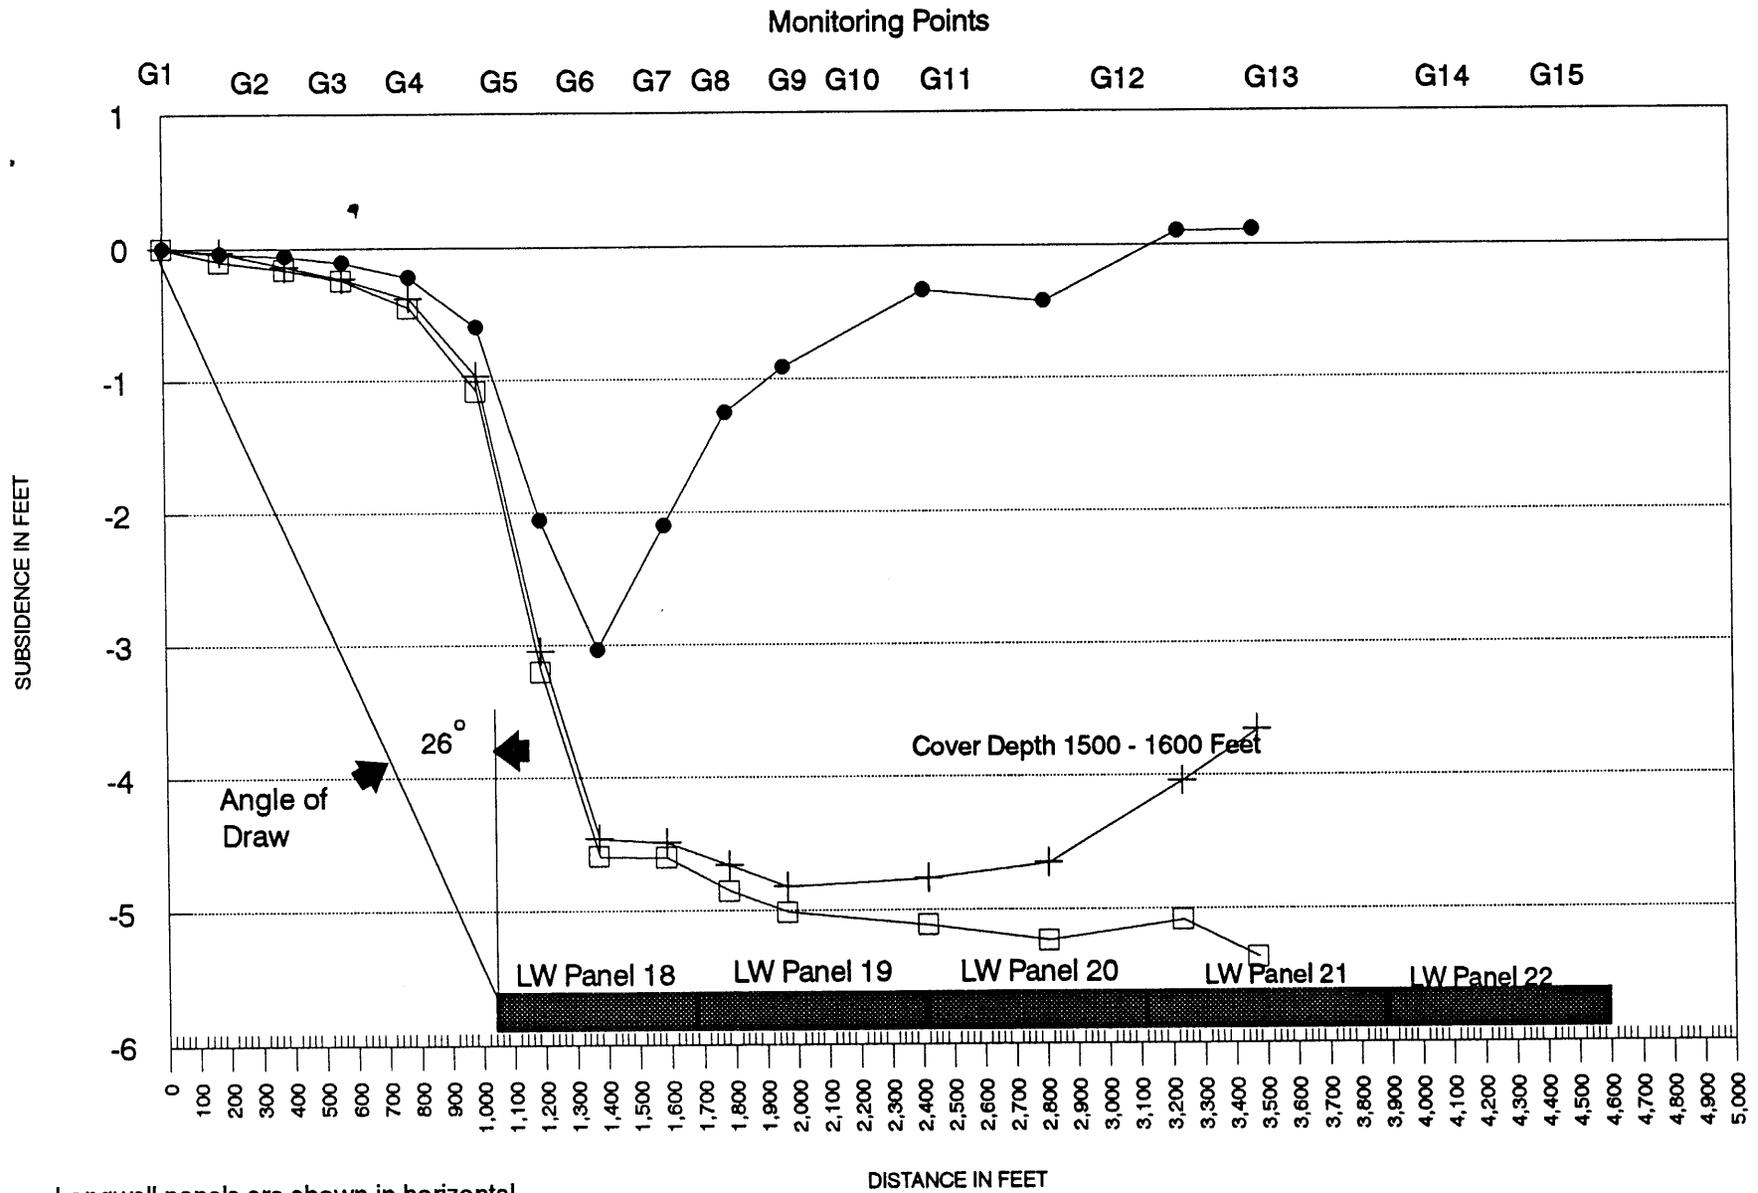
FIGURE 11  
CROSS SECTION D-D

Monitoring points G1 through G-1 through G-43 as shown on Map 521.121f were surveyed for vertical movement. Cross Sections D-D (Figure 11), E-E (Figure 12), G-G, and H-H were plotted from the data at these monitoring points. As can be seen on the cross sections, maximum subsidence is 5.36 feet at monitoring station G-15 feet.

As shown on Cross Sections D-D and E-E, the angle of draw at these locations is 26 degrees and 24 degrees respectively. Not enough data are available at Cross Sections G-G and H-H to calculate the angle of draw at these locations.
