**SUBSIDENCE MONITORING REPORT
1996
STAR POINT MINE
ACT/007/006**

**Cyprus Plateau Mining Corporation
P.O. Drawer PMC
Price, Utah 84501**

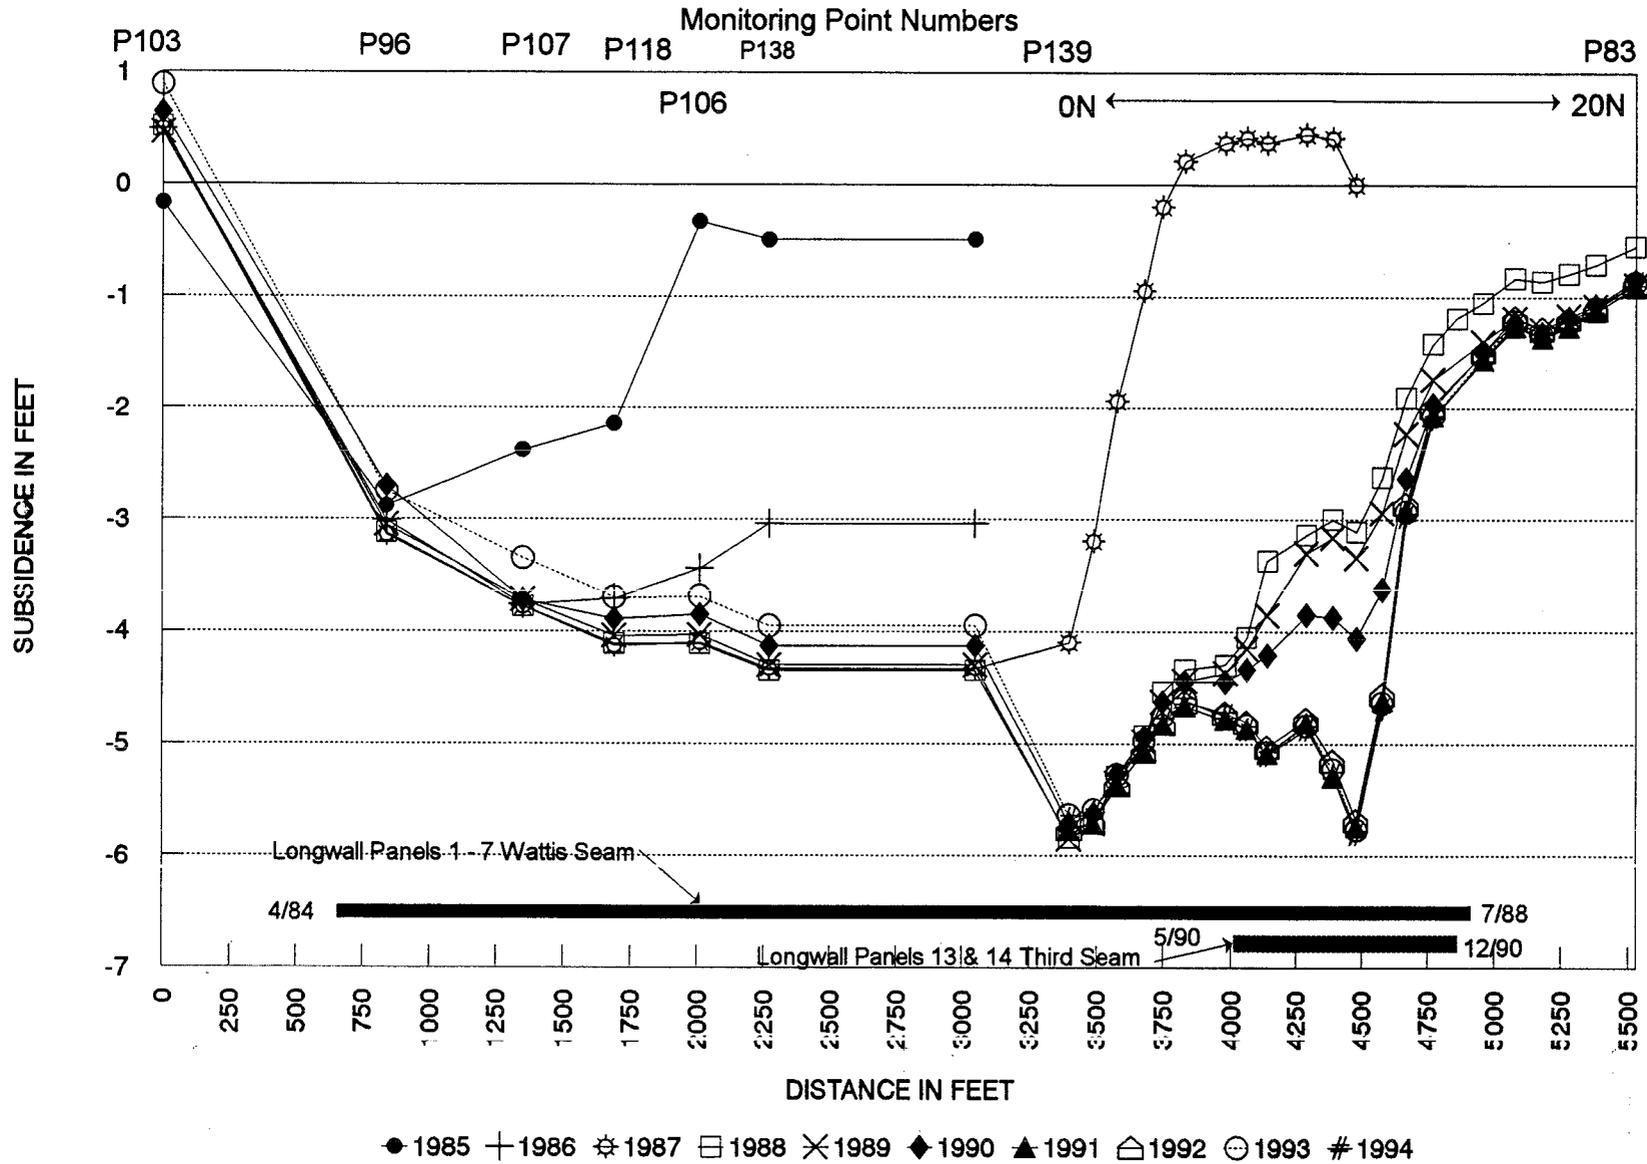
FIGURE 1 CROSS SECTION A-A

Cross sections have been plotted through Panels 1-7, 13 and 14 (Figure 1), Panel 2 (Figure 2), and Panel 4 (Figure 3). Cross Section F-F has been plotted of monitoring points U-18 through U-32 (Figure 10) showing the angle of draw at this location of 15 degrees. Please refer to Map 521.121e for cross section locations.

As can be seen on Figures 1, 2, and 3, subsidence has stopped above the longwall panels in the area of longwall panels 1-7 and 13 and 14. Subsidence reached its maximum during the third year after mining. Figure 1 shows the subsidence profile diagonally through the nine longwall panels. The progression of subsidence can be seen to the north as successive panels were mined.

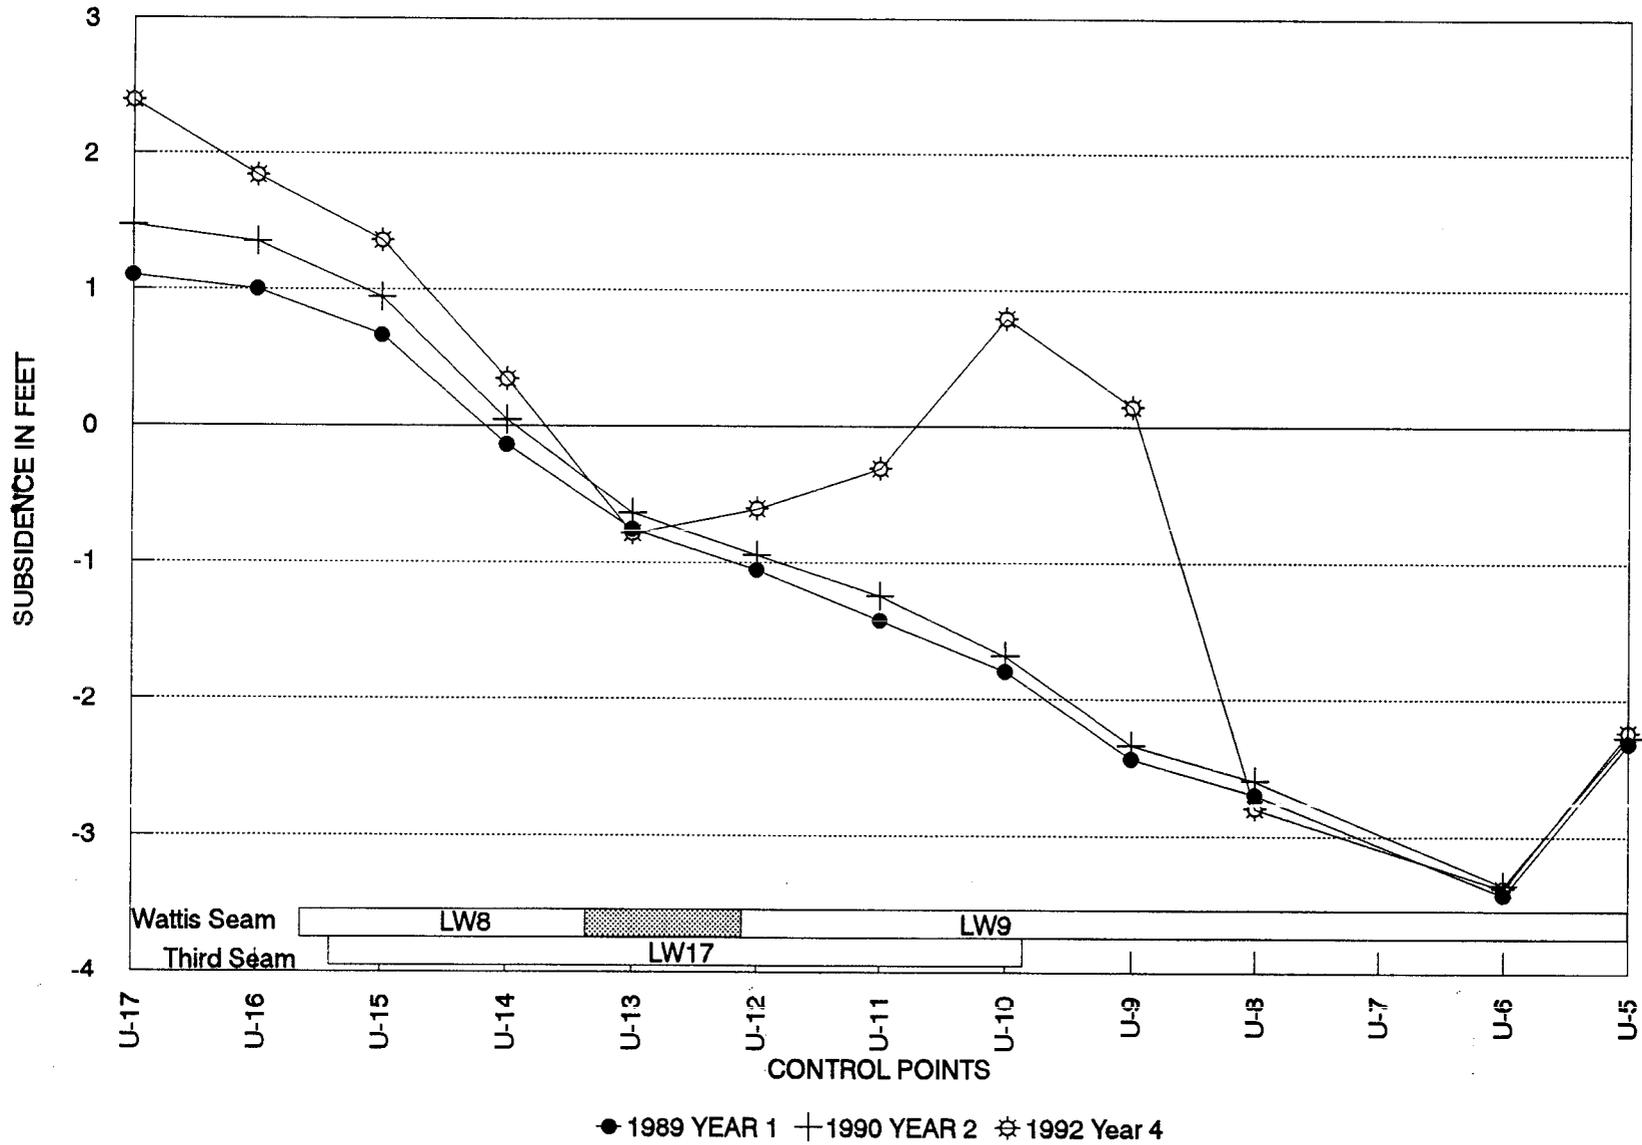
FIGURE 4
U-NORTH NEAR-STREAM PROFILE

A cross section through Points U5-U17 in Section 18 (Figure 4) indicates a maximum vertical drop of 3.4 feet. These monitoring points were not monitored in 1991 due to hazardous conditions but, were monitored again in 1992. They were not monitored in 1993 due to hazardous conditions. As can be seen on the cross section, mining of longwall panels 16 and 17 in the Third Seam caused additional movement.

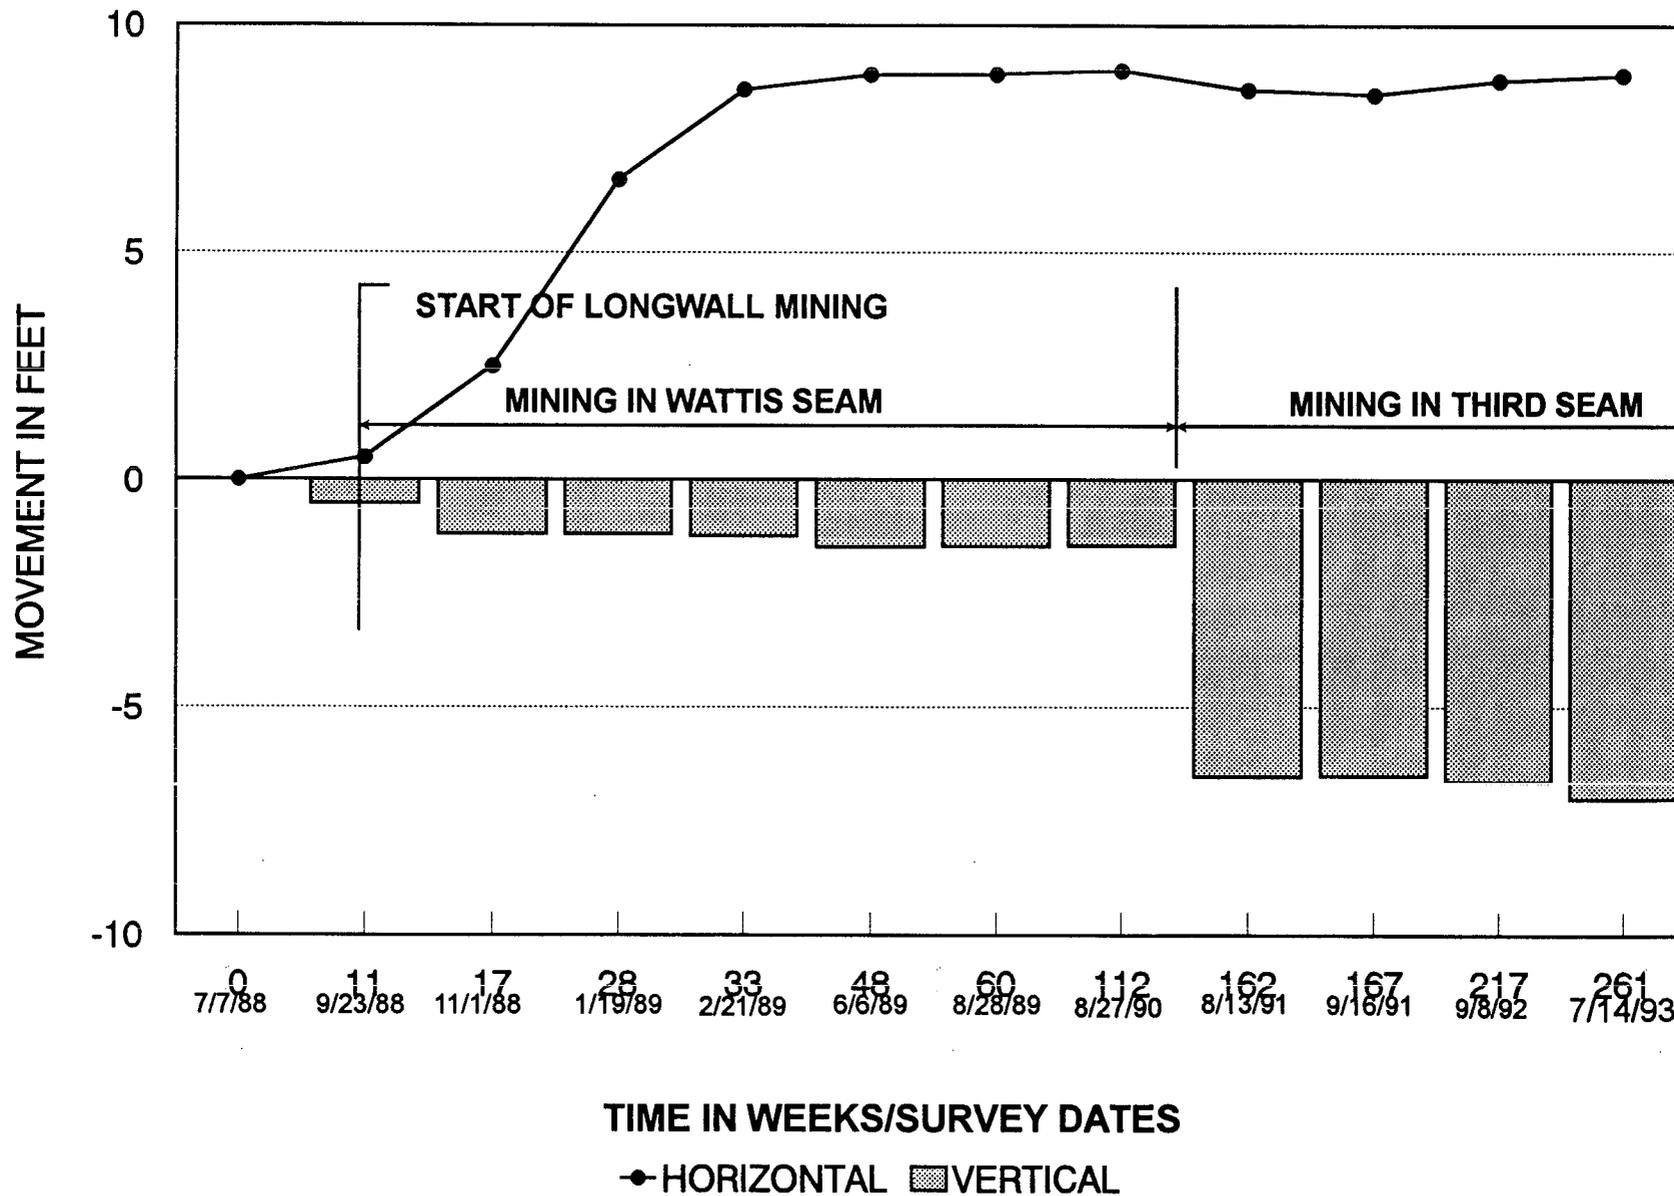
FIGURE 5
U-NORTH SUBSIDENCE MONITORING
HORIZONTAL AND VERTICAL MOVEMENT GRAPH
STATION U1

Horizontal and vertical movement graphs have been made of monitoring points U1, U2, U3, and U4, Figures 5, 6, 7, and 8 respectively. Point U1, which is located directly above the north edge of longwall mining in the Wattis coal seam, shows the most vertical and horizontal movement. Point U4 which is located north of mining in the Wattis Seam and at the north edge of mining in the Third Seam shows the least movement.

A portion of the surface cracks near monitoring points U1 and U2 in Section 18 have been repaired to reduce the likelihood of accidents. The cracks were backfilled and the area fenced. Signs are in place in the area warning the public of the potential danger of the unstable ground. This area is fee land owned by the U.S. Fuel Company; Cyprus Plateau Mining Corporation has an agreement with U.S. Fuel which allows mining impacts. In the fall of 1995, the cracks were plugged with foam to provide additional protection to the public and provide a base for future backfilling.

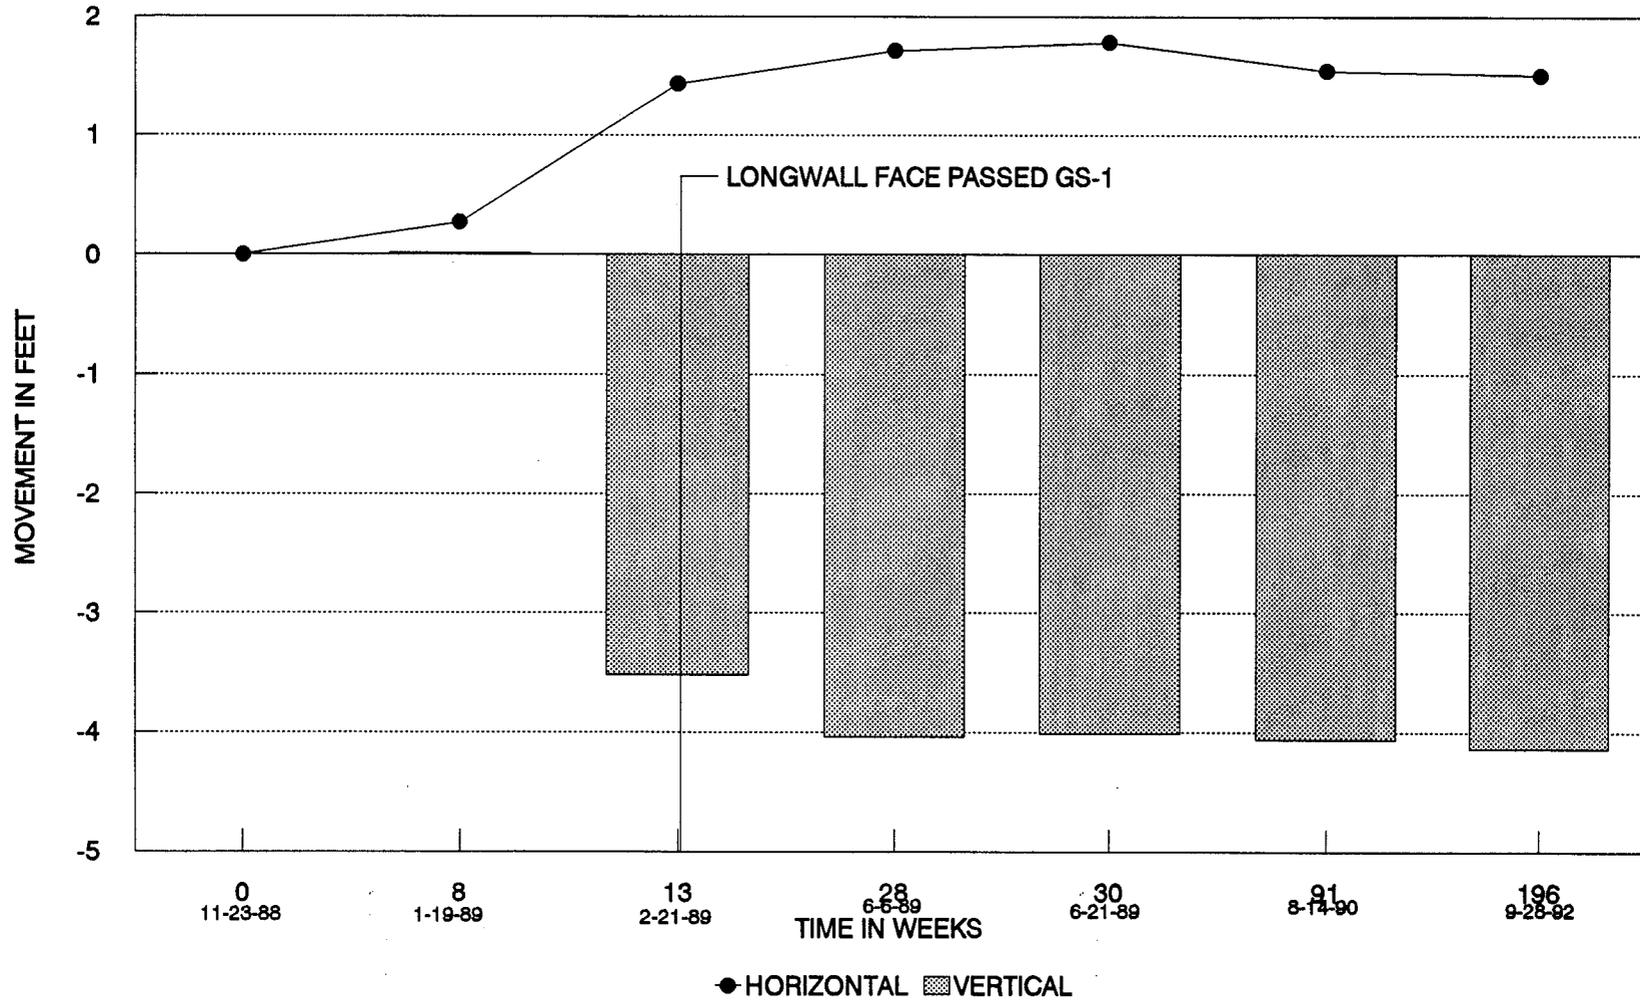
FIGURE 9
STATION GS-1 U-NORTH
HORIZONTAL AND VERTICAL MOVEMENT GRAPH

A horizontal and vertical movement graph (Figure 9) has been plotted of monitoring point GS-1 near the stream in Section 18. Probably because of the shallow overburden at the GS-1 point location, maximum subsidence occurred within 15 weeks of the longwall face passing the point. This monitoring point was not surveyed in 1991 and 1993 because of the hazardous condition previously discussed but, was surveyed in 1992. Mining of the Third seam was approximately 220 feet away and appears to have had only minor additional impact on this point.

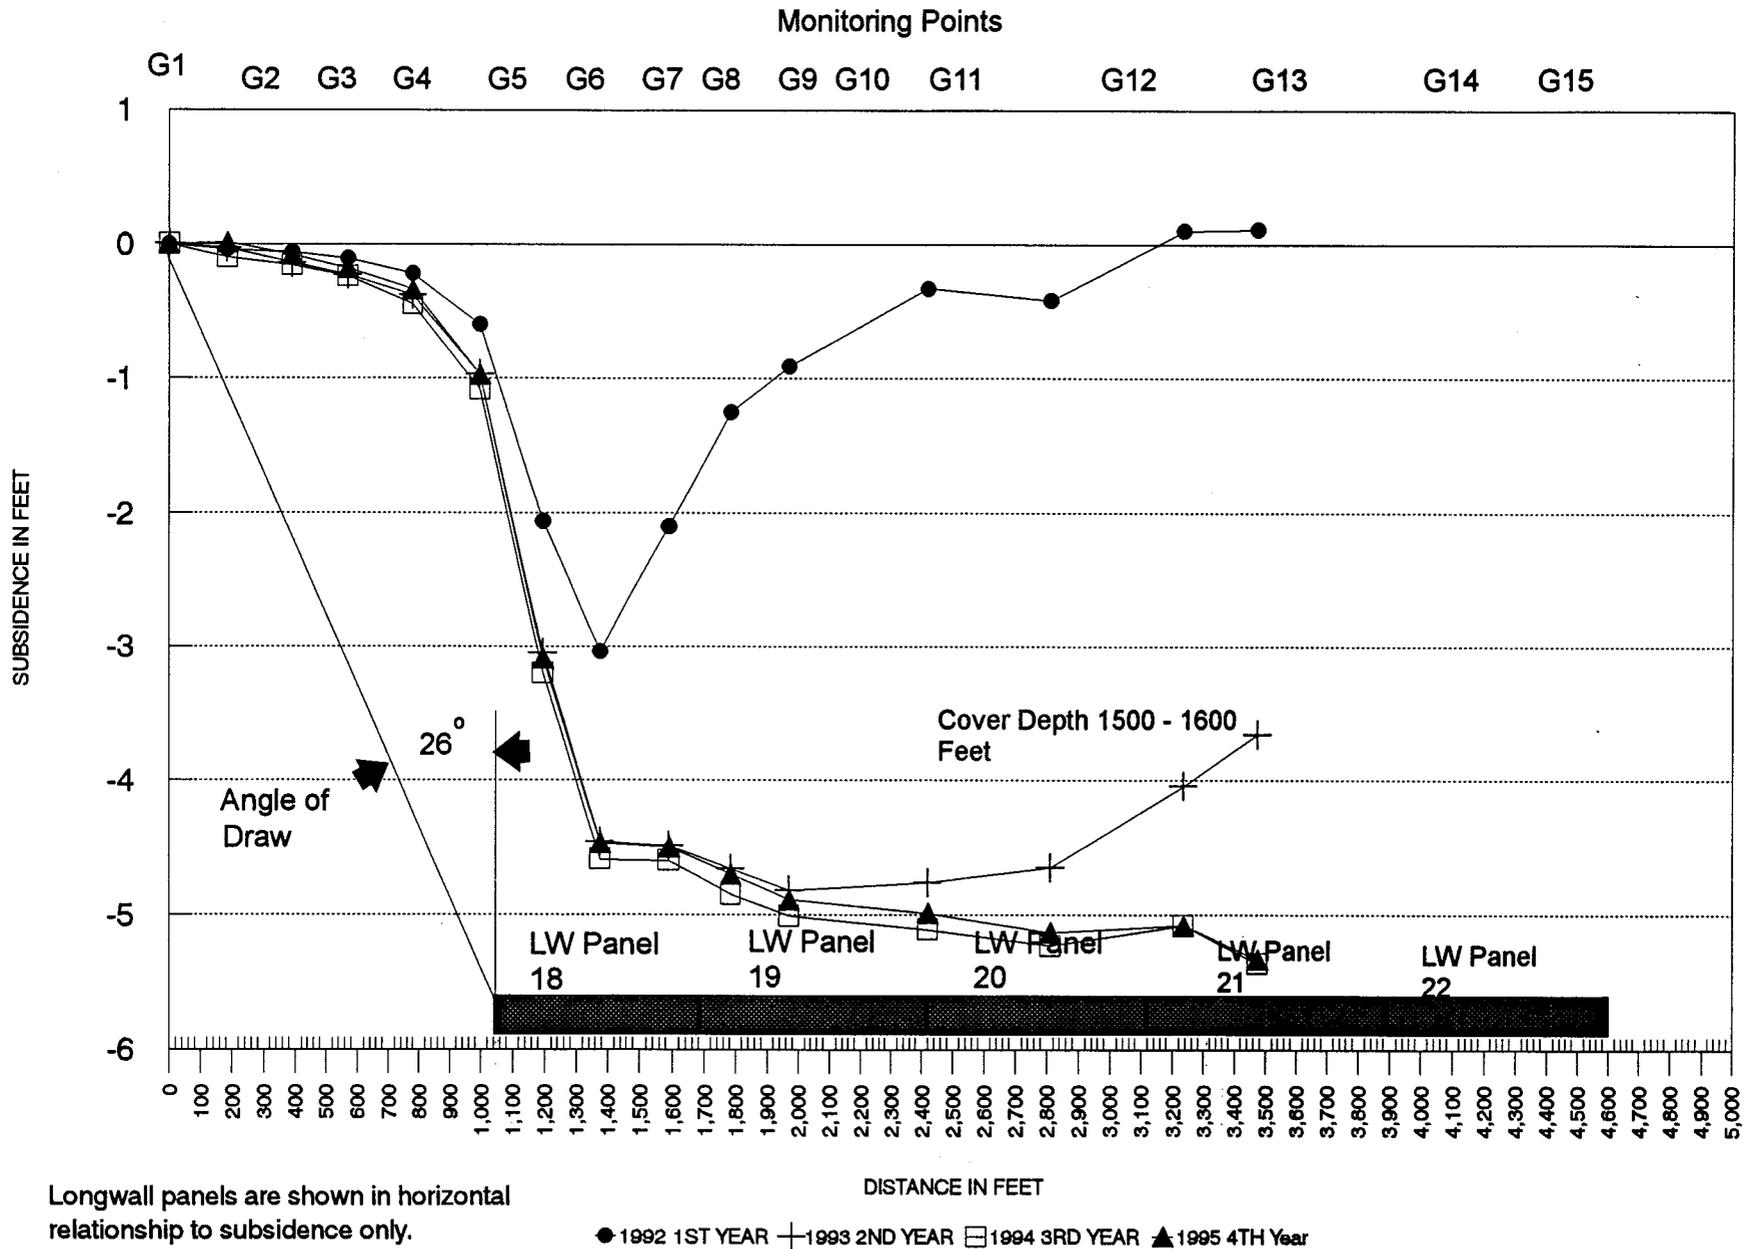
FIGURE 11 CROSS SECTION D-D

Monitoring points G-1 through G-63 as shown on Map 521.121f were surveyed for vertical movement. Cross Sections D-D (Figure 11), E-E (Figure 12), G-G, and H-H were plotted from the data at these monitoring points. As can be seen on the cross sections, maximum subsidence is 5.33 feet at monitoring station G-15. Subsidence at the Fox points is greatest at Fox 3, at 5.74 feet.

As shown on Cross Sections D-D and E-E, the angle of draw at these locations is 26 degrees and 24 degrees respectively. The angle of draw at Cross Sections G-G and H-H are 26 degrees and 5 degrees, respectively. It appears that the angle of draw is affected by faulting or jointing of the strata.

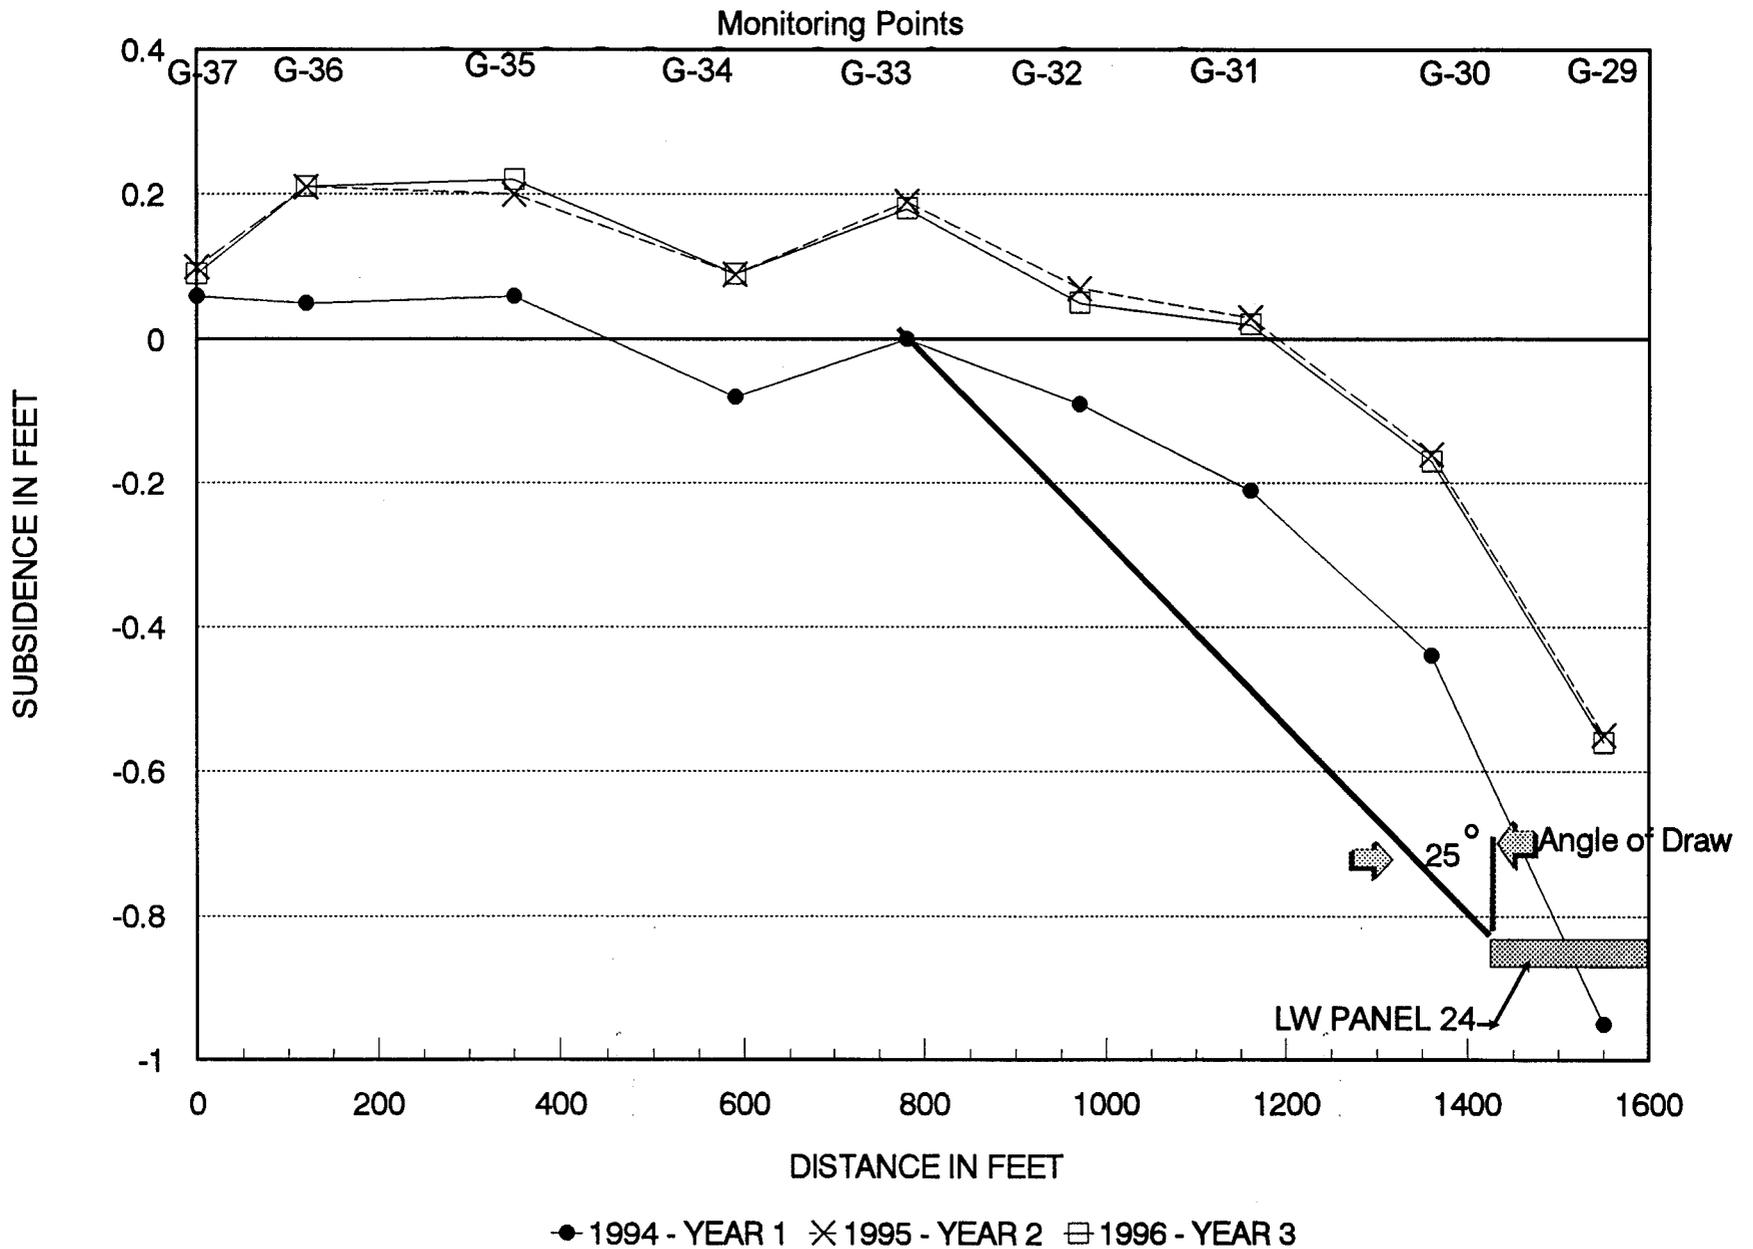
FIGURE 13
CROSS SECTION G - G

Monitoring points G-20 through G-94, as shown of Maps 521.121f and 521.121g1, were surveyed for vertical movement. Cross section G-G (Figure 13) and H-H (Figure 14) were plotted from some of the data at these monitoring points. Maximum subsidence during the 1996 monitoring is 6.59 feet a station G-58.
