November 18, 1997

RE: Hydrogeologic Issues Related to Longwall Abandonment Within Castle Valley Ridge.

CYPRUS PLATEAU MINING COMPANY

HYDROGEOLOGY ASSOCIATED WITH LONGWALL ABANDONMENT

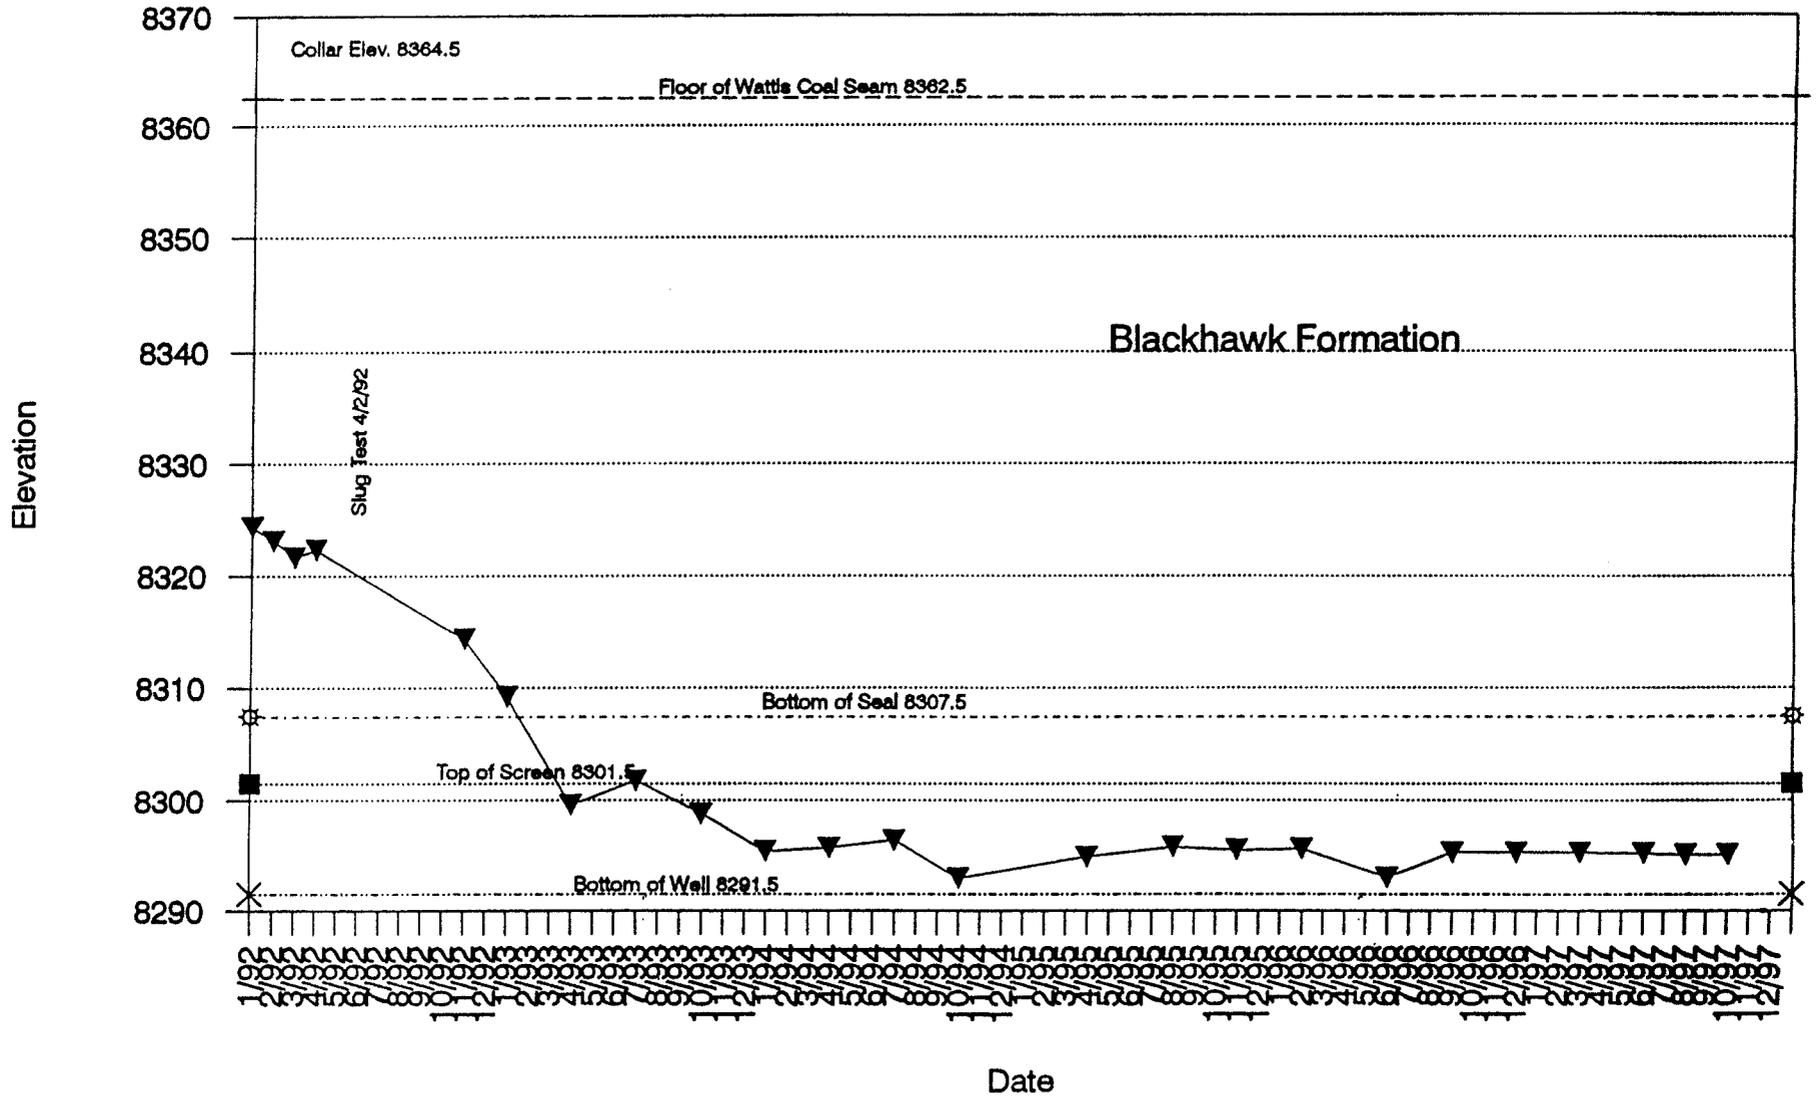
Figure 31
Well P92-01A-WD
Water Level Graph

Attached graphs for in-mine wells P92-01A-WD, P92-01B-WD, P92-01C-WD, P92-02-WD, and P92-04-WD show a consistent decline in water levels as mining advanced southward. The graphs

for wells P92-01C-WD, P92-02-WD, and P92-04-WD also show a partial recovery of water level following termination of mining. Graphs for wells P92-01A-WD and P92-01B-WD show little or no recovery to date.

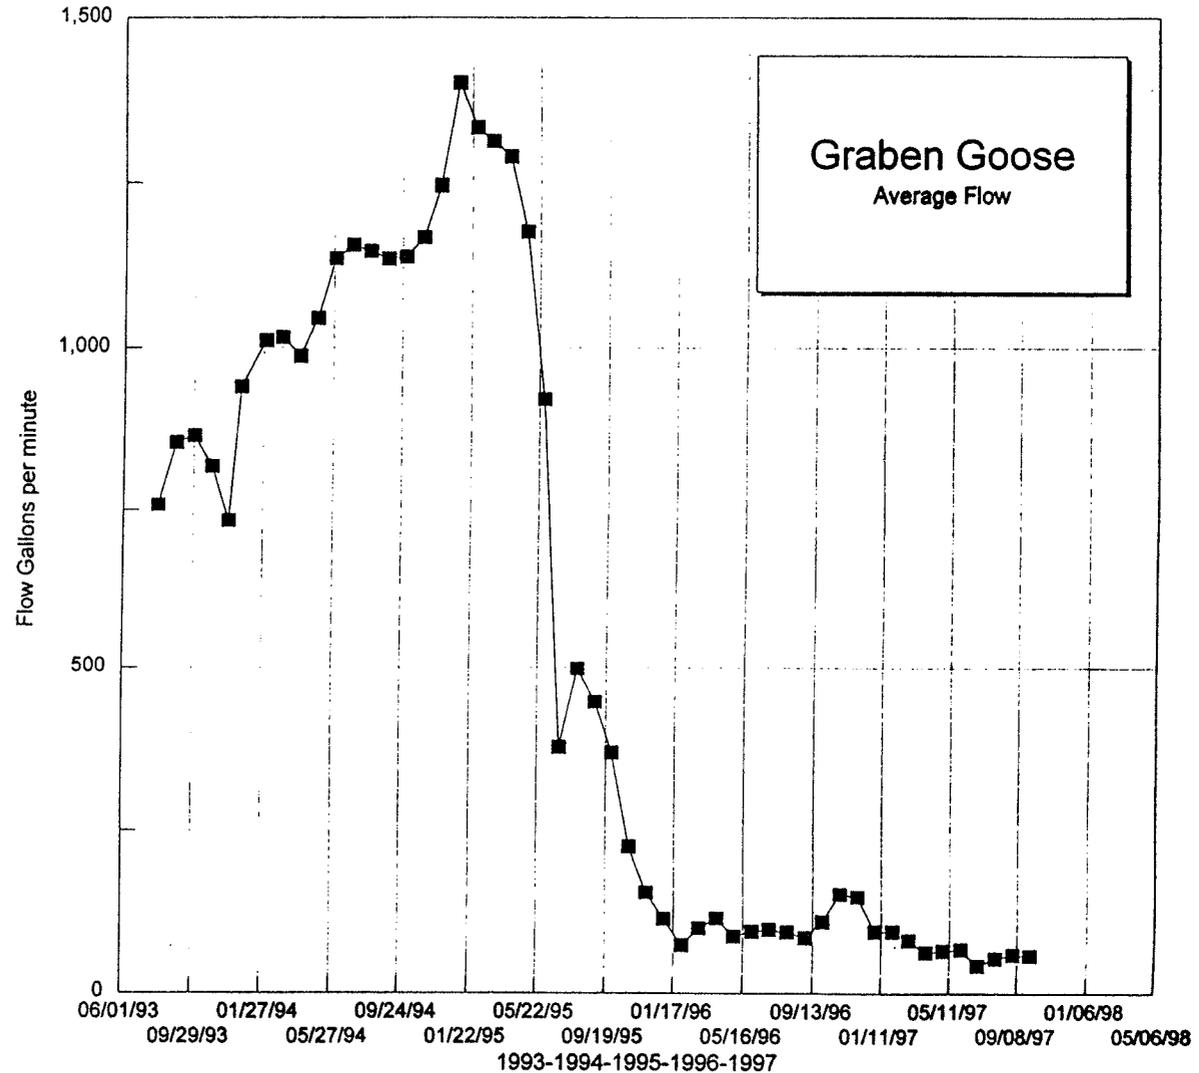
WATER METER READINGS AT GRABEN GOOSE

The overall lack of water entering the mine from northern mine sections is also verified through a review of pumping data collected from the Graben Goose pump. As shown in the attached figure, pumping levels declined substantially during the mid 1990's when mining retreated from the Gentry Ridge area and moved northward into Castle Valley Ridge. As shown in the figure, pumping subsequent to this move reduced from an all time high of 1,398 gpm to a current flow of approximately 50 gpm.

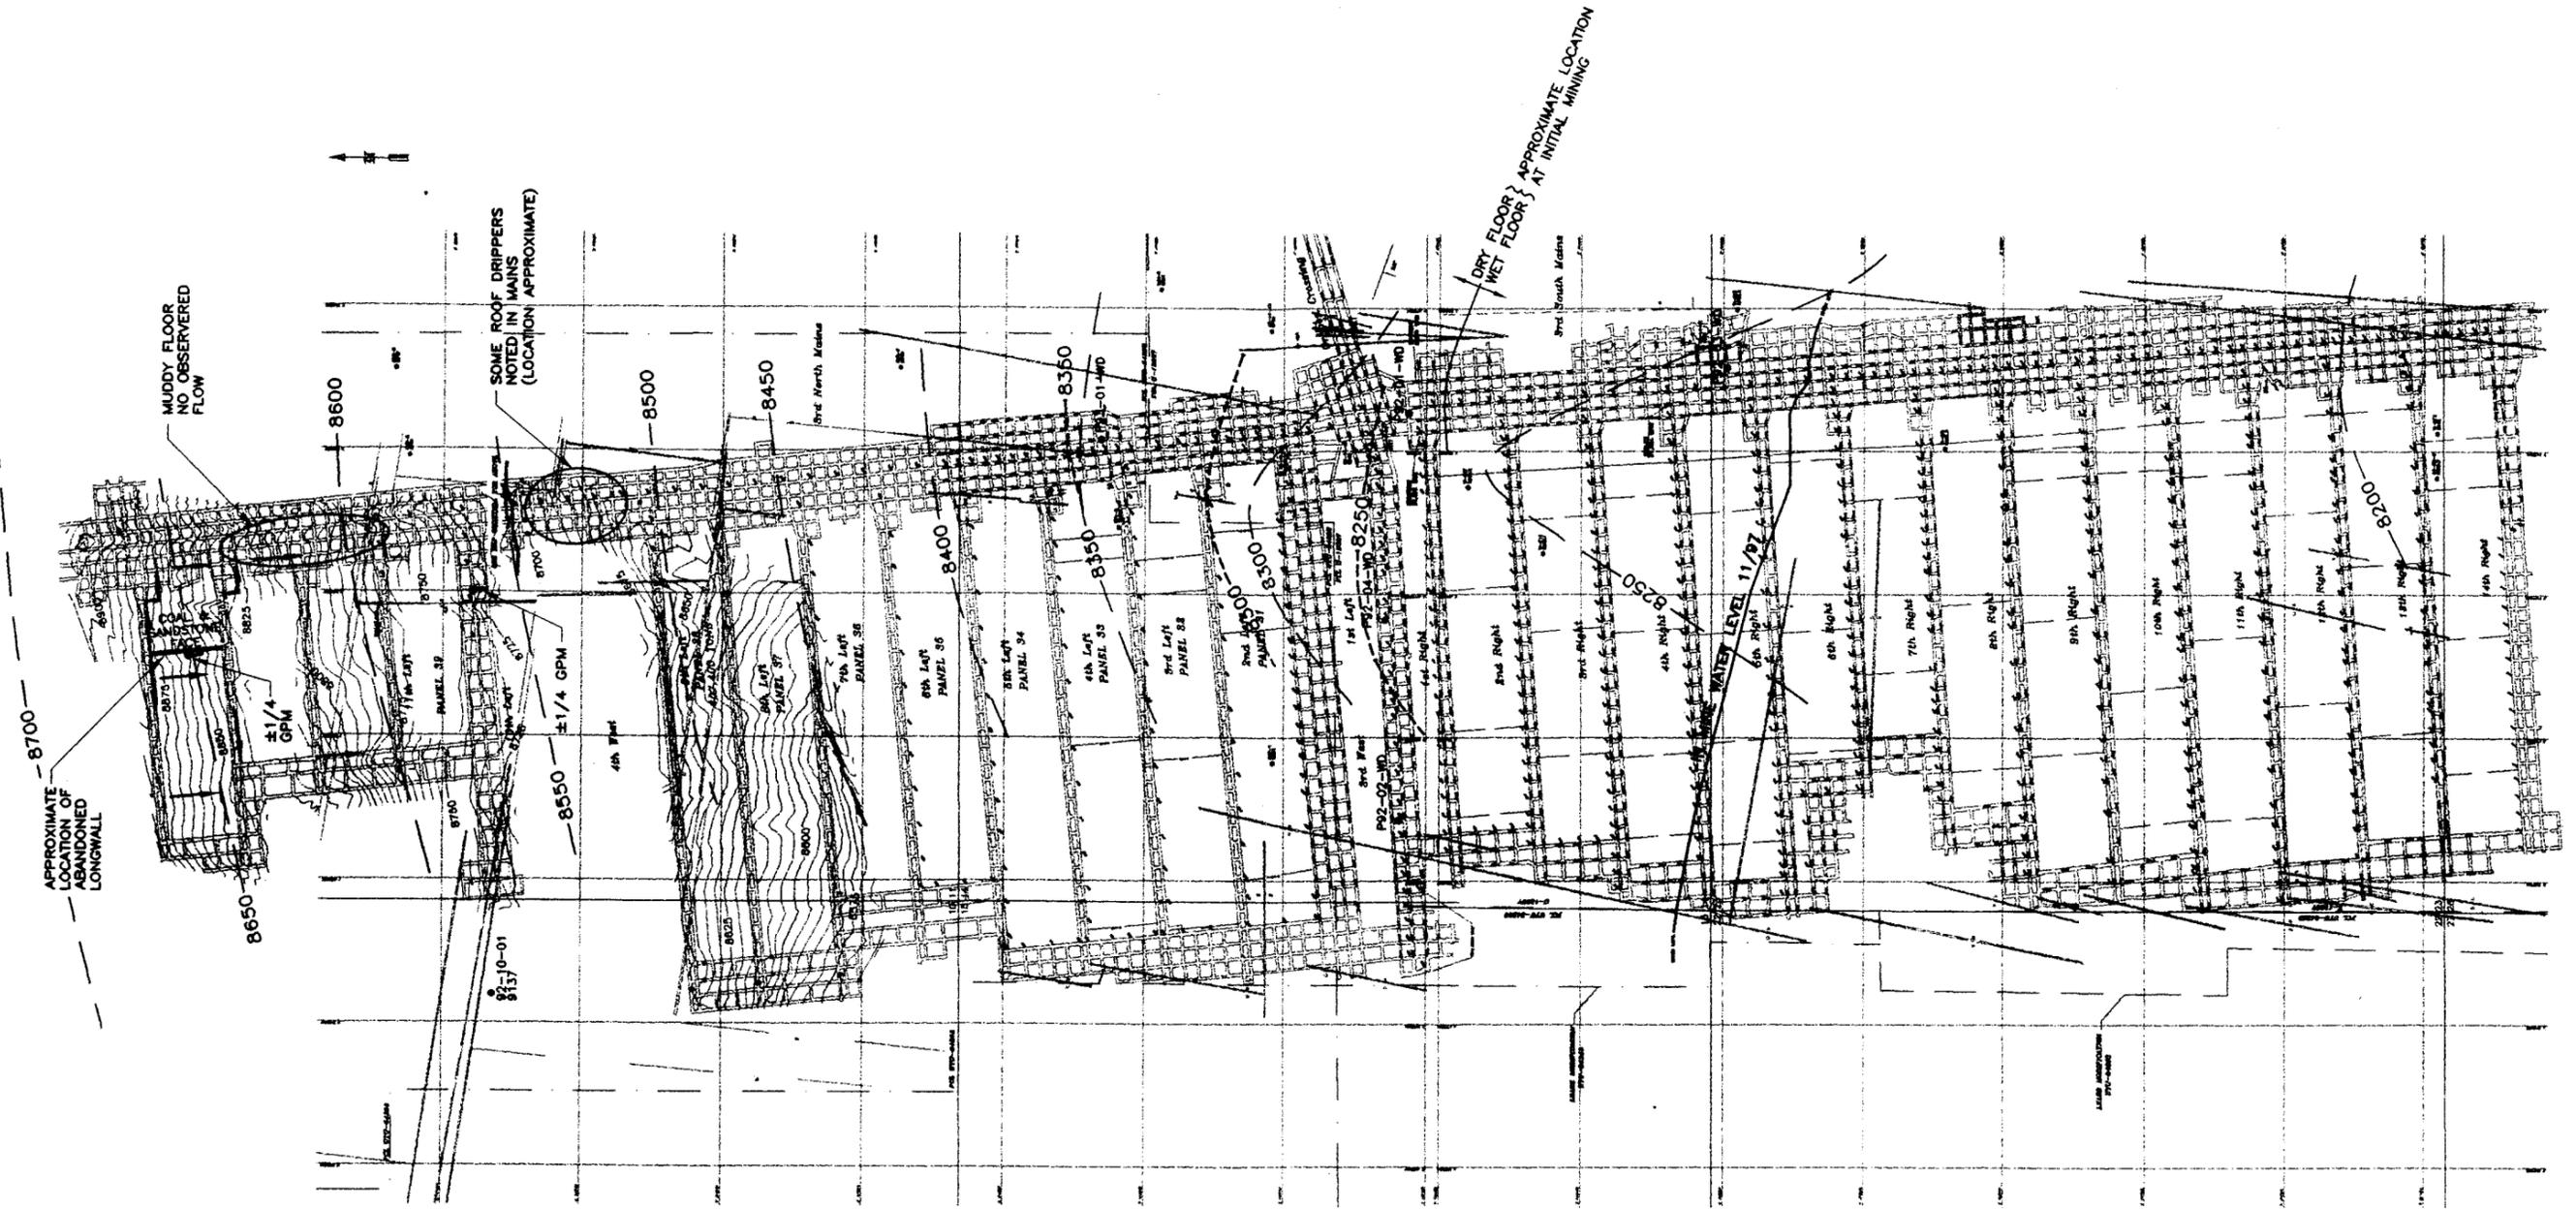
FIGURE NO.
 1
 OF 1
 002-19-100

Initial hydrogeologic investigations of the Gentry Ridge Coal tract completed in the late 1980's and early 1990's projected a southward trending groundwater gradient which would be intercepted by mining within a short distance south of the Graben Crossing. Further clarification regarding where the water might be encountered during mining was made following the completion of drill holes P92-01-WD, P92-02-WD and P92-04-WD. Water was subsequently encountered within the 3rd South Mains just south of 1st Right (see Figure 1 attached).

The in-mine ponded water level noted on November 4, 1997 was found at the intersection of Cross-Cut 82 with the #3 Entry, and at the intersection of Cross-Cut 83 with the #2 Entry as shown on the attached figure. As shown on Figure 1, the current water level is below (south) of the dry/wet interface noted during mine development. Current data taken from the monitoring wells identified above shows an approximate overall net decline in water level (depending upon well location) to be between 25 and 118 feet. Overlaying 1993 water level data over mine workings containing the abandoned Longwall unit shows that the water level is in excess of 210 feet below the mine workings. Current water levels would be greater than 210 feet deep since local water levels have dropped since 1993 as documented above. Since long term water levels can not rise to the pre-mining levels noted on Figure 1 (due to tunnel diversions), there is no possibility of the mine being flooded with base groundwater.

The Longwall unit is located near the extreme north end of the abandoned mine workings, and is itself located just west of a natural ridge. As shown on Figure 1, any water found within the mains just north and east of the Longwall will move east, then southward. Similarly, any water found north and west of the Longwall, will move within the gob area to the south and west. Any pooling which could occur within the gob area behind the Longwall unit will overtop down gradient tunnel intersections and continue to move southward away from the abandoned section. A small floor seep located approximately midway along the Longwall unit is discussed hereafter.
