**STAR POINT MINE
1997 SUBSIDENCE
MONITORING REPORT**

ANNUAL REPORT

MARCH 1998

**SUBSIDENCE MONITORING REPORT
1997
STAR POINT MINE
ACT/007/006**

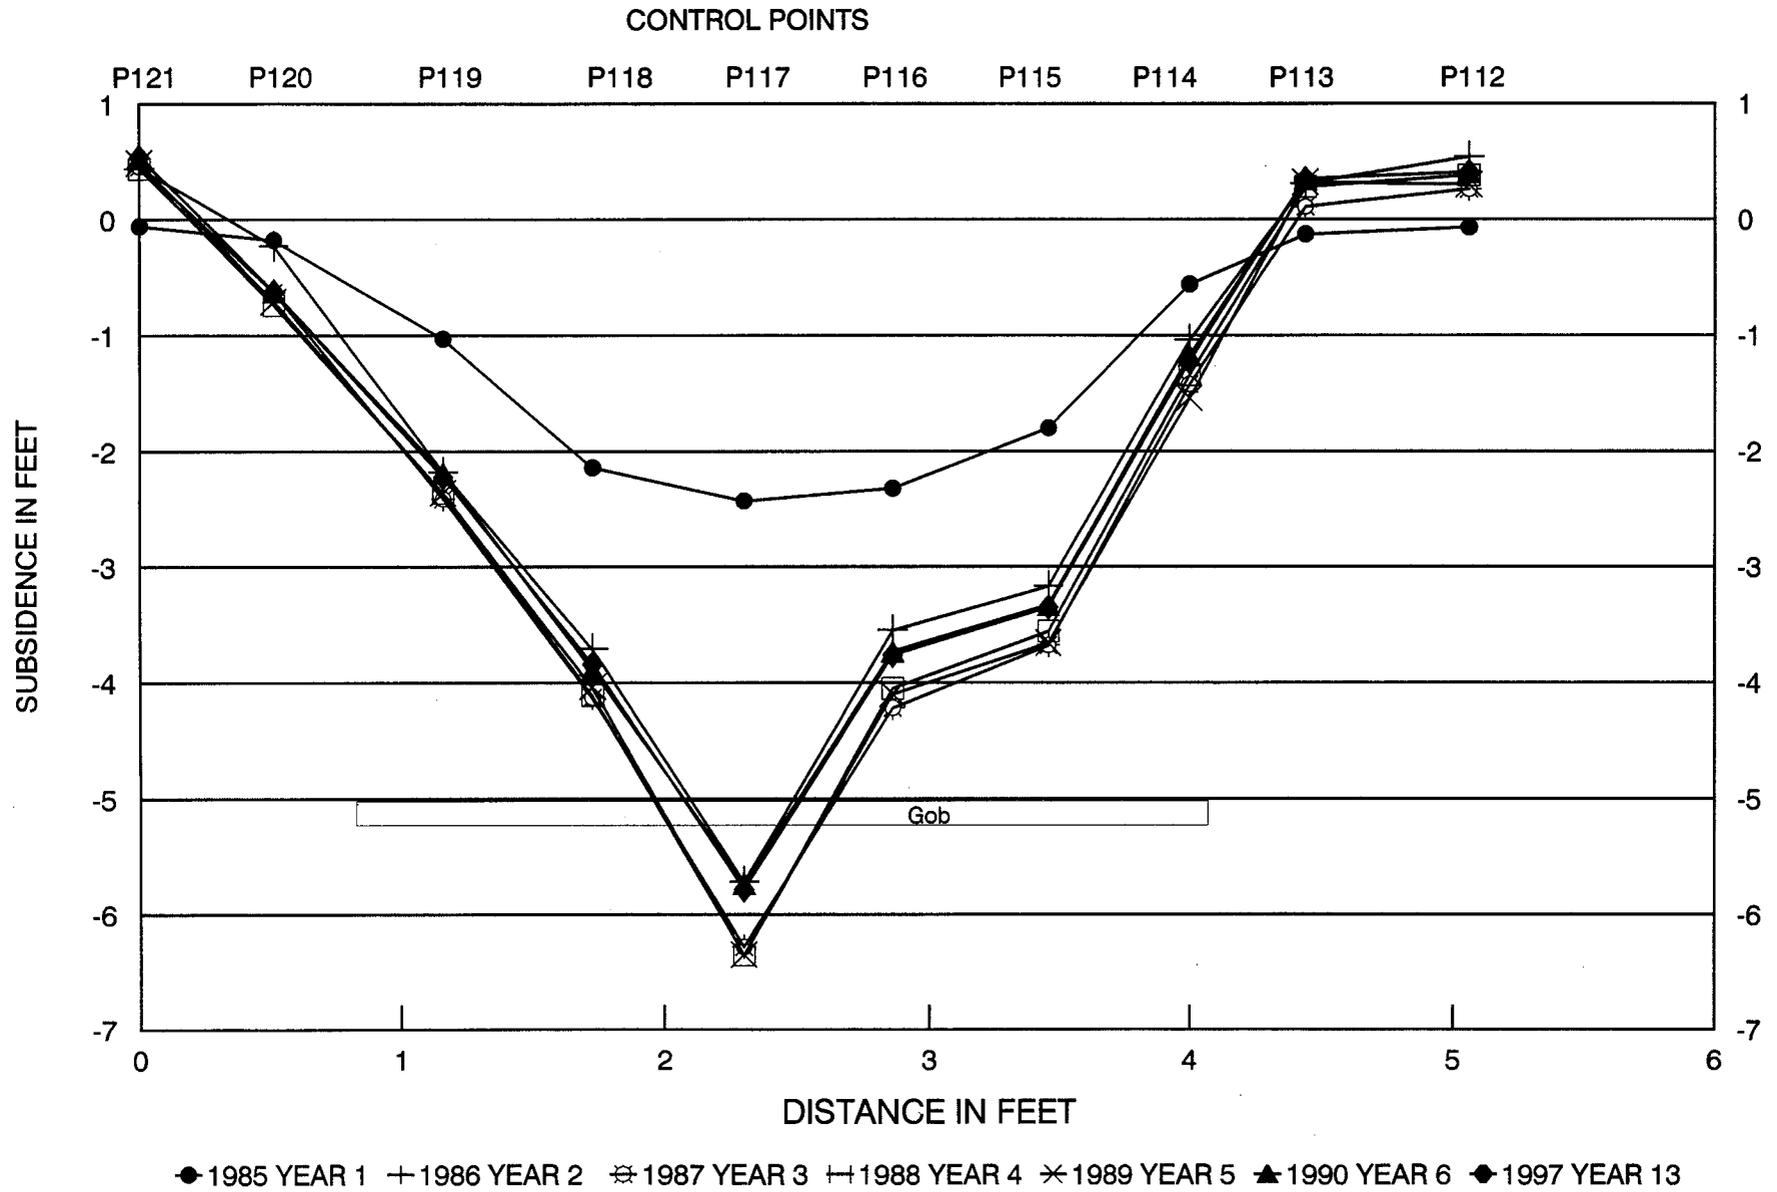
FIGURE 2
CROSS SECTION B-B LONGWALL PANEL 2

Cross sections have been plotted through Panels 1-7, 13 and 14, Cross Section, A-A (Figure 1), Cross Section B-B, Panel 2 (Figure 2), and Cross Section C-C Panel 4 (Figure 3). Cross Section F-F has been plotted of monitoring points U-18 through U-32 (Figure 10) showing the angle of draw at this location of 15 degrees. Refer to Map 521.121e for cross section locations.

As can be seen on Figures 1, 2, and 3, subsidence has stopped above the longwall panels in the area of longwall panels 1-7 and 13 and 14. Subsidence reached its maximum during the third year after mining. Figure 1 shows the subsidence profile diagonally through the nine longwall panels. The progression of subsidence can be seen to the north as successive panels were mined.

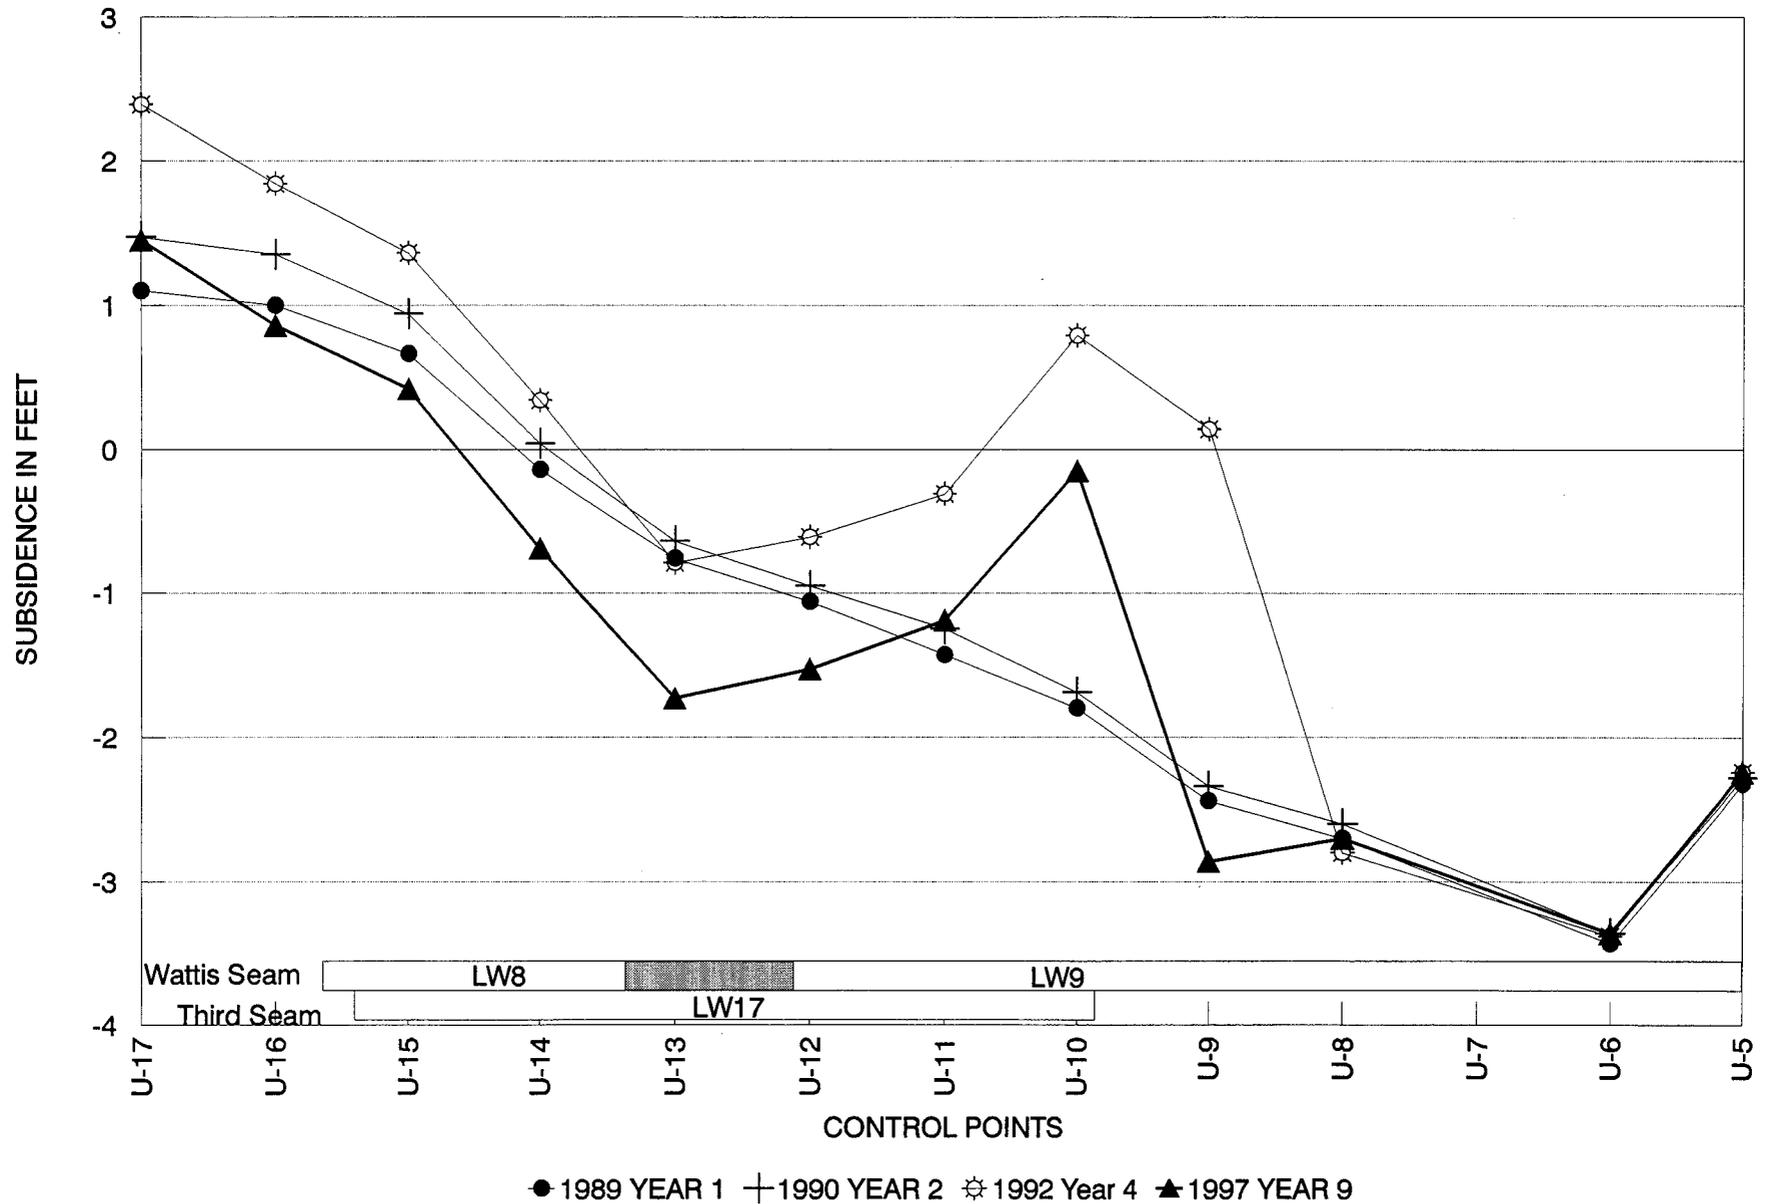
FIGURE 4 U-NORTH NEAR-STREAM PROFILE

Cross Section D-D through Points U5-UI7 in Section 18 (Figure 4) indicates a maximum vertical drop of 3.4 feet. Subsidence in this area has reached its maximum. These monitoring points were monitored in 1997 to verify that maximum movement has been reached, and do not need to be monitored again. They were not monitored in 1993 due to hazardous conditions.

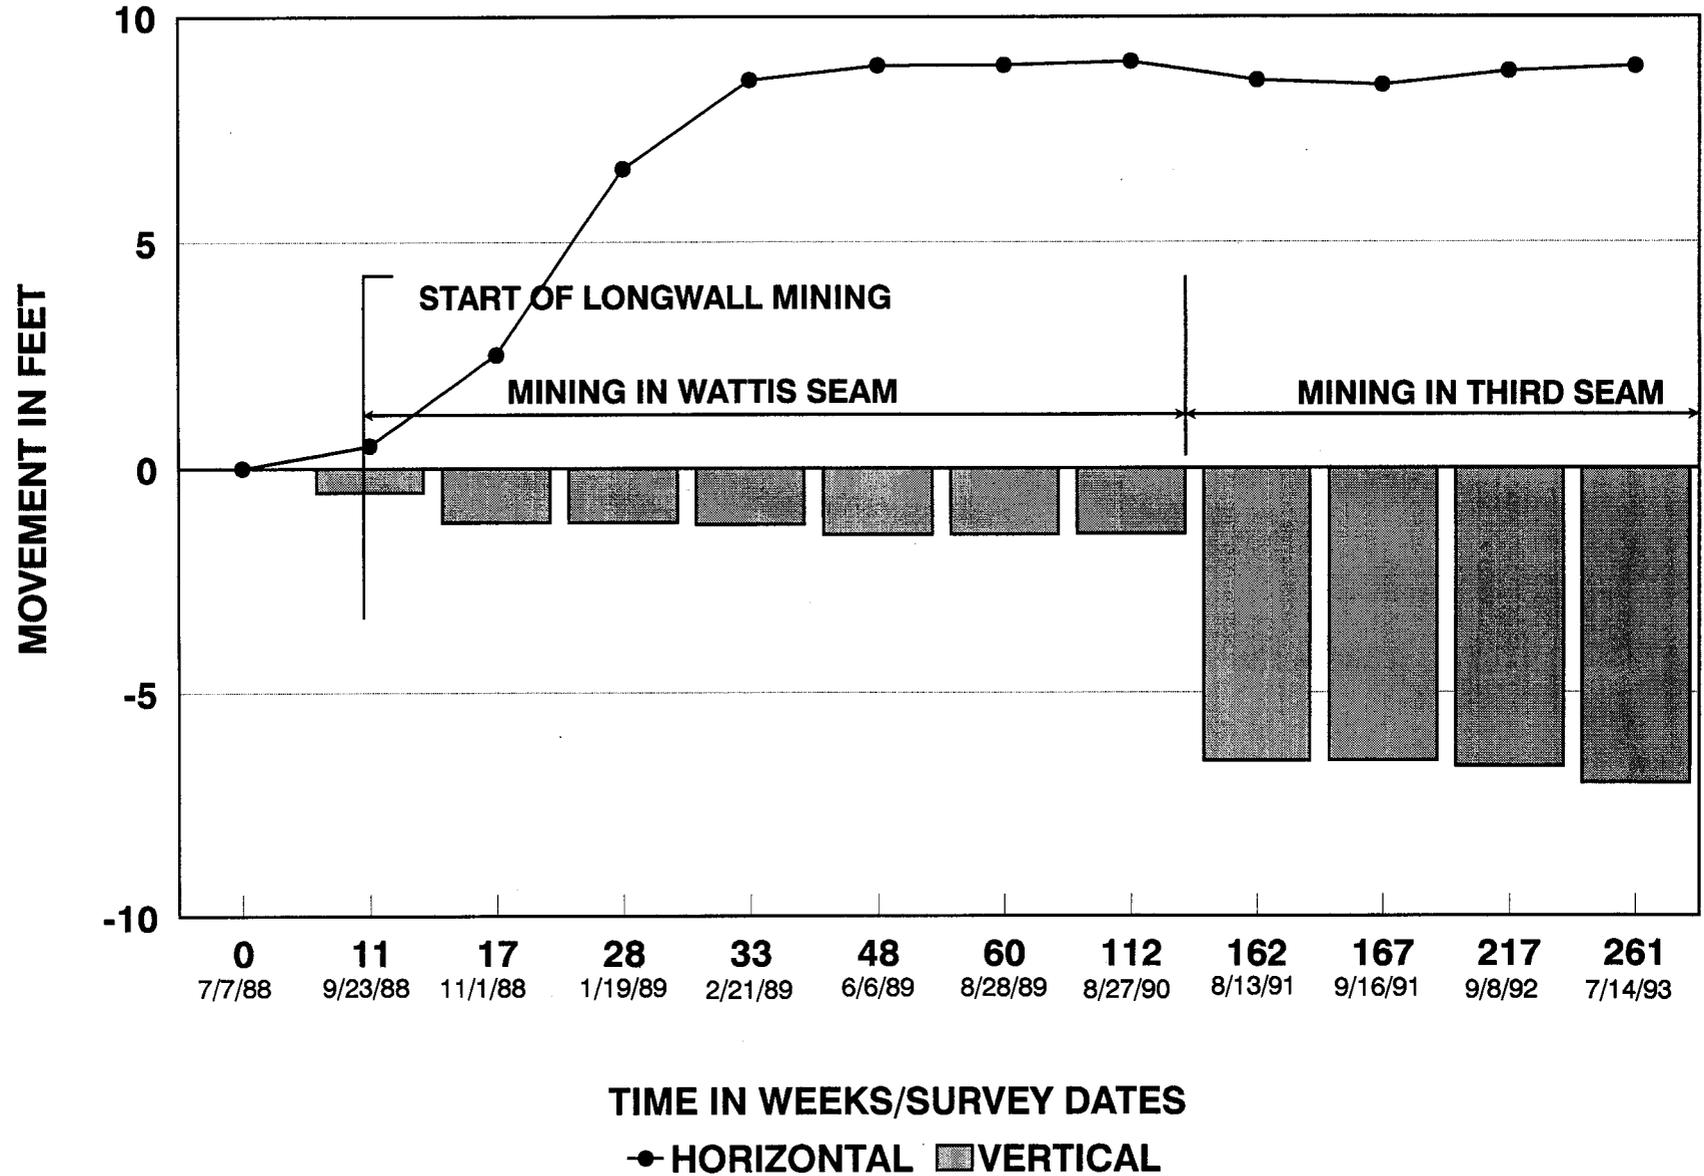
FIGURE 5
U-NORTH SUBSIDENCE MONITORING
HORIZONTAL AND VERTICAL MOVEMENT GRAPH
STATION U1

Horizontal and vertical movement graphs have been made of monitoring points U1, U2, U3, and U4, Figures 5, 6, 7, and 8 respectively. Point U1, which is located directly above the north edge of longwall mining in the Wattis coal seam, shows the most vertical and horizontal movement. Point U4 which is located north of mining in the Wattis Seam and at the north edge of mining in the Third Seam shows the least movement. These monitoring points have reached maximum subsidence and do not need to be monitored again.

A portion of the surface cracks near monitoring points U1 and U2 in Section 18 have been repaired to reduce the likelihood of accidents. The cracks were backfilled and the area fenced. Signs are in place in the area warning the public of the potential danger of the unstable ground. This area is fee land owned by the U.S. Fuel Company; Cyprus Plateau Mining Corporation has an agreement with U.S. Fuel which allows mining impacts. In the fall of 1995, the cracks were plugged with foam to provide additional protection to the public and provide a base for future backfilling.

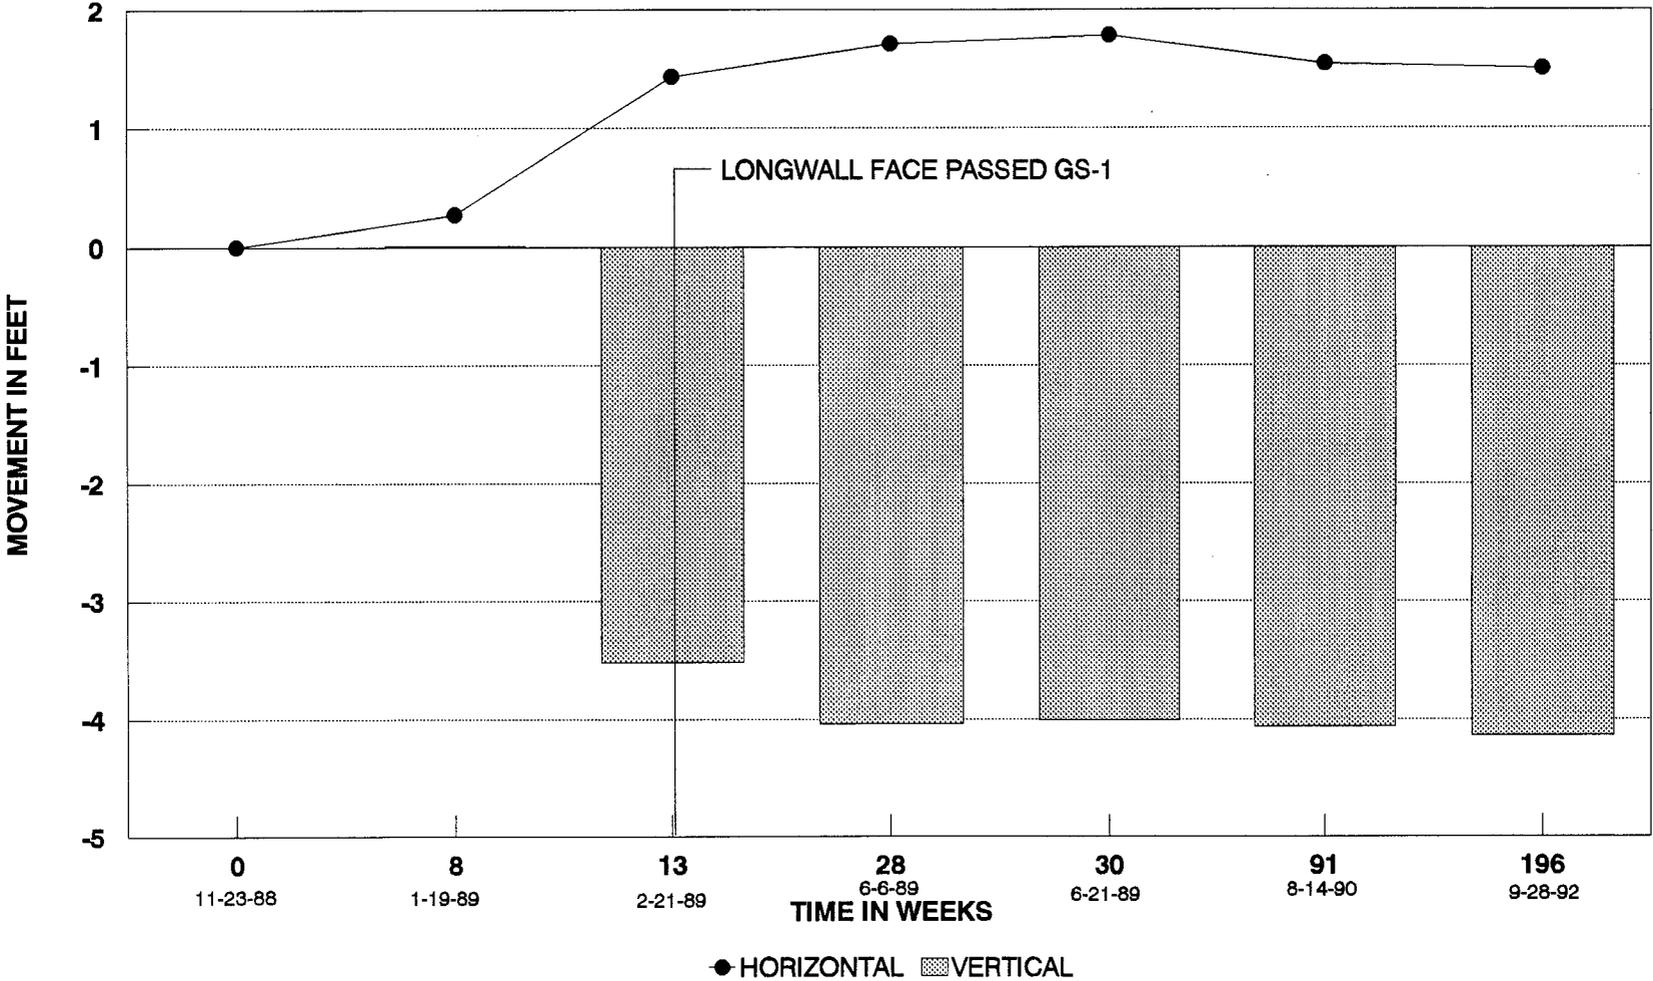
FIGURE 9
STATION GS-1 U-NORTH
HORIZONTAL AND VERTICAL MOVEMENT GRAPH

A horizontal and vertical movement graph (Figure 9) has been plotted of monitoring point GS-1 near the stream in Section 18. Probably because of the shallow overburden at the GS-1 point location, maximum subsidence occurred within 15 weeks of the longwall face passing the point. This monitoring point was not surveyed in 1991 and 1993 because of the hazardous condition previously discussed but, was surveyed in 1992. Mining of the Third seam was approximately 220 feet away and appears to have had only minor additional impact on this point.

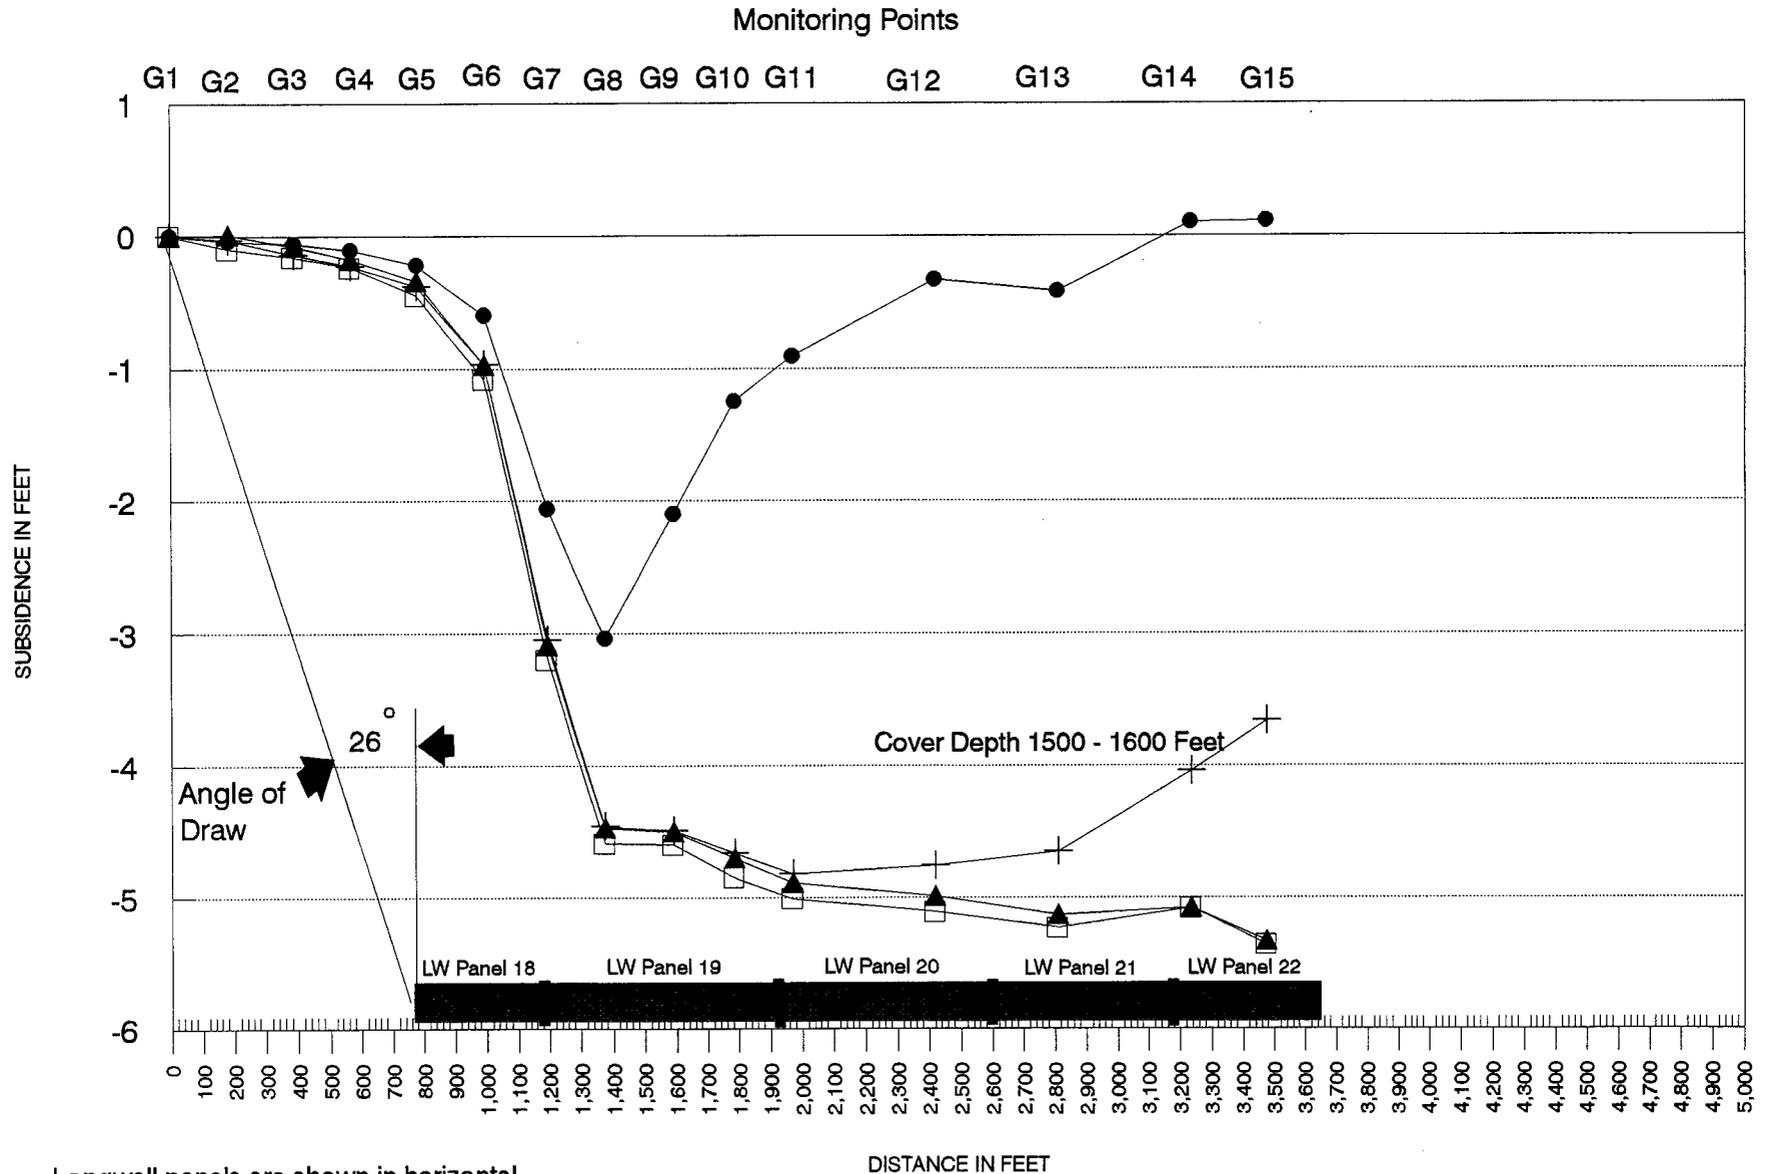
FIGURE 11 CROSS SECTION D-D

Monitoring points G-1 through G-19 were not surveyed in 1997; Cross Section D-D, Figure 11 shows the subsidence profile. As can be seen on Figure 11, subsidence appears to have reached maximum extent in this area. Monitoring points G-20 through G-49 as shown on Map 521.121f were surveyed for vertical movement. Cross Sections D-D (Figure 11), E-E (Figure 12), G-G (Figure 13), H-H (Figure 14), I-I' (Figure 15), and J-J' (Figure 16) were plotted from the data at these monitoring points. As can be seen on the cross sections, maximum subsidence is 5.33 feet at monitoring station G-

As shown on Cross Sections D-D and E-E, Figures 11 and 12 respectively, the angle of draw at these locations is 26 degrees and 24 degrees. The angle of draw at Cross Sections G-G and H-H, Figures 13 and 14 respectively are 25 degrees and 5 degrees, respectively. It appears that the angle of draw is affected by faulting or jointing of the strata. No conclusions can be reached about the angle of draw at Cross Sections I-I' and J-J' because subsidence is felt to be within surveying accuracy.

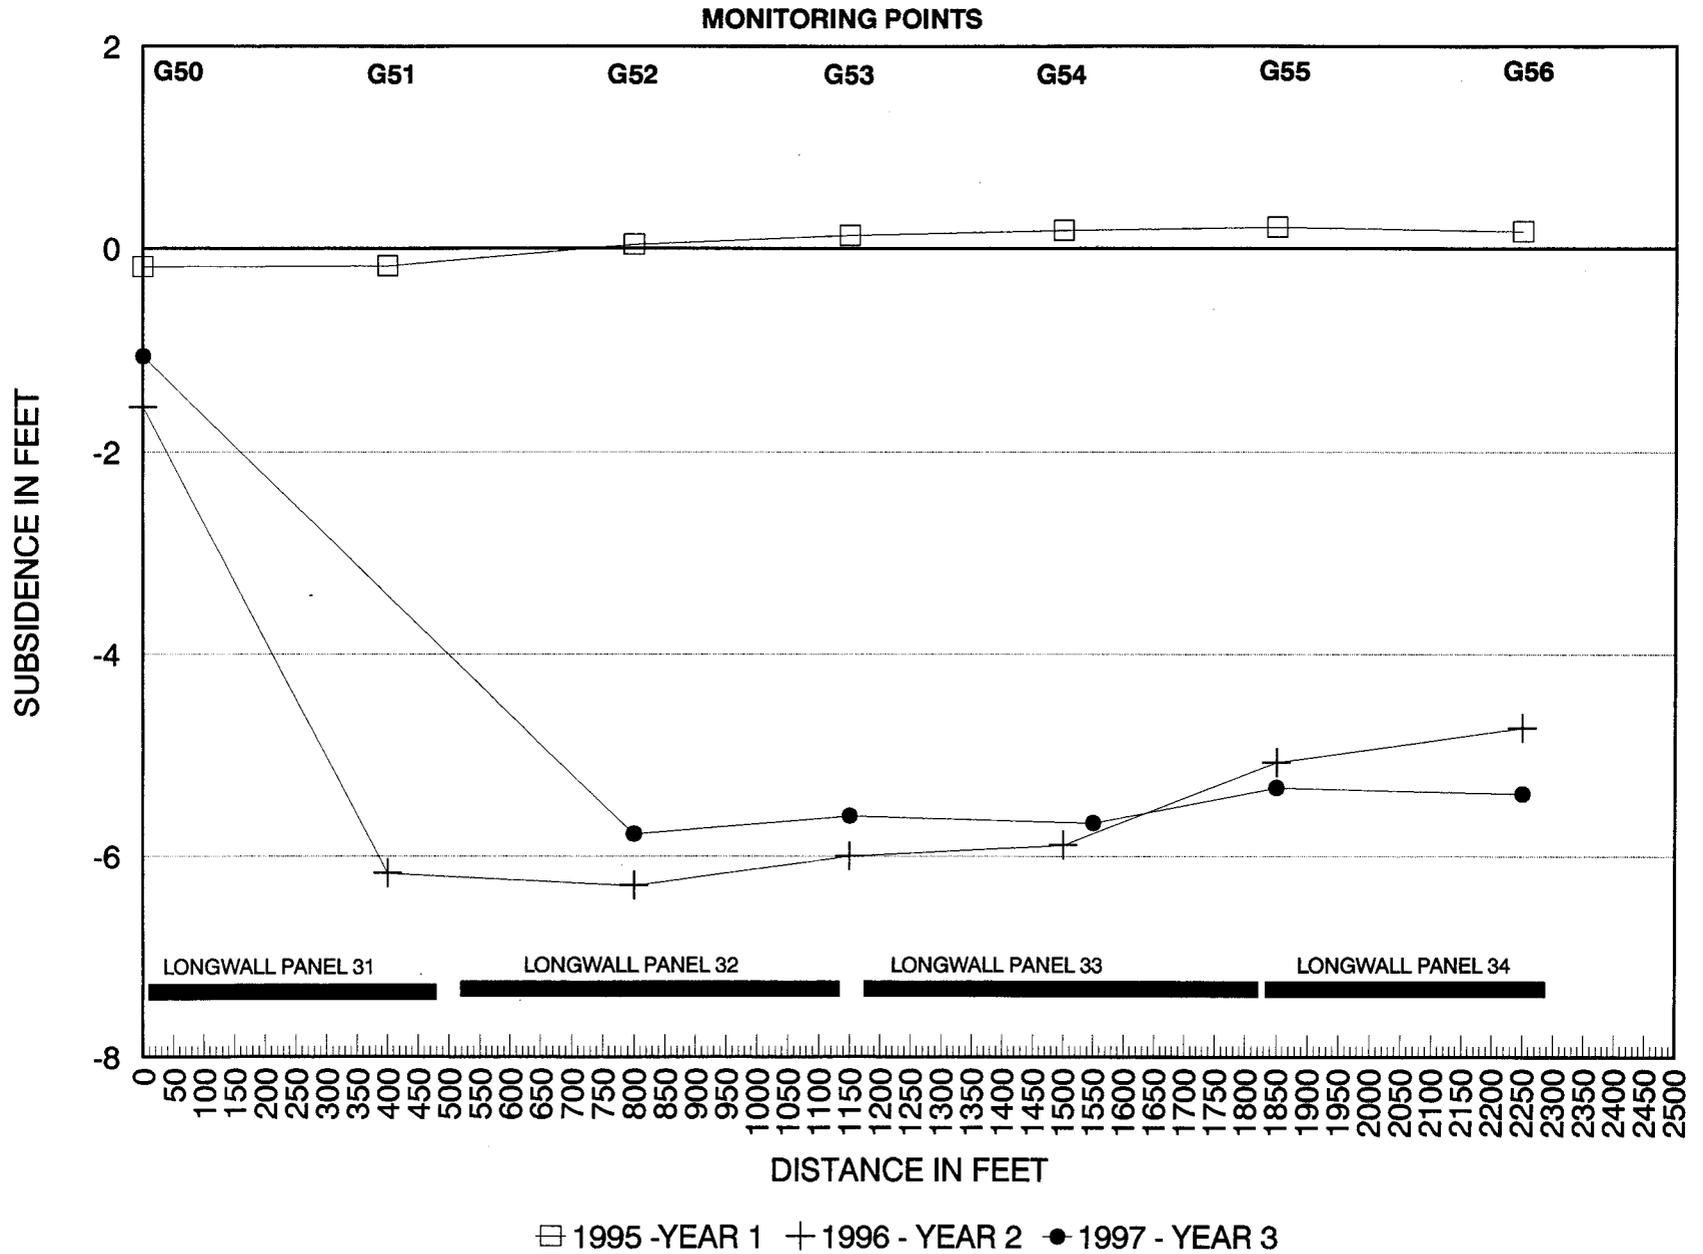
FIGURE 17
CROSS SECTION K-K'

Monitoring points G-50 through G-104, as shown of Map 521.121g1, were surveyed for vertical movement. Cross sections K-K' (Figure 17), L-L' (Figure 18), M-M' (Figure 19), N-N' (Figure 20), O-O' (Figure 21), and P-P' (Figure 22) were plotted from data at these monitoring points. Maximum subsidence during the 1997 monitoring is 6.59 feet a station G-58 above Longwall Panel Number 32.

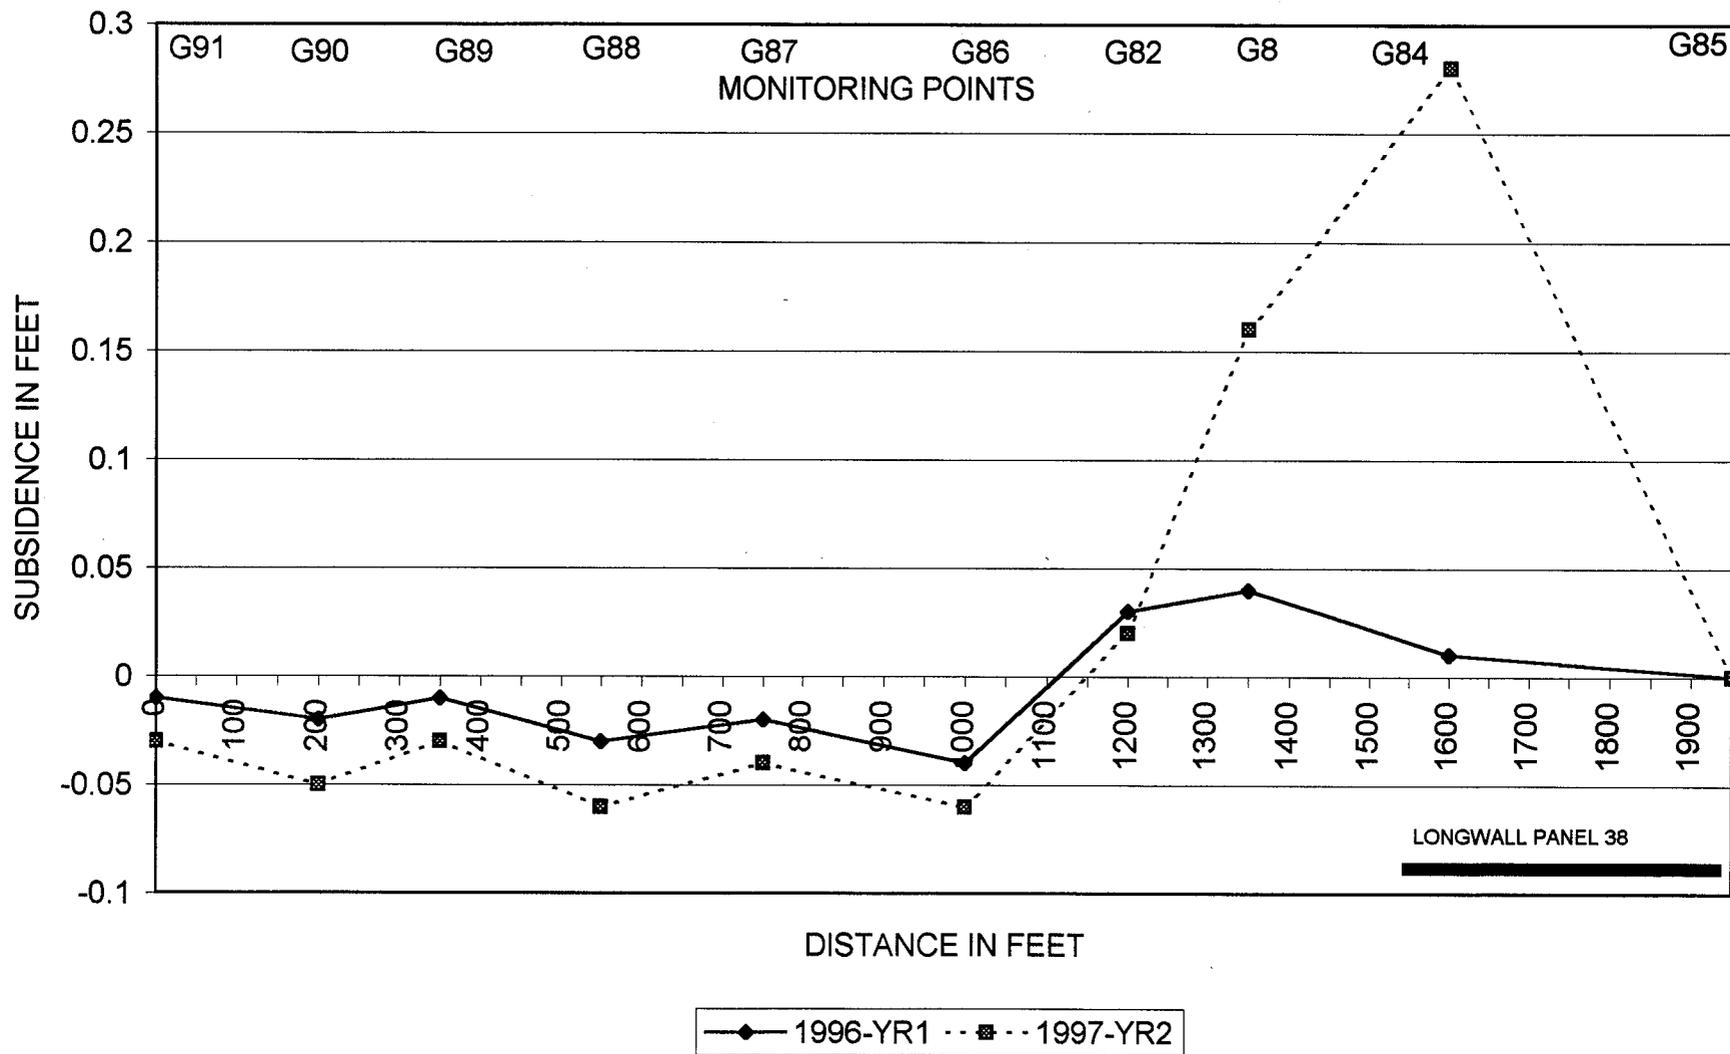
FIGURE 20
CROSS SECTION N-N'

Mining of the entries beneath the Little Park channel was not conducted. Even though subsidence Cross Sections N-N', and O-O' indicate minor subsidence beneath the channel, it is not clear that subsidence actually occurred. The channel is outside of the angle of draw expected when comparing the angle of draws experienced elsewhere in the area west of the graben. There is no physical evidence of subsidence at the ground surface in the channel. Further monitoring in 1998 and beyond will document any ground surface movement or cracking in this area.
