State of Utah
 DEPARTMENT OF NATURAL RESOURCES
 DIVISION OF OIL, GAS AND MINING

October 31, 2000

Re: Technical Field Visit Corner Canyon Reclamation, Plateau Mining Corporation,
 Star Point Mine, ~~000000~~

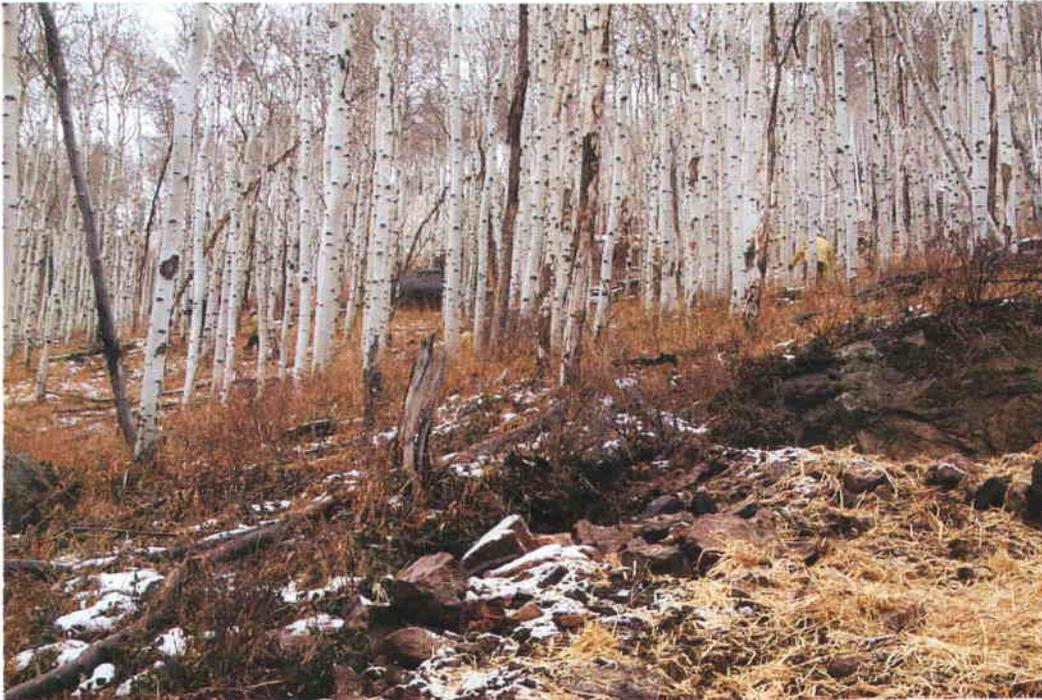
Figure 1

The cut slopes are 3 feet to 4 feet high. Much of the highwalls are in bedrock that has a very high slope stability safety factor. See Figures 1 through 3.

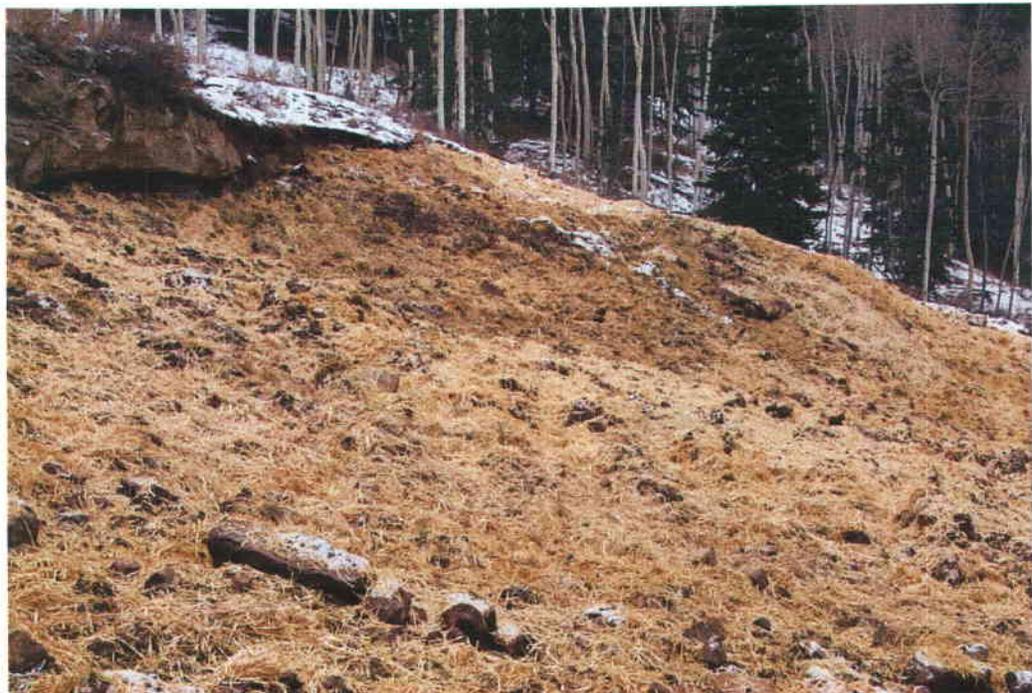
Figure 2

The highwalls were eliminated. Figures 2 and 3 show the reclaimed fan highwall. The location of the portal is shown by the log sticking out of the ground in Figure 3. The permittee was able to reclaim the highwall by constructing a ramp to push the fill material above the portal.

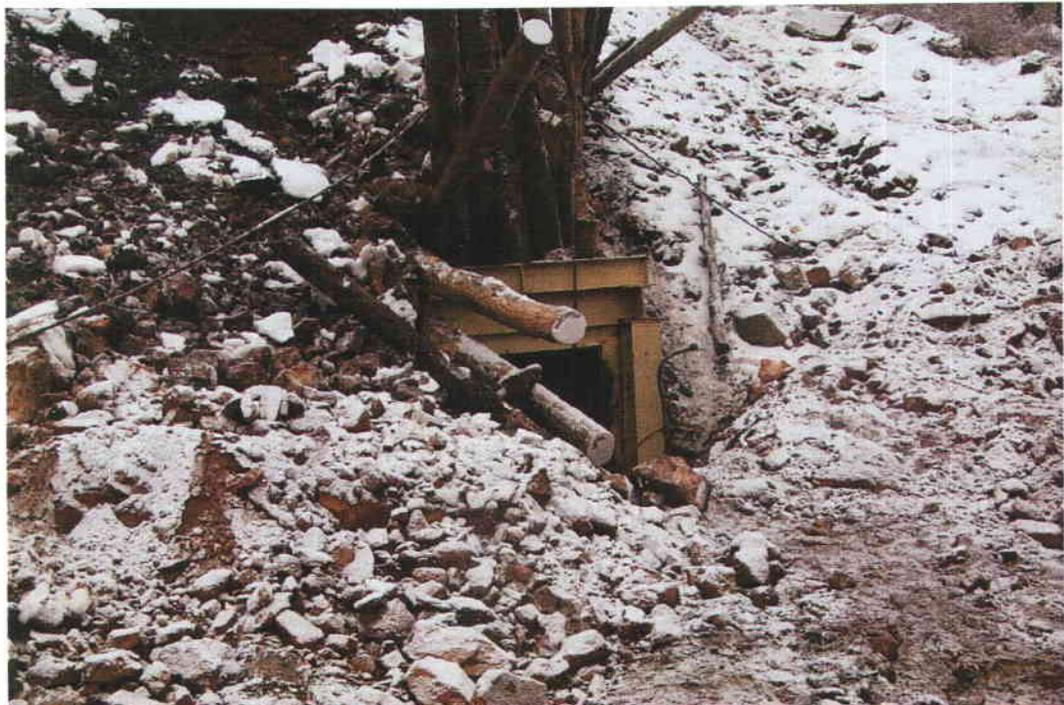
Figure 4

The portals were backfilled by constructing a log fence above the portal. Fill was placed behind the log fence. The cables holding the log fence were released and the fill slide over the portal. At the fan portal the fill did not completely cover the portal. The permittee hand-shoveled fill to seal the portal completely. See Figure 4.

The portals will be sealed from inside the mine by backfilling the area 25 feet and placing a seal. The seal and backfill are needed to prevent air from entering the mine. After the portals were backfilled from the surface the sound of air flowing into the mine could still be heard.
