**State of Utah**  
 DEPARTMENT OF NATURAL RESOURCES  
 DIVISION OF OIL, GAS AND MINING

December 21, 2000

Re: Technical Field Visit to the Mudwater Canyon Fan Portals, Plateau Mining Corporation, Star Point Mine, C/007/006

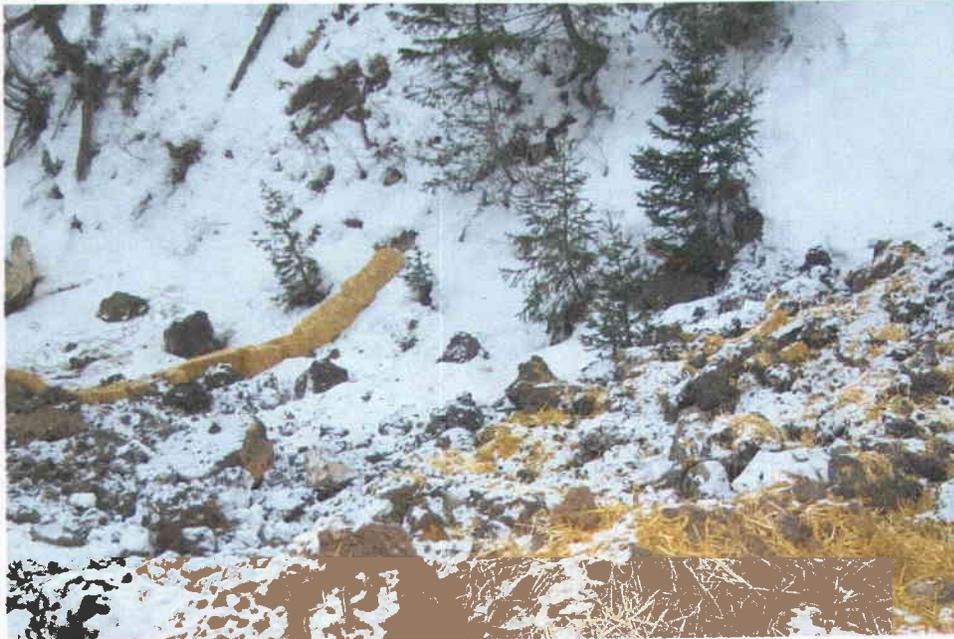
During the previous field visit on November 27, 2000, Division staff had made a few suggestions about the channel and the berm along the edge of the disturbed area. The operator made the changes to the channel by putting more rock in the transition area just before it makes a steep drop. The channel was also better defined than it had previously been. (See Figures 1 and 2.)

**Figure 1.** Steep portion of the channel with straw bales at the bottom.

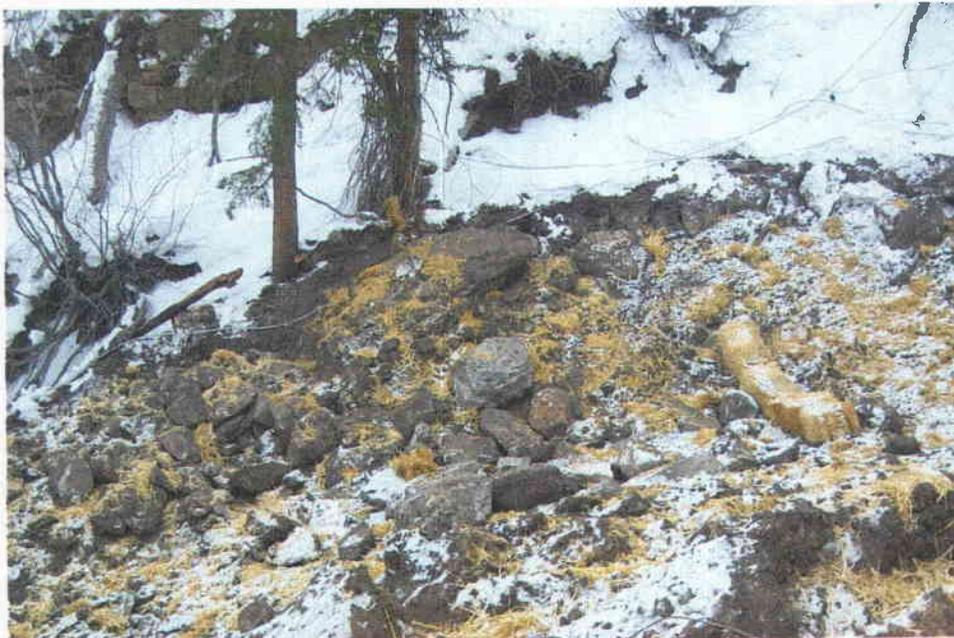
**Figure 2.** Upper portion of the channel with straw bales.

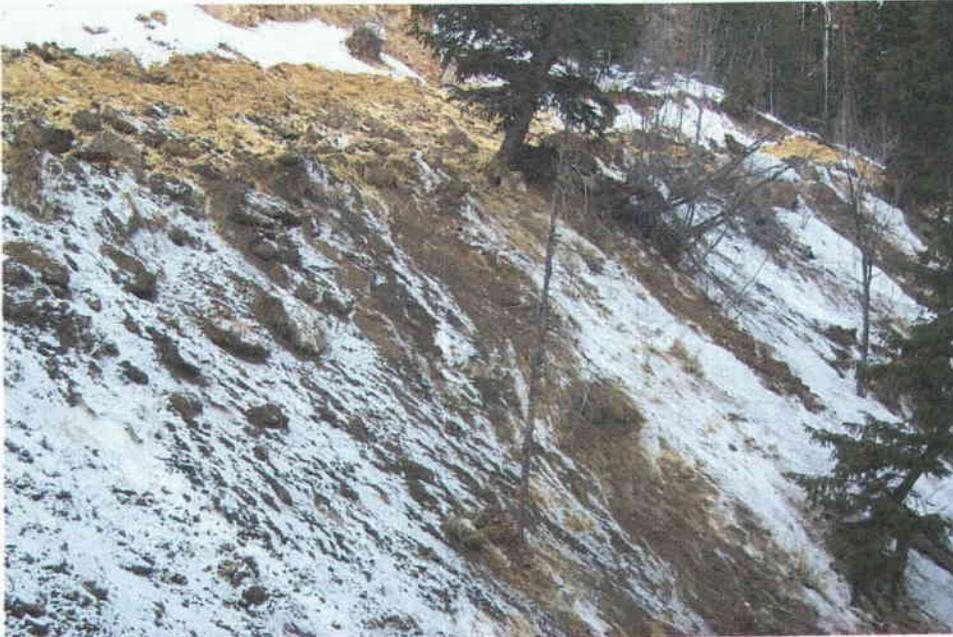
Although the berm was essentially eliminated, there is still a fairly sharp break at the edge of the pad. Because of the limited amount of space available and also because of the small equipment that had to be used, it was not possible to take out this break (see Figure 3).

**Figure 3.** Break in the slope from the disturbed area to the undisturbed area.

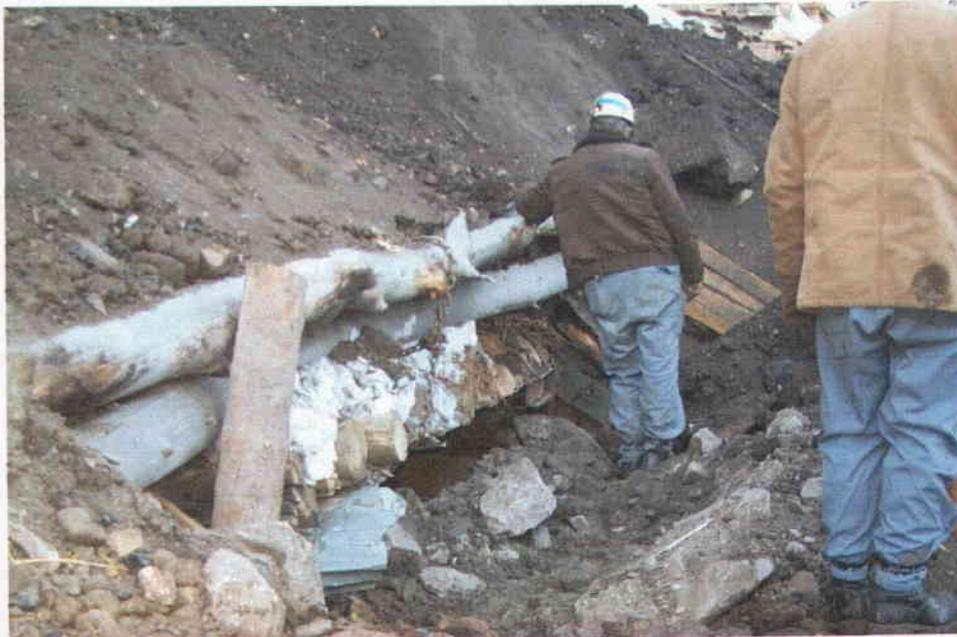
Above the portal brow, the operator had put in two horizontal aspen logs that were held in place by two log posts (Figure 4). Above this "fence," the operator stacked fill with the idea that it would come down and cover the portal when the fence was gone; however, much of the fill was frozen so it did not come down on its own. We used picks and shovels to pull it down by hand after which Mr. Pappas broadcast seeded, we planted about 40 seedlings, and we applied straw mulch. The final configuration is shown in Figures 5 and 6.

**Figure 4.** "Fence" above the portal brow.

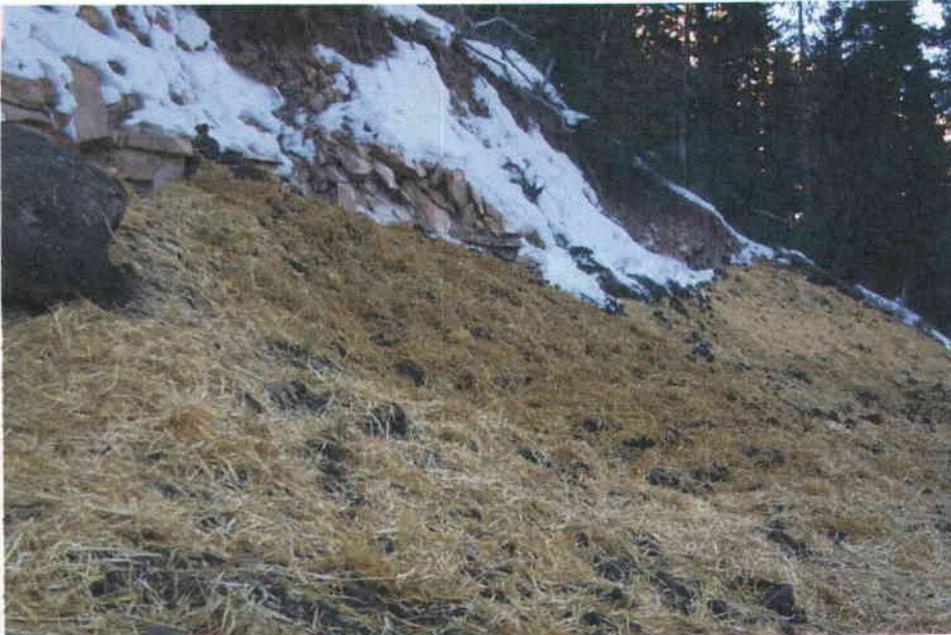
**Figure 5.** Final configuration of the portal area.

The site should be inspected at least once a year for the next few years for any signs of piping into this or any of the other portals. The chances for revegetation success are high, and, between revegetation, roughening, and the mulch, there should not be too much offsite sedimentation. There are two rows of straw bales for sediment control in the channel.

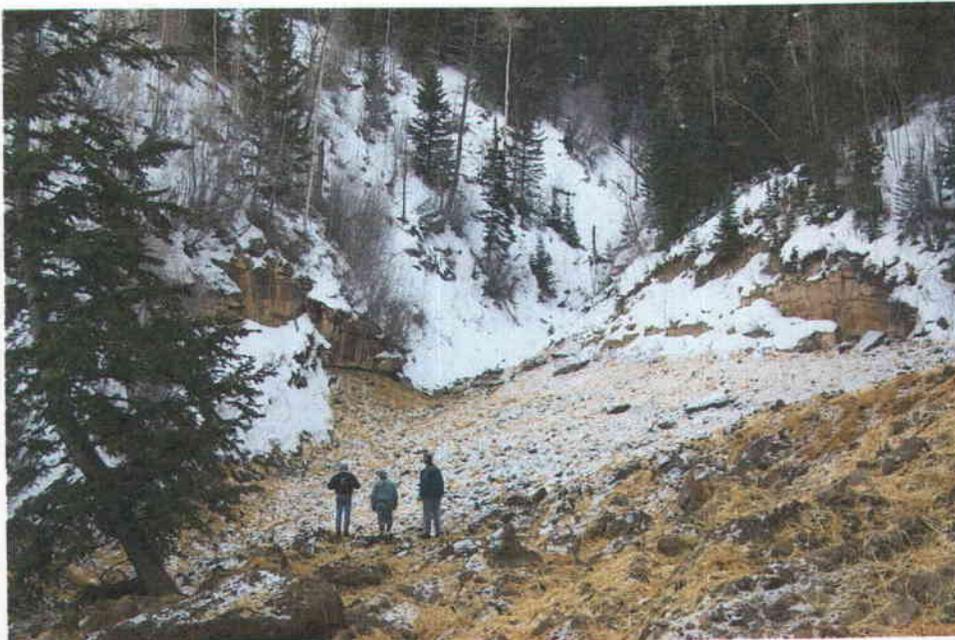
**Figure 6.** Final configuration of the fan portal area. Just to the left of center is a backfilled abandoned portal.

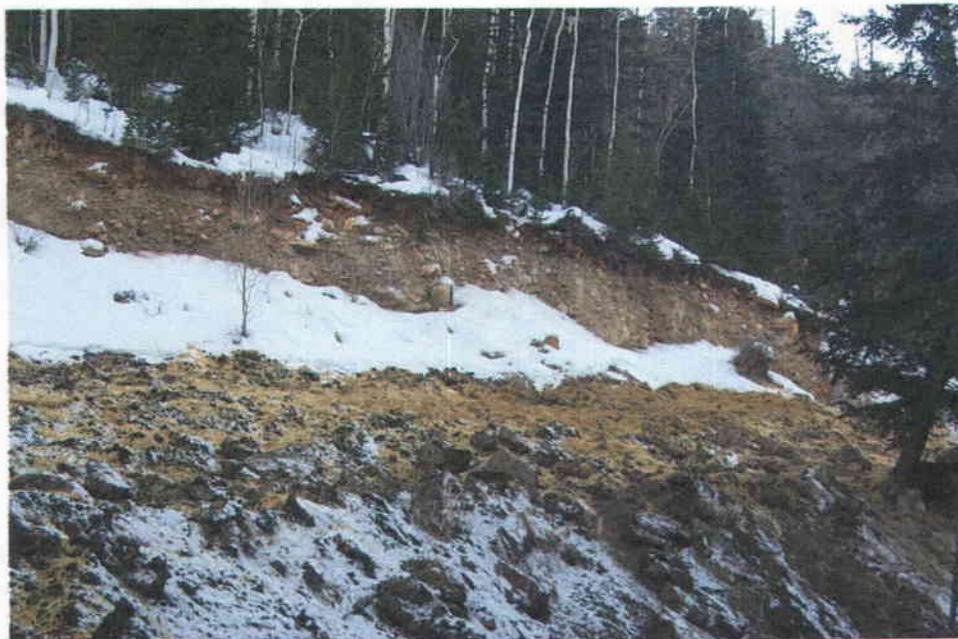
**Figure 7.** Final configuration of the portals to the west of the fan portal.
