Re: Star Point Spring/ Haug Stockpond, Star Point Mine C/007/0006 Outgoing File

INSPECTION REPORT

Subject: Citizens Complaint, Star Point Spring Impacts

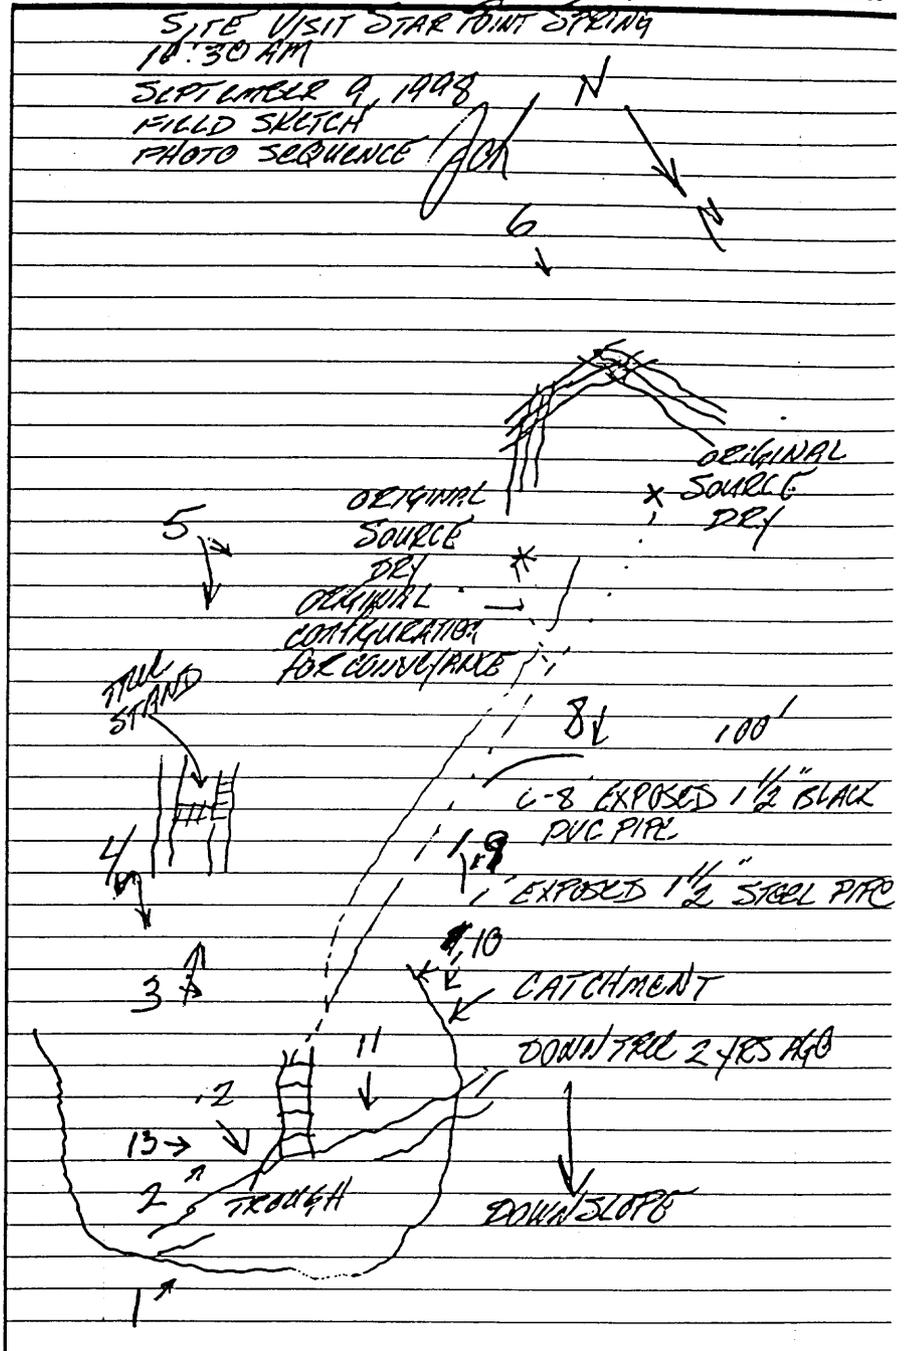
-Sketch/Photo Log prepared by DOGM, Joe Helfrich, on September 9, 1998 showing where each of the 13 photos were taken at the Starpoint Spring site.
